**California Department of Fish and Wildlife  
East Marin County  
San Francisco Bay Watersheds  
Stream Habitat Assessment Reports**

# **Old Mill Creek**

*Surveyed 2009  
Report Completed in 2013*

**STREAM INVENTORY REPORT**

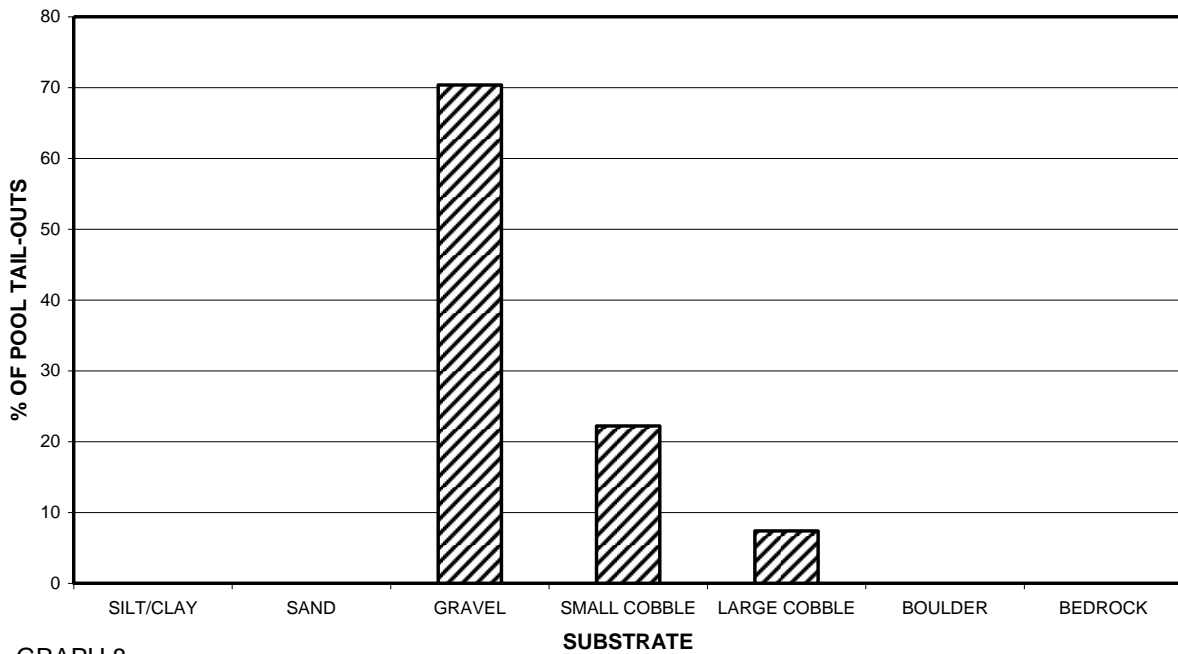
GRAPH 8

Table 6 summarizes the dominant substrate by habitat type. Graph 8 depicts the dominant substrate observed in pool tail-outs. Gravel dominance was observed in 70% of pool tail-outs, small cobble dominance was observed in 22% of pool tail-outs.

### OLD MILL CREEK 2009 SUBSTRATE COMPOSITION IN POOL TAIL-OUTS

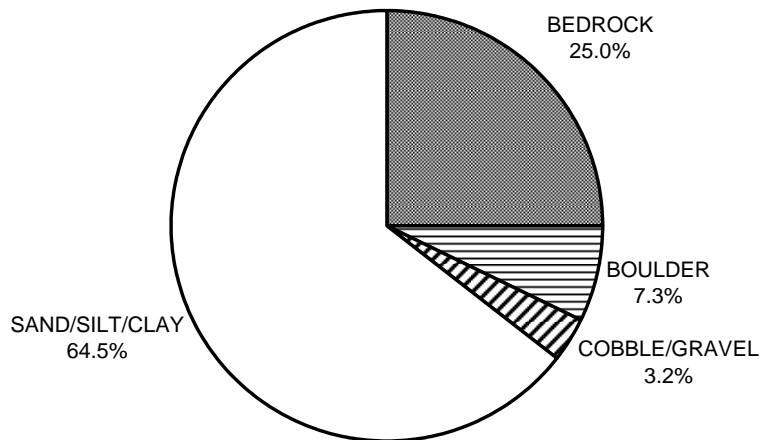
GRAPH 10

For the stream reach surveyed, the mean percent right bank vegetated was 52%. The mean percent left bank vegetated was 46%. The dominant elements composing the structure of the stream banks consisted of 25% bedrock, 7% boulder, 3% cobble/gravel, 65% sand/silt/clay, (Graph 10). Hardwood trees were the dominant vegetation type observed in 33% of the units surveyed. Additionally, 29.8% of the units surveyed had coniferous trees as the dominant vegetation type, and 27.4% had brush as the dominant vegetation (Graph 11).

**OLD MILL CREEK 2009  
DOMINANT BANK COMPOSITION IN SURVEY REACH**

The percentage of right and left bank covered with vegetation 52% and 46%, respectively. In areas of stream bank erosion or where bank vegetation is sparse, planting endemic species of coniferous and hardwood trees, in conjunction with bank stabilization, is recommended.

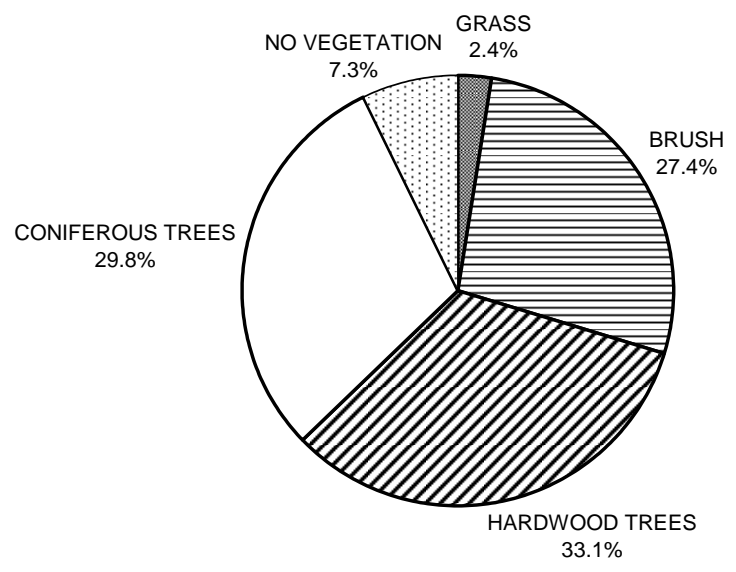
GRAPH 11

**OLD MILL CREEK 2009  
DOMINANT BANK VEGETATION IN SURVEY REACH**
