**California Department of Fish and Wildlife**  
**East Marin County**  
**San Francisco Bay Watersheds**  
**Stream Habitat Assessment Reports**

# **San Anselmo Creek**

*Surveyed 2009*

**STREAM INVENTORY REPORT**

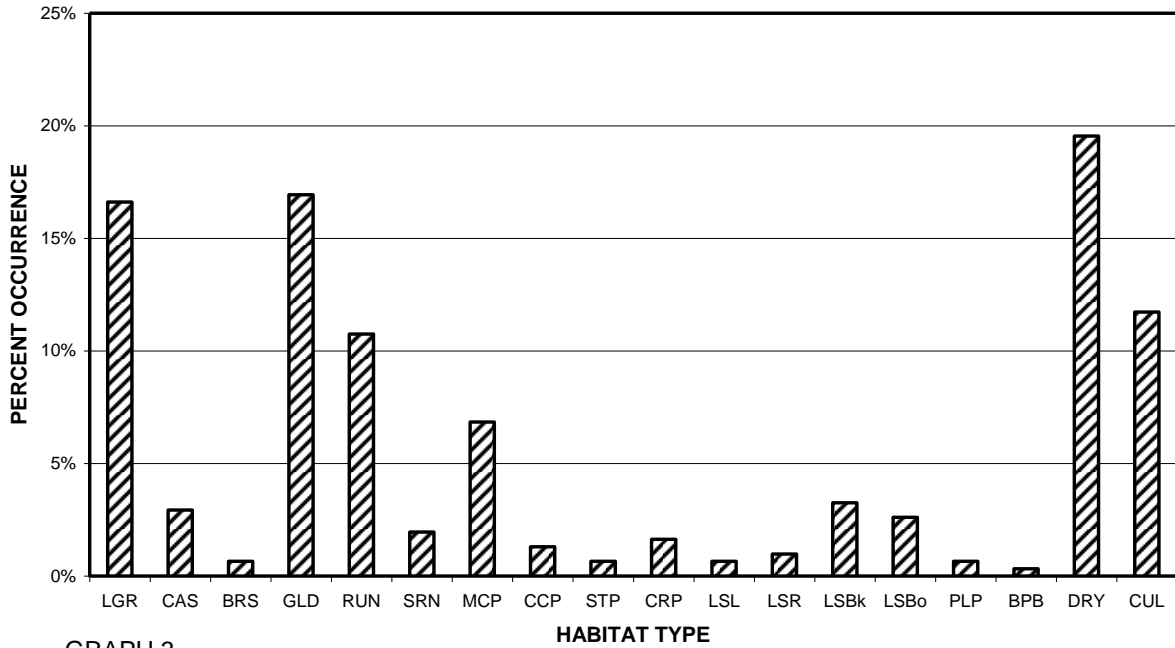
GRAPH 2

**SAN ANSELMO CREEK 2009  
HABITAT TYPES BY PERCENT OCCURRENCE**

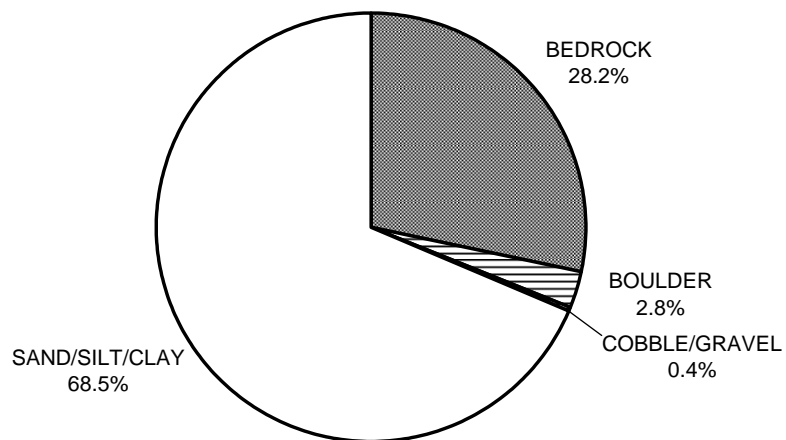
GRAPH 9

For the stream reach surveyed, the mean percent right bank vegetated was 49%. The mean percent left bank vegetated was 53%. The dominant elements composing the structure of the stream banks consisted of 28% bedrock, 3% boulder, and 69% sand/silt/clay (Graph 10). Hardwood trees were the dominant vegetation type observed in 65% of the units surveyed. Additionally, 27% of the units surveyed had brush as the dominant vegetation type, and 3% had grass as the dominant vegetation (Graph 11).

**SAN ANSELMO CREEK 2009  
DOMINANT BANK COMPOSITION IN SURVEY REACH**
