STREAM INVENTORY REPORT

Larsen Creek

A stream inventory was conducted on 9/14/2005 on Larsen Creek. The survey began at the confluence with San Geronimo Creek and extended upstream 0.5 miles.

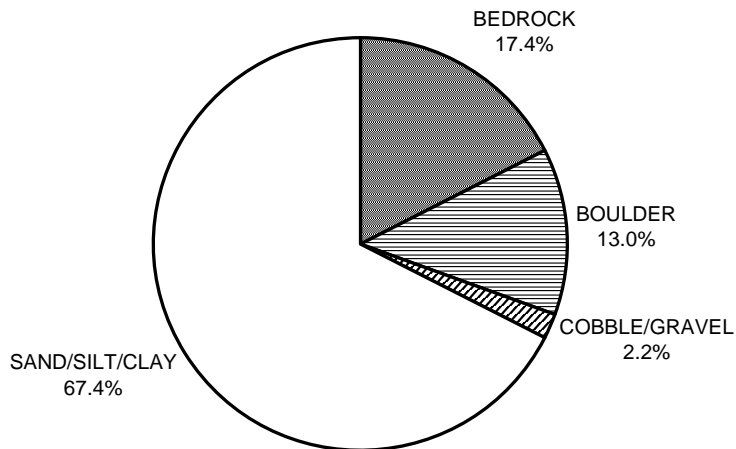
GRAPH 10

For the stream reach surveyed, the mean percent right bank vegetated was 68%. The mean percent left bank vegetated was 74% (Table 7) The dominant elements composing the structure of the stream banks consisted of 67% sand/silt/clay 17% bedrock, 13% boulder and 2% cobble/gravel (Graph 10). Hardwood trees were the dominant vegetation type observed in 61% of the units surveyed. Additionally, 28% of the units surveyed had brush as the dominant vegetation type, and 11% had grass as the dominant vegetation (Graph 11).
