**California Department of Fish and Game
Walker Creek Watershed
Stream Habitat Assessment Reports**

Salmon Creek

STREAM INVENTORY REPORT

Assessment October 2008

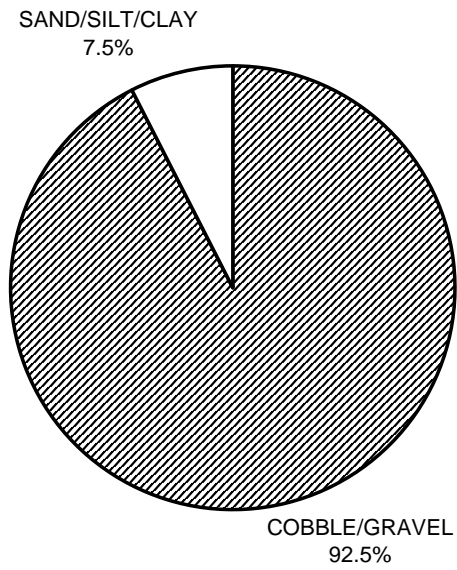
GRAPH 9

For the stream reach surveyed, the mean percent right bank vegetated was 78%. The mean percent left bank vegetated was 82%. The dominant elements composing the structure of the stream banks consisted of 92% cobble/gravel, 8% sand/silt/clay, (Graph 10). Deciduous trees were the dominant vegetation type observed in 90% of the units surveyed. Additionally, 8% of the units surveyed had grass as the dominant vegetation type.

**SALMON CREEK 2008
DOMINANT BANK COMPOSITION IN SURVEY REACH**

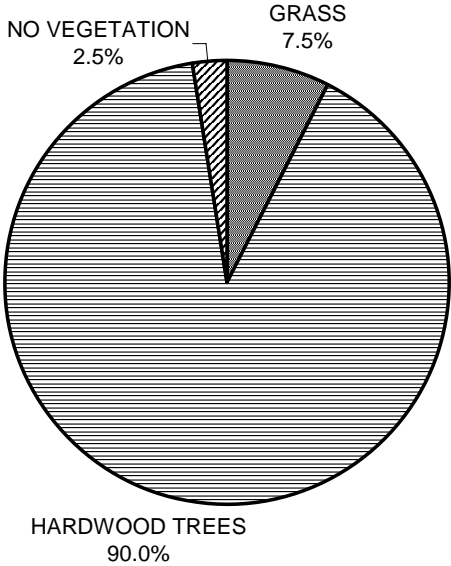
GRAPH 10

**SALMON CREEK 2008
DOMINANT BANK VEGETATION IN SURVEY REACH**

The percentage of right and left bank covered with vegetation was HIGH at 78% and 82%, respectively. In areas of stream bank erosion or where bank vegetation is sparse, planting endemic species of coniferous and hardwood trees, in conjunction with bank stabilization, is recommended.
