California Department of Fish and Game
Lagunitas Watershed
Stream Habitat Assessment Reports

Upper San Geronimo Creek

STREAM INVENTORY REPORT

Assessment completed 2007

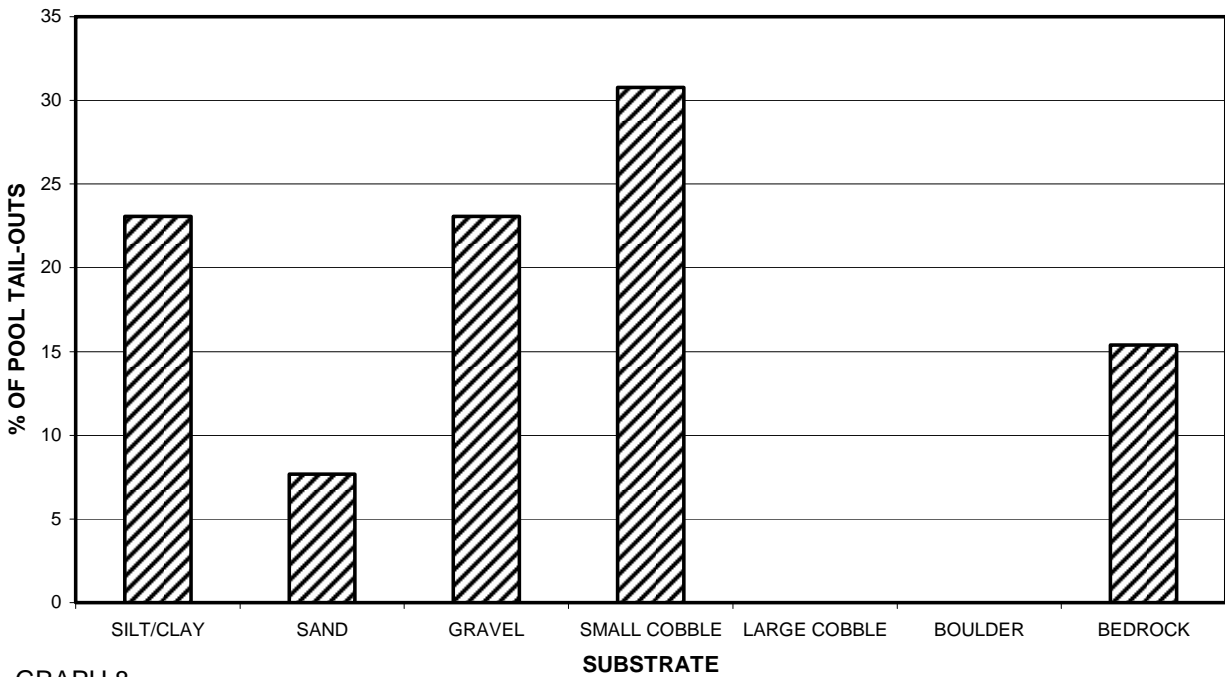
GRAPH 8

Table 6 summarizes the dominant substrate by habitat type. Graph 8 depicts the dominant substrate observed in pool tail-outs. A gravel-dominant substrate was observed in 23% of pool tail-outs, while small cobble was observed in 31% of pool tail-outs.

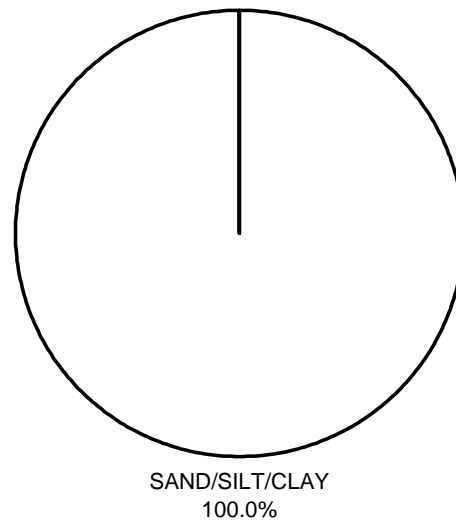
GRAPH 10

For the stream reach surveyed, the mean percent right bank vegetated was 70%. The mean percent left bank vegetated was 75%. The dominant elements composing the structure of the stream banks consisted of 100% sand/silt/clay (Graph 10). Mixed hardwood trees was the dominant vegetation type observed in 83% of the units surveyed. Additionally, 14% of the units surveyed had brush as the dominant vegetation type, and 4% had grass as the dominant vegetation (Graph 11).
