SELBY CREEK – SILVERADO TRAIL CULVERT FISH PASSAGE ASSESSMENT

NAPA COUNTY, CALIFORNIA

NAPA COUNTY RESOURCE CONSERVATION DISTRICT
1303 JEFFERSON ST. SUITE 500B NAPA, CALIFORNIA 94559
WWW.NAPARCD.ORG

OCTOBER, 2006

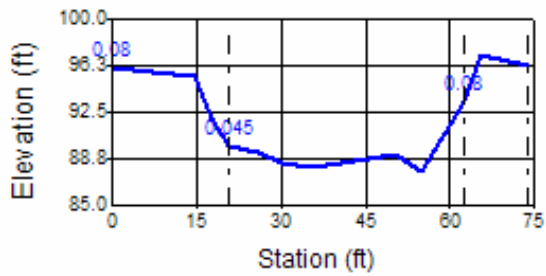
Channel Cross Section

Station (ft)	Elevation (ft)	Roughness Coefficient
0.00	95.98	0.080
14.49	95.37	
17.67	91.94	
20.84	89.72	0.045
25.98	89.30	
29.93	88.31	
35.72	88.07	
50.30	89.02	
55.00	87.78	
62.29	93.24	0.080
65.26	97.07	
73.74	96.24
