Evaluating the Pollution Potential of the M/V FERNSTREAM

M/V FERNSTREAM Task Force

Assessing the *M/V FERNSTREAM*

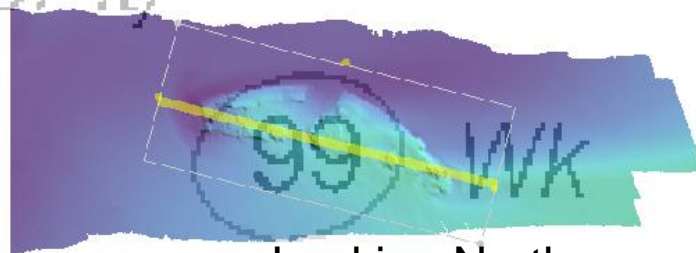
Looking North

WRECK LOCATION: 37-49-11.96N, 122-27-32.56W | LENGTH: 415 FEET | BEAM: 100 FEET | HEIGHT ABOVE BOTTOM: 22 FEET | SHOALEST DEPTH: 123 FEET

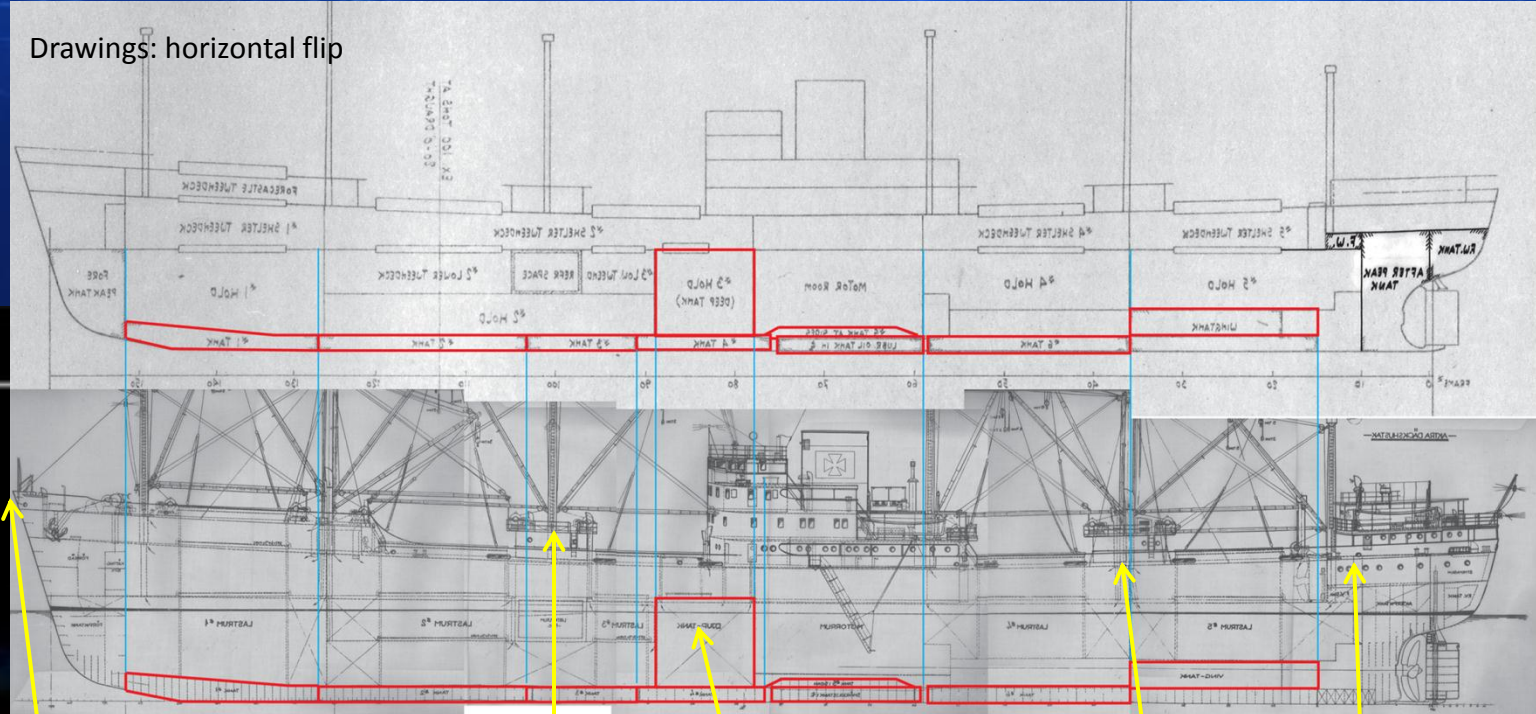
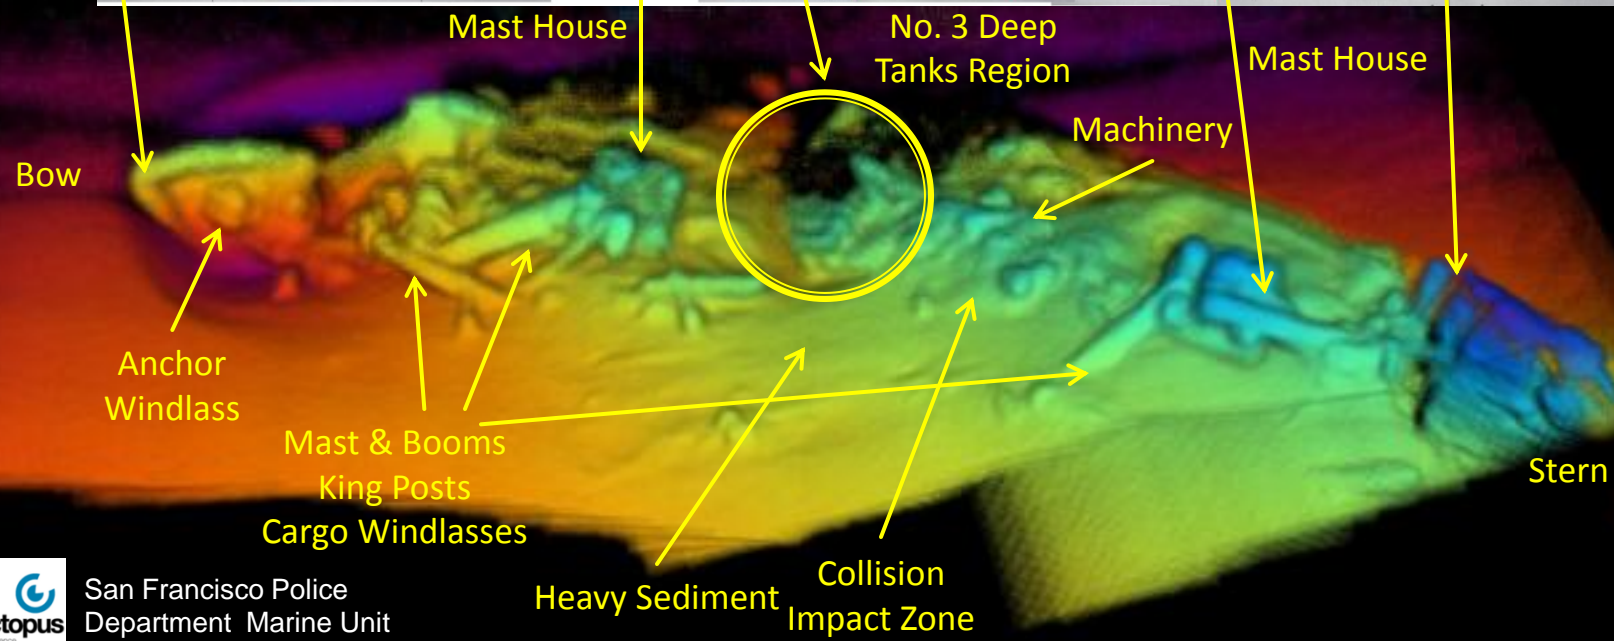
Looking North

Survey Date: July 8, 2013

Drawings: horizontal flip
