Site Name: Refugio Rd Low-flow Xing-7

Stream Name: Quiota Creek

Structure Owner: Santa Barbara County Public Works-Roads Division

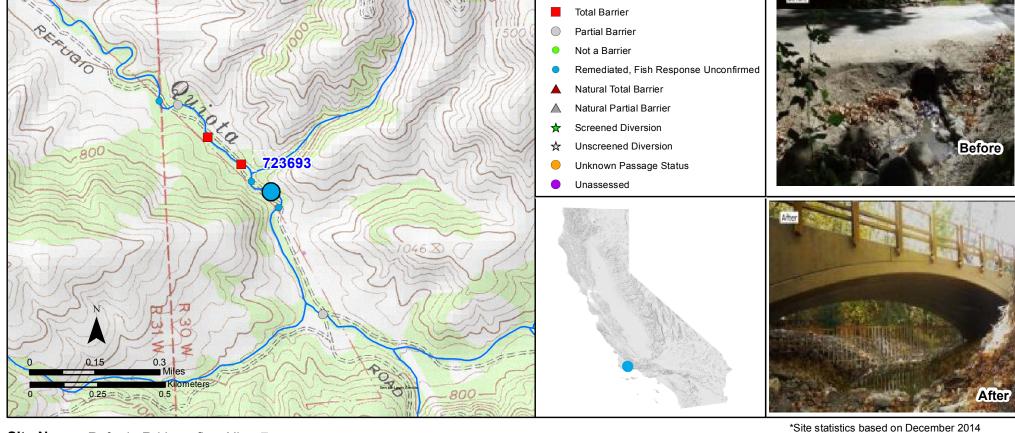
Notes: Low-flow crossing and degraded culvert were replaced by a bridge with a 60-foot bottomless-arched culvert. Two rock weirs were intalled as grade control and to create habitat. Expected to benefit juvenile and adult southern steelhead passage. Cachuma Project Biology Staff will conduct snorkel surveys within the creek 3x per year (spring, summer and fall) to verify an tract steelhead/raibow trout abundance within and around the project site. Before: Total barrier per professional judgement by Cachuma Conservation Release Board. This is a low-flow crossing is impassable during low flows due to insufficient water depth across the road surface. The culvert diameter is very small and likely produces excessive velocities and/or shallow depth for upstream passage in addition to having a very small area to jump into. During higher flows the downstream pool depth will allow salmonids to jump onto the road surface, but excessive water velocities across the surface may limit/prevent upstream passage for smaller steelhead. A narrow window of ideal flows will likely pass some larger steelhead for a short duration.
