Site Name: UPRR and Highway 101 Culvert

Stream Name: Tajiguas Creek

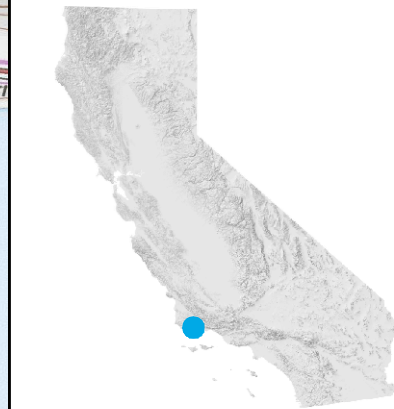
Notes: In November 2014, Caltrans fixed passage through the culvert by adding backwatering weirs thus expanding the migration window. Before: Temporal barrier assessed using the DFG Restoration Manual Red-Green-Gray passage filter by Stoecker in 2010. Assessment report is unavailable, but information was provided by CDFW staff. Per the 2010 assessment: culvert has slope of 0.01 percent, the bottom of the culvert was very rough cut ston and it backwaters to the mid-point of the culvert. CDFW stated that it was likely a partial (low flow) barrier. Per the 2002 Stoecker Assessment Report: access to survey Tajiguas Creek was not obtained and surveys were conducted from the beach and Highway 101 to obtain general information about the culvert. Without access and formal assessment of this culvert, passage severity was determined to be extremely high to impassable. Total length of structure: 0.06 miles. Assuming this culvert is similar to other long concrete CALTRANS culverts built over Highway 101, upstream steelhead migration is impossible due to the excessive culvert length, lack of resting areas within the culvert, shallow water conditions during low flows, and accelerated velocities encountered during high flows.
