**FINAL REPORT:
SISKIYOU COUNTY CULVERT INVENTORY AND FISH PASSAGE
EVALUATION**

Ross N. Taylor, Michael Love, Thomas D. Grey, and Anabel L. Knoche

March 28, 2002

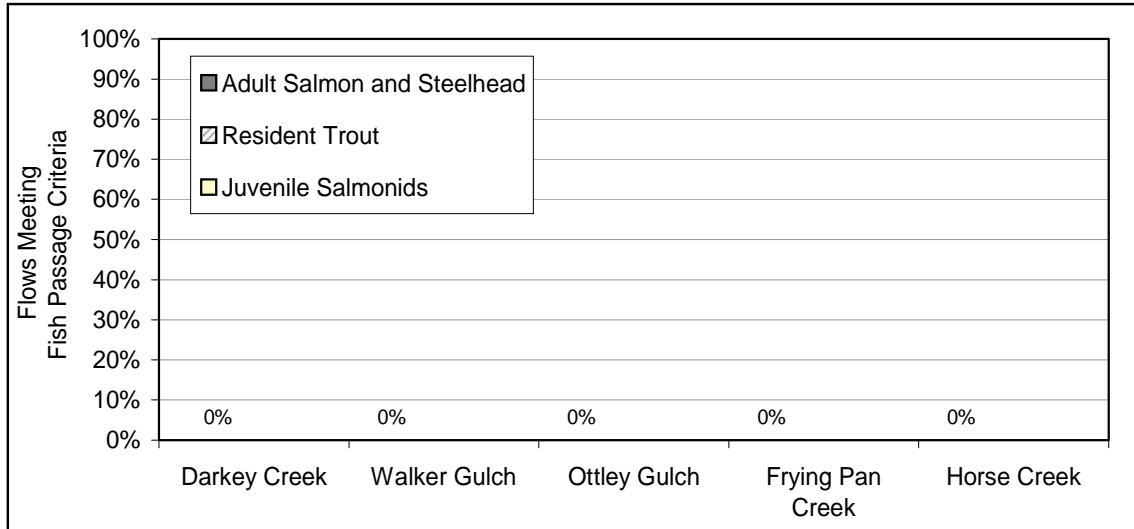
Figure 6. Percent passable as estimated by the GREEN-GRAY-RED evaluation filter for five Siskiyou County stream crossings located on Klamath River tributaries downstream of the Scott River confluence, by life stages.

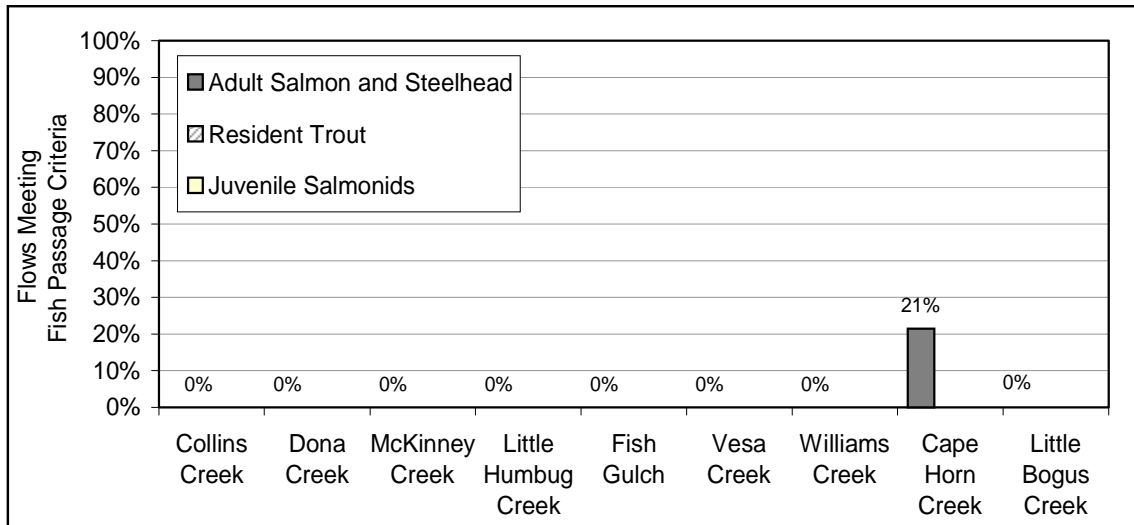
Figure 7. Percent passable as estimated by the GREEN-GRAY-RED evaluation filter and FishXing for nine Siskiyou County stream crossings located on Klamath River tributaries upstream of the Scott River confluence, by life stages.

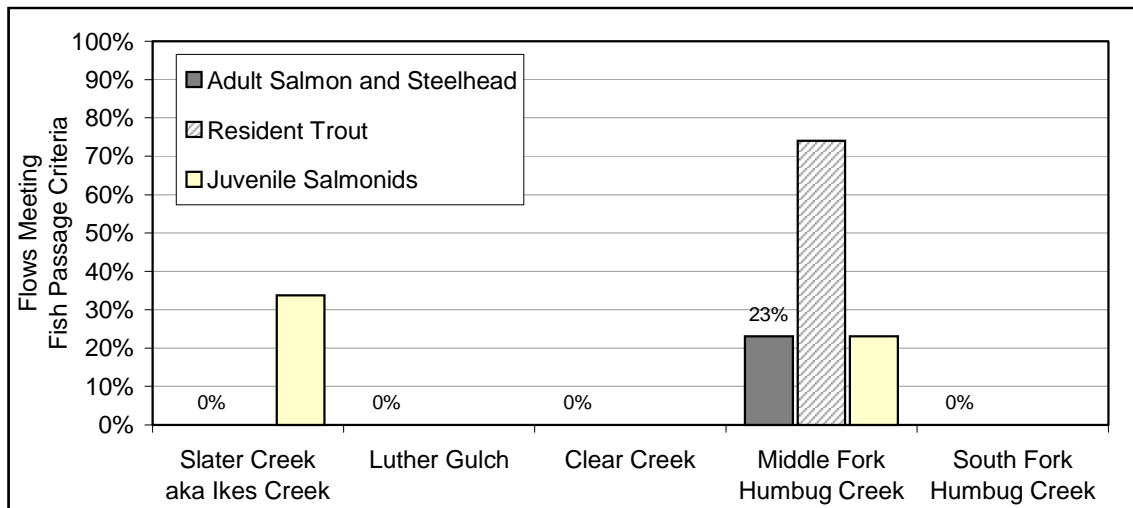
Figure 8. Percent passable as estimated by the **GREEN-GRAY-RED** evaluation filter and FishXing for five Siskiyou County stream crossings located on Indian Creek (Slater and Luther Creeks) and Humbug Creek tributaries, by life stages.

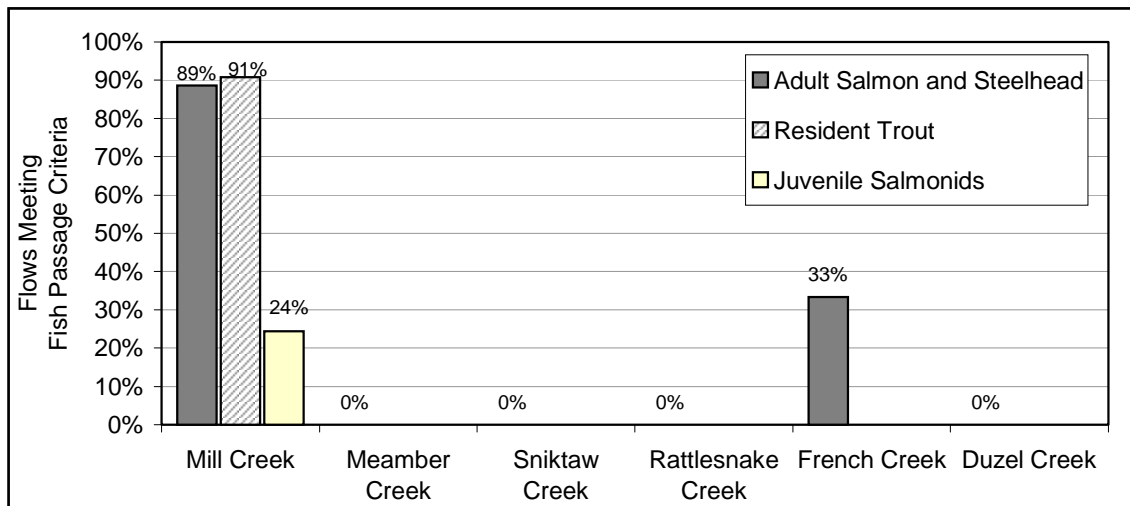
Figure 10. Percent passable as estimated by the GREEN-GRAY-RED evaluation filter and FishXing for six Siskiyou County stream crossings located on Scott River tributaries, by lifestages.
