Summary of 2016 Reconnaissance Fish Passage Surveys

During February and March of 2016, 179 Reconnaissance Fish Passage Surveys were conducted on state highways in Butte and Sacramento counties. 138 sites were surveyed on Highway 99 in Butte County, 24 sites were surveyed on Highway 99 in Sacramento County, and 17 sites were surveyed on Highway 104 in Sacramento County. The Reconnaissance Surveys were performed in accordance with the California Department of Transportation's (Caltrans') Reconnaissance Fish Passage Assessment Instructions and Procedures manual¹. 25 of the 179 sites (14%) were identified as requiring a Detailed Fish Passage Survey.

County: Butte Route: 99 Postmile: 0.01 Survey Date: 02/09/2016

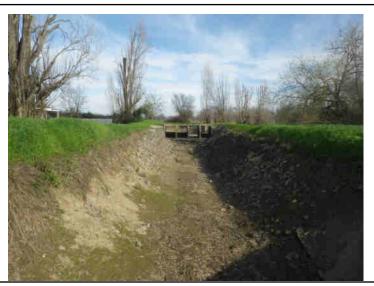
Upstream Looking Upstream

-			
Does the site contain an active channel width				
Is the stream gradient < 20%?	Yes			
	Salmonid ESU/DPS			
ESU (Chinook and Coho Salmon) or DPS (S	Steelhead)			
Central Valley Spring-Run Chinook				
Central Valley Fall_Late Fall-Run Chinook				
Central Valley Steelhead	Historia Anadremena Pessh?			
	Historic Anadromous Reach?			
<u> </u>	ng supported an anadromous fish population?			
Source Aerial imagery; irrigation cana	al with no upstream connectivity to a natural stream Crossing Type			
Crossing Type Culvert	ID 120101			
General Description: concrete double bay bo	<u> </u>			
Contral Description. Portorete double bay be	Photos

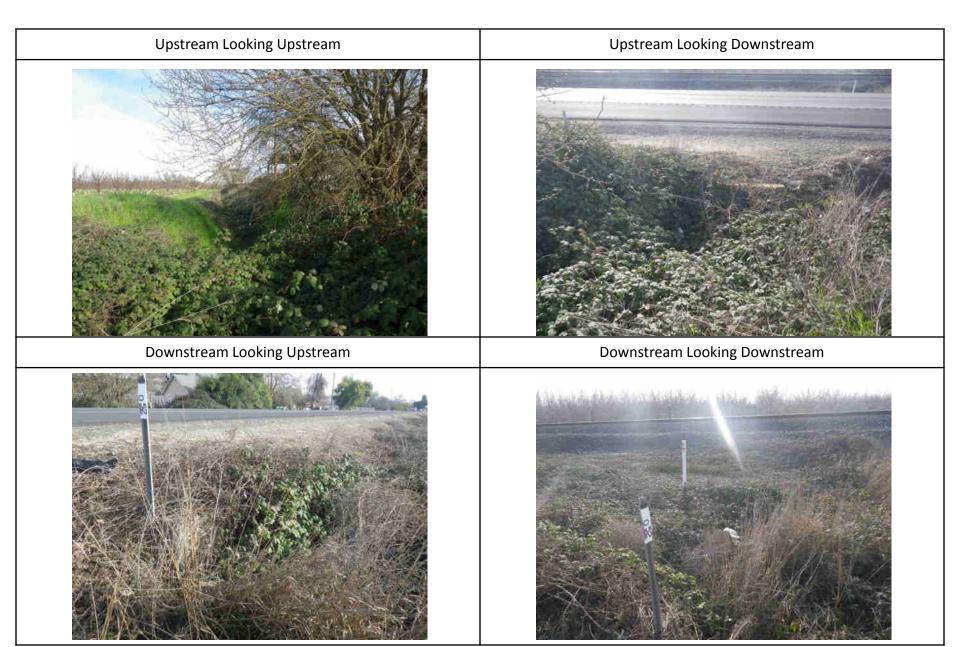
County: Butte Route: 99 Postmile: 0.52 Survey Date: 02/09/2016

Central Valley Spring-Run Chinook					
Central Valley Fall_Late Fall-Run Chinook					
Central Valley Steelhead					
Historic Anadromous Reach?					
Has the stream reach upstream of the crossing supported an anadromous fish population?					
Source Aerial imagery; irrigation canal with no upstream connectivity to a natural stream					
Crossing Type					
Crossing Type Culvert ID					
General Description: concrete pipe culvert					
Photos

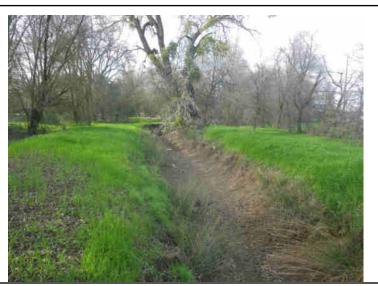
Upstream Looking Upstream

Central Valley Spring-Run Chinook	
Central Valley Fall_Late Fall-Run Chinook	
Central Valley Steelhead	
Historic Anadromous Reach?	
Has the stream reach upstream of the crossing supported an anadromous fish population?	
Source Aerial imagery; irrigation canal with no upstream connectivity to a natural stream	
Crossing Type	
Crossing Type Culvert ID	
General Description: concrete box culvert; juvenile pikeminnow observed in culvert; this is an irrigation canal	
Photos

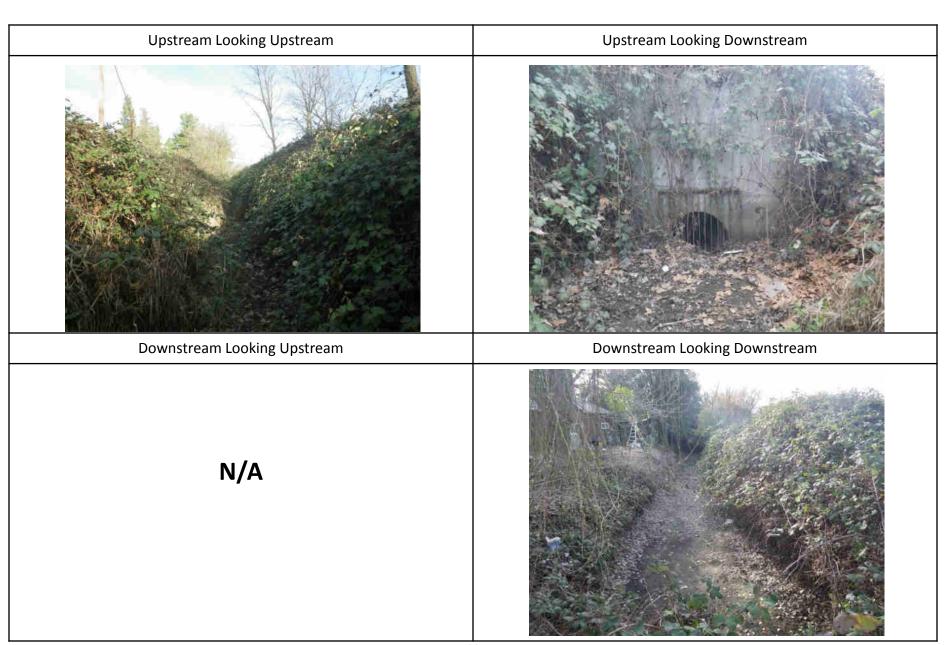
County: Butte Route: 99 Postmile: 3.68 Survey Date: 02/09/2016

ESU (Chinook and Coho Salmon)		200010			
Central Valley Spring-Run Chinook	<u> </u>				
Central Valley Fall_Late Fall-Run C					
Central Valley Steelhead					
	Histori	c Anadromous Reach?			
Has the stream reach upstream of t	he crossing supported an anad	romous fish population?	Unknown		
Source Tributary to Morriso		, . 			
		Crossing Type			
Crossing Type Culvert		ID			
General Description: concrete pipe	e culvert in concrete form; the o	utlet was on private prope	erty behind a fence		
		Photos

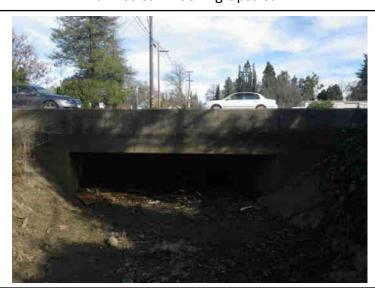
Downstream Looking Upstream

Central Valley Spring-Run Chinook		
Central Valley Fall_Late Fall-Run Chinook		
Central Valley Steelhead		
	Historic Anadromous Reach?	
Has the stream reach upstream of the crossing sup	pported an anadromous fish population?	
Source Aerial imagery; irrigation canal with	no upstream connectivity to a natural stream	
	Crossing Type	
Crossing Type Culvert	ID	
General Description: concrete box culvert; this is a	an irrigation canal	
	Photos

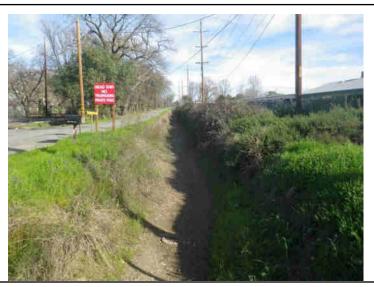
Upstream Looking Upstream

Central Valley Spring-Run Chinook		
Central Valley Fall_Late Fall-Run Chinook		
Central Valley Steelhead		
	Historic Anadromous Reach?	
Has the stream reach upstream of the crossing supp	· · · · · · · · · · · · · · · · · · ·	
Source Aerial imagery; irrigation canal with	no upstream connectivity to a natural stream	
	Crossing Type	
Crossing Type Culvert General Description: concrete double bay box culv	ID	
General Description. Concrete double bay box curv

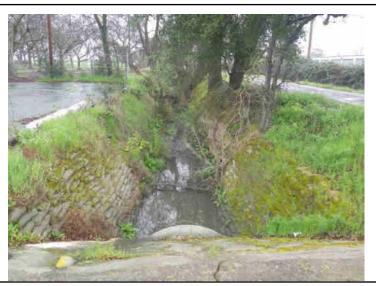
Upstream Looking Upstream

ESU (Chinook and Coho Salmon) or DPS	<u> </u>						
	Histori	c Anadromous Rea	ch?				
Has the stream reach upstream of the cross				No			
Source Aerial imagery; irrigation ca	nal with no upstream co	·	al stream				
		Crossing Type					
Crossing Type Culvert	()	ID					
General Description: Concrete pipe culver	t in a concrete form. Mo		canal.

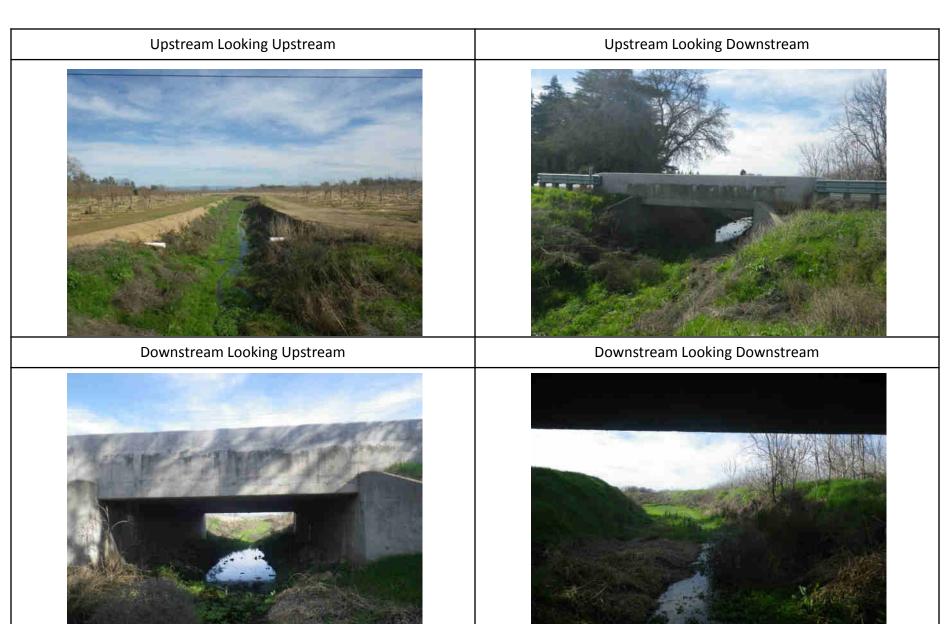
County: Butte Route: 99 Postmile: 5.34 Survey Date: 02/09/2016

Central Valley Spring-Run Chinook		
Central Valley Fall_Late Fall-Run Chinook		
Central Valley Steelhead		
Н	listoric Anadromous Reach?	
Has the stream reach upstream of the crossing supported an	anadromous fish population? Unknown	
Source		
	Crossing Type	
Crossing Type bridge w/o potential passage constrain		
General Description: concrete bridge with no passage const	traints	
	Photos

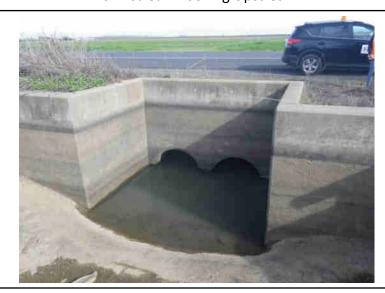
Downstream Looking Upstream

Salmonid ESU/DPS					
ESU (Chinook and Coho Salmon) or DPS (Steelhead)					
Central Valley Spring-Run Chinook					
Central Valley Fall_Late Fall-Run Chinook					
Central Valley Steelhead					
Historic Anadromous Reach?					
Has the stream reach upstream of the crossing supported an anadromous fish population?					
Source Aerial imagery; irrigation canal with no upstream connectivity to a natural stream					
Crossing Type					
Crossing Type Culvert ID General Description: double concrete pipe culvert in concrete form; this is an irrigation canal					
Photos 2.1 Unetroom Locking Unetroom Photo I. PUT 00 5 64 2.4 2.00 2046

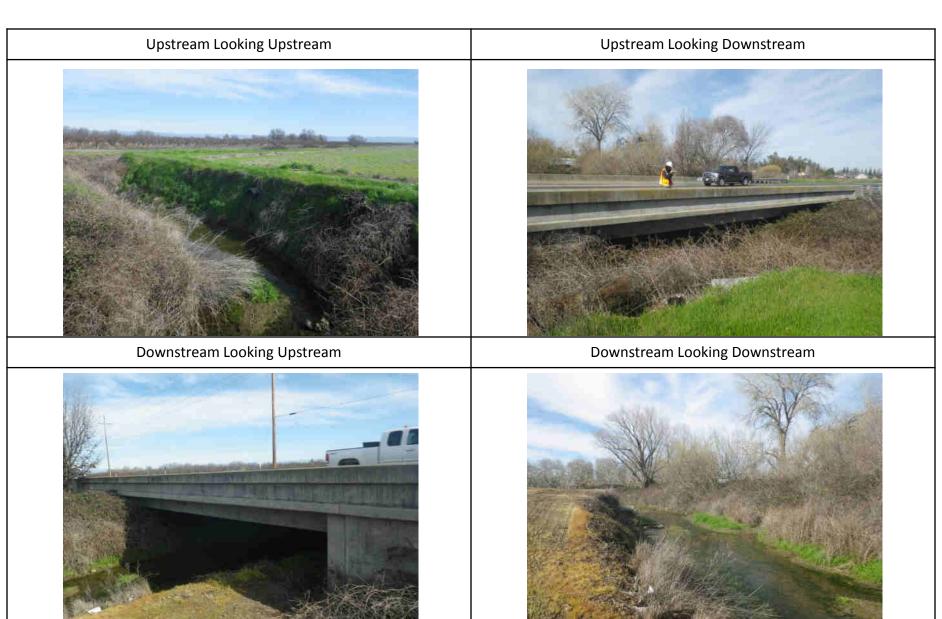
County: Butte Route: 99 Postmile: 6.11 Survey Date: 02/09/2016

Salmonid ESU/DPS				
ESU (Chinook and Coho Salmon) or DPS (Steelhead)				
Central Valley Spring-Run Chinook				
Central Valley Fall_Late Fall-Run Chinook				
Central Valley Steelhead	_			
Historic Anadromous Reach?				
Has the stream reach upstream of the crossing supported an anadromous fish population? Unknown				
Source				
Crossing Type				
Crossing Type bridge w/o potential passage constraints ID 120002				
General Description: concrete bridge with no passage constraints				
Photos

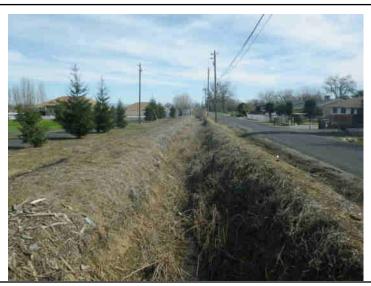
Upstream Looking Upstream

Salmonid ESU/DPS					
ESU (Chinook and Coho Salmon) or DPS (Steelhead)					
Central Valley Spring-Run Chinook					
Central Valley Fall_Late Fall-Run Chinook					
Central Valley Steelhead					
Historic Anadromous Reach?					
Has the stream reach upstream of the crossing supported an anadromous fish population?					
Source Aerial imagery; irrigation canal with no upstream connectivity to a natural stream					
Crossing Type					
Crossing Type Culvert ID					
General Description: concrete box culvert; no PM at site so PM is an estimation; this is a irrigation canal					
Photos

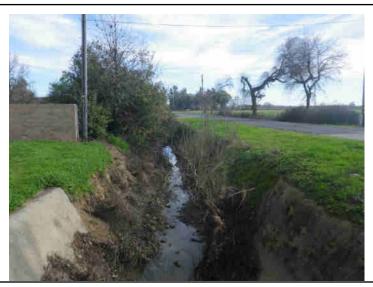
Upstream Looking Upstream

Central Valley Spring-Run Chinook			
Central Valley Fall_Late Fall-Run Chinook			
Central Valley Steelhead			
Historic Anadromous Reach?			
Has the stream reach upstream of the crossing supported an anadromous fish population?			
Source Aerial imagery; irrigation canal with no upstream connectivity to a natural stream			
Crossing Type			
Crossing Type Culvert ID			
General Description: concrete box culvert; this is likely an irrigation canal			
Photos

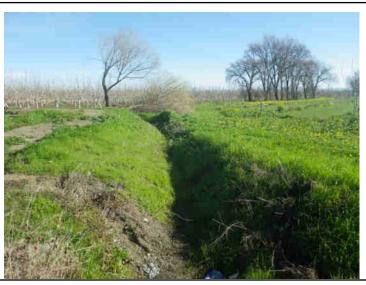
Upstream Looking Upstream

County: Butte Route: 99 Postmile: 7.40 Survey Date: 02/09/2016

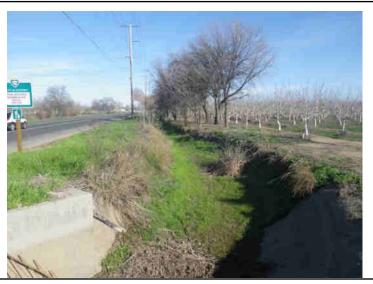
Upstream Looking Upstream

Salmonid ESU/DPS		
ESU (Chinook and Coho Salmon) or DPS (Steelhe	ead)		
Central Valley Spring-Run Chinook			
Central Valley Fall_Late Fall-Run Chinook			
Central Valley Steelhead			
	Historic Anadromous Reach?		
Has the stream reach upstream of the crossing supp	ported an anadromous fish population?]	
Source Aerial imagery; irrigation canal with	no upstream connectivity to a natural stream		
Crossing Type			
Crossing Type Culvert	ID		
General Description: concrete box culvert; this is a	n irrigation canal; no postmile present so the postmile is an est	timate	
	Photos

County: Butte Route: 99 Postmile: 7.41 Survey Date: 02/09/2016

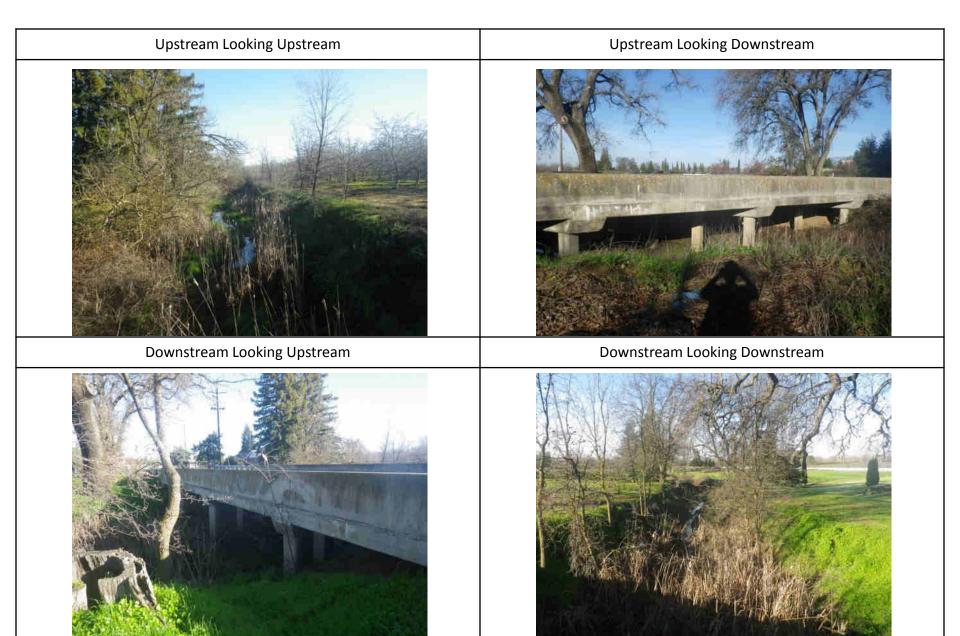
County: Butte Route: 99 Postmile: 8.21 Survey Date: 02/09/2016

Salmonid ESU/DPS			
ESU (Chinook and Coho Salmon) or DPS (Steelhead)				
Central Valley Spring-Run Chinook				
Central Valley Fall_Late Fall-Run Chinook				
Central Valley Steelhead	Hataila Anadamana Basako			
	Historic Anadromous Reach?			
Has the stream reach upstream of the crossing supported a	an anadromous fish population? Unknown			
Source	Creecing Type			
Canading Time bridge u/o note still account	ints ID 12.0003			
Crossing Type bridge w/o potential passage constra General Description: concrete bridge without passage con				
General Description: concrete bridge without passage constraints Photos

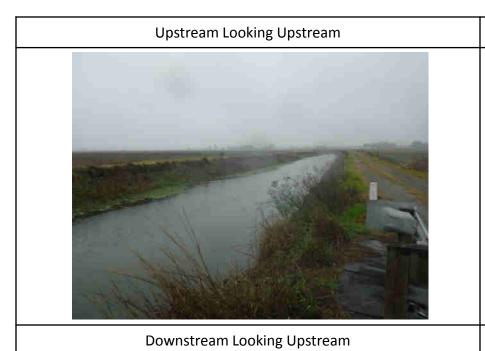
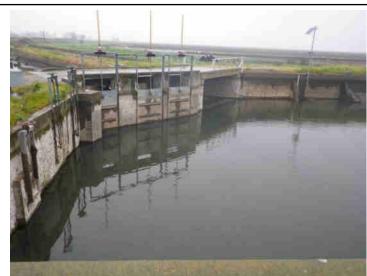
County: Butte Route: 99 Postmile: 9.21 Survey Date: 02/09/2016

-	Natural Stream Channel?	<u> </u>	
Is there a definable channel upstream of culvert?	Yes		
·			
Is the primary function for storm water runoff or road			
Is the waterway a concrete-lined flood control chann			
	Potential Fish Bearing Stream?		
Does the site contain an active channel width >2 fee	et? Yes		
Is the stream gradient < 20%?	Yes		
	Salmonid ESU/DPS		
ESU (Chinook and Coho Salmon) or DPS (Steelhe	ad)		
Central Valley Spring-Run Chinook			
Central Valley Fall_Late Fall-Run Chinook			
Central Valley Steelhead			
	Historic Anadromous Reach?		
Has the stream reach upstream of the crossing supp	ported an anadromous fish population?		
Source Aerial imagery; irrigation canal with	no upstream connectivity to a natural stream		
Crossing Type			
Crossing Type Culvert	ID 120004		
General Description: concrete double bay box culve	ert with concrete bottom		
Photos

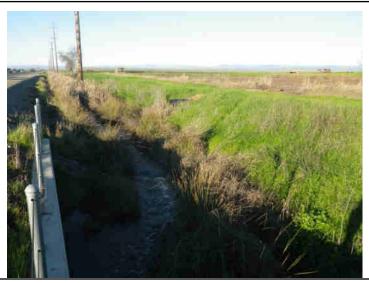
Upstream Looking Upstream

Salmonid ESU/DPS					
ESU (Chinook and Coho Salmon) or DPS (Steelhead)					
Central Valley Spring-Run Chinook					
Central Valley Fall_Late Fall-Run Chinook					
Central Valley Steelhead Historic Anadromous Peach?					
Historic Anadromous Reach?					
Has the stream reach upstream of the crossing supported an anadromous fish population? No Source Aerial imagery; irrigation canal with no upstream connectivity to a natural stream					
Source Aerial imagery; irrigation canal with no upstream connectivity to a natural stream Crossing Type					
Crossing Type Culvert ID					
General Description: concrete double bay box culvert	1				
Photos

County: Butte Route: 99 Postmile: 9.55 Survey Date: 02/08/2016

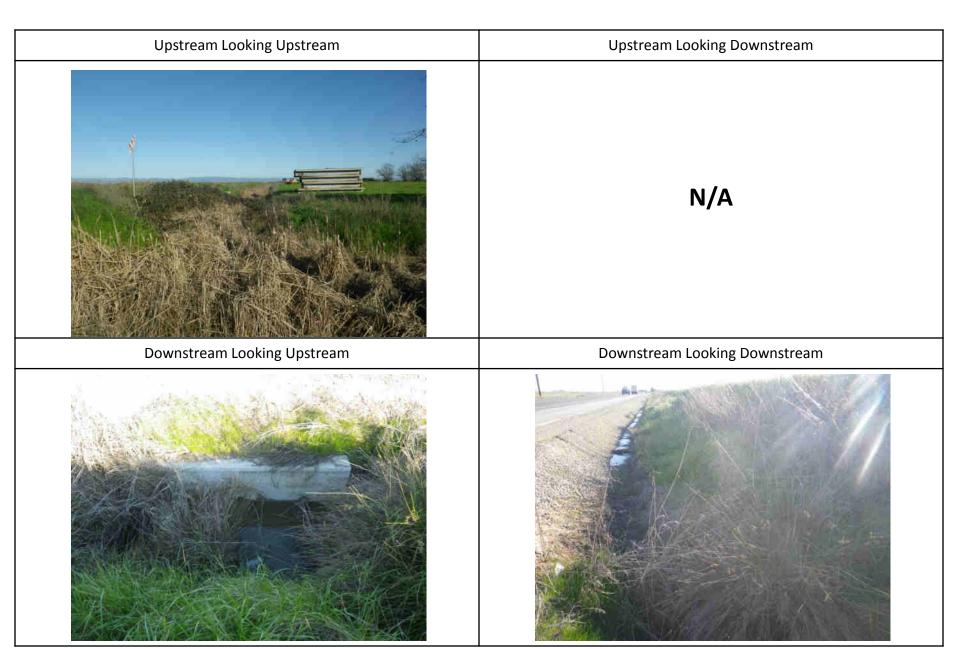
County: Butte Route: 99 Postmile: 9.62 Survey Date: 02/08/2016

ESIL (Chinack and Caha Salman) as DDC (Charless II)	Salmonid ESU/DPS				
ESU (Chinook and Coho Salmon) or DPS (Steelhead) Central Valley Spring-Run Chinook					
Central Valley Spring-Run Chinook Central Valley Fall_Late Fall-Run Chinook					
Central Valley Fall_Late Fall-Rull Chillook Central Valley Steelhead					
Central valley Steelifeau	Historic Anadromous Reach?				
Has the stream reach upstream of the crossing supported					
Source Aerial imagery; irrigation canal with no up	· · · · · · · · · · · · · · · · · · ·				
processing property and married up	Crossing Type				
Crossing Type Culvert	ID				
	rm; outlet unable to be located; irrigation canal that flows into a roadside of	ditch			
	Photos

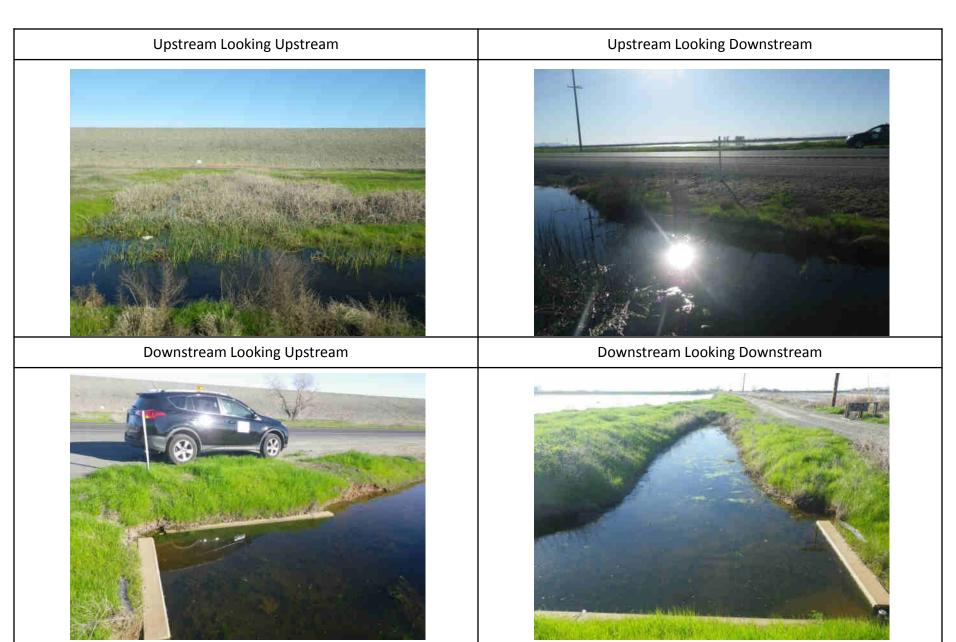
County: Butte Route: 99 Postmile: 10.65 Survey Date: 02/08/2016

Is the stream grad	dient < 20	%?		Yes					
			S	Salmonid ESU/DPS					
		almon) or DPS (S	teelhead)						
Central Valley Spi	ring-Run	Chinook							
Central Valley Fal	II_Late Fa	II-Run Chinook							
Central Valley Ste	eelhead								
			Histori	c Anadromous Rea	ch?				
<u></u>			g supported an anad			No			
Source A	erial imag	ery; irrigation cana	I with no upstream co		al stream				
0 : =			1	Crossing Type					
Consol Description			te form: this culvert o	ID	the Thermalita	Afterbay lo	ree into a road	drainage/	etorm
General Description: concrete pipe in concrete form; this culvert passes seepage from the Thermalito Afterbay levee into a road drainage/storm water runoff ditch; the culvert is clogged									
				Photos

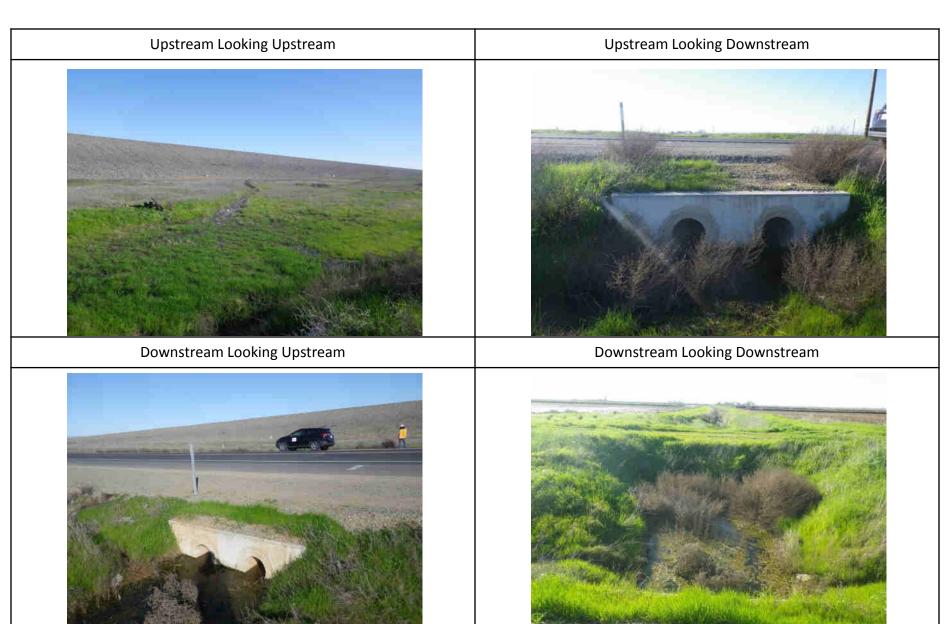
County: Butte Route: 99 Postmile: 10.93 Survey Date: 02/08/2016

Is the stream gr	radient < 20	0%?		Yes				
			S	almonid ESU/DPS				
		Salmon) or DPS (S	teelhead)					
Central Valley S	Spring-Run	Chinook						
Central Valley F	Fall_Late Fa	all-Run Chinook						
Central Valley S	Steelhead							
			Histori	c Anadromous Rea	ch?			
			g supported an anad		-	No		
Source	Aerial imag	gery; irrigation cana	l with no upstream co		al stream			
0	Tumo Cont	ort		Crossing Type				
General Descrip	Type Culv		ulvert in concrete form	ID n: this culvert passes	seepage from the	Thermalito Afterbay le	vee into ar	n irrigation
Conordi Dosoni	cana					The state of the s	. 30	9
				Photos			-1

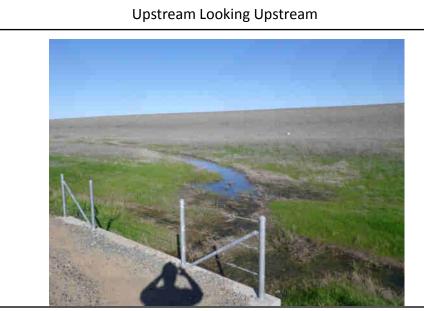
County: Butte Route: 99 Postmile: 11.22 Survey Date: 02/08/2016

Is the stream gradient < 20	0%?		Yes					
			almonid ESU/DPS					
ESU (Chinook and Coho S	<u> </u>	eelhead)						
Central Valley Spring-Run								
Central Valley Fall_Late Fall_Late Fall_Late	all-Run Chinook							
Central Valley Steelhead								
			c Anadromous Read		1			
Has the stream reach upst				-	No			
Source Aerial imag	gery; irrigation canal	with no upstream co		al stream				
			Crossing Type					
Crossing Type Culv		outvort peaces with	ID	from the Theres	olita Aftarbas	lovoo into a :	rood	1
General Description: concrete box culvert; this culvert passes water that seeps directly from the Thermalito Afterbay levee into a road drainage/storm water runoff ditch								
			Photos

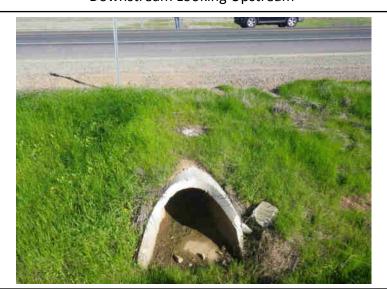
Downstream Looking Upstream

Central Valley Fall_Late Fall-Run Chinook		
Central Valley Steelhead		
	Historic Anadromous Reach?	
Has the stream reach upstream of the crossing	ng supported an anadromous fish population?	
Source Aerial imagery; irrigation cana	al with no upstream connectivity to a natural stream	
	Crossing Type	
Crossing Type Culvert	ID	
General Description: concrete pipe culvert; t	his road drainage/storm water runoff ditch collects seepage from the Thermalito Aft	erbay levee
	Photos

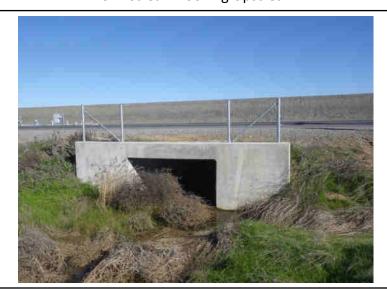
Downstream Looking Upstream

FOUNDAMENTAL CONTRACTOR OF THE	Salmonid ESU/DPS	
ESU (Chinook and Coho Salmon) or DPS (Steelhe	ad)	
Central Valley String Bun Chinaek		
Central Valley Spring-Run Chinook		
Central Valley Fall_Late Fall-Run Chinook	Historic Anadromous Reach?	
Has the stream reach unstream of the areasing supplied		
Has the stream reach upstream of the crossing supp Source Aerial imagery; irrigation canal with r	no upstream connectivity to a natural stream	
rional imagory, imgalion candi with	Crossing Type	
Crossing Type Culvert	ID	
<u> </u>	n irrigation canal seeping from the base of the Thermalito Afterbay levee	
	Photos

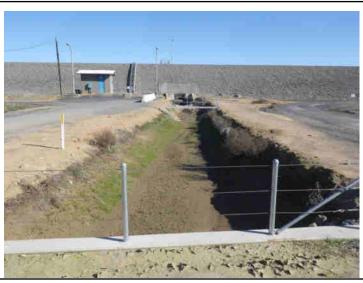
Upstream Looking Upstream

Salmonid ESU/DPS	
ESU (Chinook and Coho Salmon) or DPS (Steelf	nead)	
Central Valley Spring-Run Chinook		
Central Valley Fall_Late Fall-Run Chinook		
Central Valley Steelhead		
	Historic Anadromous Reach?	
Has the stream reach upstream of the crossing support	pported an anadromous fish population?	
Source Aerial imagery; irrigation canal with	n no upstream connectivity to a natural stream	
	Crossing Type	
Crossing Type Culvert	ID	
General Description: double bay concrete box cul	vert; this is a irrigation canal coming from the base of the Thermalito Afterbay	
	Photos

County: Butte Route: 99 Postmile: 12.83 Survey Date: 02/08/2016

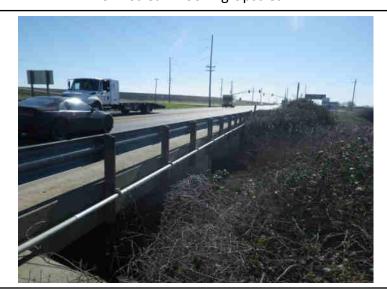
Downstream Looking Upstream

Is the stream gradient < 20%?	Yes				
	Salmonid ESU/DPS				
ESU (Chinook and Coho Salmon) or DPS (Steel	head)				
Central Valley Spring-Run Chinook					
Central Valley Fall_Late Fall-Run Chinook					
Central Valley Steelhead					
	Historic Anadromous Reach?				
Has the stream reach upstream of the crossing su	· · · · · · · · · · · · · · · · · · ·	No			
Source Aerial imagery; irrigation canal wit	h no upstream connectivity to a natural stream				
	Crossing Type				
Crossing Type bridge w/o potential passag	<u> </u>				
General Description: Ino postmile marker at site s Thermalito Afterbay levee	o PM is estimated; this is an irrigation canal created fror	n a pumping station at the base of the			
	Photos

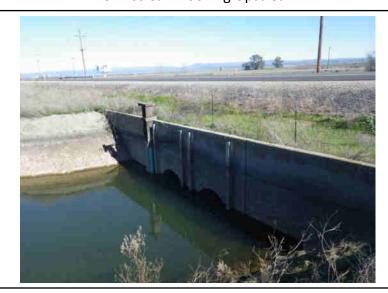
Downstream Looking Upstream

RECONN	AISSANCE SURVEY INFORMATION	
County: BUT	Route: 99	PM: 14.03
	Survey Information	
Date 2/8/2016 Time 11:	20 Agency Performing Survey HDR	
Data Recorder JV (24 hr.	clock) Survey Team JV, BS	
	Site Information	
	GPS Data	
Longitude -121.68886385 Latitud	de 39.50683506	
GPS HDOP 1.53 Loc. of	f GPS Point above outlet PM	
	Hydrologic Information	
Stream Name Western Canal	Source: CT Bridge log	
Basin East Side	Quad Name (7.5') SHIPPEE	
USGS Hydrologic Unit LOWER_BUTTE	CalWater Unit HA Butte Basin	
CalWater Unit HU COLUSA BASIN	CalWater Unit HSA Butte Basin	
	Natural Stream Channel?	
Is there a definable channel upstream of culvert?	Yes	
Is the primary function for storm water runoff or road		
Is the waterway a concrete-lined flood control channe	el? No	
	Potential Fish Bearing Stream?	
Does the site contain an active channel width >2 fee	Yes Yes	
Is the stream gradient < 20%?	Yes	
	Salmonid ESU/DPS	
ESU (Chinook and Coho Salmon) or DPS (Steelhed	ad)

Central Valley Spring-Run Chinook		
Central Valley Fall_Late Fall-Run Chinook		
Central Valley Steelhead		
	Historic Anadromous Reach?	
Has the stream reach upstream of the crossing supp	orted an anadromous fish population?	
Source Aerial imagery; irrigation canal with r	o upstream connectivity to a natural stream	
	Crossing Type	
Crossing Type bridge w/o potential passage of		
General Description: this is an irrigation canal origin	ating from Thermalito Afterbay	
	Photos

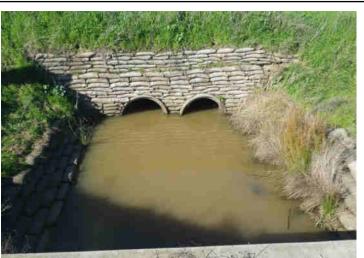
Upstream Looking Upstream

Is the waterway a concrete-lined flood control chann			
	Potential Fish Bearing Stream?		
Does the site contain an active channel width >2 fee	et? Yes		
Is the stream gradient < 20%?	Yes		
	Salmonid ESU/DPS		
ESU (Chinook and Coho Salmon) or DPS (Steelhe	ead)		
Central Valley Spring-Run Chinook			
Central Valley Fall_Late Fall-Run Chinook			
Central Valley Steelhead	<u> </u>		
	Historic Anadromous Reach?		
Has the stream reach upstream of the crossing supp	· · · · · · · · · · · · · · · · · · ·		
Source Aerial imagery; irrigation canal with	no upstream connectivity to a natural stream		
	Crossing Type		
Crossing Type Culvert	ID		
General Description: concrete box culvert built in 1			
	Photos

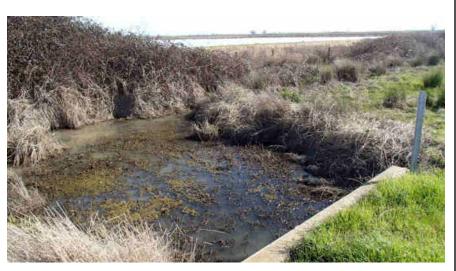
Upstream Looking Upstream

Salmonid ESU/DPS		
ESU (Chinook and Coho Salmon) or DPS (Steelhe	ad)		
Central Valley Spring-Run Chinook			
Central Valley Fall_Late Fall-Run Chinook			
Central Valley Steelhead			
	Historic Anadromous Reach?		
Has the stream reach upstream of the crossing supp	oorted an anadromous fish population?		
Source Aerial imagery; irrigation canal with	no upstream connectivity to a natural stream		
	Crossing Type		
Crossing Type Culvert	ID		
General Description: Concrete pipe culvert with a c	oncrete headwall.		
	Photos

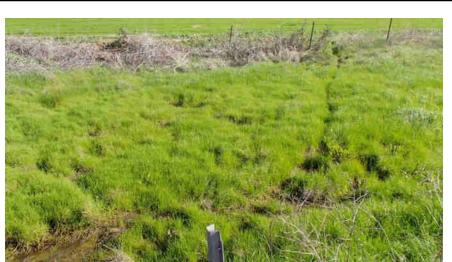
Upstream Looking Upstream

Is the stream gradient < 20%?	yes		
	Salmonid ESU/DPS		
ESU (Chinook and Coho Salmon) or DPS (Steelho	ead)		
Central Valley Spring-Run Chinook			
Central Valley Fall_Late Fall-Run Chinook			
Central Valley Steelhead			
	Historic Anadromous Reach?		
Has the stream reach upstream of the crossing sup			
Source Aerial imagery; irrigation canal with	no upstream connectivity to a natural stream		
	Crossing Type		
Crossing Type Culvert General Description: Concrete pipe culvert with co	ID		
General Description.

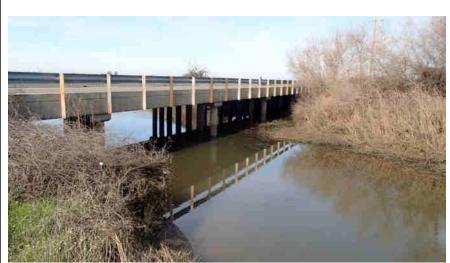
Upstream Looking Downstream

Salmonid ESU/DPS		
ESU (Chinook and Coho Salmon) or DPS (Steelhe	ad)		
Central Valley Spring-Run Chinook			
Central Valley Fall_Late Fall-Run Chinook			
Central Valley Steelhead			
	Historic Anadromous Reach?		
Has the stream reach upstream of the crossing supp	orted an anadromous fish population?		
Source Tributary to Butte Creek, CV Spring-	run 5-Year Status Review (NMFS 2005)		
	Crossing Type		
Crossing Type bridge w/o potential passage	constraints ID 12-0120		
General Description: Concrete pillar bridge.			
	Photos

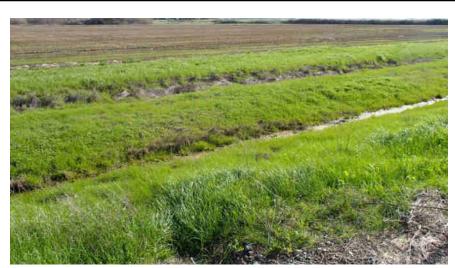
Upstream Looking Upstream

Central Valley Spring-Run Chinook				
Central Valley Fall_Late Fall-Run Chinook				
Central Valley Steelhead				
Historic Anadromous Reach?				
Has the stream reach upstream of the crossing supported an anadromous fish population?				
Source Aerial imagery; irrigation canal with no upstream connectivity to a natural stream				
Crossing Type				
Crossing Type Culvert ID				
General Description: Concrete pipe culvert with concrete headwall				
Photos

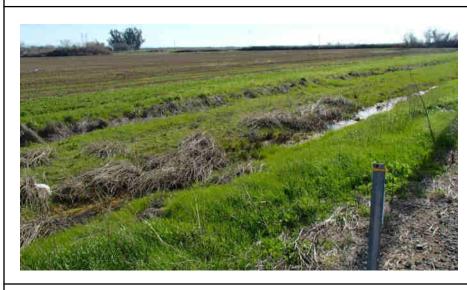
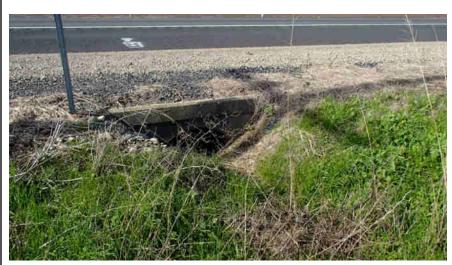
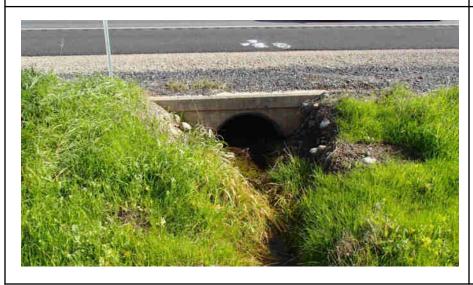
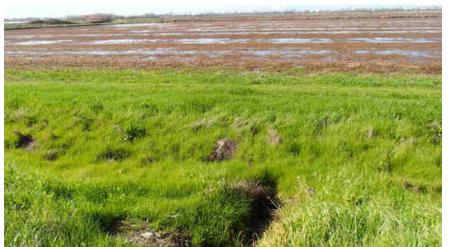
Central Valley Spring-Run Chinook			
Central Valley Fall_Late Fall-Run Chinook			
Central Valley Steelhead			
	Historic Anadromous Reach?		
Has the stream reach upstream of the crossing sup	ported an anadromous fish population?		
Source Aerial imagery; irrigation canal with	no upstream connectivity to a natural stream		
	Crossing Type		
Crossing Type Culvert	ID		
General Description: concrete pipe culvert with con			
	Photos

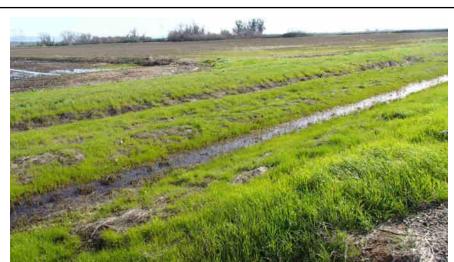
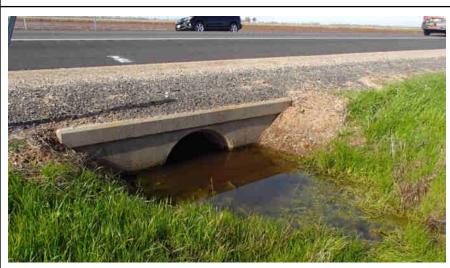
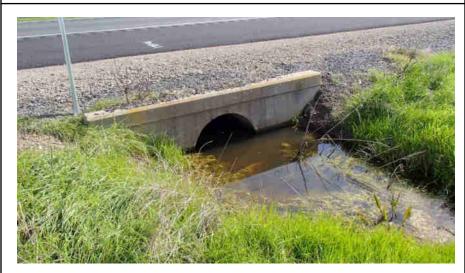
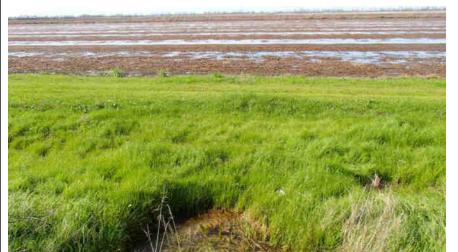
County: Butte Route: 99 Postmile: 15.61 Survey Date: 02/05/2016

Central Valley Spring-Run Chinook			
Central Valley Fall_Late Fall-Run Chinook			
Central Valley Steelhead			
Historic Anadromous Reach?			
Has the stream reach upstream of the crossing supported an anadromous fish population? No			
Source Crossing Type			
Crossing Type			
Crossing Type Culvert ID General Description: concrete pipe culvert with concrete headwall	1		
Photos

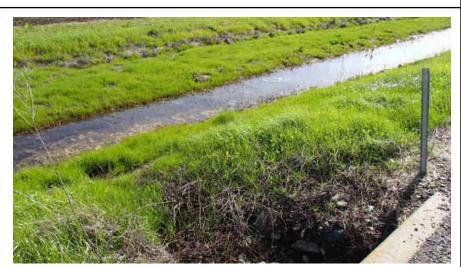
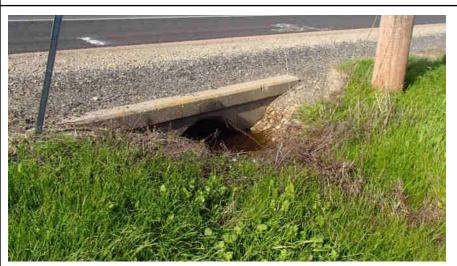
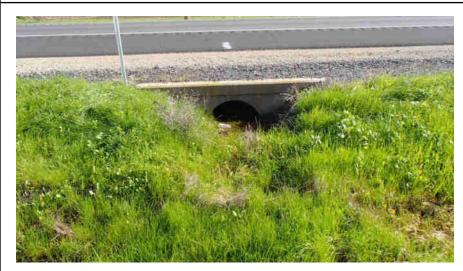
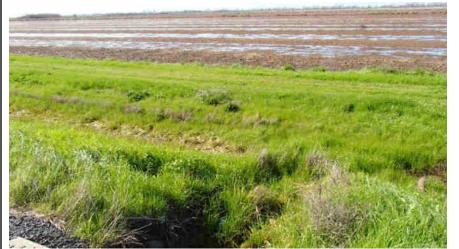
County: Butte Route: 99 Postmile: 15.67 Survey Date: 02/05/2016

- and mage :		
Is the waterway a concrete-lined flood control chann			
	Potential Fish Bearing Stream?		
Does the site contain an active channel width >2 feels the stream gradient < 20%?	et? No Yes		
	Salmonid ESU/DPS		
ESU (Chinook and Coho Salmon) or DPS (Steelhe	ead)		
Central Valley Spring-Run Chinook			
Central Valley Fall_Late Fall-Run Chinook			
Central Valley Steelhead			
	Historic Anadromous Reach?		
Has the stream reach upstream of the crossing sup	ported an anadromous fish population?		
Source			
	Crossing Type		
Crossing Type Culvert	ID		
General Description: Concrete pipe culvert with a concrete pipe culver	concrete headwall.		
	Photos

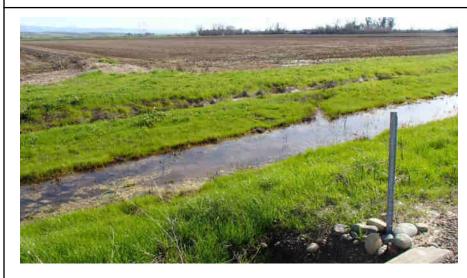
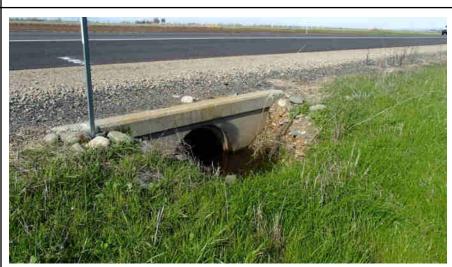
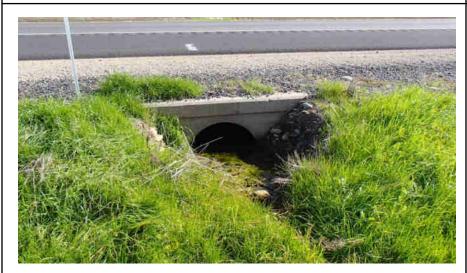
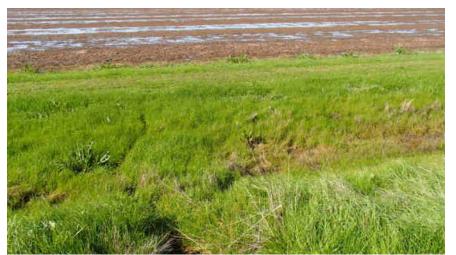
County: Butte Route: 99 Postmile: 15.69 Survey Date: 02/05/2016

Central Valley Spring-Run Chinook				
Central Valley Fall_Late Fall-Run Chinook				
Central Valley Steelhead				
Historic Anadromous Reach?				
Has the stream reach upstream of the crossing supported an anadromous fish population?				
Source Crossing Type				
Crossing Type				
Crossing Type Culvert ID				
General Description: Concrete pipe culvert with a concrete headwall.				
Photos

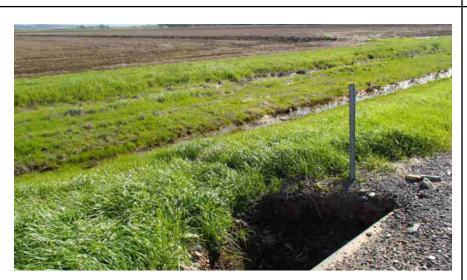
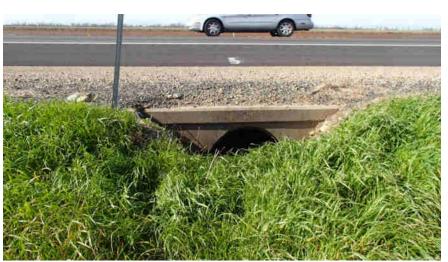
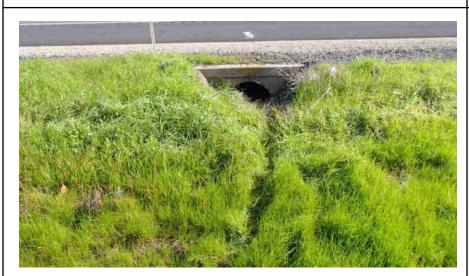
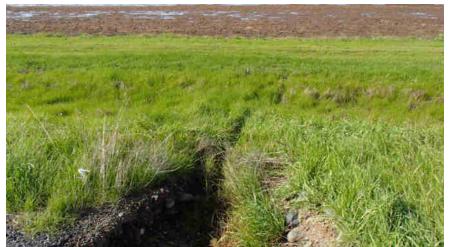
County: Butte Route: 99 Postmile: 15.71 Survey Date: 02/05/2016

Central Valley Fall_Late Fall-Run (Chinook				
Central Valley Steelhead					
Central Valley Spring-Run Chinook					
	Historio	Anadromous Reach?			
Has the stream reach upstream of	the crossing supported an anadr	omous fish population?	No		
Source					
		Crossing Type			
Crossing Type Culvert		ID			
General Description: Concrete pip	e culvert with a concrete headwa				
		Photos

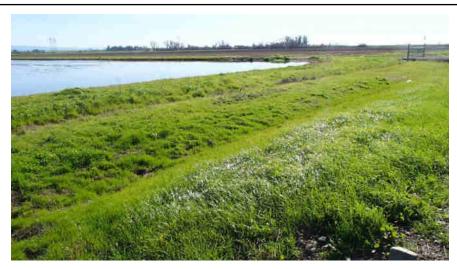
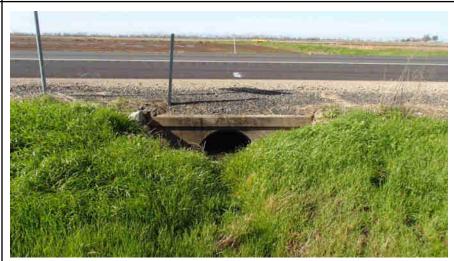
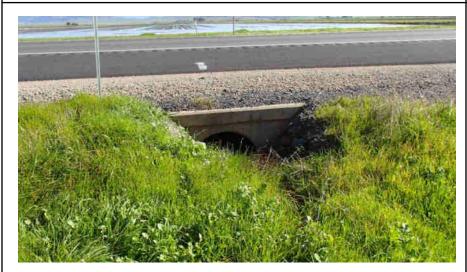
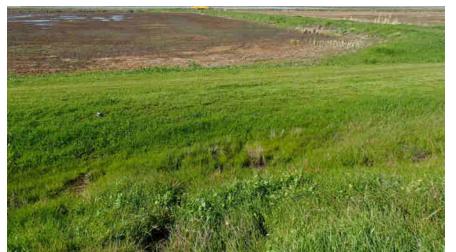
County: Butte Route: 99 Postmile: 15.80 Survey Date: 02/05/2016

Salmonid ESU/DPS				
ESU (Chinook and Coho Salmon) or DPS (Steelhead)				
Central Valley Spring-Run Chinook				
Central Valley Fall_Late Fall-Run Chinook				
Central Valley Steelhead				
Historic Anadromous Reach?				
Has the stream reach upstream of the crossing supported an anadromous fish population?	No			
Source				
Crossing Type				
Crossing Type Culvert ID				
General Description: Concrete pipe culvert with a concrete headwall.				
Photos

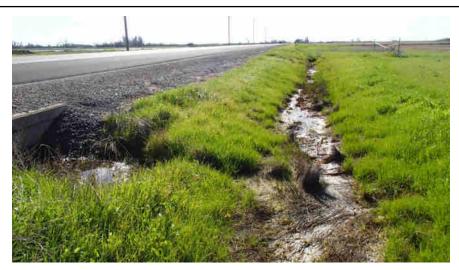
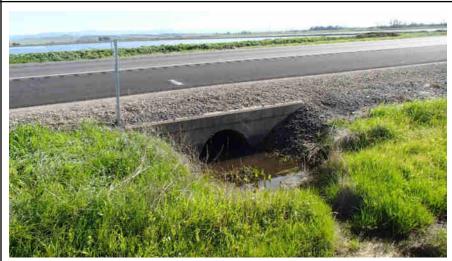
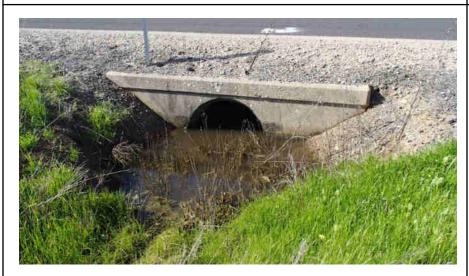
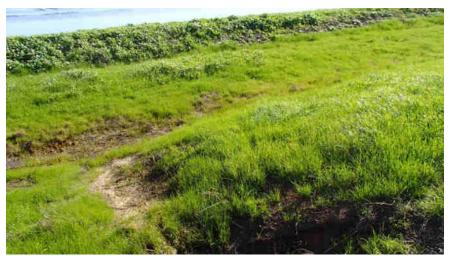
County: Butte Route: 99 Postmile: 15.89 Survey Date: 02/05/2016

Central Valley Spring-Run Chinook	senieau)		
Central Valley Fall_Late Fall-Run Chinook			
Central Valley Steelhead			
	Historic Anadromous Reach?		
Has the stream reach upstream of the crossing	supported an anadromous fish population?		
Source			
	Crossing Type		
Crossing Type Culvert	ID		
General Description: Concrete pipe culvert with	h a concrete headwall.		
	Photos

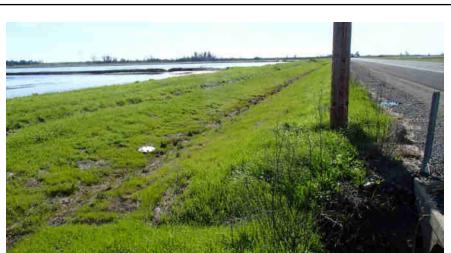
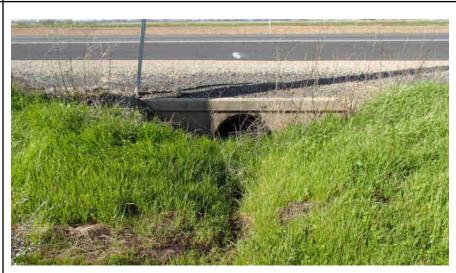
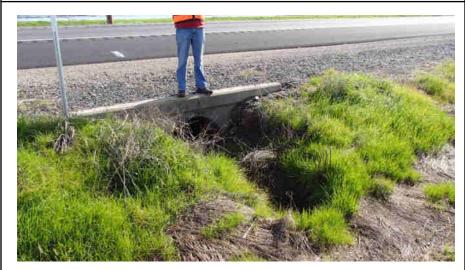
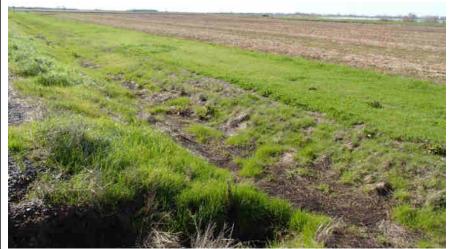
County: Butte Route: 99 Postmile: 15.97 Survey Date: 02/05/2016

•		ial Fish Bearing Stream	?		
Does the site contain an active char					
Does the site contain an active char Is the stream gradient < 20%?	inei width >2 leet?	No yes	<u></u>		
is the stream gradient < 2070:	S	Salmonid ESU/DPS			
ESU (Chinook and Coho Salmon) o		amonia 200/Di 0			
Central Valley Spring-Run Chinook					
Central Valley Fall_Late Fall-Run Cl	ninook				
Central Valley Steelhead					
	Histori	c Anadromous Reach?			
Has the stream reach upstream of the	ne crossing supported an anad	romous fish population?	No		
Source					
		Crossing Type			
Crossing Type Culvert		ID			
General Description: Concrete pipe	e culvert with a concrete headw	all.			
		Photos

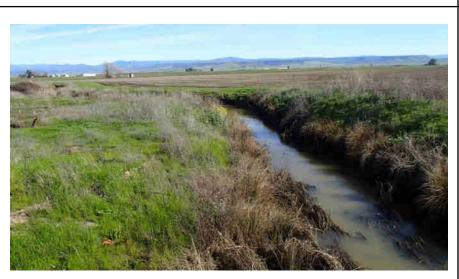
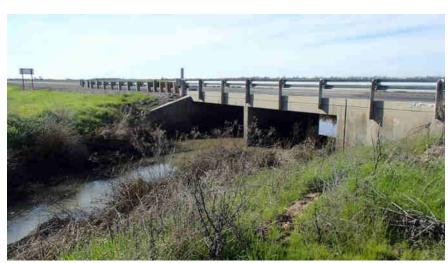
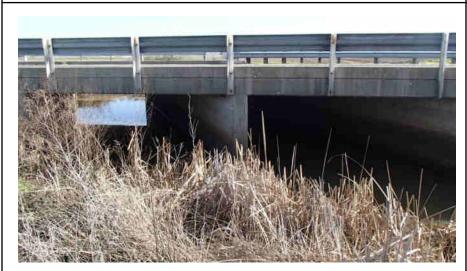
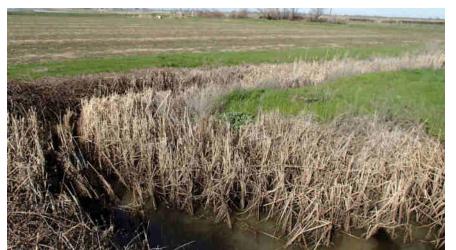
County: Butte Route: 99 Postmile: 16.09 Survey Date: 02/05/2016

Central Valley Spring-Run Chinook			
Central Valley Fall_Late Fall-Run Chinook			
Central Valley Steelhead			
	Historic Anadromous Reach?		
Has the stream reach upstream of the crossing su			
Source Tributary to Butte Creek, CV Sprin	g-run 5-Year Status Review (NMFS 2005)		
	Crossing Type		
Crossing Type bridge w/o potential passag			
General Description: Double concrete bay bridge			
	Photos

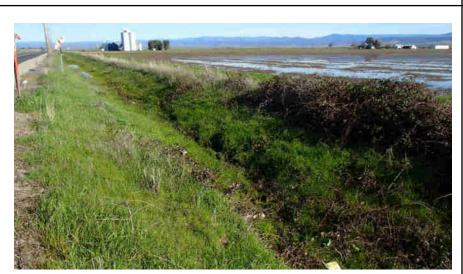
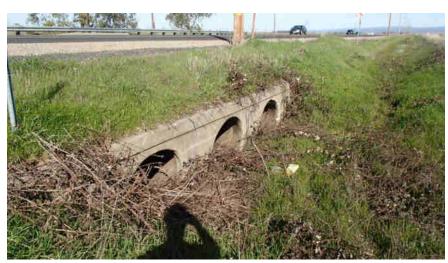
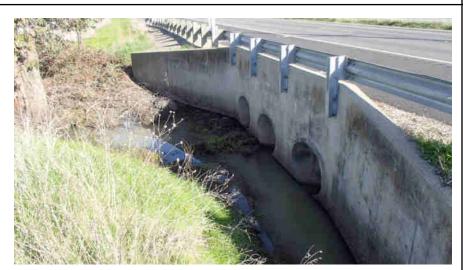
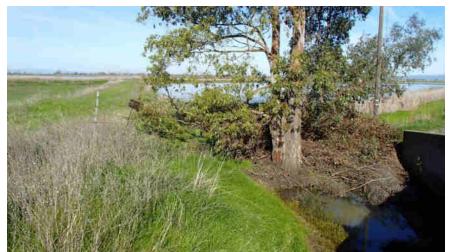
County: Butte Route: 99 Postmile: 16.38 Survey Date: 02/05/2016

ESU (Chinook and Coho Salmon) or DPS (Steelhead)				
Central Valley Spring-Run Chinook				
Central Valley Fall_Late Fall-Run Chinook				
Central Valley Steelhead				
Historic Anadromous Reach?				
Has the stream reach upstream of the crossing supported an anadromous fish population? No				
Source Crossing Type				
Crossing Type				
Crossing Type Culvert ID General Description: Three concrete pipe culverts with a concrete pipe headwall.	1			
Photos 3.1 Upstream Looking Upstream - Photo I 3.1_BUT_99_16.38_UU

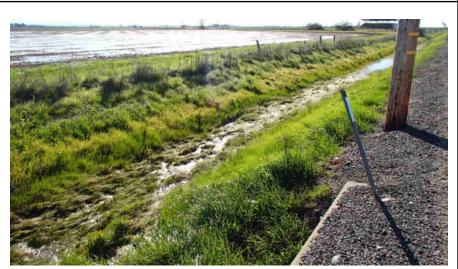
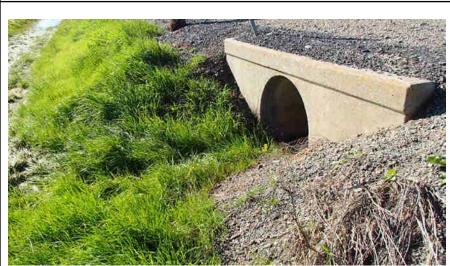
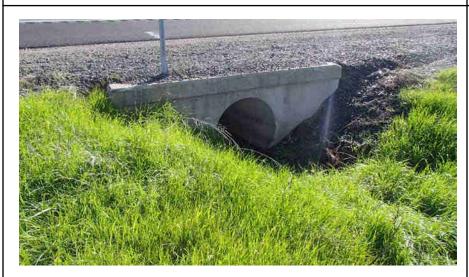
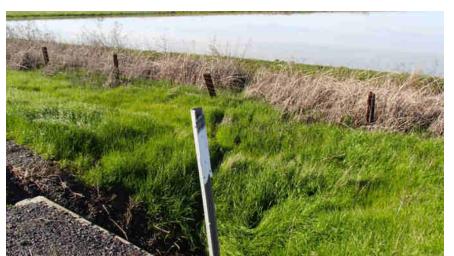
County: Butte Route: 99 Postmile: 16.43 Survey Date: 02/05/2016

Upstream Looking Upstream

Upstream Looking Downstream

Downstream Looking Upstream

Downstream Looking Downstream

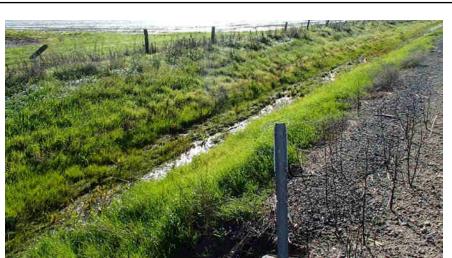
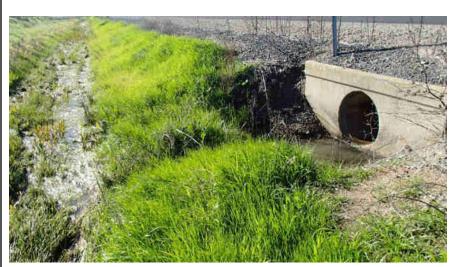
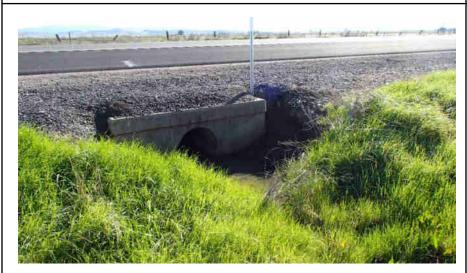
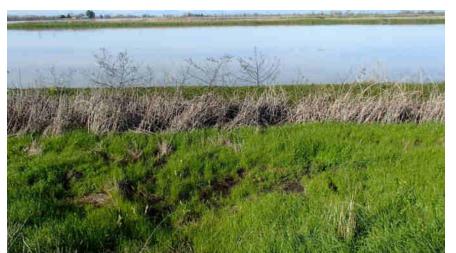
County: Butte Route: 99 Postmile: 16.46 Survey Date: 02/05/2016

Salmonid ESU/DPS			
ESU (Chinook and Coho Salmon) or DPS (Steelhe	ead)			
Central Valley Spring-Run Chinook				
Central Valley Fall_Late Fall-Run Chinook				
Central Valley Steelhead				
	Historic Anadromous Reach?			
Has the stream reach upstream of the crossing supp	ported an anadromous fish population?			
Source				
	Crossing Type			
Crossing Type Culvert	ID			
General Description: Concrete pipe culvert with a concrete headwall.				
	Photos

Upstream Looking Upstream

Upstream Looking Downstream

Downstream Looking Upstream

Downstream Looking Downstream

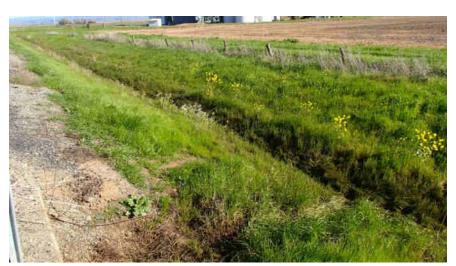
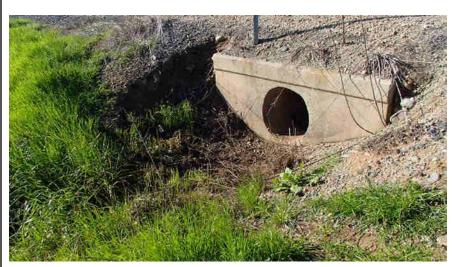
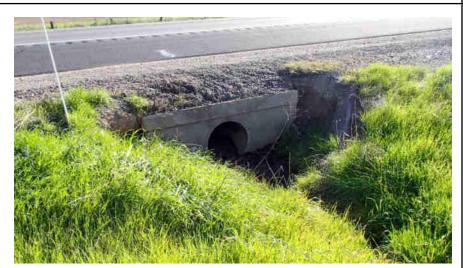
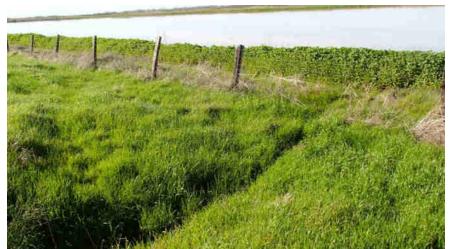
County: Butte Route: 99 Postmile: 16.57 Survey Date: 02/05/2016

Central Valley Spring-Run Chinook			
Central Valley Fall_Late Fall-Run Chinook			
Central Valley Steelhead			
Historic Anadromous Reach?	7		
Has the stream reach upstream of the crossing supported an anadromous fish population? No]		
Source Crossing Type			
Crossing Type Culvert ID			
General Description: Concrete pipe culvert with a concrete headwall.			
Photos

Upstream Looking Upstream

Upstream Looking Downstream

Downstream Looking Upstream

Downstream Looking Downstream

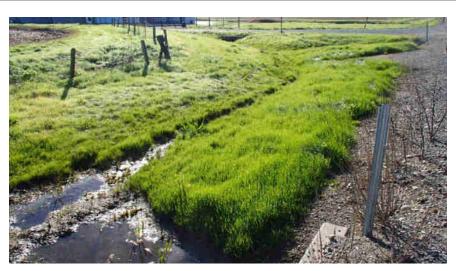
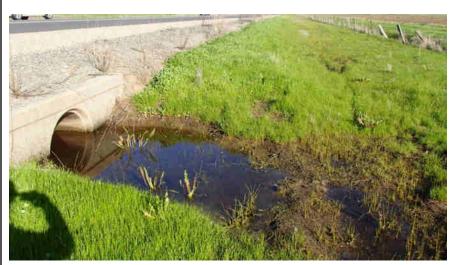
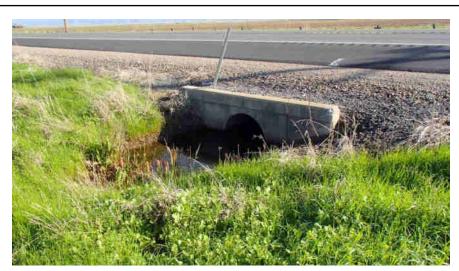
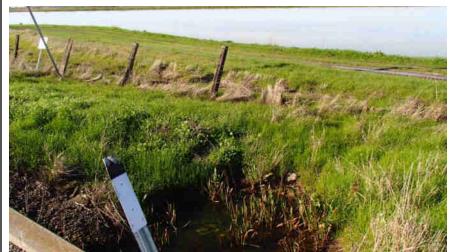
County: Butte Route: 99 Postmile: 16.68 Survey Date: 02/05/2016

Central Valley Spring-Run Chinook	au)			
Central Valley Fall_Late Fall-Run Chinook	_			
Central Valley Steelhead				
Samuel Valley Steemista	Historic Anadromous Reach?			
Has the stream reach upstream of the crossing supp				
Source				
	Crossing Type			
Crossing Type Culvert	ID			
General Description: Concrete pipe culvert with a concrete pipe culvert wi	oncrete headwall.			
Photos

Upstream Looking Upstream

Upstream Looking Downstream

Downstream Looking Upstream

Downstream Looking Downstream
