Summary of 2016 Reconnaissance Fish Passage Surveys

During February and March of 2016, 179 Reconnaissance Fish Passage Surveys were conducted on state highways in Butte and Sacramento counties. 138 sites were surveyed on Highway 99 in Butte County, 24 sites were surveyed on Highway 99 in Sacramento County, and 17 sites were surveyed on Highway 104 in Sacramento County. The Reconnaissance Surveys were performed in accordance with the California Department of Transportation's (Caltrans') Reconnaissance Fish Passage Assessment Instructions and Procedures manual¹. 25 of the 179 sites (14%) were identified as requiring a Detailed Fish Passage Survey.

County: Butte Route: 99 Postmile: 0.01 Survey Date: 02/09/2016

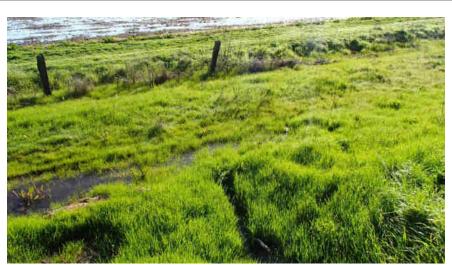
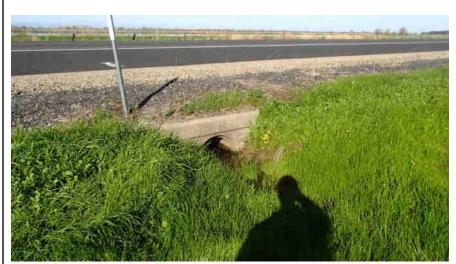
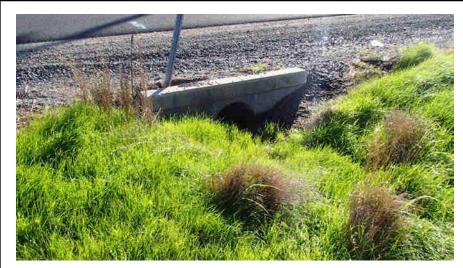
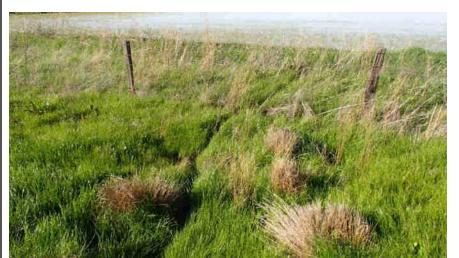
County: Butte Route: 99 Postmile: 16.77 Survey Date: 02/05/2016

Central Valley Spring-Run Chinook			
Central Valley Fall_Late Fall-Run Chinook			
Central Valley Steelhead			
Historic Anadromous Reach?	1		
Has the stream reach upstream of the crossing supported an anadromous fish population? No			
Source Crossing Type			
Crossing Type Culvert ID			
General Description: Concrete pipe culvert with a concrete headwall.	1		
Photos

Upstream Looking Upstream

Upstream Looking Downstream

Downstream Looking Upstream

Downstream Looking Downstream

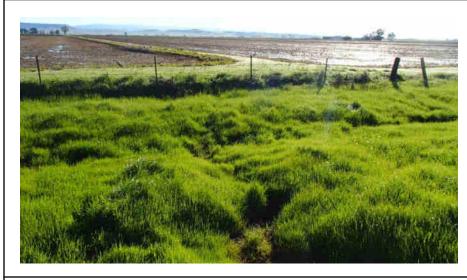
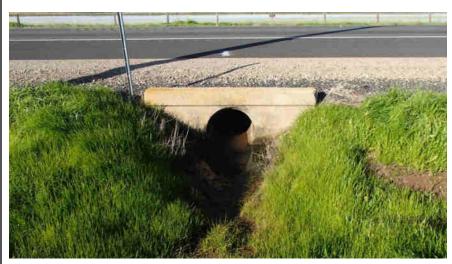
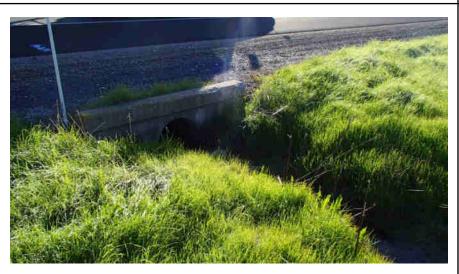
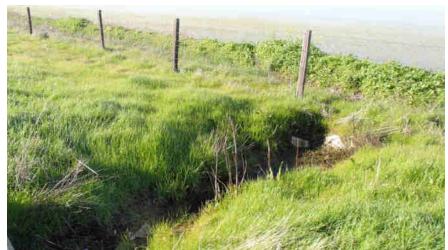
Postmile: 16.91 Survey Date: 02/05/2016

ESU (Chinook and Coho Salmon) or DPS (Ste	elhead)		
Central Valley Spring-Run Chinook			
Central Valley Fall_Late Fall-Run Chinook	<u></u>		
Central Valley Steelhead			
	Historic Anadromous Reach?		
Has the stream reach upstream of the crossing	supported an anadromous fish population?		
Source			
	Crossing Type		
Crossing Type Culvert	ID		
General Description: Concrete pipe culvert with a concrete headwall.			
	Photos

Upstream Looking Upstream

Downstream Looking Upstream

Downstream Looking Downstream

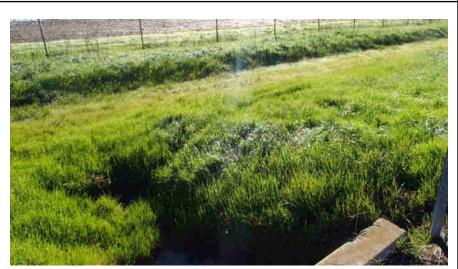
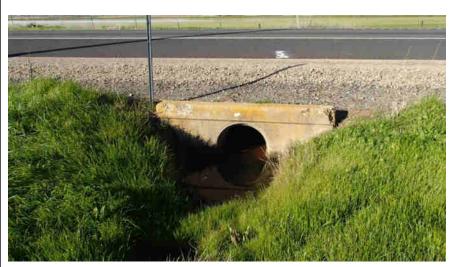
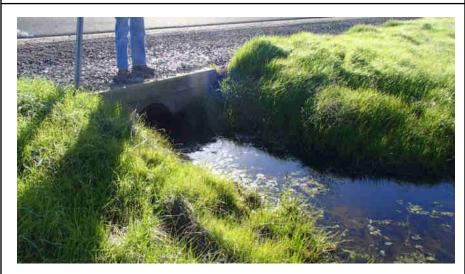
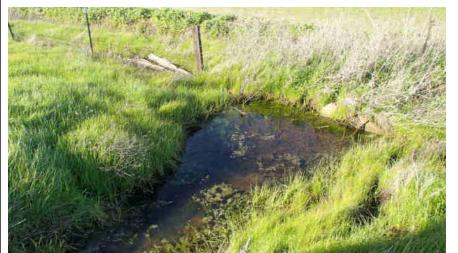
County: Butte Route: 99 Postmile: 17.03 Survey Date: 02/05/2016

Central Valley Spring-Run Chinook			
Central Valley Fall_Late Fall-Run Chinook			
Central Valley Steelhead			
	Historic Anadromous Reach?		
Has the stream reach upstream of the crossing sup	ported an anadromous fish population?		
Source			
	Crossing Type		
Crossing Type Culvert	ID		
General Description: Concrete pipe culvert with a concrete headwall.			
	Photos

Upstream Looking Upstream

Upstream Looking Downstream

Downstream Looking Upstream

Downstream Looking Downstream

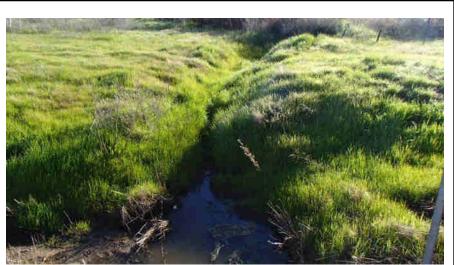
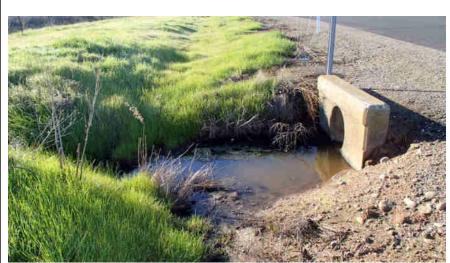
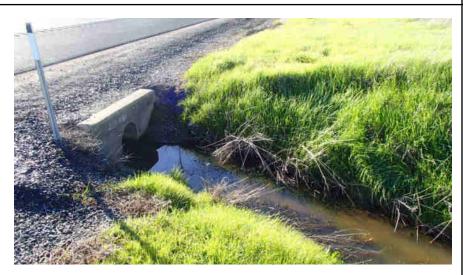
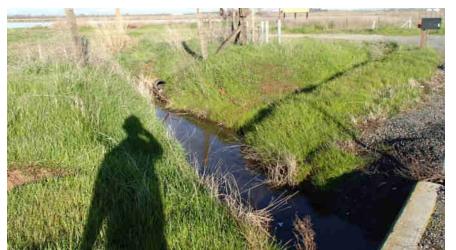
County: Butte Route: 99 Postmile: 17.16 Survey Date: 02/05/2016

Central Valley Spring-Run Chinook			
Central Valley Fall_Late Fall-Run Chinook			
Central Valley Steelhead			
Historic Anadromous Reach?			
Has the stream reach upstream of the crossing supported an anadromous fish population? No			
Source Crossing Type			
Crossing Type			
Crossing Type Culvert ID			
General Description: Concrete pipe culvert with a concrete headwall.			
Photos

Upstream Looking Upstream

Upstream Looking Downstream

Downstream Looking Upstream

Downstream Looking Downstream

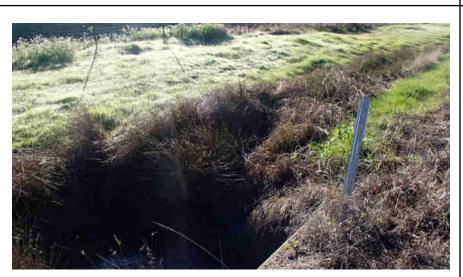
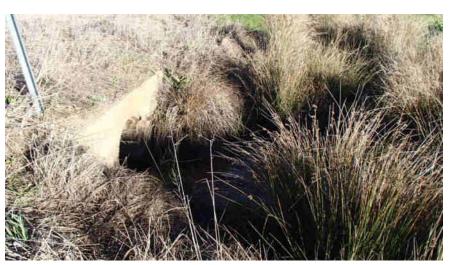
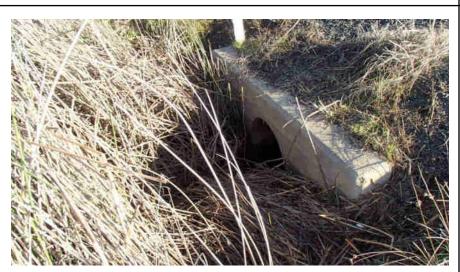
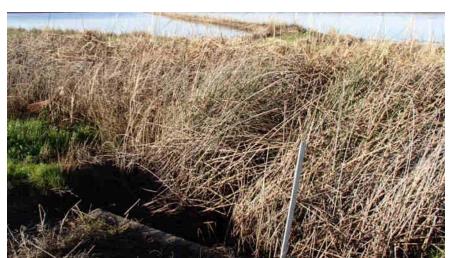
County: Butte Route: 99 Postmile: 17.33 Survey Date: 02/05/2016

Central Valley Spring-Run Chinook					
Central Valley Fall_Late Fall-Run Chi	ook				
Central Valley Steelhead					
		adromous Reach?			
Has the stream reach upstream of the	crossing supported an anadromo	us fish population?	No		
Source	0				
. = [-	Cro	ssing Type			
Crossing Type Culvert	uh cent with a seriousta basedwall	ID			
General Description: Concrete pipe culvert with a concrete headwall.					
O.A. Hasters and J. H. H. H. S.		Photos

Upstream Looking Upstream

Upstream Looking Downstream

Downstream Looking Upstream

Downstream Looking Downstream

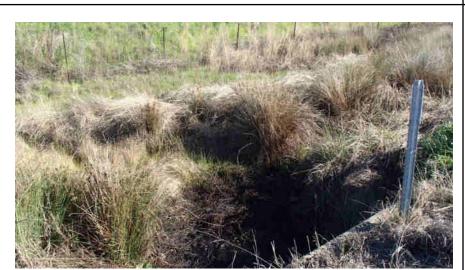
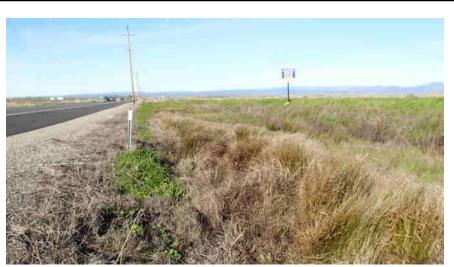
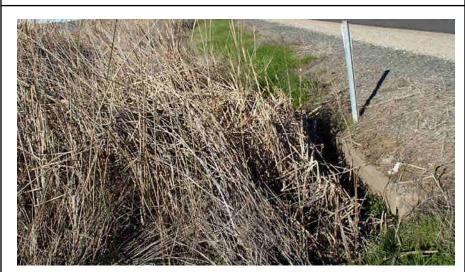
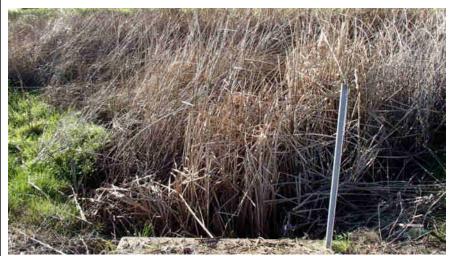
County: Butte Route: 99 Postmile: 17.41 Survey Date: 02/04/2016

Central Valley Spring-Run Chinook			
Central Valley Fall_Late Fall-Run Chinook			
Central Valley Steelhead			
Historic Anadromous Reach?			
Has the stream reach upstream of the crossing supported an anadromous fish population?			
Source Crossing Type			
Crossing Type			
Crossing Type Culvert ID			
General Description: Double concrete pipe culvert with a conrete headwall.			
Photos

Upstream Looking Upstream

Upstream Looking Downstream

Downstream Looking Upstream

Downstream Looking Downstream

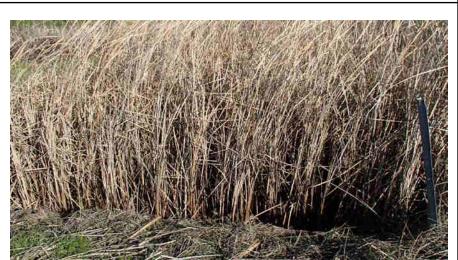
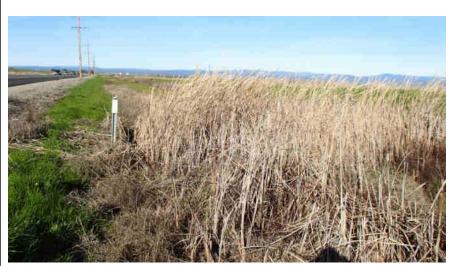
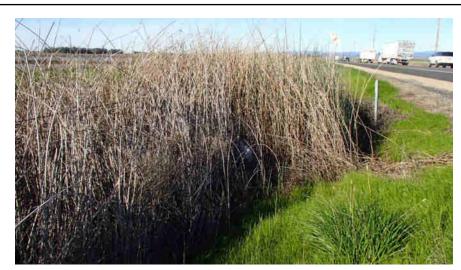
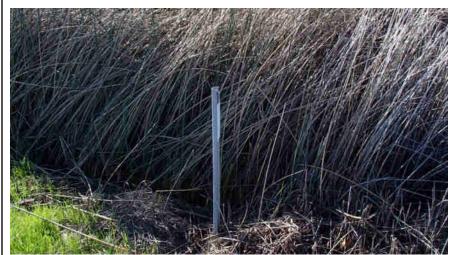
County: Butte Route: 99 Postmile: 17.51 Survey Date: 02/04/2016

Central Valley Spring-Run Chinook			
Central Valley Fall_Late Fall-Run Chinook			
Central Valley Steelhead			
Historic Anadromous Reach?			
Has the stream reach upstream of the crossing supported an anadromous fish population?			
Source State of Trans.			
Crossing Type			
Crossing Type Culvert ID			
General Description: Double concrete box culvert.			
Photos

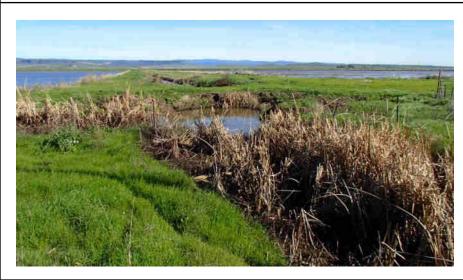
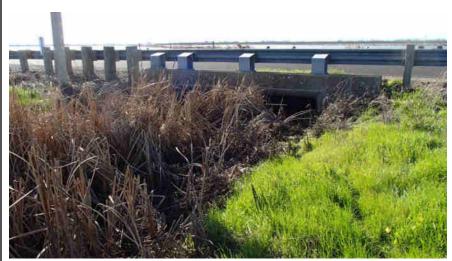
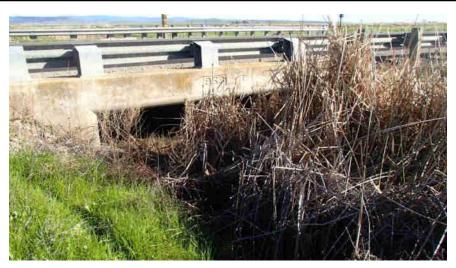
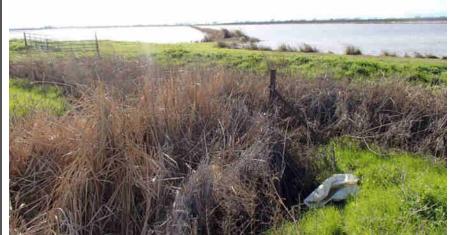
County: Butte Route: 99 Postmile: 17.67 Survey Date: 02/04/2016

Central Valley Spring-Run Chinook			
Central Valley Fall_Late Fall-Run Chinook			
Central Valley Steelhead	Historia Anadramana Bassi C		
	Historic Anadromous Reach?		
Has the stream reach upstream of the crossing sup	ported an anadromous fish population?		
Source	Crossing Type		
Crossing Type Culvert	ID		
General Description: Double concrete pipe culvert		1	
Photos

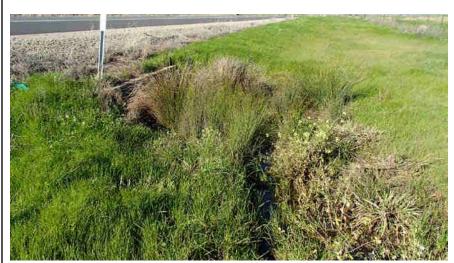
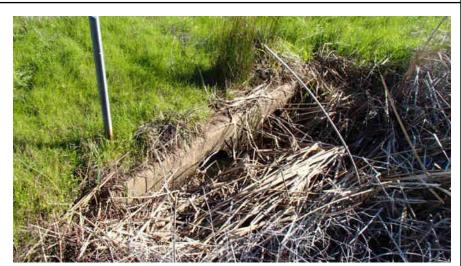
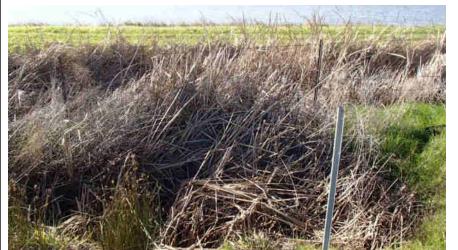
County: Butte Route: 99 Postmile: 17.71 Survey Date: 02/04/2016

Central Valley Spring-Run Chinook			
Central Valley Fall_Late Fall-Run Chinook			
Central Valley Steelhead			
	Historic Anadromous Reach?		
Has the stream reach upstream of the crossir	ng supported an anadromous fish population?		
Source			
	Crossing Type		
Crossing Type Culvert	ID		
General Description: Concrete pipe culvert v	vith a concrete headwall.		
	Photos

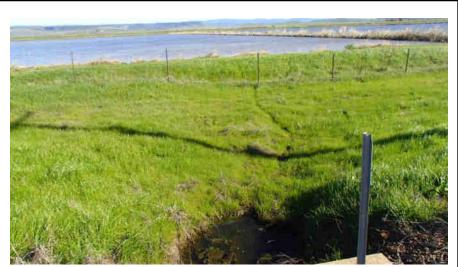
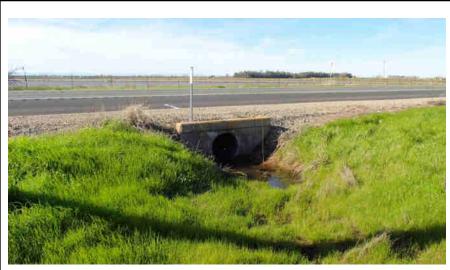
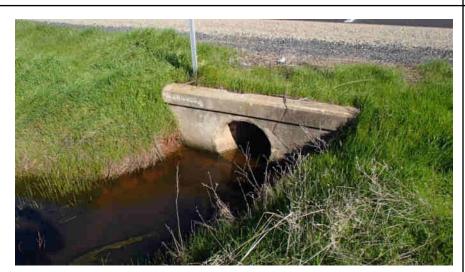
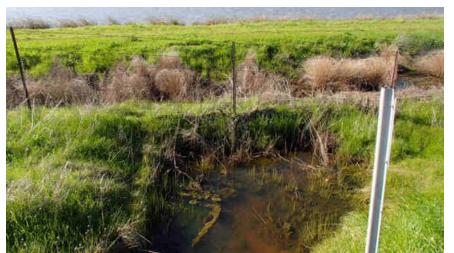
County: Butte Route: 99 Postmile: 17.78 Survey Date: 02/04/2016

Central Valley Spring-Run Chinook			
Central Valley Fall_Late Fall-Run Chinook			
Central Valley Steelhead			
	Historic Anadromous Reach?		
Has the stream reach upstream of the crossing s	supported an anadromous fish population? Unknown		
Source Tributary to Butte Creek, CV Spr	ing-run 5-Year Status Review (NMFS 2005)		
	Crossing Type		
Crossing Type Culvert	ID		
General Description: Double concrete pipe culvert with a concrete headwall.			
	Photos

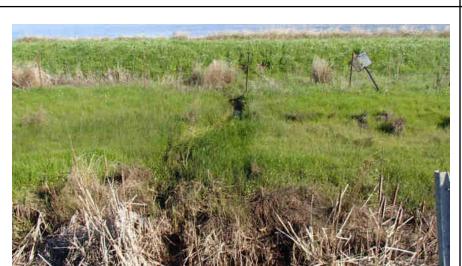
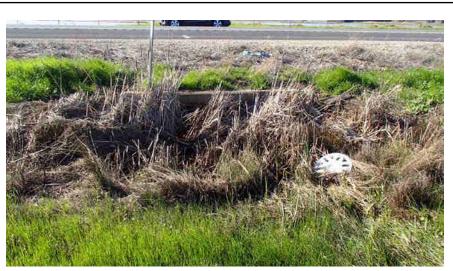
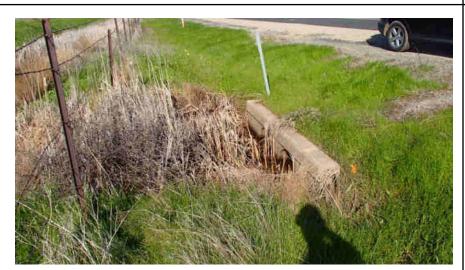
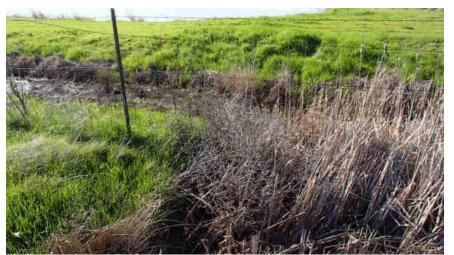
County: Butte Route: 99 Postmile: 17.91 Survey Date: 02/04/2016

Salmonid ESU/DPS		
ESU (Chinook and Coho Salmon) or DPS (Sto	eelhead)		
Central Valley Spring-Run Chinook			
Central Valley Fall_Late Fall-Run Chinook			
Central Valley Steelhead			
	Historic Anadromous Reach?		
Has the stream reach upstream of the crossing	supported an anadromous fish population?		
Source			
	Crossing Type		
Crossing Type Culvert	ID		
General Description: Concrete pipe culvert with	th a concrete headwall.		
Photos

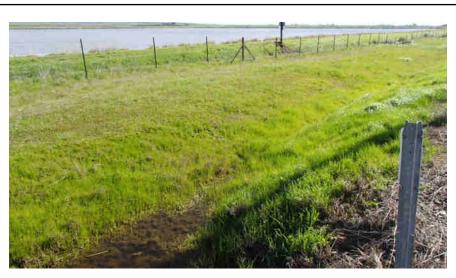
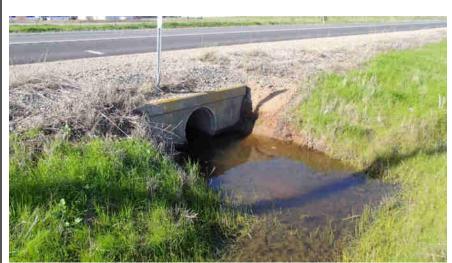
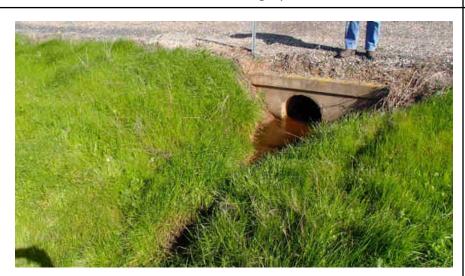
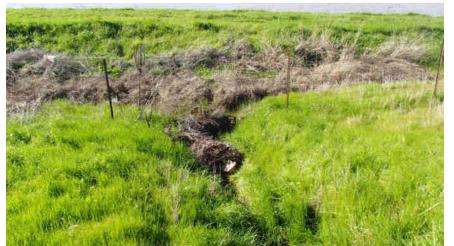
County: Butte Route: 99 Postmile: 18.06

Central Valley Spring-Run Chinook	<u> </u>		
Central Valley Fall_Late Fall-Run Chinook			
Central Valley Steelhead			
	Historic Anadromous Reach?		
Has the stream reach upstream of the crossing sup	ported an anadromous fish population?		
Source			
	Crossing Type		
Crossing Type Culvert	ID		
General Description: Concrete pipe culvert with a concrete headwall.			
	Photos

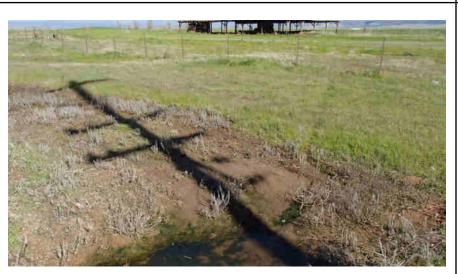
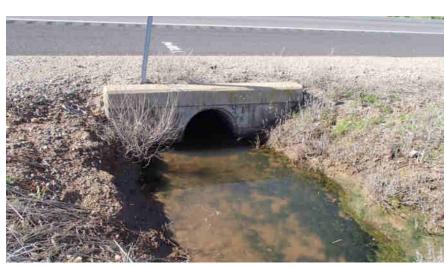
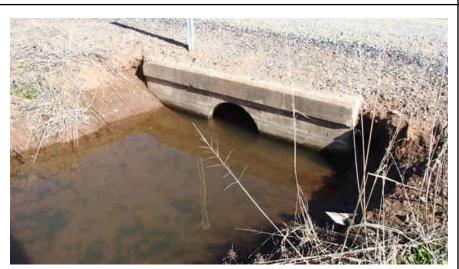
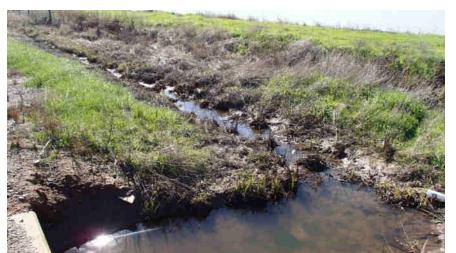
County: Butte Route: 99 Postmile: 18.20 Survey Date: 02/04/2016

Central Valley Spring-Run Chinook		
Central Valley Fall_Late Fall-Run Chinook		
Central Valley Steelhead		
	Historic Anadromous Reach?	
Has the stream reach upstream of the crossing s	supported an anadromous fish population?	
Source		
	Crossing Type	
Crossing Type Culvert	ID	
General Description: Concrete pipe culvert with	a concrete headwall.	
	Photos

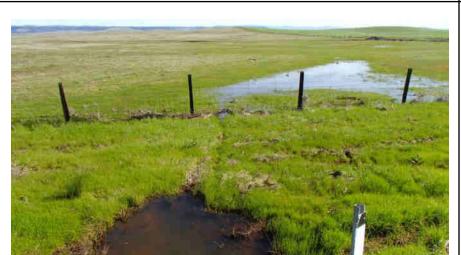
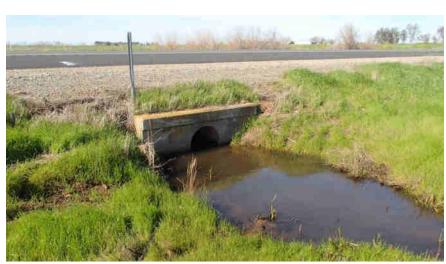
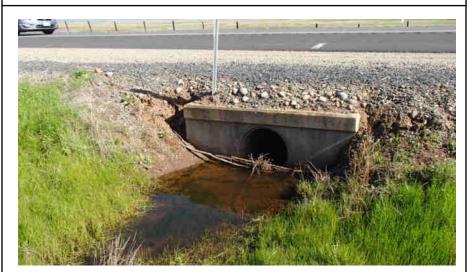
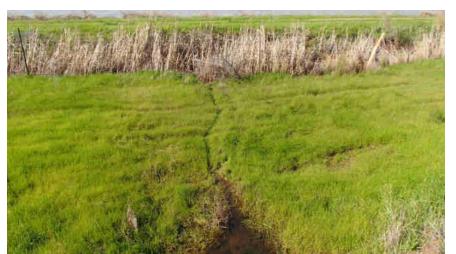
County: Butte Route: 99 Postmile: 18.60 Survey Date: 02/04/2016

Central Valley Steelhead	
Historic Anadromous Reach?	
Has the stream reach upstream of the crossing supported an anadromous fish population?	
Source	
Crossing Type	
Crossing Type Culvert ID	
General Description: Concrete box culvert with a concrete headwall.	
Photos

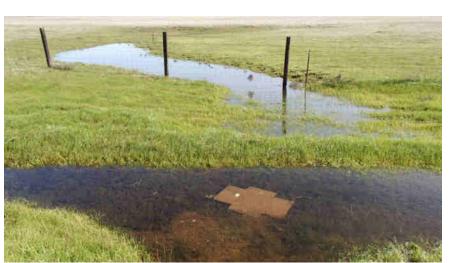
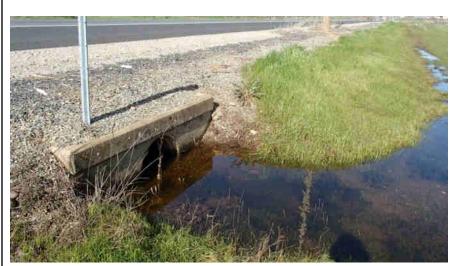
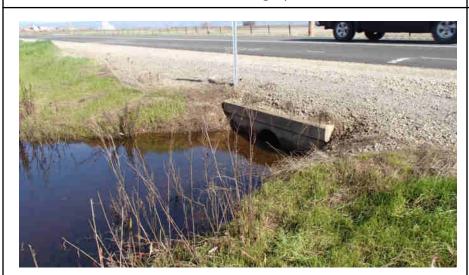
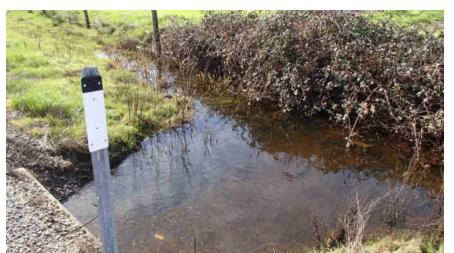
County: Butte Route: 99 Postmile: 19.30 Survey Date: 02/04/2016

Central Valley Spring-Run Chinook					
Central Valley Fall_Late Fall-Run Chinook					
Central Valley Steelhead					
Historic Anadromous Reach?					
Has the stream reach upstream of the crossing supported an anadromous fish population? Unknown	n _				
Source Crossing Type					
Crossing Type					
Crossing Type bridge w/o potential passage constraints ID 12-0122					
General Description: Double bay bridge.					
Photos

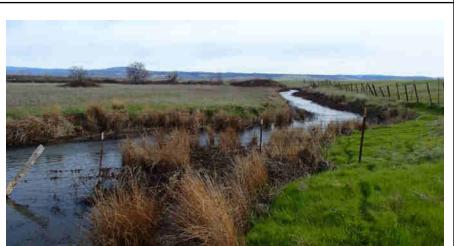
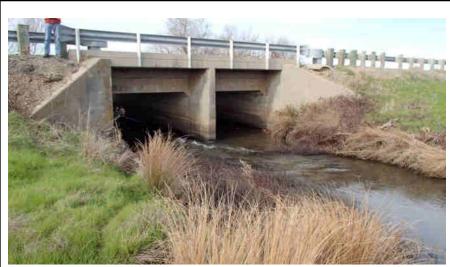
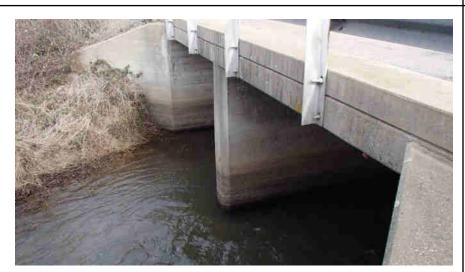
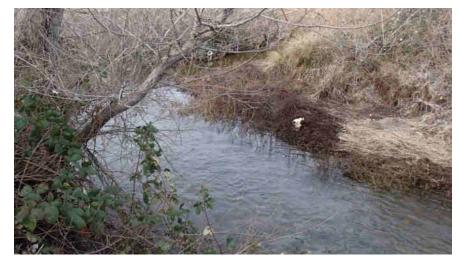
County: Butte Route: 99 Postmile: 19.51 Survey Date: 02/04/2016

Is the stream gradient < 20%?	Yes				
	Salmonid ESU/DPS				
ESU (Chinook and Coho Salmon) or DPS (Ste	eelhead)				
Central Valley Spring-Run Chinook					
Central Valley Fall_Late Fall-Run Chinook					
Central Valley Steelhead					
	Historic Anadromous Reach?				
Has the stream reach upstream of the crossing	supported an anadromous fish population? Unknown				
Source	Out of the Town				
	Crossing Type				
Crossing Type Culvert	ID				
General Description: Concrete pipe culvert in a concrete form.					
	Photos

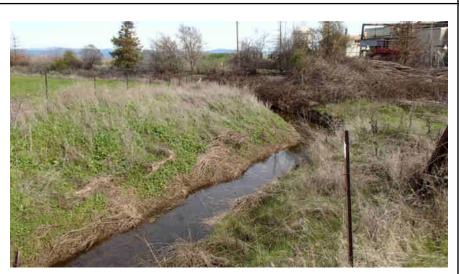
Salmonid ESU/DPS					
ESU (Chinook and Coho Salmon) or DPS (Steelhead)					
Central Valley Fall_Late Fall-Run Chinook					
Central Valley Steelhead					
Central Valley Spring-Run Chinook					
Historic Anadromous Reach?					
Has the stream reach upstream of the crossing supported an anadromous fish population? Unknown Unknown					
Source Tributary to Butte Creek, CV Spring-run 5-Year Status Review (NMFS 2005) Crossing Type					
Crossing Type Culvert ID					
General Description: Concrete box culvert. Most likely a irrigation canal.					
Photos

3.1 Upstream Looking Upstream - Photo I 3.1_BUT_99_19.72_UU	7				
3.1 Upstream Looking Downstream - Photo I 3.2 Upstream Looking Downstream - Photo I 3.2_BUT_99_19.72_UD

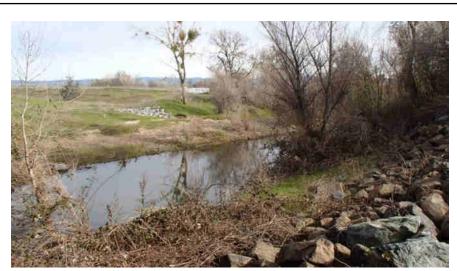
latural Stream Channel?	
Is there a definable channel upstream of culvert?	Yes	
Is the primary function for storm water runoff or road drainage?:	No	
Is the waterway a concrete-lined flood control channel?	No	
Pote	ential Fish Bearing Stream?	
Does the site contain an active channel width >2 feet?	Yes	
Is the stream gradient < 20%?	Yes	
	Salmonid ESU/DPS	
ESU (Chinook and Coho Salmon) or DPS (Steelhead)		
Central Valley Spring-Run Chinook		
Central Valley Fall_Late Fall-Run Chinook		
Central Valley Steelhead		
History	toric Anadromous Reach?	
Has the stream reach upstream of the crossing supported an ar	nadromous fish population? Unknown	
Source Tributary to Butte Creek, CV Spring-run 5-Year	Status Review (NMFS 2005)	
	Crossing Type	
Crossing Type bridge w/o potential passage constraints	ID 12-0196	
General Description:		
	Photos

3.1 Upstream Looking Upstream - Photo I 3.1_BUT	_99_20.60_UU	
3.2 Upstream Looking Downstream - Photo I 3.2_BUT	_99_20.60_UD	
<u></u>	_99_20.60_DU	
3.4 Downstream Looking Downstream - Photo ID 3.4_BUT	_99_20.60_DD	
Deta	ailed Survey Required?	
Detailed Survey Required?: No		
Report Date 03-15-2016

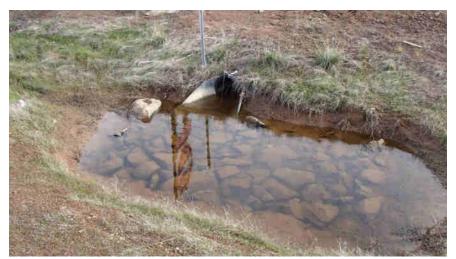
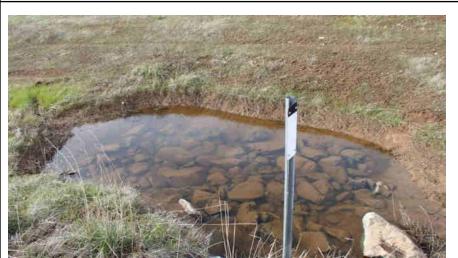
Upstream Looking Upstream	Upstream Looking Downstream
N/A	N/A
Downstream Looking Upstream	Downstream Looking Downstream

Central Valley Spring-Run Chinook		
Central Valley Fall_Late Fall-Run Chinook		
Central Valley Steelhead		
Historic Anadromous Reach?		
Has the stream reach upstream of the crossing supported an anadromous fish population?		
Source		
Crossing Type		
Crossing Type Culvert ID		1
General Description: PVC pipe culvert with precast end secton. Could not locate upstream end of culvert.		
Photos

3.1 Upstream Looking Upstream - Photo I n/a		
3.2 Upstream Looking Downstream - Photo I n/a		
3.3 Downstream Looking Upstream - Photo ID 3.3 BUT_99_21.26_DU

3.4 Downstream Looking Downstream - Photo ID 3.4_BUT_99_21.26_DD		
Detailed Survey Required?		
Detailed Survey Required?: No

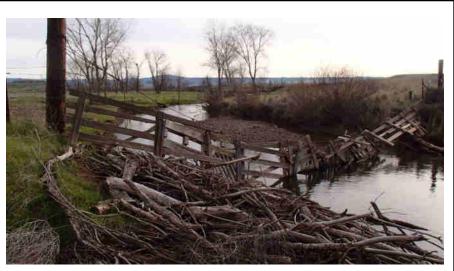
Central Valley Spring-Run Chinook	
Central Valley Fall_Late Fall-Run Chinook	
Central Valley Steelhead	
Historic Anadromous Reach?	
Has the stream reach upstream of the crossing supported an anadromous fish population? Yes	
Source Tributary to Butte Creek, CV Spring-run 5-Year Status Review (NMFS 2005)	
Crossing Type	
Crossing Type bridge w/o potential passage constraints ID 12-0196	
General Description:	
Photos	_

3.1 Upstream Looking Upstream - Photo I 3.1_BUT_99_22.95_UU	
3.2 Upstream Looking Downstream - Photo I 3.2_BUT_99_22.95_UD	
3.3 Downstream Looking Upstream - Photo ID 3.3_BUT_99_22.95_DU	_

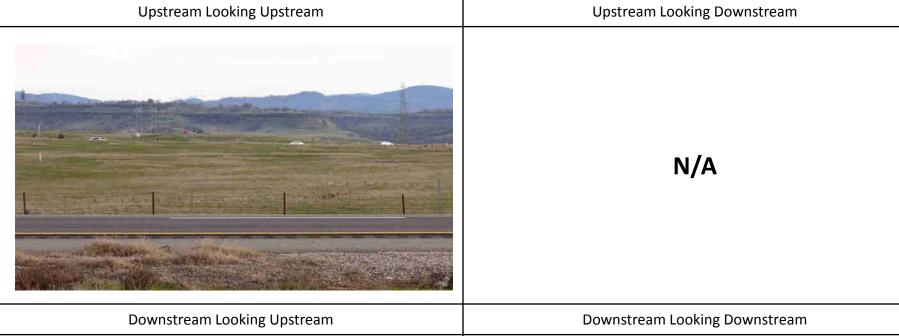
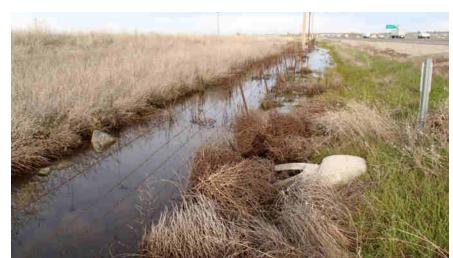
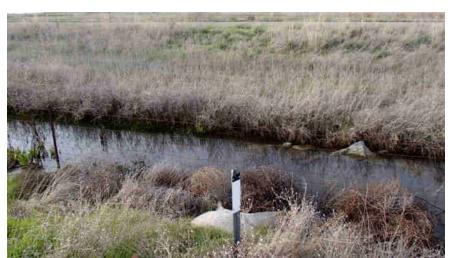
County: Butte Route: 99 Postmile: 23.40 Survey Date: 02/04/2016

-	Natural Stream Channel?	
Is there a definable channel upstream of culvert?	No No	
Is the primary function for storm water runoff or road dra		
Is the waterway a concrete-lined flood control channel?	No	
	Potential Fish Bearing Stream?	
Does the site contain an active channel width >2 feet?	No	
Is the stream gradient < 20%?	yes	
	Salmonid ESU/DPS	
ESU (Chinook and Coho Salmon) or DPS (Steelhead)		
Central Valley Spring-Run Chinook		
Central Valley Fall_Late Fall-Run Chinook		
Central Valley Steelhead		
	Historic Anadromous Reach?	
Has the stream reach upstream of the crossing supported	ed an anadromous fish population?	
Source		
	Crossing Type	
Crossing Type Culvert	ID	
General Description: Concrete pipe culvert with precase	t end sections.	
	Photos

3.1 Upstream Looking Upstream - Photo I 3.	1_BUT_99_23.40_UU	
3.2 Upstream Looking Downstream - Photo I	a	
3.3 Downstream Looking Upstream - Photo ID 3.	3_BUT_99_23.40_DU

3.4 Downstream Looking Downstream - Photo ID 3.	4_BUT_99_23.40_DD	
	Detailed Survey Required?	
Detailed Survey Required?: No		
D + D + 00 45 0040

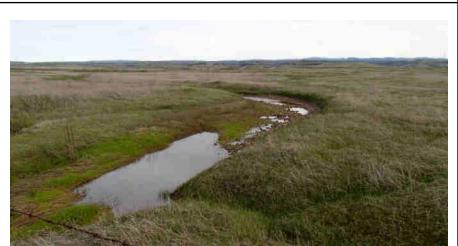
Is the waterway a concrete-lined flood control chann		
	Potential Fish Bearing Stream?	
Does the site contain an active channel width >2 fee	et? Yes	
Is the stream gradient < 20%?	Yes	
	Salmonid ESU/DPS	
ESU (Chinook and Coho Salmon) or DPS (Steelhe	ead)	
Central Valley Spring-Run Chinook		
Central Valley Fall_Late Fall-Run Chinook		
Central Valley Steelhead		
	Historic Anadromous Reach?	
Has the stream reach upstream of the crossing supp	<u> </u>	
Source Tributary to Butte Creek, CV Spring	-run 5-Year Status Review (NMFS 2005)	
	Crossing Type	
Crossing Type Culvert	ID	
General Description: Double concrete box culvert.		
Od Hadron Lastin III de Silvin	Photos	7

3.1 Upstream Looking Upstream - Photo I	3.1_BUT_99_23.60_UU	<u></u>
3.2 Upstream Looking Downstream - Photo I	3.2_BUT_99_23.60_UD	_ ¬
3.3 Downstream Looking Upstream - Photo ID	3.3_BUT_99_23.60_DU	_ _

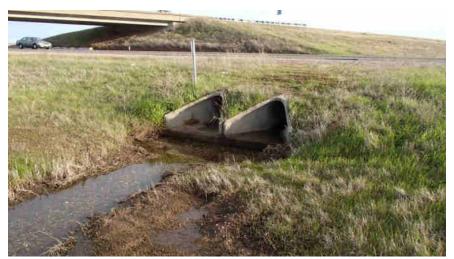
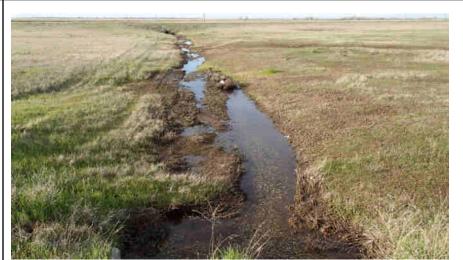
County: Butte Route: 99 Postmile: 23.90 Survey Date: 02/04/2016

Central Valley Spring-Run Chinook		
Central Valley Fall_Late Fall-Run Chinook		
Central Valley Steelhead		
	Historic Anadromous Reach?	
Has the stream reach upstream of the crossing supp	orted an anadromous fish population?	
Source		
	Crossing Type	
Crossing Type Culvert	ID	
General Description: Two concrete pipe culverts wi	th precast end sections.	
	Photos

3.1 Upstream Looking Upstream - Photo I	3.1_BUT_99_23.90_UU	
3.2 Upstream Looking Downstream - Photo I	n/a	
3.3 Downstream Looking Upstream - Photo ID	3.3_BUT_99_23.90_DU

3.4 Downstream Looking Downstream - Photo ID	3.4_BUT_99_23.90_DD]
	Detailed Survey Required?	
Detailed Survey Required?: No

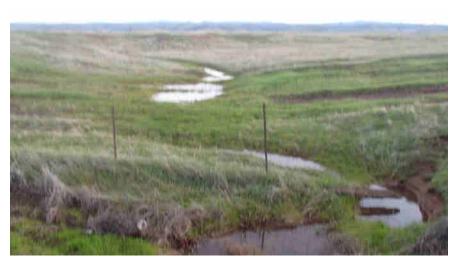
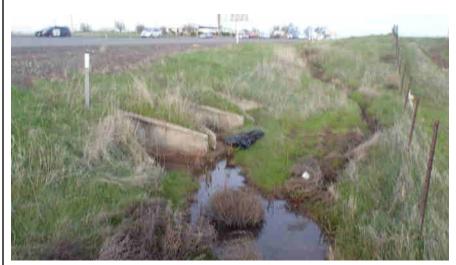
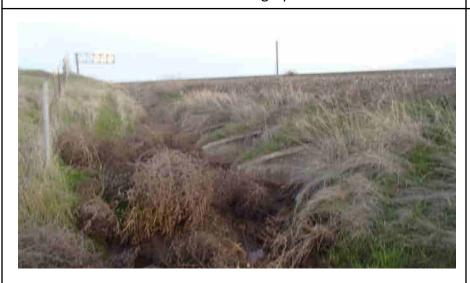
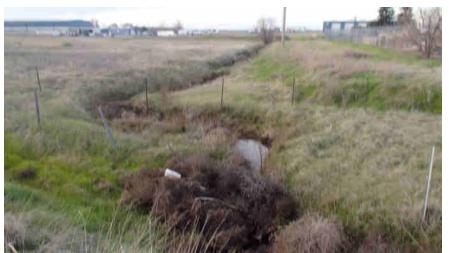
County: Butte Route: 99 Postmile: 24.10 Survey Date: 02/04/2016

Is the waterway a concrete-lined flood control chan		
	Potential Fish Bearing Stream?	
Does the site contain an active channel width >2 fe	eet? No	
Is the stream gradient < 20%?	yes	
	Salmonid ESU/DPS	
ESU (Chinook and Coho Salmon) or DPS (Steelh	ead)	
Central Valley Spring-Run Chinook		
Central Valley Fall_Late Fall-Run Chinook		
Central Valley Steelhead		
	Historic Anadromous Reach?	
Has the stream reach upstream of the crossing sup		
Source Tributary to Butte Creek, CV Spring	g-run 5-Year Status Review (NMFS 2005)	
	Crossing Type	
Crossing Type Culvert	ID	
General Description: Three concrete pipe culverts		
Od Hadron Lock Holes Took	Photos

3.1 Upstream Looking Upstream - Photo I	3.1_BUT_99_24.10_UU	
3.2 Upstream Looking Downstream - Photo I	3.2_BUT_99_24.10_UD	
3.3 Downstream Looking Upstream - Photo ID	3.3_BUT_99_24.10_DU

3.4 Downstream Looking Downstream - Photo ID	3.4_BUT_99_24.10_DD	
	Detailed Survey Required?	
Detailed Survey Required?: No

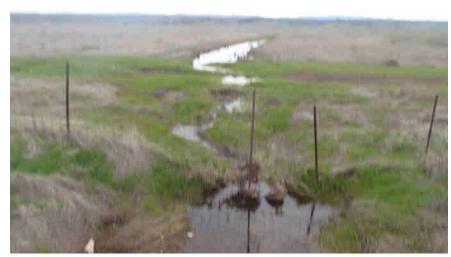
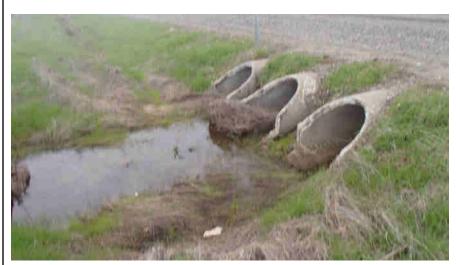
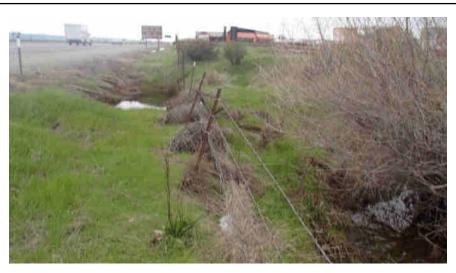
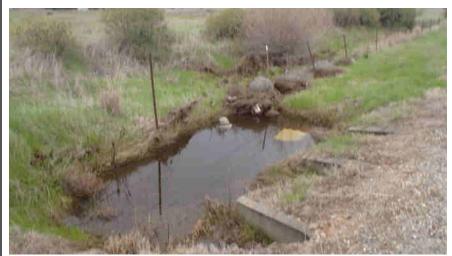
County: Butte Route: 99 Postmile: 24.58 Survey Date: 02/03/2016

Salmonid ESU/DPS	
ESU (Chinook and Coho Salmon) or DPS (Steelhea	nd)	
Central Valley Spring-Run Chinook		
Central Valley Fall_Late Fall-Run Chinook		
Central Valley Steelhead		
	Historic Anadromous Reach?	
Has the stream reach upstream of the crossing suppo	orted an anadromous fish population?	
Source		
	Crossing Type	
Crossing Type Culvert	ID	
General Description: Three concrete pipe culverts w	ith concrete precast end sections.	
	Photos

3.1 Upstream Looking Upstream - Photo I	3.1_BUT_99_24.58_UU	
3.2 Upstream Looking Downstream - Photo I	3.2_BUT_99_24.58_UD	
3.3 Downstream Looking Upstream - Photo ID	3.3_BUT_99_24.58_DU

3.4 Downstream Looking Downstream - Photo ID	3.4_BUT_99_24.58_DD	
	Detailed Survey Required?	
Detailed Survey Required?: No]	
Report Date 03-15-2016	1

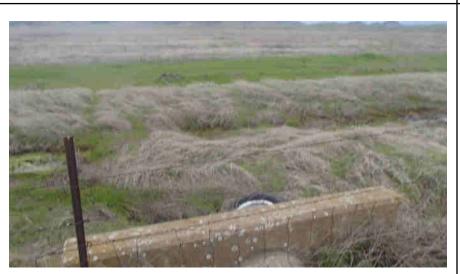
Basin East Side Quad Name (7.5') HAMLIN CANYON USGS Hydrologic Unit LOWER_BUTTE CalWater Unit HA Butte Basin
USGS Hydrologic Unit LOWER_BUTTE CalWater Unit HA Butte Basin
CalWater Unit HU COLUSA BASIN CalWater Unit HSA Butte Basin
Natural Stream Channel?
Is there a definable channel upstream of culvert?
Is the primary function for storm water runoff or road drainage?: Yes
Is the waterway a concrete-lined flood control channel?
Potential Fish Bearing Stream?
Does the site contain an active channel width >2 feet?
Is the stream gradient < 20%? yes
Salmonid ESU/DPS
ESU (Chinook and Coho Salmon) or DPS (Steelhead)
Central Valley Spring-Run Chinook
Central Valley Fall_Late Fall-Run Chinook
Central Valley Steelhead
Historic Anadromous Reach?
Has the stream reach upstream of the crossing supported an anadromous fish population?
Source
Crossing Type
Crossing Type Culvert ID
General Description: Concrete pipe with a concrete headwall.

Photos
3.1 Upstream Looking Upstream - Photo I 3.1_BUT_99_24.70_UU
3.2 Upstream Looking Downstream - Photo I 3.2_BUT_99_24.70_UD
3.3 Downstream Looking Upstream - Photo ID 3.3_BUT_99_24.70_DU

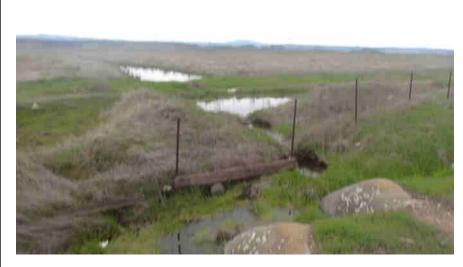
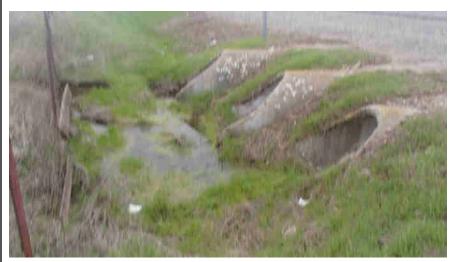
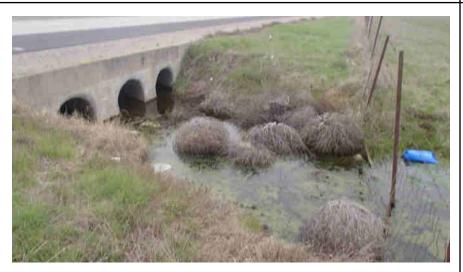
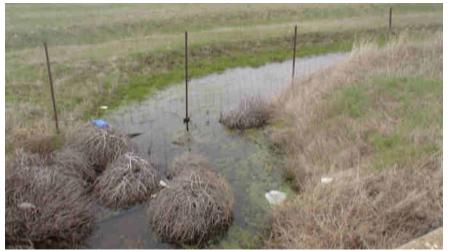
County: Butte Route: 99 Postmile: 24.85 Survey Date: 02/03/2016

Salmonid ESU/DPS		
ESU (Chinook and Coho Salmon) or DPS (Steelhe	ad)		
Central Valley Spring-Run Chinook			
Central Valley Fall_Late Fall-Run Chinook			
Central Valley Steelhead			
	Historic Anadromous Reach?		
Has the stream reach upstream of the crossing supp	ported an anadromous fish population?		
Source			
	Crossing Type		
Crossing Type Culvert	ID		
General Description: Three concrete pipe culverts i	n concrete form.		
Photos

3.1 Upstream Looking Upstream - Photo I	3.1_BUT_99_24.85_UU		
3.2 Upstream Looking Downstream - Photo I	3.2_BUT_99_24.85_UD		
3.3 Downstream Looking Upstream - Photo ID	3.3_BUT_99_24.85_DU

3.4 Downstream Looking Downstream - Photo ID	3.4_BUT_99_24.85_DD		
Detailed Survey Required?			
Detailed Survey Required?: No

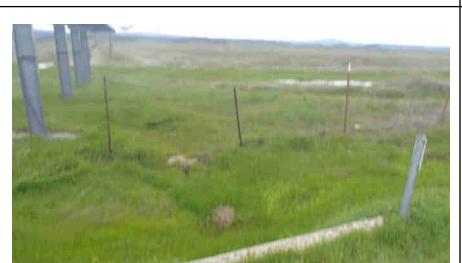
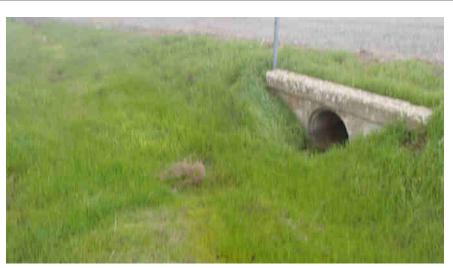
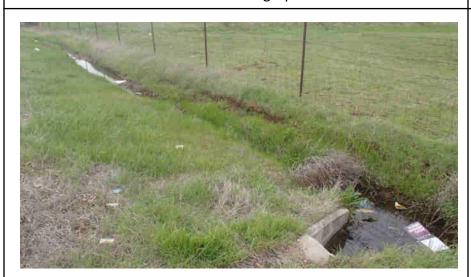
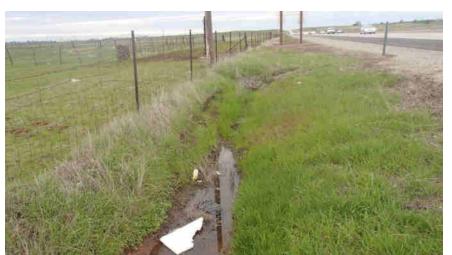
County: Butte Route: 99 Postmile: 24.90 Survey Date: 02/03/2016

Upstream Looking Upstream

Upstream Looking Downstream

Downstream Looking Upstream

Downstream Looking Downstream

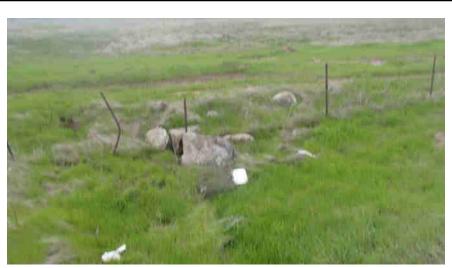
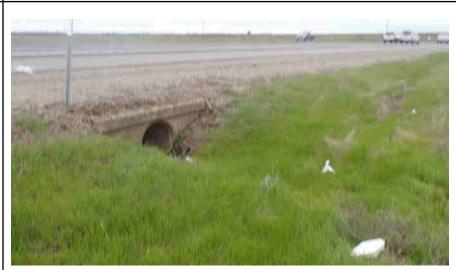
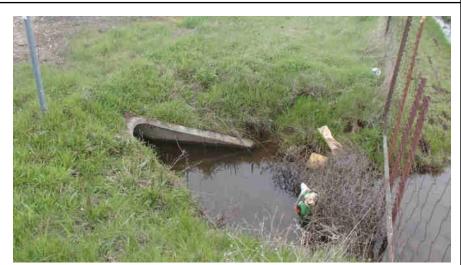
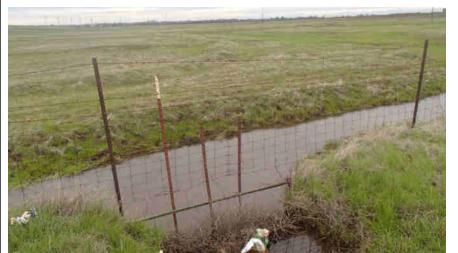
County: Butte Route: 99 Postmile: 25.05 Survey Date: 02/03/2016

FOUNDAMENT OF THE PROPERTY OF	Salmonid ESU/DPS	
ESU (Chinook and Coho Salmon) or DPS (Steelhead)	1	
Central Valley Spring-Run Chinook]	
Central Valley Fall_Late Fall-Run Chinook]	
Central Valley Steelhead	Historic Anadromous Reach?	
Has the atroom reach unctroom of the		
Has the stream reach upstream of the crossing supporte Source	d an anadromous fish population?	
Source	Crossing Type	
Crossing Type Culvert	ID	
General Description: Concrete pipe culvert with concrete	te precast end section.	
Photos

3.1 Upstream Looking Upstream - Photo I 3.	1_BUT_99_25.05_UU	
3.2 Upstream Looking Downstream - Photo I 3.2	2_BUT_99_25.05_UD	
3.3 Downstream Looking Upstream - Photo ID 3.3	3_BUT_99_25.05_UD

3.4 Downstream Looking Downstream - Photo ID 3.	4_BUT_99_25.05_DD	
Detailed Survey Required?		
Detailed Survey Required?: No

Upstream Looking Upstream

Upstream Looking Downstream

Downstream Looking Upstream

Downstream Looking Downstream

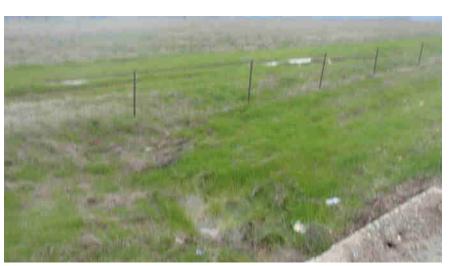
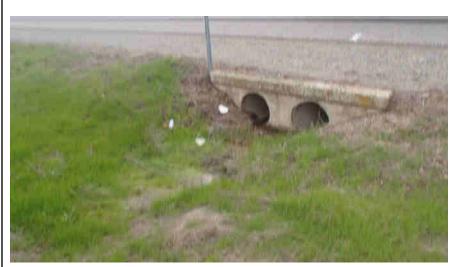
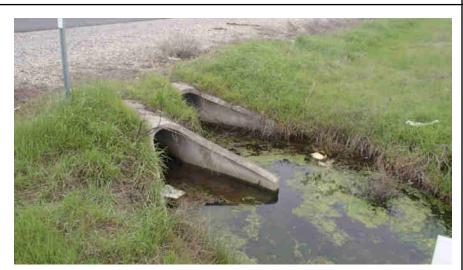
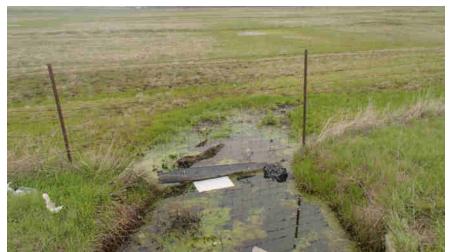
County: Butte Route: 99 Postmile: 25.06 Survey Date: 02/03/2016

Central Valley Spring-Run Chinook		
Central Valley Fall_Late Fall-Run Chinook		
Central Valley Steelhead Historic Anadromous Boach?		
Historic Anadromous Reach?		
Has the stream reach upstream of the crossing supported an anadromous fish population? No		
Source Crossing Type		
Crossing Type Culvert ID		
General Description: Two concrete pipe culverts with precast end sections.		
Photos

3.1 Upstream Looking Upstream - Photo I 3.1_BUT_99_25.06_UU		
3.2 Upstream Looking Downstream - Photo I 3.2_BUT_99_25.06_UD		
3.3 Downstream Looking Upstream - Photo ID 3.3 BUT_99_25.06_DU

3.4 Downstream Looking Downstream - Photo ID 3.4 BUT_99_25.06_DD		
Detailed Survey Required?		
Detailed Survey Required?: No

Upstream Looking Upstream

Upstream Looking Downstream

Downstream Looking Upstream

Downstream Looking Downstream

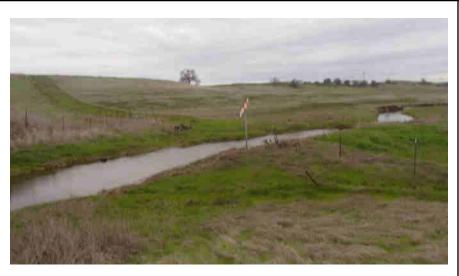
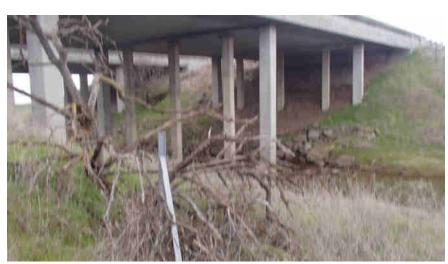
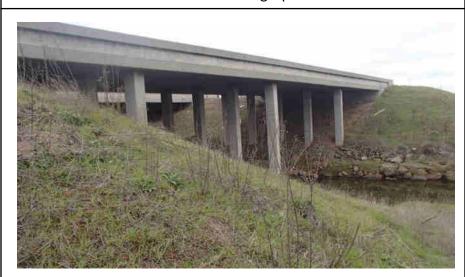
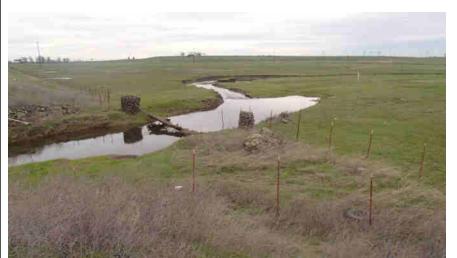
County: Butte Route: 99 Postmile: 25.35 Survey Date: 02/03/2016

Central Valley Spring-Run Chinook		
Central Valley Fall_Late Fall-Run Chinook		
Central Valley Steelhead		
Historic Anadromous Reach?		
Has the stream reach upstream of the crossing supported an anadromous fish population? Unknown		
Source Tributary to Butte Creek, CV Spring-run 5-Year Status Review (NMFS 2005)		
Crossing Type		
Crossing Type bridge w/o potential passage constraints ID		
General Description:		
Photos

3.1 Upstream Looking Upstream - Photo I 3.1_BUT_99_25.35_UU		
3.2 Upstream Looking Downstream - Photo I 3.2_BUT_99_25.35_UD		
3.3 Downstream Looking Upstream - Photo ID 3.3_BUT_99_25.35_UD

3.4 Downstream Looking Downstream - Photo ID 3.4_BUT_99_25.35_DD		
Detailed Survey Required?		
Detailed Survey Required?: No

Upstream Looking Upstream

Upstream Looking Downstream

Downstream Looking Upstream

Downstream Looking Downstream

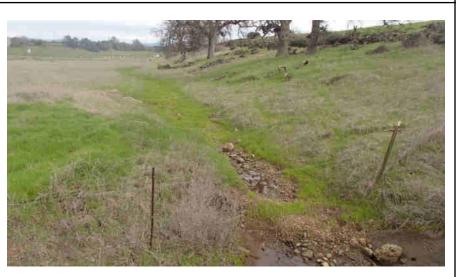
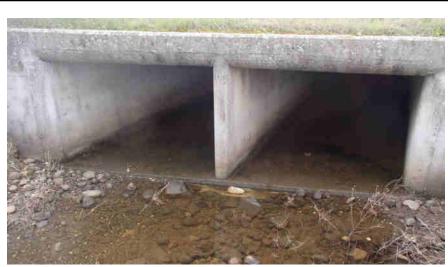
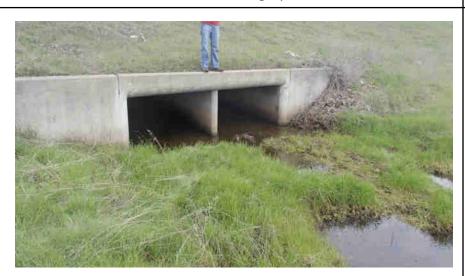
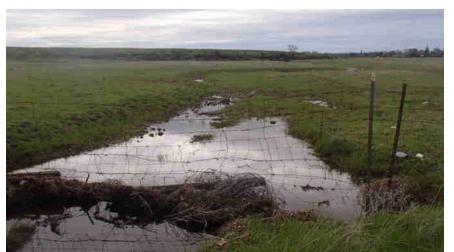
County: Butte Route: 99 Postmile: 25.98 Survey Date: 02/03/2016

•			
Is the primary function for storm water r			
Is the waterway a concrete-lined flood of	<u> </u>		
	Potential Fish Bearing Stream?		
Does the site contain an active channel	width >2 feet?		
Is the stream gradient < 20%?	yes		
	Salmonid ESU/DPS		
ESU (Chinook and Coho Salmon) or D	PS (Steelhead)		
Central Valley Spring-Run Chinook			
Central Valley Fall_Late Fall-Run Chino	ok		
Central Valley Steelhead			
	Historic Anadromous Reach?		
Has the stream reach upstream of the c	rossing supported an anadromous fish population?		
Source			
	Crossing Type		
Crossing Type Culvert	ID		
General Description: Double concrete	box culvert.		
Photos

3.1 Upstream Looking Upstream - Pho	o I 3.1_BUT_99_25.98_UU		
3.2 Upstream Looking Downstream - P	hoto I 3.2_BUT_99_25.98_UD		
3.3 Downstream Looking Upstream - P	hoto ID 3.3_BUT_99_25.98_DU

3.4 Downstream Looking Downstream	- Photo ID 3.4_BUT_99_25.98_DD		
Detailed Survey Required?			
Detailed Survey Required?:	No

Upstream Looking Upstream

Upstream Looking Downstream

Downstream Looking Upstream

Downstream Looking Downstream

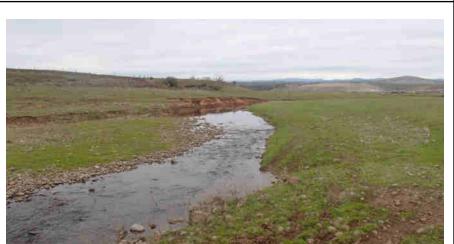
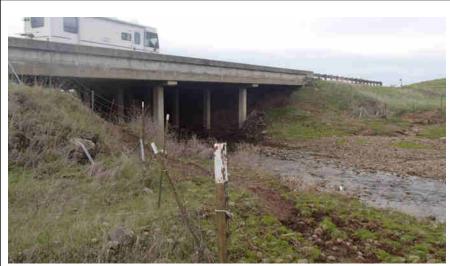
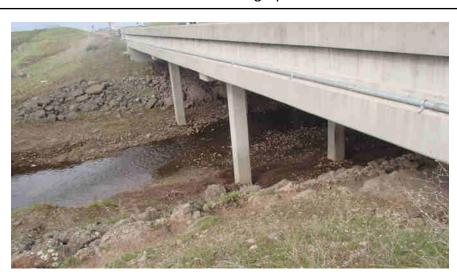
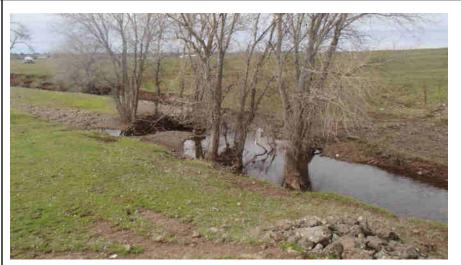
County: Butte Route: 99 Postmile: 26.14 Survey Date: 02/03/2016

Salmonid ESU/DPS				
ESU (Chinook and Coho Salmon) or DPS (Steelhead)				
Central Valley Spring-Run Chinook				
Central Valley Fall_Late Fall-Run Chinook				
Central Valley Steelhead				
Historic Anadromous Reach?				
Has the stream reach upstream of the crossing supported an anadromous fish population? Unknown				
Source Tributary to Butte Creek, CV Spring-run 5-Year Status Review (NMFS 2005)				
Crossing Type				
Crossing Type bridge w/o potential passage constraints ID 12-0129				
General Description:				
Photos

3.1 Upstream Looking Upstream - Photo I 3.1_BUT_99_26.14_UU				
3.2 Upstream Looking Downstream - Photo I 3.2_BUT_99_26.14_UD				
3.3 Downstream Looking Upstream - Photo ID 3.3_BUT_99_26.14_DU

3.4 Downstream Looking Downstream - Photo ID 3.4_BUT_99_26.14_DD				
Detailed Survey Required?				
Detailed Survey Required?: No

Upstream Looking Upstream

Upstream Looking Downstream

Downstream Looking Upstream

Downstream Looking Downstream

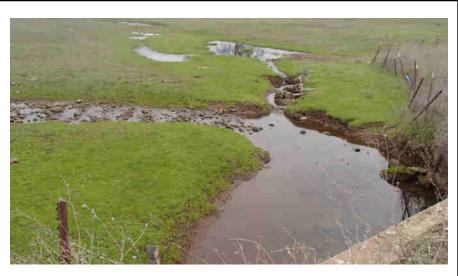
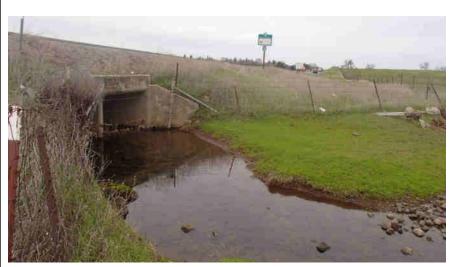
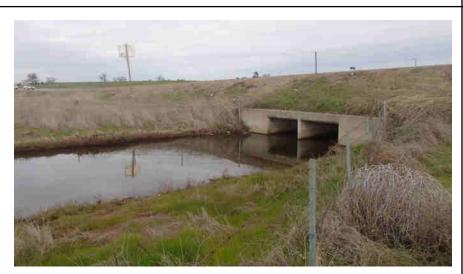
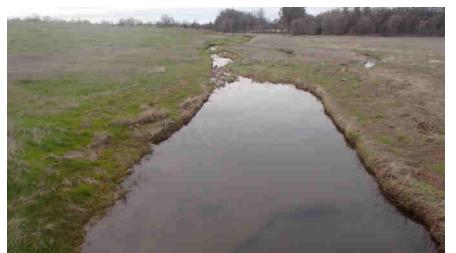
County: Butte Route: 99 Postmile: 27.33 Survey Date: 02/03/2016

Central Valley Fall_Late Fall-Run Chinook	<u>_</u>		
Central Valley Steelhead			
	Historic Anadromous Reach?		
Has the stream reach upstream of the crossing supp	orted an anadromous fish population? Unknown		
Source			
	Crossing Type		
Crossing Type Culvert	ID		
General Description: Double concrete box culvert w	ith wingwalls.		
	Photos

3.1 Upstream Looking Upstream - Photo I	3.1_BUT_99_27.33_UU		
3.2 Upstream Looking Downstream - Photo I	3.2_BUT_99_27.33_UD		
3.3 Downstream Looking Upstream - Photo ID	3.3_BUT_99_27.33_DU

3.4 Downstream Looking Downstream - Photo ID	3.4_BUT_99_27.33_DD		
	Detailed Survey Required?		
Detailed Survey Required?: Yes	1		
Report Date 03-15-2016	_

RECONNAISSANCE SURVEY INFORMATION Route: 99 County: BUT PM: 27.33 **Access Information** Land Ownership: Owner(s) fenced agriculture Upstream private Downstream private Owner(s) fenced agriciulture Accessible from road? Upstream? Yes Fence Limitations Downstream? Yes Limitations Fence **Vegetation Removal Required?** No (If "Yes", comment and take photograph) Upstream? Photo ID Comments No (If "Yes", comment and take photograph) Downstream? Photo ID Comments Maintenance Assistance Required? No (If "Yes", comment and take photograph) Upstream? Photo ID Comments No Downstream? (If "Yes", comment and take photograph) Photo ID Comments **Confined Space Assessment** If answer is "No" to any of the questions below, site must have confined spaces equipment for surveying. DO NOT ENTER CULVÉRT Is culvert diameter > 60"? Can you see all the way through the end of the culvert? Yes

Upstream Looking Upstream

Upstream Looking Downstream

Downstream Looking Upstream

Downstream Looking Downstream

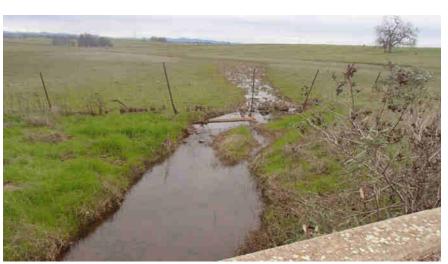
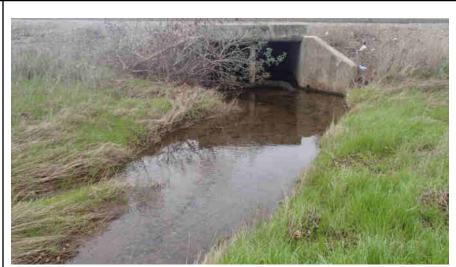
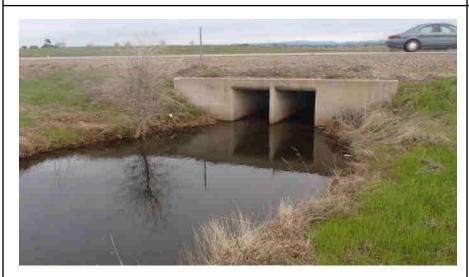
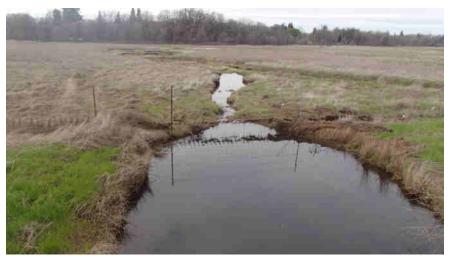
County: Butte Route: 99 Postmile: 27.38 Survey Date: 02/03/2016

Central Valley Spring-Run Chinook	<u></u>		
Central Valley Fall_Late Fall-Run Chinook			
Central Valley Steelhead			
	Historic Anadromous Reach?		
Has the stream reach upstream of the crossing supp	orted an anadromous fish population? Unknown		
Source			
	Crossing Type		
Crossing Type Culvert	ID		
General Description: Double concrete box culvert w	rith wingwalls.		
	Photos

3.1 Upstream Looking Upstream - Photo I	3.1_BUT_99_27.38_UU		
3.2 Upstream Looking Downstream - Photo I	3.2_BUT_99_27.38_UD		
3.3 Downstream Looking Upstream - Photo ID	3.3_BUT_99_27.38_DU

3.4 Downstream Looking Downstream - Photo ID	3.4_BUT_99_27.38_DD		
	Detailed Survey Required?		
Detailed Survey Required?: Yes			
Report Date 03-15-2016

RECONNAISSANCE SURVEY INFORMATION Route: 99 County: BUT PM: 27.38 **Access Information** Land Ownership: Upstream private Owner(s) Downstream private Owner(s) Accessible from road? Upstream? Yes Limitations Fence Downstream? Yes Limitations Fence **Vegetation Removal Required?** No (If "Yes", comment and take photograph) Upstream? Photo ID Comments No (If "Yes", comment and take photograph) Downstream? Photo ID Comments Maintenance Assistance Required? No (If "Yes", comment and take photograph) Upstream? Photo ID Comments No Downstream? (If "Yes", comment and take photograph) Photo ID Comments **Confined Space Assessment** If answer is "No" to any of the questions below, site must have confined spaces equipment for surveying. DO NOT ENTER CULVÉRT Is culvert diameter > 60"?

Upstream Looking Upstream

Upstream Looking Downstream

Downstream Looking Upstream

Downstream Looking Downstream
