Summary of 2016 Reconnaissance Fish Passage Surveys

During February and March of 2016, 179 Reconnaissance Fish Passage Surveys were conducted on state highways in Butte and Sacramento counties. 138 sites were surveyed on Highway 99 in Butte County, 24 sites were surveyed on Highway 99 in Sacramento County, and 17 sites were surveyed on Highway 104 in Sacramento County. The Reconnaissance Surveys were performed in accordance with the California Department of Transportation's (Caltrans') Reconnaissance Fish Passage Assessment Instructions and Procedures manual¹. 25 of the 179 sites (14%) were identified as requiring a Detailed Fish Passage Survey.

County: Butte Route: 99 Postmile: 0.01 Survey Date: 02/09/2016

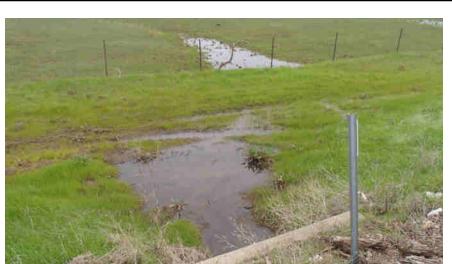
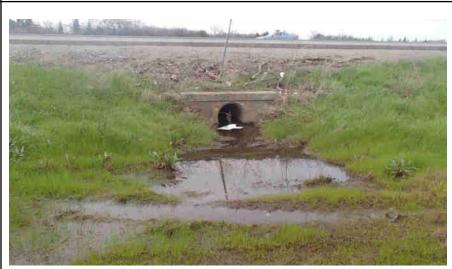
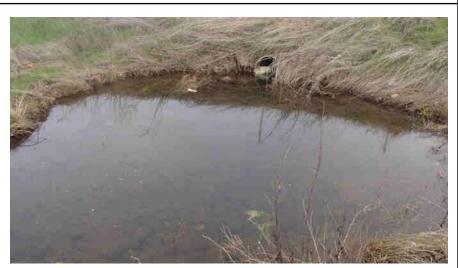
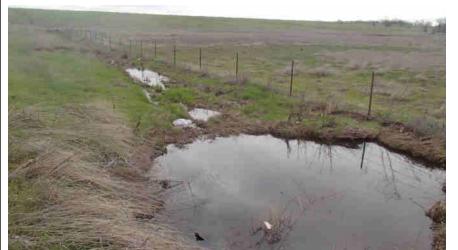
County: Butte Route: 99 Postmile: 27.43 Survey Date: 02/03/2016

Central Valley Spring-Run Chinook			
Central Valley Fall_Late Fall-Run Chinook			
Central Valley Steelhead			
	Historic Anadromous Reach?		
Has the stream reach upstream of the crossing sup	ported an anadromous fish population? Unknown		
Source	O		
	Crossing Type		
Crossing Type Culvert	ID ID	1	
General Description: Concrete pipe culvert with a concrete pipe culver			
	Photos

3.1 Upstream Looking Upstream - Photo I	3.1_BUT_99_27.43_UU	_	
3.2 Upstream Looking Downstream - Photo I	3.2_BUT_99_27.43_UD	<u> </u>	
3.3 Downstream Looking Upstream - Photo ID	3.3_BUT_99_27.43_DU	<u>_</u>

3.4 Downstream Looking Downstream - Photo ID	3.4_BUT_99_27.43_DD		
	Detailed Survey Required?		
Detailed Survey Required?: No			
Report Date 03-15-2016

Upstream Looking Upstream

Upstream Looking Downstream

Downstream Looking Upstream

Downstream Looking Downstream

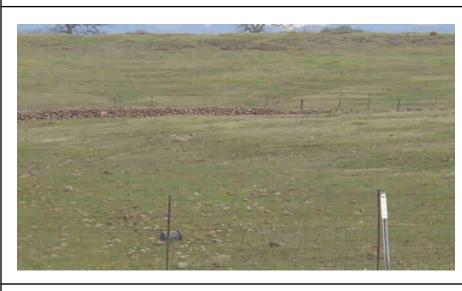
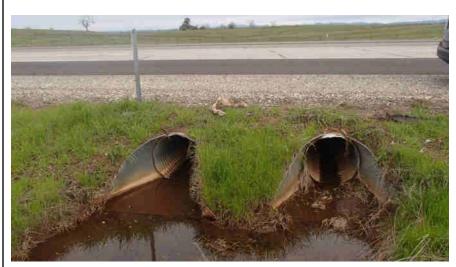
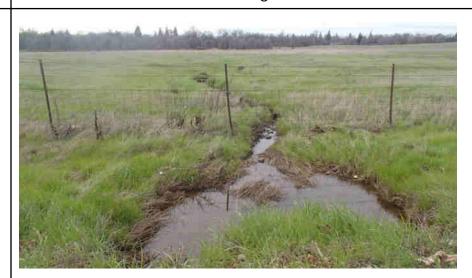
County: Butte Route: 99 Postmile: 27.60 Survey Date: 02/03/2016

Central Valley Spring-Run Chinook			
Central Valley Fall_Late Fall-Run Chinook			
Central Valley Steelhead			
Historic Anadromous Reach?			
Has the stream reach upstream of the crossing supported an anadromous fish population? Unknown			
Source			
Crossing Type			
Crossing Type Culvert ID			
General Description: Two corrugated steel pipe culverts with precast end sections.			
Photos

3.1 Upstream Looking Upstream - Photo I 3.1_BUT_99_27.60_UU			
3.2 Upstream Looking Downstream - Photo I			
3.3 Downstream Looking Upstream - Photo ID 3.3_BUT_99_27.60_UD

3.4 Downstream Looking Downstream - Photo ID 3.4_BUT_99_27.60_DD			
Detailed Survey Required?			
Detailed Survey Required?: No

Upstream Looking Upstream

Downstream Looking Upstream

Downstream Looking Downstream

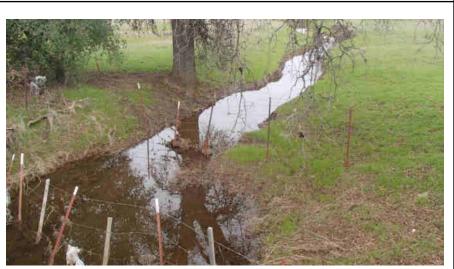
County: Butte Route: 99 Postmile: 27.85 Survey Date: 02/03/2016

Central Valley Spring-Run Chinook			
Central Valley Fall_Late Fall-Run Chinook			
Central Valley Steelhead			
	Historic Anadromous Reach?		
Has the stream reach upstream of the crossing supp	ported an anadromous fish population? Unknown		
Source			
	Crossing Type		
Crossing Type bridge w/o potential passage			
General Description: Double box concrete bridge w	rith concrete wingwalls.		
	Photos

3.1 Upstream Looking Upstream - Photo I	3.1_BUT_99_27.85_UU		
3.2 Upstream Looking Downstream - Photo I	3.2_BUT_99_27.85_UD		
3.3 Downstream Looking Upstream - Photo ID	3.3_BUT_99_27.85_DU

Upstream Looking Upstream

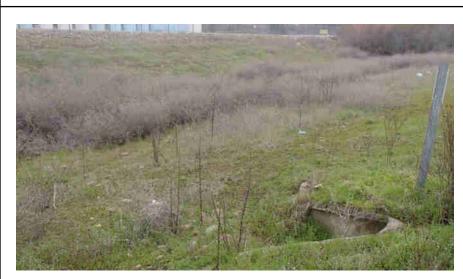
Upstream Looking Upstream

Central Valley Fall_Late Fall-Run Chinook		
Central Valley Steelhead		
	Historic Anadromous Reach?	
Has the stream reach upstream of the crossing sup	ported an anadromous fish population?	
Source		
	Crossing Type	
Crossing Type Culvert	ID	
General Description: Concrete pipe culvert with precast end section.		
Photos

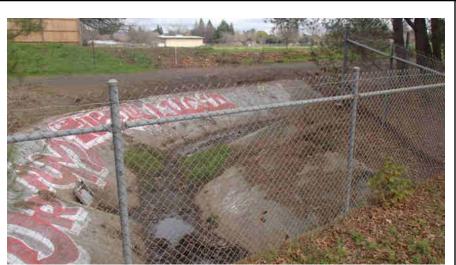
Upstream Looking Upstream

Central Valley Spring-Run Chinook				
Central Valley Fall_Late Fall-Run Chinook				
Central Valley Steelhead				
	Historic Anadromous Reach?			
Has the stream reach upstream of the crossing support	orted an anadromous fish population?			
Source				
	Crossing Type			
Crossing Type Culvert	ID			
General Description: Concrete box culvert in a conc	rete form.			
	Photos

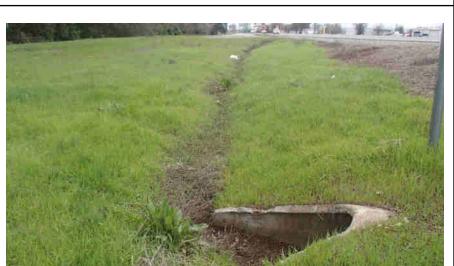
Upstream Looking Upstream

Salmonid ESU/DPS				
ESU (Chinook and Coho Salmon) or DPS (Steell	nead)				
Central Valley Spring-Run Chinook					
Central Valley Fall_Late Fall-Run Chinook					
Central Valley Steelhead					
	Historic Anadromous Reach?				
Has the stream reach upstream of the crossing su	pported an anadromous fish population?				
Source					
	Crossing Type				
Crossing Type Culvert	ID				
General Description: Concrete pipe culvert with concrete precast end sections.					
	Photos

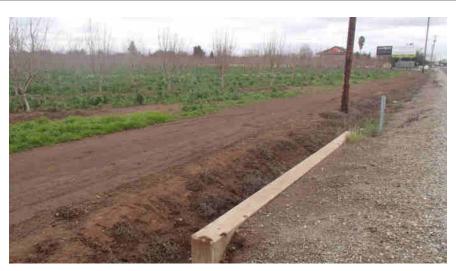
Upstream Looking Upstream

monid ESU/DPS			
ESU (Chinook and Coho Salmon)					
Central Valley Spring-Run Chinook					
Central Valley Fall_Late Fall-Run C	Chinook				
Central Valley Steelhead	Historia	Anadramana Basaka			
		Anadromous Reach?			
Has the stream reach upstream of	the crossing supported an anadro	mous fish population?	No		
Source		Crossing Type			
Consider Time Cultion		ID			
Crossing Type Culvert General Description: Doulble cond	crete hox culvert in a concrete form				
Photos

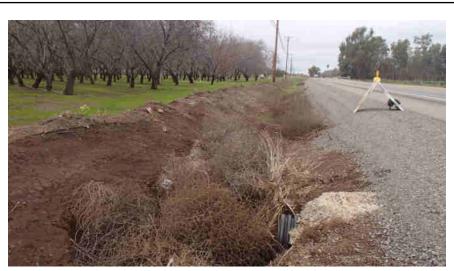
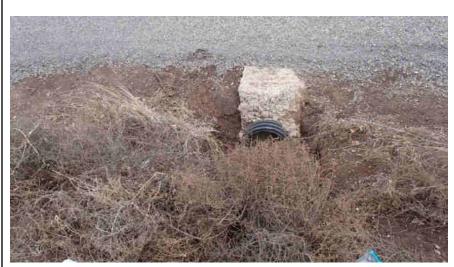
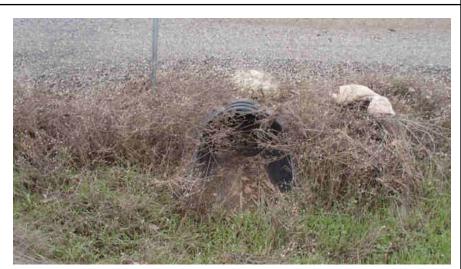
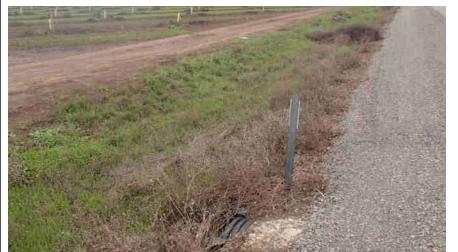
County: Butte Route: 99 Postmile: 39.70 Survey Date: 02/02/2016

ESU (Chinook and Coho Salmon) or DPS (Steelho	ead)			
Central Valley Spring-Run Chinook	<u> </u>			
Central Valley Fall_Late Fall-Run Chinook				
Central Valley Steelhead				
	Historic Anadromous Reach?			
Has the stream reach upstream of the crossing sup	ported an anadromous fish population?			
Source				
	Crossing Type			
Crossing Type Culvert	ID			
General Description: Corrugated plastic pipe culvert with projections.				
	Photos

3.1 Upstream Looking Upstream - Photo I	3.1_BUT_99_39.70_UU			
3.2 Upstream Looking Downstream - Photo I	3.2_BUT_99_39.70_UD			
3.3 Downstream Looking Upstream - Photo ID	3.3_BUT_99_39.70_DU

3.4 Downstream Looking Downstream - Photo ID	3.4_BUT_99_39.70_DD			
Detailed Survey Required?				
Detailed Survey Required?: No				
B . B

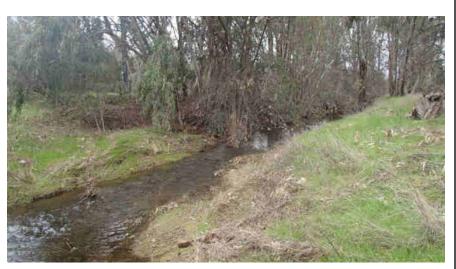
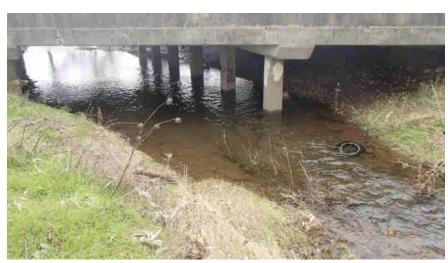
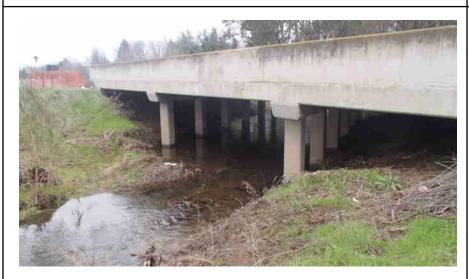
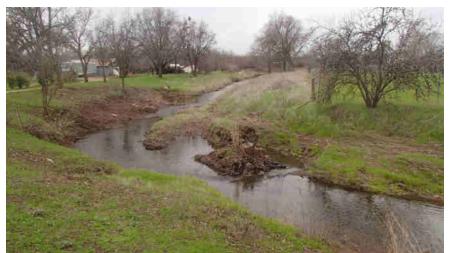
County: Butte Route: 99 Postmile: 39.71 Survey Date: 02/02/2016

Salmonid ESU/DPS			
ESU (Chinook and Coho Salmon) or DPS (Steelhead)			
Central Valley Spring-Run Chinook			
Central Valley Fall_Late Fall-Run Chinook			
Central Valley Steelhead			
Historic Anadromous Reach?			
Has the stream reach upstream of the crossing supported an anadromous fish population? Unknown			
Source Tributary to Rock Creek			
Crossing Type			
Crossing Type bridge w/o potential passage constraints ID 12-0026			
General Description:			
Photos

3.1 Upstream Looking Upstream - Photo I 3.1_BUT_99_39.71_UU			
3.2 Upstream Looking Downstream - Photo I 3.2_BUT_99_39.71_UD			
3.3 Downstream Looking Upstream - Photo ID 3.3_BUT_99_39.71_DU

3.4 Downstream Looking Downstream - Photo ID 3.4_BUT_99_39.71_DD			
Detailed Survey Required?			
Detailed Survey Required?: No

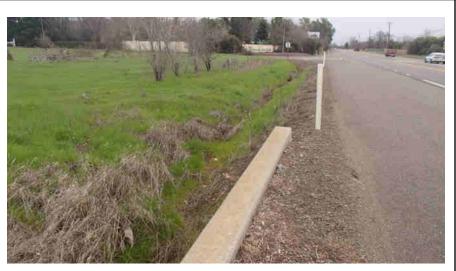
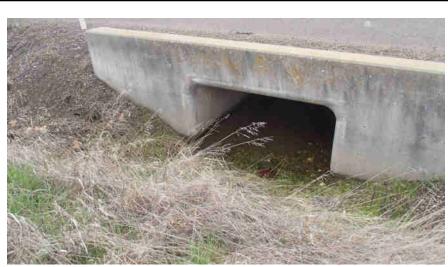
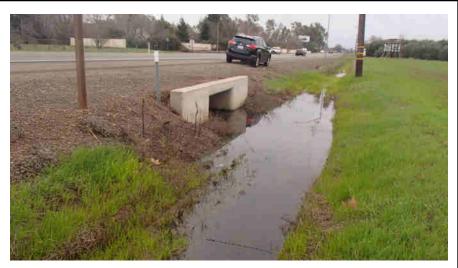
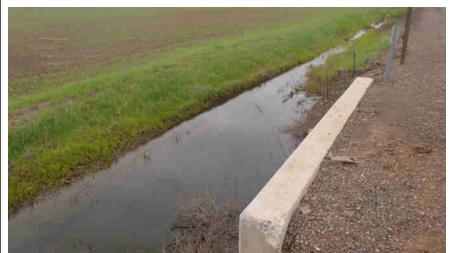
County: Butte Route: 99 Postmile: 39.90 Survey Date: 02/02/2016

-		
Does the site contain an active channel width			
Is the stream gradient < 20%?	Yes		
ESU (Chinook and Coho Salmon) or DPS (St	Salmonid ESU/DPS		
Central Valley Spring-Run Chinook	eemeau)		
Central Valley Fall_Late Fall-Run Chinook			
Central Valley Steelhead			
Samuel Valley Classificad	Historic Anadromous Reach?		
Has the stream reach upstream of the crossing			
Source			
	Crossing Type		
Crossing Type Culvert	ID		
General Description: Concrete box culvert in a	a concrete form.		
	Photos

3.1 Upstream Looking Upstream - Photo I	3.1_BUT_99_39.90_UU		
3.2 Upstream Looking Downstream - Photo I	3.2_BUT_99_39.90_UD		
3.3 Downstream Looking Upstream - Photo ID

3.4 Downstream Looking Downstream - Photo	3.4_BUT_99_39.90_DD		
Detailed Survey Required?			
Detailed Survey Required?: No

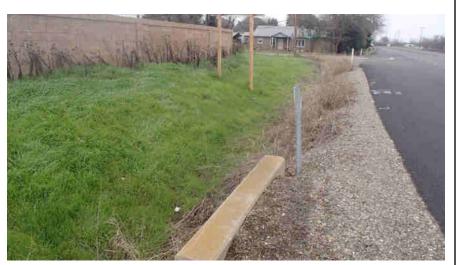
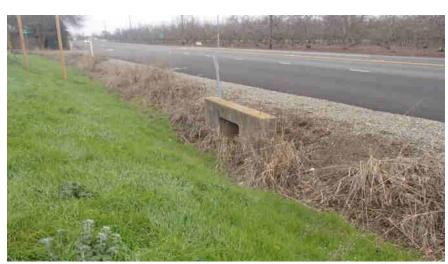
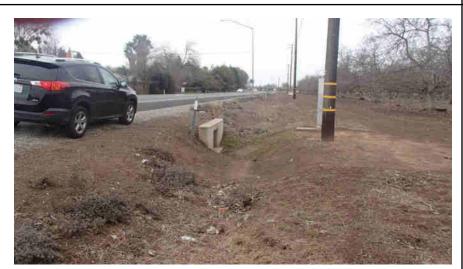
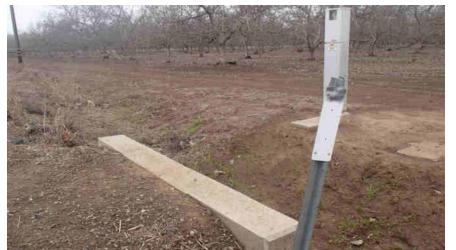
County: Butte Route: 99 Postmile: 40.30 Survey Date: 02/02/2016

Central Valley Spring-Run Chinook			
Central Valley Fall_Late Fall-Run Chinook			
Central Valley Steelhead			
Historic Anadromous Reach?			
Has the stream reach upstream of the crossing supported an anadromous fish population?			
Source			
Crossing Type			
Crossing Type Culvert ID			
General Description: Concrete box culvert in a concrete form.			
Photos

3.1 Upstream Looking Upstream - Photo I 3.1_BUT_99_40.30_UU			
3.2 Upstream Looking Downstream - Photo I 3.2_BUT_99_40.30_UD			
3.3 Downstream Looking Upstream - Photo ID 3.3 BUT_99_40.30_DU

3.4 Downstream Looking Downstream - Photo ID 3.4_BUT_99_40.30_DD			
Detailed Survey Required?			
Detailed Survey Required?: No

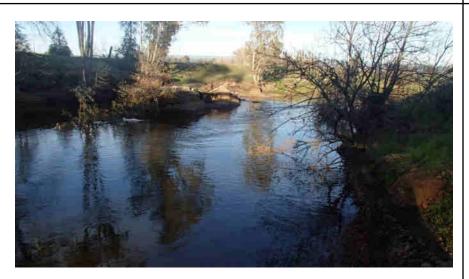
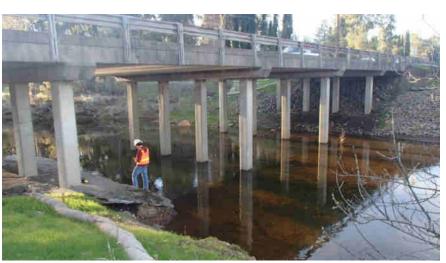
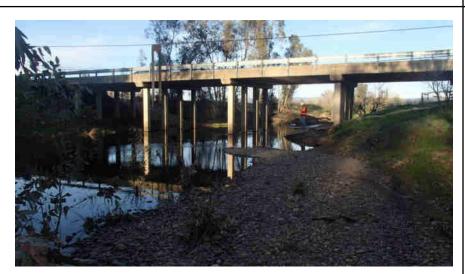
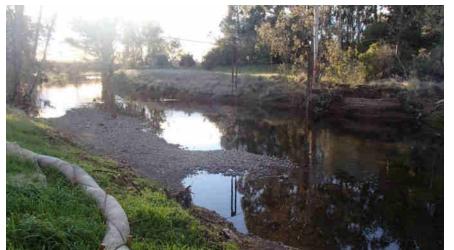
County: Butte Route: 99 Postmile: 40.65 Survey Date: 02/01/2016

Source CV Spring-run 5-Year Status Review (NMFS 2005) Crossing Type Crossing Type bridge w/o potential passage constraints ID 12-0027 General Description: Photos 3.1 Upstream Looking Upstream - Photo I 3.1_BUT_99_40.65_UU 3.2 Upstream Looking Downstream - Photo I 3.2_BUT_99_40.65_UD 3.3 Downstream Looking Upstream - Photo ID 3.3_BUT_99_40.65_DU	Has the stream reach upstream of the crossing supported an anadromous fish population? Yes			
Crossing Type bridge w/o potential passage constraints ID 12-0027 General Description: Photos 3.1 Upstream Looking Upstream - Photo I 3.1_BUT_99_40.65_UU 3.2 Upstream Looking Downstream - Photo I 3.2_BUT_99_40.65_UD 3.3 Downstream Looking Upstream - Photo ID 3.3_BUT_99_40.65_DU				
Photos 3.1 Upstream Looking Upstream - Photo I 3.2 Upstream Looking Downstream - Photo I 3.3 Downstream Looking Upstream - Photo ID 3.4 Upstream Looking Upstream - Photo ID 3.5 Downstream Looking Upstream - Photo ID 3.6 DU 3.7 Downstream Looking Upstream - Photo ID 3.8 Downstream Looking Upstream - Photo ID	Crossing Type

3.1 Upstream Looking Upstream - Photo I 3.1_BUT_99_40.65_UU 3.2 Upstream Looking Downstream - Photo I 3.2_BUT_99_40.65_UD 3.3 Downstream Looking Upstream - Photo ID 3.3_BUT_99_40.65_DU	General Description:

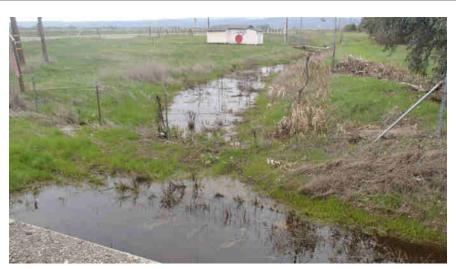
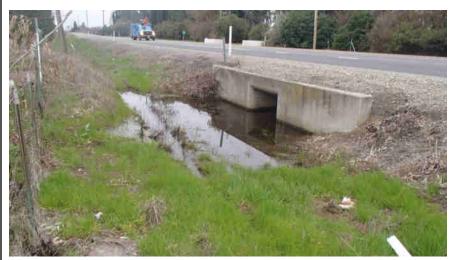
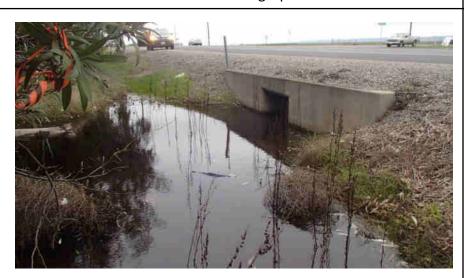
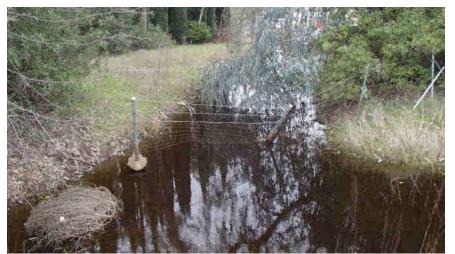
County: Butte Route: 99 Postmile: 40.90 Survey Date: 02/02/2016

Central Valley Spring-Run Chinook		
Central Valley Fall_Late Fall-Run Chinook		
Central Valley Steelhead		
	Historic Anadromous Reach?	
Has the stream reach upstream of the crossing supp	ported an anadromous fish population? Unknown	
Source		
	Crossing Type	
Crossing Type Culvert	ID	
General Description: Concrete box culvert in a concrete form.

-	Photos	
3.1 Upstream Looking Upstream - Photo I	3.1_BUT_99_40.90_UU	
3.2 Upstream Looking Downstream - Photo I	3.2_BUT_99_40.90_UD	
3.3 Downstream Looking Upstream - Photo ID	3.3_BUT_99_40.90_DU

3.4 Downstream Looking Downstream - Photo ID	3.4_BUT_99_40.90_DD	
	Detailed Survey Required?	
Detailed Survey Required?: Yes		
Report Date 03-15-2016

RECONNAISSANCE SURVEY INFORMATION Route: 99 County: BUT PM: 40.90 **Access Information** Land Ownership: Upstream private Owner(s) Downstream private Owner(s) Accessible from road? Upstream? Yes Limitations Downstream? Yes Limitations **Vegetation Removal Required?** No (If "Yes", comment and take photograph) Upstream? Photo ID Comments No (If "Yes", comment and take photograph) Downstream? Photo ID Comments Maintenance Assistance Required? No (If "Yes", comment and take photograph) Upstream? Photo ID Comments No Downstream? (If "Yes", comment and take photograph) Photo ID Comments **Confined Space Assessment** If answer is "No" to any of the questions below, site must have confined spaces equipment for surveying. DO NOT ENTER CULVÉRT Is culvert diameter > 60"?

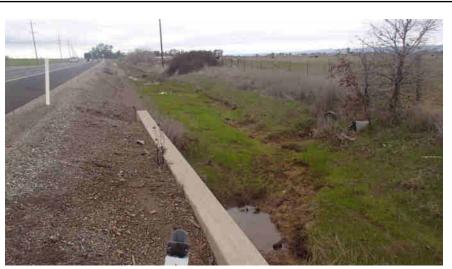
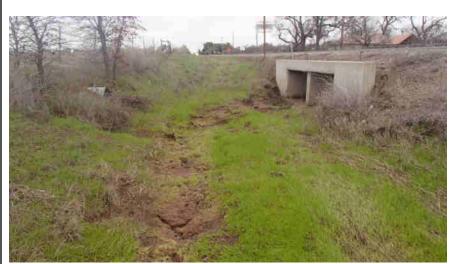
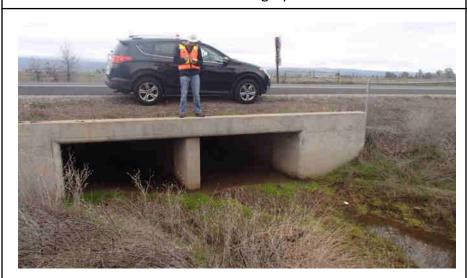
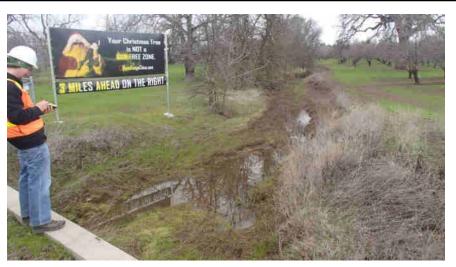
County: Butte Route: 99 Postmile: 41.14 Survey Date: 02/02/2016

Is the stream gradient < 20%?	Yes		
	Salmonid ESU/DPS		
ESU (Chinook and Coho Salmon) or DPS (Steelh	ead)		
Central Valley Spring-Run Chinook			
Central Valley Fall_Late Fall-Run Chinook			
Central Valley Steelhead	Historia Anadromous Booch?		
	Historic Anadromous Reach?		
Has the stream reach upstream of the crossing sup	ported an anadromous fish population? Unknown		
Source	Crossing Type		
Crossing Type Culturate	ID		
Crossing Type Culvert			
General Description: Double concrete box in a concrete form.

2.4 Unetroom Looking Unetroom - Photo I	Photos		
3.1 Upstream Looking Upstream - Photo I	3.1_BUT_99_41.14_UU	=	
3.2 Upstream Looking Downstream - Photo I	3.2_BUT_99_41.14_UD	=

3.3 Downstream Looking Upstream - Photo ID	3.3_BUT_99_41.14_DU		
3.4 Downstream Looking Downstream - Photo ID	3.4_BUT_99_41.14_DD		
	Detailed Survey Required?		
Detailed Survey Required?: Yes			
Report Date 03-15-2016

RECONNAISSANCE SURVEY INFORMATION Route: 99 County: BUT PM: 41.14 **Access Information** Land Ownership: Upstream private Owner(s) Downstream private Owner(s) Accessible from road? Upstream? Yes Limitations Downstream? Yes Limitations **Vegetation Removal Required?** No (If "Yes", comment and take photograph) Upstream? Photo ID Comments No (If "Yes", comment and take photograph) Downstream? Photo ID Comments Maintenance Assistance Required? No (If "Yes", comment and take photograph) Upstream? Photo ID Comments No Downstream? (If "Yes", comment and take photograph) Photo ID Comments **Confined Space Assessment** If answer is "No" to any of the questions below, site must have confined spaces equipment for surveying. DO NOT ENTER CULVÉRT Is culvert diameter > 60"?

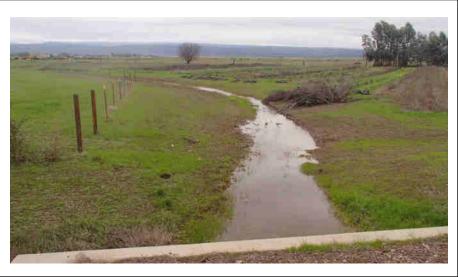
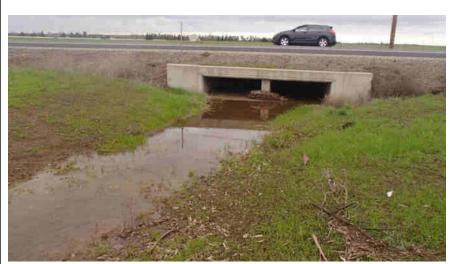
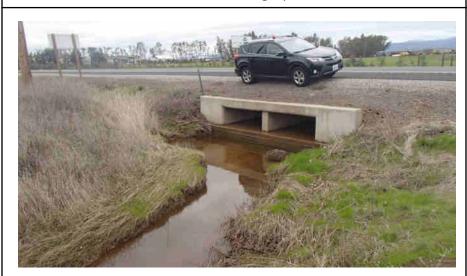
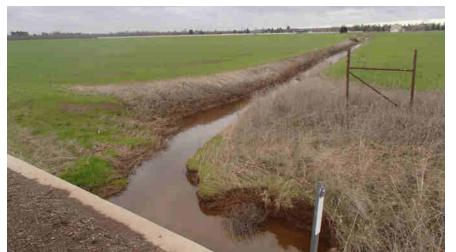
County: Butte Route: 99 Postmile: 41.70 Survey Date: 02/02/2016

Central Valley Spring-Run Chinook	<u> </u>		
Central Valley Fall_Late Fall-Run Chinook	ᆜ		
Central Valley Steelhead			
	Historic Anadromous Reach?		
Has the stream reach upstream of the crossing supp	orted an anadromous fish population? Unknown		
Source			
	Crossing Type		
Crossing Type Culvert	ID		
General Description: Double concrete box culvert in			
	Photos

3.1 Upstream Looking Upstream - Photo I	3.1_BUT_99_41.70_UU	<u> </u>	
3.2 Upstream Looking Downstream - Photo I	3.2_BUT_99_41.70_UD	<u> </u>	
3.3 Downstream Looking Upstream - Photo ID	3.3_BUT_99_41.70_DU	<u> </u>

3.4 Downstream Looking Downstream - Photo ID	3.4_BUT_99_41.70_DD		
	Detailed Survey Required?		
Detailed Survey Required?: Yes

RECONNAISSANCE SURVEY INFORMATION Route: 99 County: BUT PM: 41.70 **Access Information** Land Ownership: Upstream private Owner(s) Downstream private Owner(s) Accessible from road? Upstream? Yes Limitations Downstream? Yes Limitations **Vegetation Removal Required?** No (If "Yes", comment and take photograph) Upstream? Photo ID Comments No (If "Yes", comment and take photograph) Downstream? Photo ID Comments Maintenance Assistance Required? No (If "Yes", comment and take photograph) Upstream? Photo ID Comments No Downstream? (If "Yes", comment and take photograph) Photo ID Comments **Confined Space Assessment** If answer is "No" to any of the questions below, site must have confined spaces equipment for surveying. DO NOT ENTER CULVÉRT Is culvert diameter > 60"?

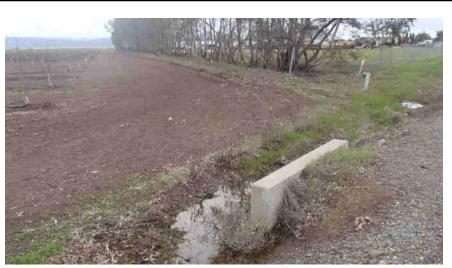
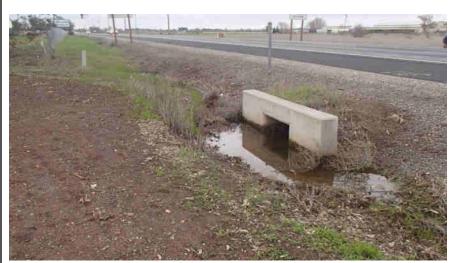
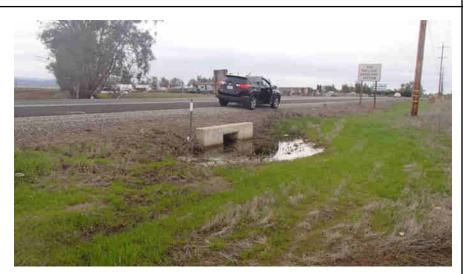
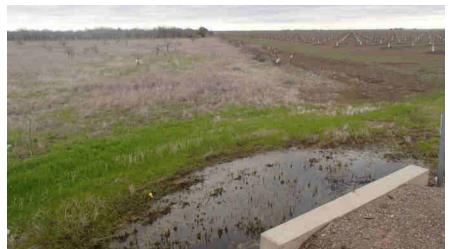
County: Butte Route: 99 Postmile: 41.90 Survey Date: 02/02/2016

Central Valley Spring-Run Chinook	edu)	
Central Valley Fall_Late Fall-Run Chinook		
Central Valley Steelhead		
	Historic Anadromous Reach?	
Has the stream reach upstream of the crossing sup	ported an anadromous fish population?	
Source	· · · · · · · · · · · · · · · · · · ·	
	Crossing Type	
Crossing Type Culvert	ID	
General Description: Concrete box culvert in a con	ncrete form.	
	Photos

3.4 Downstream Looking Downstream - Photo ID	3.4_BUT_99_41.90_DD	
	Detailed Survey Required?	
Detailed Survey Required?: No

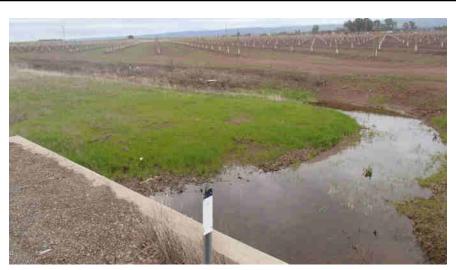
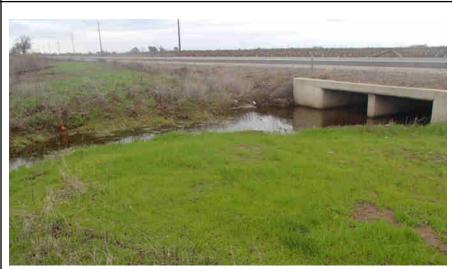
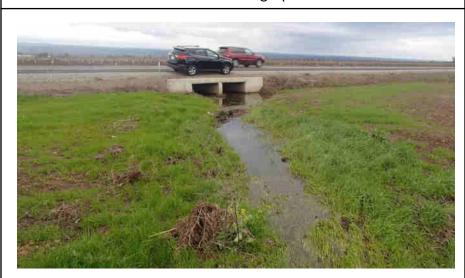
County: Butte Route: 99 Postmile: 42.30 Survey Date: 02/02/2016

Central Valley Spring-Run Chinook		
Central Valley Fall_Late Fall-Run Chinook		
Central Valley Steelhead		
	Historic Anadromous Reach?	
Has the stream reach upstream of the crossing supp	ported an anadromous fish population? Unknown	
Source		
	Crossing Type	
Crossing Type Culvert	ID	
General Description: Double concrete box culvert i	n a concrete form.	
	Photos

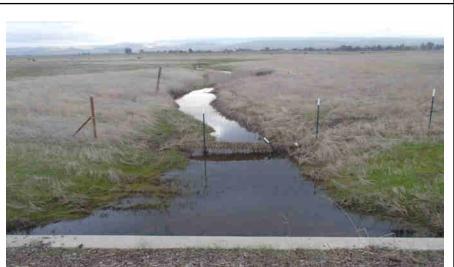
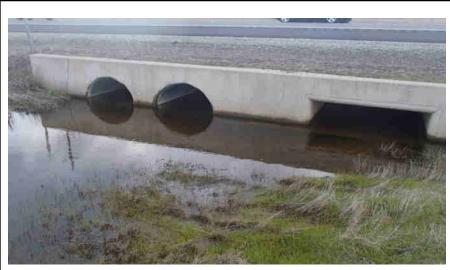
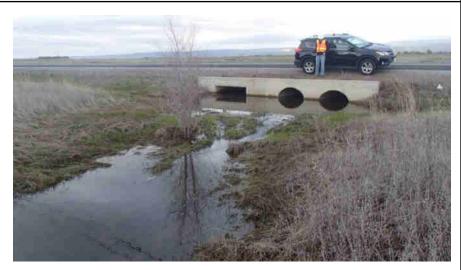
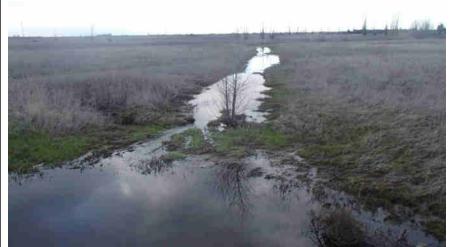
County: Butte Route: 99 Postmile: 42.70 Survey Date: 02/02/2016

Salmonid ESU/DPS				
ESU (Chinook and Coho Salmon)	<u> </u>					
Central Valley Spring-Run Chinook						
Central Valley Fall_Late Fall-Run C	Chinook					
Central Valley Steelhead	112-4	. A J				
		ic Anadromous Reach?				
Has the stream reach upstream of	the crossing supported an anad	romous fish population?				
Source		Crossing Type				
O i T Others						
Crossing Type Culvert General Description: Two corruga	ted steel nine squashed culvert	ID	culvert all in a concre	te form		
General Description. Two corruga	ned steel pipe squashed culvert		culvert, all ill a concre	te ioiii.

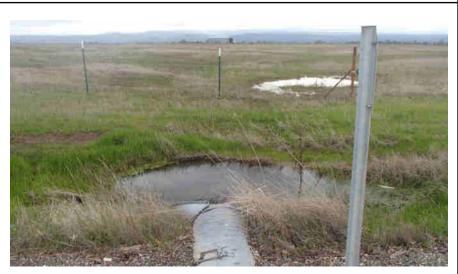
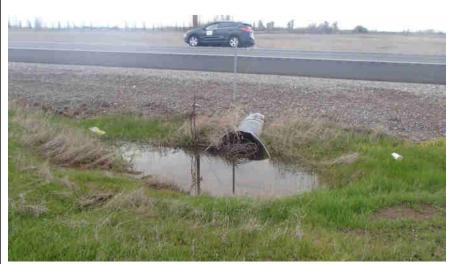
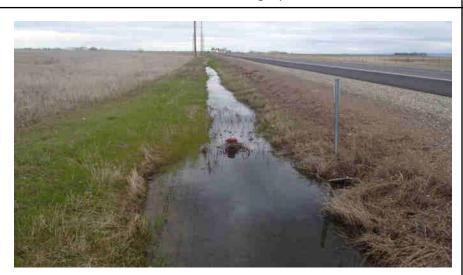
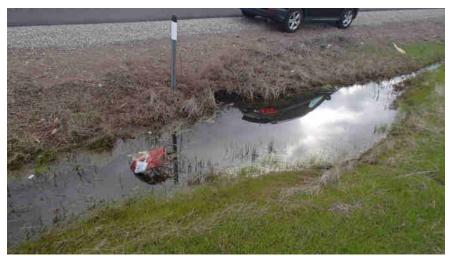
County: Butte Route: 99 Postmile: 42.80 Survey Date: 02/02/2016

S	almonid ESU/DPS				
ESU (Chinook and Coho Salmon) or D	PS (Steelhead)					
Central Valley Spring-Run Chinook						
Central Valley Fall_Late Fall-Run Chino	ok					
Central Valley Steelhead						
	Histori	c Anadromous Reach?	•			
Has the stream reach upstream of the c	rossing supported an anadi	romous fish population?				
Source						
		Crossing Type				
Crossing Type Culvert		ID				
General Description: Projecting corrug	ated steel pipe culvert.					
		Photos

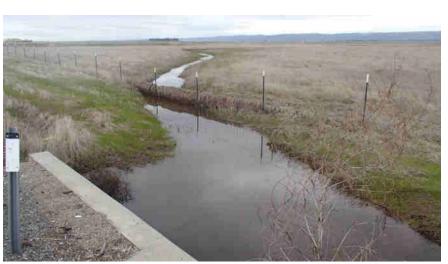
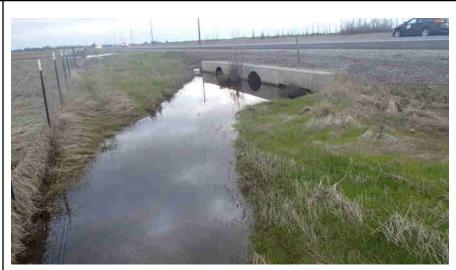
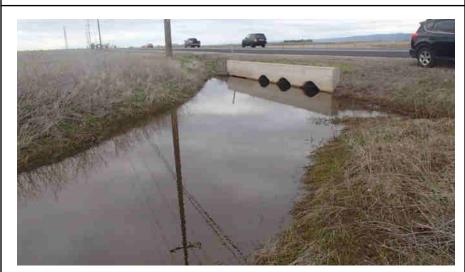
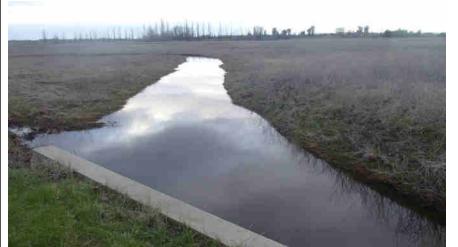
County: Butte Route: 99 Postmile: 42.90 Survey Date: 02/02/2016

•		
Is the waterway a concrete-lined flood control chann		
	Potential Fish Bearing Stream?	
Does the site contain an active channel width >2 fee	et? Yes	
Is the stream gradient < 20%?	Yes	
	Salmonid ESU/DPS	
ESU (Chinook and Coho Salmon) or DPS (Steelhe	ead)	
Central Valley Spring-Run Chinook	=	
Central Valley Fall_Late Fall-Run Chinook	\dashv	
Central Valley Steelhead	Historia Anadramaus Passis 2	
	Historic Anadromous Reach?	
Has the stream reach upstream of the crossing sup	ported an anadromous fish population?	
Source	Crossing Type	
Outside Trace Outside		
Constal Possistion: Three corrugated steel pipe of	IDulverts and two concrete box culverts in a concrete form.	
General Description: Triffee corrugated steel pipe C

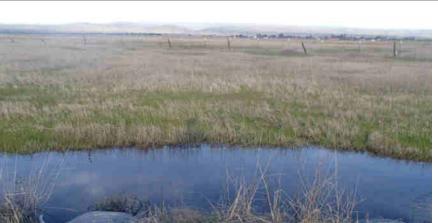
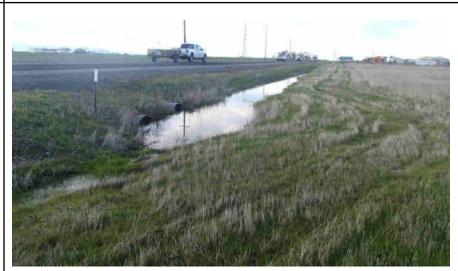
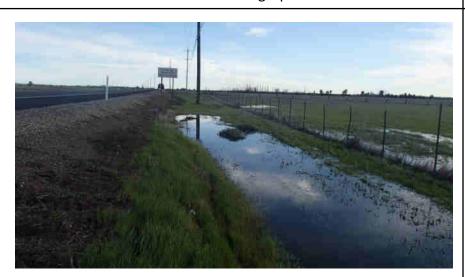
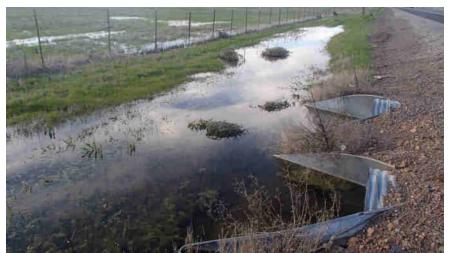
County: Butte Route: 99 Postmile: 43.10 Survey Date: 02/01/2016

•	tream of the crossing supported ar	anauromous iisn population?		
Source		Crossing Type		
Crossing Type Cu	vert	ID		
·	o corrugated steel pipe culverts wit			1
		Photos

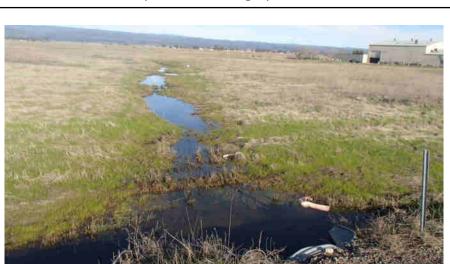
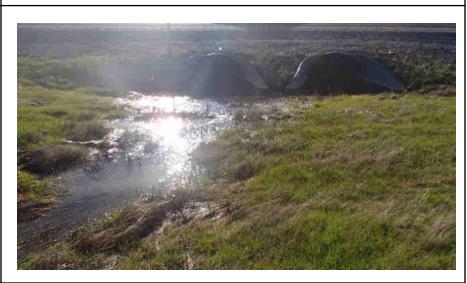
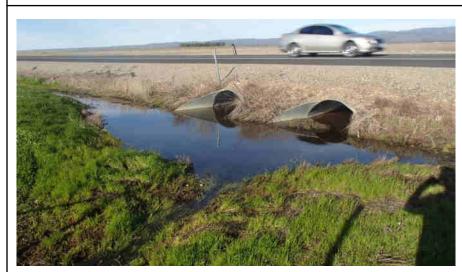
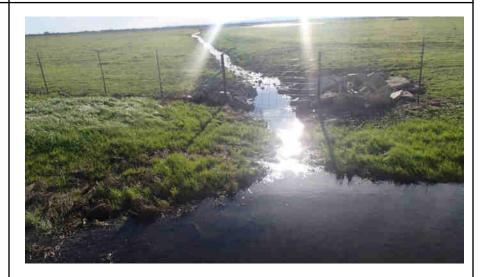
County: Butte Route: 99 Postmile: 43.33 Survey Date: 02/01/2016

ESII (Chinack	and Coho	Salmon) or DPS (S		Salmonid ESU/DPS				
Central Valley			neau)					
		all-Run Chinook						
Central Valley								
			Histori	c Anadromous Reach	1?			
Has the stream	n reach ups	tream of the crossir	ng supported an anad	romous fish population	?			
Source	,			, ,				
				Crossing Type				
Crossing	g Type Cul	vert		ID				
General Descr	ription: Two	corrugated steel p	ipe culverts, with end	sections.				
				Photos

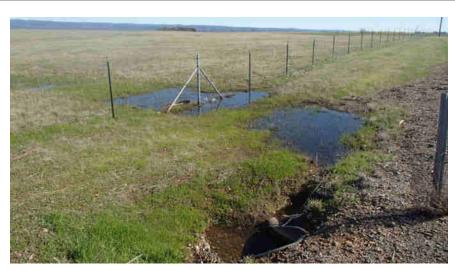
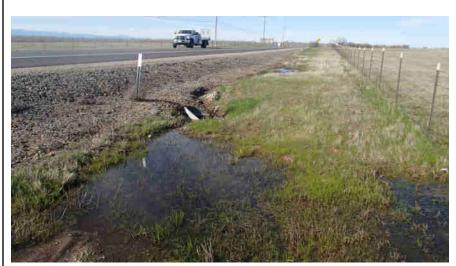
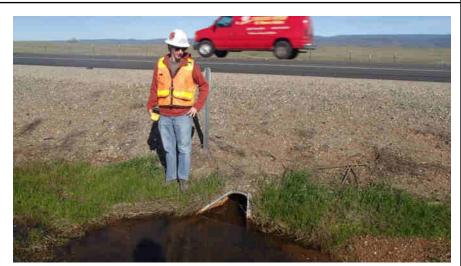
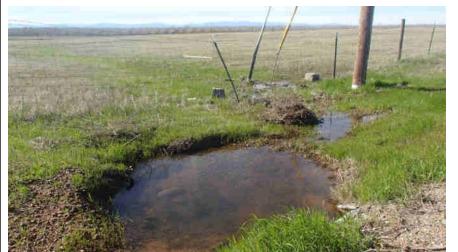
County: Butte Route: 99 Postmile: 43.40 Survey Date: 02/01/2016

Central Valley Steelhead		
	Historic Anadromous Reach?	
·	n of the crossing supported an anadromous fish population?	
Source		
	Crossing Type	
Crossing Type Culvert	ID	
General Description: corrugat		
	Photos

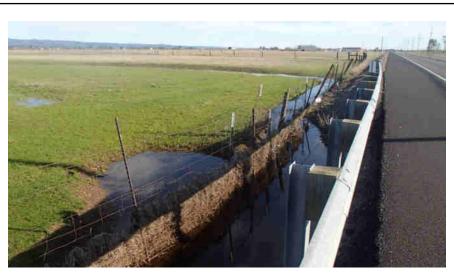
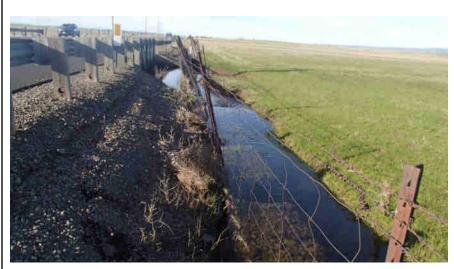
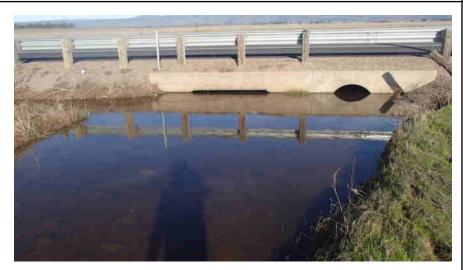
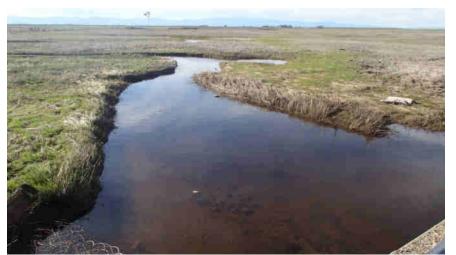
County: Butte Route: 99 Postmile: 43.64 Survey Date: 02/01/2016

Lieu the etreem reach unstrange of the engineering		
Has the stream reach upstream of the crossing sup Source	ported an anadromous fish population? Unknown	_
Source	Crossing Type	
Crossing Type Culvert	ID	
<u></u>	ox and one concrete pipe (elliptical) in a concrete form.	1
	Photos

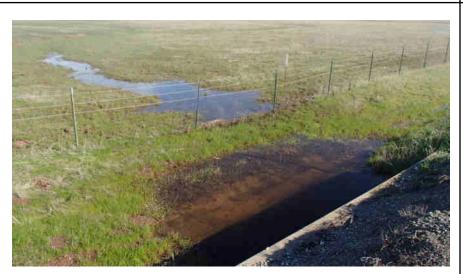
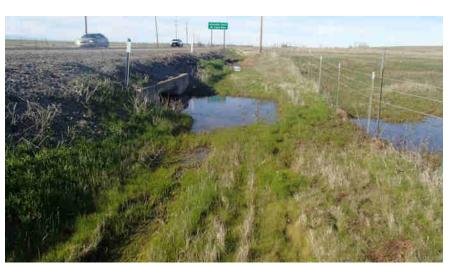
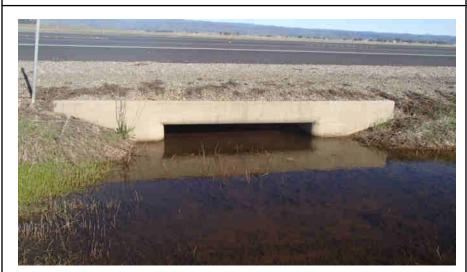
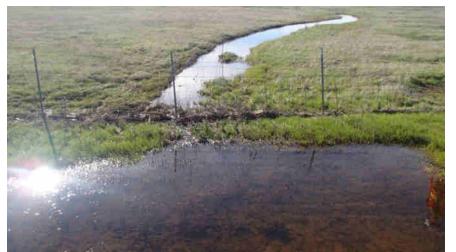
County: Butte Route: 99 Postmile: 43.80 Survey Date: 02/01/2016

ESU (Chinook and Coho Salmon) or DPS (Steelhe	ad)	
Central Valley Spring-Run Chinook		
Central Valley Fall_Late Fall-Run Chinook		
Central Valley Steelhead		
	Historic Anadromous Reach?	
Has the stream reach upstream of the crossing supp	orted an anadromous fish population?	
Source	One calma Torre	
	Crossing Type	
Crossing Type Culvert	ID	
General Description: concrete box culvert	Photos	
OA Hastroom Localism II. (1997)	Photos

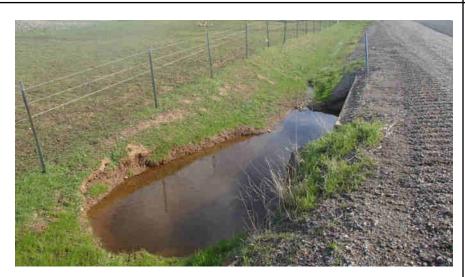
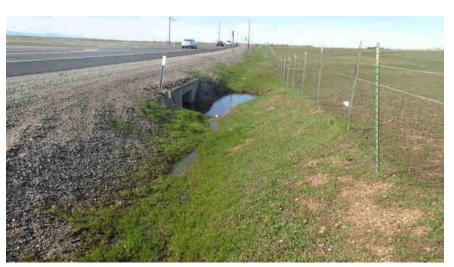
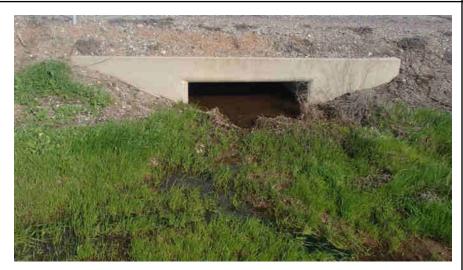
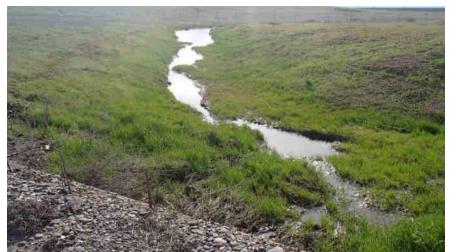
County: Butte Route: 99 Postmile: 44.30 Survey Date: 02/01/2016

Central Valley Spring-Run Chinook		
Central Valley Fall_Late Fall-Run Chinook		
Central Valley Steelhead		
	Historic Anadromous Reach?	
Has the stream reach upstream of the crossing supp	orted an anadromous fish population? Unknown	1
Source	Crossing Type	
Crossing Type Culvert General Description: Concrete box culvert.	ID	
General Description.	Dhatas

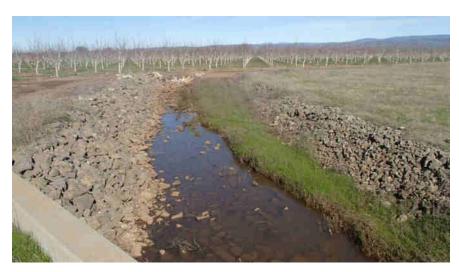
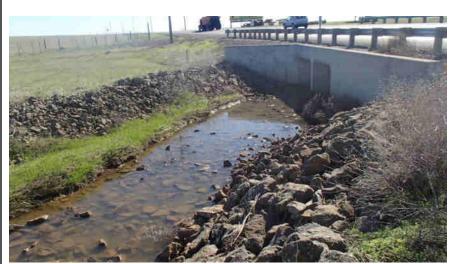
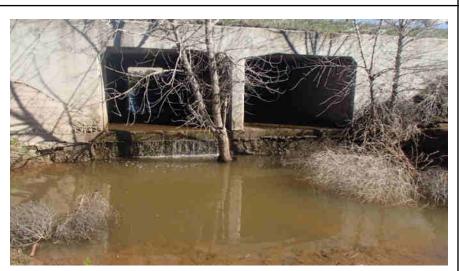
County: Butte Route: 99 Postmile: 44.90 Survey Date: 02/01/2016

•			<u></u>		
Is the primary function for storm water	_	No			
Is the waterway a concrete-lined flood	control channel?	No			
	Potential	Fish Bearing Strea	ım?		
Does the site contain an active channel	el width >2 feet?	Yes			
Is the stream gradient < 20%?		Yes			
	Sal	Imonid ESU/DPS			
ESU (Chinook and Coho Salmon) or	OPS (Steelhead)				
Central Valley Spring-Run Chinook					
	Historic	Anadromous Reacl	h?		
Has the stream reach upstream of the	crossing supported an anadro	mous fish population	n? Unkno	own	
Source					
	(Crossing Type			
Crossing Type Culvert		ID			
General Description: Double concrete	box culvert.				
		Photos

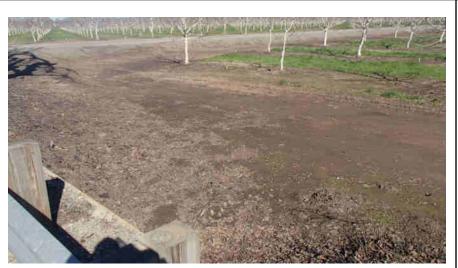
Upstream Looking Upstream

RECONNAISSANCE SURVEY INFORMATION				
County: BUT	Route: 99	PM: 45.50		
Survey Information				
Date 2/1/2016 Time	12:20 Agency Performing Survey H	IDR		
Data Recorder NO	(24 hr. clock) Survey Team NO, ST			
	Site Information			
	GPS Data			
Longitude -121.971135	Latitude 39.878904			
GPS HDOP 0.1	Loc. of GPS Point above outlet	PM		
	Hydrologic Information			
Stream Name Pine Creek	Source: sign at site			
Basin East Red Bluff HA	Quad Name (7.5') RICHARDSON SPRING	SS NW		
USGS Hydrologic Unit SACRAMENTO-LC	` '			
CalWater Unit HU TEHAMA	CalWater Unit HSA Red Bluff			
	Natural Stream Channel?			
Is there a definable channel upstream of culver				
Is the primary function for storm water runoff or				
Is the waterway a concrete-lined flood control of	channel? No			
	Potential Fish Bearing Stream?			
Does the site contain an active channel width	>2 feet? Yes			
Is the stream gradient < 20%?	Yes			
	Salmonid ESU/DPS

ESU (Chinook and Coho Salmon) or DPS (St	eelhead)			
Central Valley Spring-Run Chinook				
Central Valley Fall_Late Fall-Run Chinook				
Central Valley Steelhead				
	Historic Anadromous Reach?			
Has the stream reach upstream of the crossing	supported an anadromous fish population?			
Source CV Spring-run 5-Year Status R				
	Crossing Type			
Crossing Type bridge w/o potential pass	sage constraints ID 12-0028			
General Description: Multiple bay bridge.				
Photos

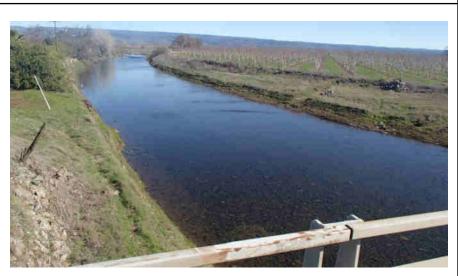
Upstream Looking Upstream

Central Valley Spring-Run	n Chinook			
Central Valley Fall_Late F	Fall-Run Chinook			
Central Valley Steelhead				
	Historic Anadromous Reach?			
Has the stream reach upsi	tream of the crossing supported an anadromous fish population?			
Source No connec	ction to known anadromous streams			
	Crossing Type			
o ,,	dge w/o potential passage constraints ID 12.0029			
General Description: Dou	uble concrete box culvert			
	Photos

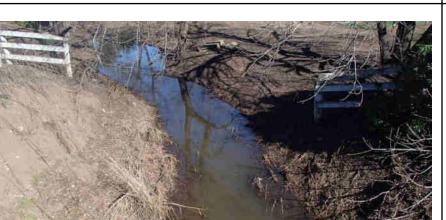
Upstream Looking Upstream

Historic A	Anadromous Reach?	
Has the stream reach upstream	of the crossing supported an anadron	nous fish population?	0
Source			
	C	rossing Type	
Crossing Type Culvert		ID	
General Description: Quadrup	e concrete box culvert.		
		Photos

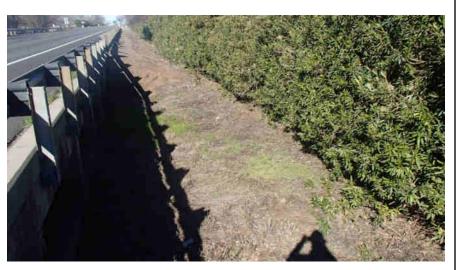
Upstream Looking Upstream

Central Valley Spring-Run Chinook		
Central Valley Fall_Late Fall-Run Chinook		
Central Valley Steelhead		
	Historic Anadromous Reach?	
Has the stream reach upstream of the crossing supp	orted an anadromous fish population?	
Source		
	Crossing Type	
Crossing Type Culvert	ID	
General Description: quadruple concrete box culve	t	
	Photos

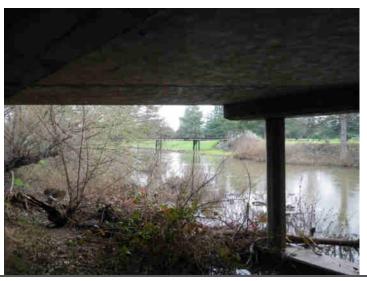
Upstream Looking Upstream

Is there a definable channel upstream of culvert?
Is the primary function for storm water runoff or road drainage?:
Is the waterway a concrete-lined flood control channel?
Potential Fish Bearing Stream?
Does the site contain an active channel width >2 feet?
Is the stream gradient < 20%?
Salmonid ESU/DPS
ESU (Chinook and Coho Salmon) or DPS (Steelhead)
Central Valley Spring-Run Chinook
Central Valley Fall_Late Fall-Run Chinook
Central Valley Steelhead
Historic Anadromous Reach?
Has the stream reach upstream of the crossing supported an anadromous fish population? Unknown
Source Tributary to Cosumnes River. Inlet and Outlet on frontage roads - no Caltrans culverts.
Crossing Type
Crossing Type Culvert ID General Description: concrete double box culvert; bordered by Stockton Blvd. on both east and west sides of the highway
Photos

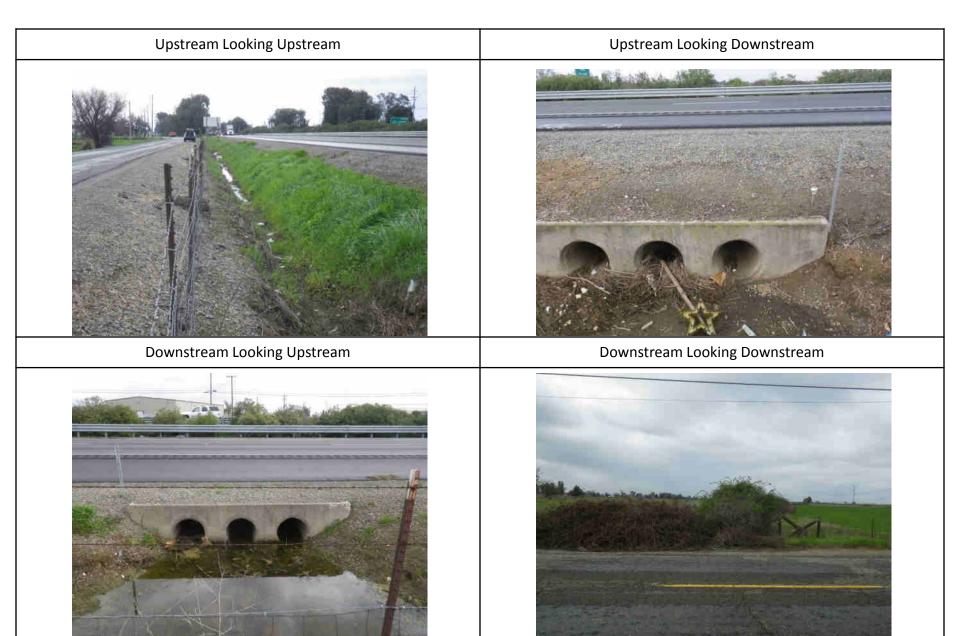
County: Sacramento Route: 99 Postmile: 3.90 Survey Date: 02/02/2016

Is the stream gradient < 20%?		Yes			
	Sa	Imonid ESU/DPS			
ESU (Chinook and Coho Salmon) or DPS (Steel	elhead)				
Central Valley Spring-Run Chinook					
Central Valley Fall_Late Fall-Run Chinook					
Central Valley Steelhead					
		Anadromous Reach			
Has the stream reach upstream of the crossing su				known	-
Source Tributary to Cosumnes River, His			onids in the Cent	trai Valley (NOAA 2005	<u> </u>
On the Tara Colored	1	Crossing Type			
Crossing Type Culvert General Description: triple concrete pipe culvert;	no postmile marko	ID er present			
General Description. Triple concrete pipe curvert,	, no positilie marke	Photos

RECONNAISSANCE SURVEY INFORMATION County: SAC Route: 99 PM: 3.90 **Access Information** Land Ownership: Upstream private Owner(s) Downstream private Owner(s) Accessible from road? Upstream? Limitations access via frintage road (East Stockton Blvd) Downstream? No Limitations access via frontage road (West Stockton Blvd) **Vegetation Removal Required?** Upstream? No (If "Yes", comment and take photograph) Photo ID Comments Unknown (If "Yes", comment and take photograph) Downstream? Photo ID SAC_99_3.90_3.4 2-02-2016 Maintenance Assistance Required? No Upstream? (If "Yes", comment and take photograph) Photo ID Comments No Downstream? (If "Yes", comment and take photograph) Photo ID **Confined Space Assessment** If answer is "No" to any of the questions below, site must have confined spaces equipment for surveying. DO NOT ENTER CULVERT Is culvert diameter > 60"?

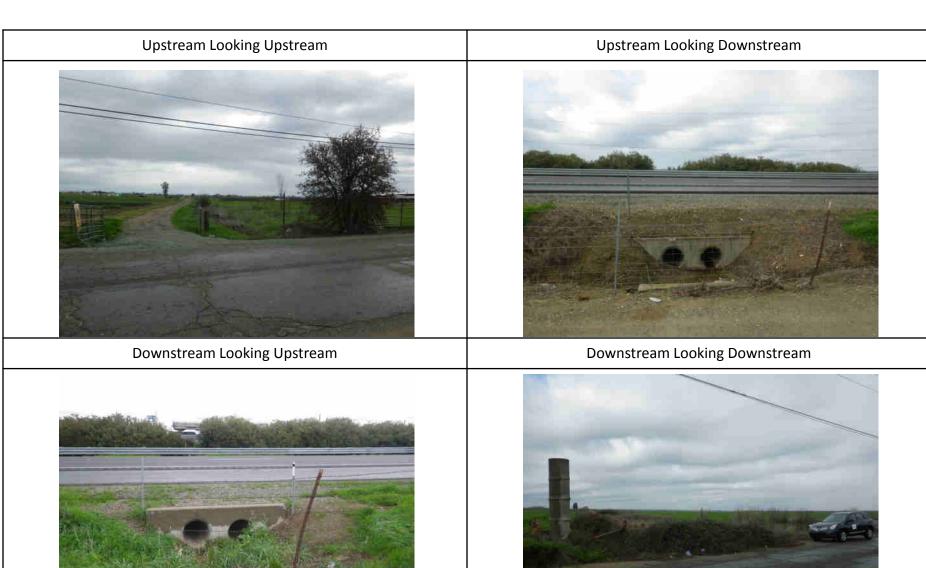
County: Sacramento Route: 99 Postmile: 4.60 Survey Date: 02/02/2016

ESU (Chinook and Coho Salmon) or DPS (Steelhe	ead)	
Central Valley Spring-Run Chinook		
Central Valley Fall_Late Fall-Run Chinook		
Central Valley Steelhead		
	Historic Anadromous Reach?	
Has the stream reach upstream of the crossing supp	ported an anadromous fish population? Unknown	_
Source Tributary to Cosumnes River, Histor	ical and Current dist. Of Pacific Salmonids in the Central Valley (NOAA 2005)	
	Crossing Type	
Crossing Type Culvert	ID	
General Description: Concrete pipe cuvert. The cha	annel upstrream of culvert no longer connects to the culvert due to agricultura	I land use.
	Photos

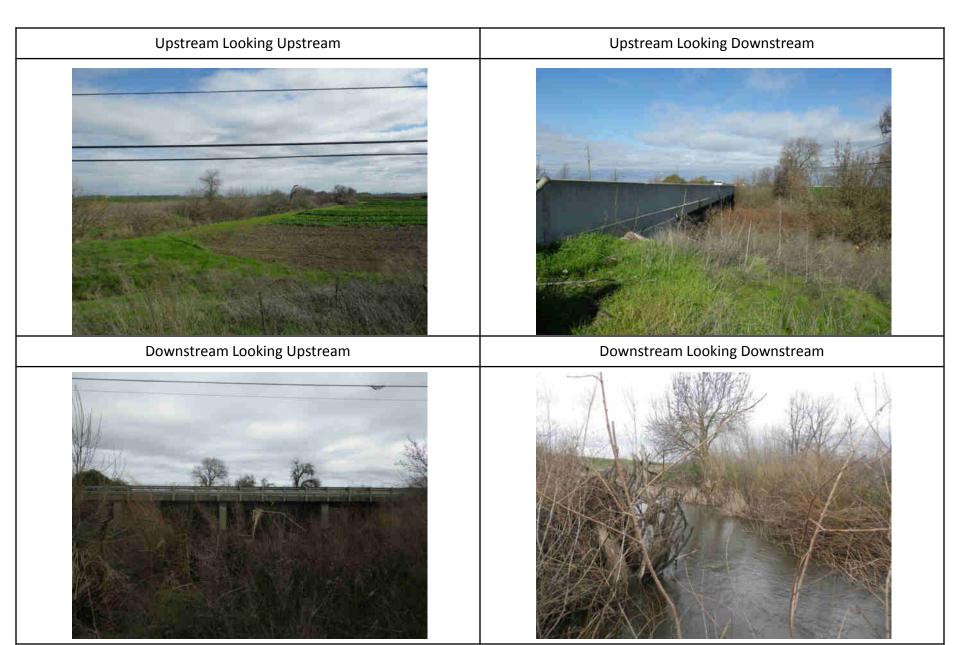
County: Sacramento Route: 99 Postmile: 4.98 Survey Date: 02/02/2016

•	romous fish populatio		Jnknown		
Source Tr	ributary to	Cosumnes River,	Historical and Currer		nonids in the Ce	entral Valley (NOAA 2005)	
				Crossing Type				
		e w/o potential pas		ID 240045				
General Description	on: sepa	rate bridge for nort	thbouth and southbou

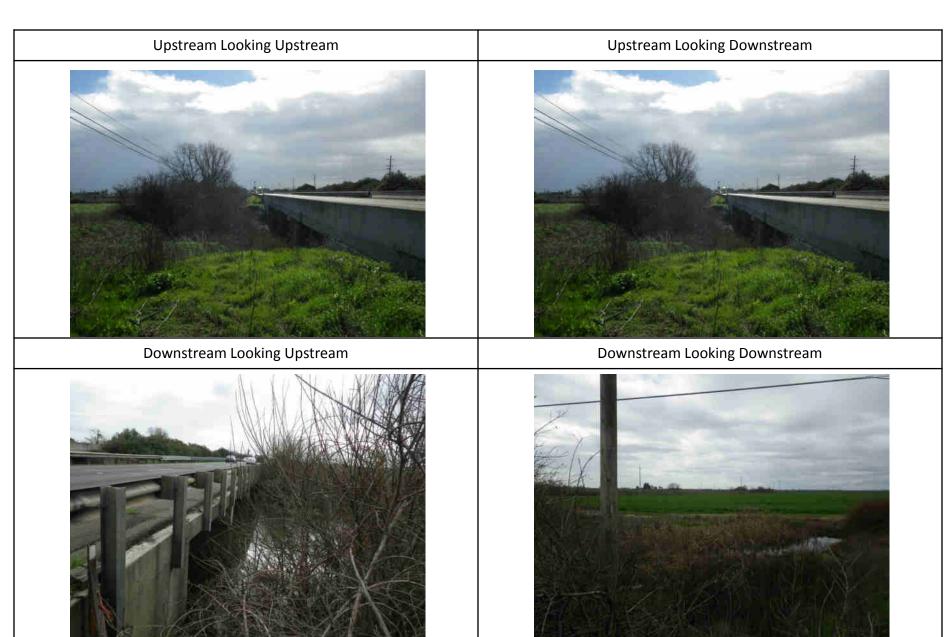
County: Sacramento Route: 99 Postmile: 5.06 Survey Date: 02/02/2016

•	separate bridge for northbou	-					
	,		Photos				
3.1 Upstream Looking	Upstream - Photo I	SAC 99 5.00	6_3.1_2-02-2016		J		
3.2 Upstream Looking			6_3.2_2-02-2016				
	ing Upstream - Photo ID	-	6_3.3_2-02-2016

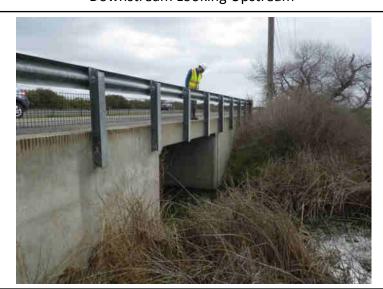
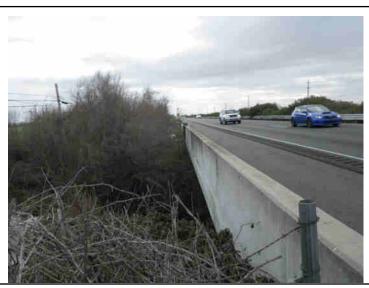
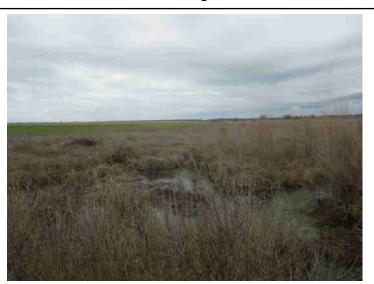
County: Sacramento Route: 99 Postmile: 6.54 Survey Date: 02/02/2016

Downstream Looking Upstream

Upstream Looking Downstream

Downstream Looking Downstream

Salmonid ESU/DPS	
ESU (Chinook and Coho Salmon) or DPS (Steelhead	d)	
Central Valley Fall_Late Fall-Run Chinook	⊒	
Central Valley Steelhead	⊒	
Central Valley Spring-Run Chinook		
	Historic Anadromous Reach?	
Has the stream reach upstream of the crossing suppo		
Source Tributary to Cosumnes River, Historica	al and Current dist. Of Pacific Salmonids in the Central Valley (NOAA 2005) Crossing Type	
Crossing Type bridge w/o potential passage co		
General Description: separate bridge for northbound		
	Photos

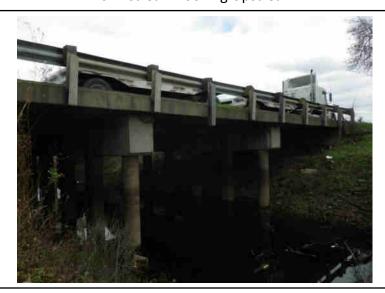
County: Sacramento Route: 99 Postmile: 6.96 Survey Date: 02/08/2016

Upstream Looking Upstream

Downstream Looking Upstream

Upstream Looking Downstream

Downstream Looking Downstream

- I - I			Crossing Type				
•	w/o potential passage co		ID 240025				
General Description: one bri	iuge for both directions o	и гапіс	Dhatas				
2.4 Unotroom Locking Heater	nom Dhota I	EAC 00 00	Photos
