Summary of 2016 Reconnaissance Fish Passage Surveys

During February and March of 2016, 179 Reconnaissance Fish Passage Surveys were conducted on state highways in Butte and Sacramento counties. 138 sites were surveyed on Highway 99 in Butte County, 24 sites were surveyed on Highway 99 in Sacramento County, and 17 sites were surveyed on Highway 104 in Sacramento County. The Reconnaissance Surveys were performed in accordance with the California Department of Transportation's (Caltrans') Reconnaissance Fish Passage Assessment Instructions and Procedures manual¹. 25 of the 179 sites (14%) were identified as requiring a Detailed Fish Passage Survey.

County: Butte Route: 99 Postmile: 0.01 Survey Date: 02/09/2016

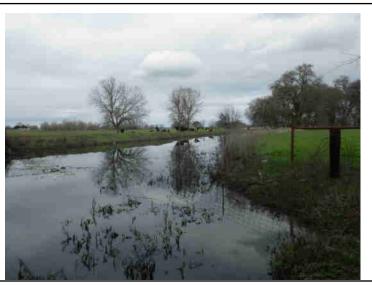
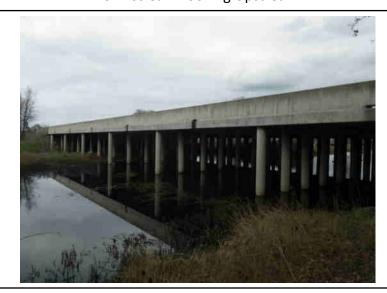
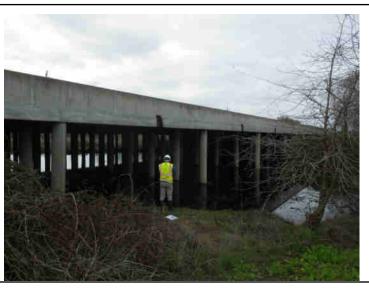
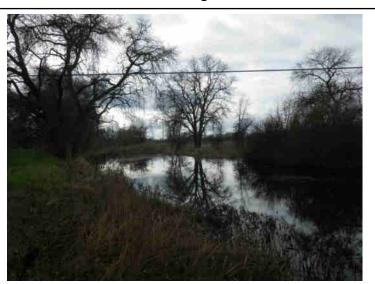
County: Sacramento Route: 99 Postmile: 7.45 Survey Date: 02/02/2016

Upstream Looking Upstream

Downstream Looking Upstream

Upstream Looking Downstream

Downstream Looking Downstream

• • •	- h···	and and		Crossing Type				
Crossing Type bridge w/o potential passage constraints ID 240022								
General Description: separate bridges for northbound and southbound traffic

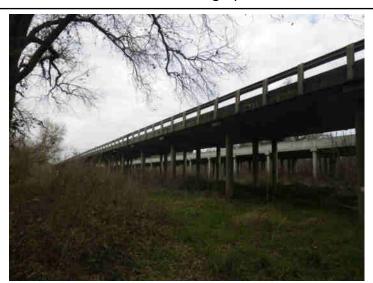
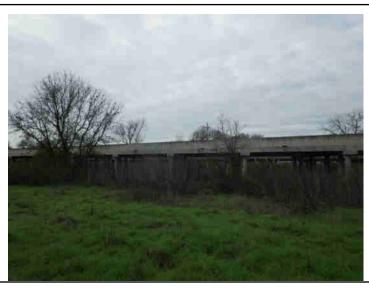
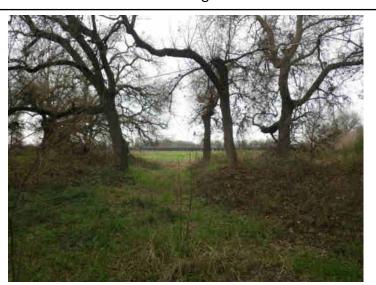
County: Sacramento Route: 99 Postmile: 8.40 Survey Date: 02/03/2016

Downstream Looking Upstream

Upstream Looking Downstream

Downstream Looking Downstream

Is the stream gradient < 20%?	Yes				
	Salmonid ESU/DPS				
ESU (Chinook and Coho Salmon) or DPS (Steelhe	ead)				
Central Valley Spring-Run Chinook					
Central Valley Fall_Late Fall-Run Chinook					
Central Valley Steelhead					
	Historic Anadromous Reach?				
Has the stream reach upstream of the crossing supp					
Source Historical and Current dist. Of Pacific Salmonids in the Central Valley (NOAA 2005)					
	Crossing Type				
Crossing Type bridge w/o potential passage					
General Description: separate bridge for northbound and southbound traffic					
Photos

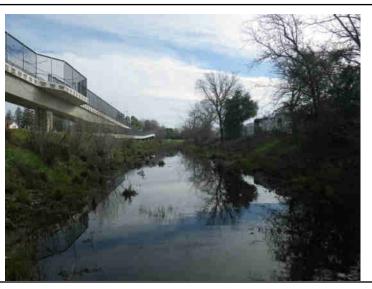
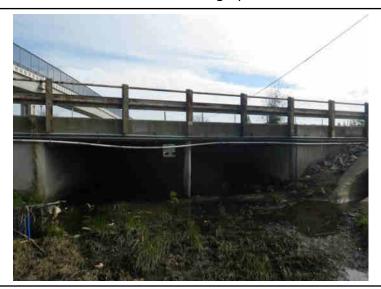
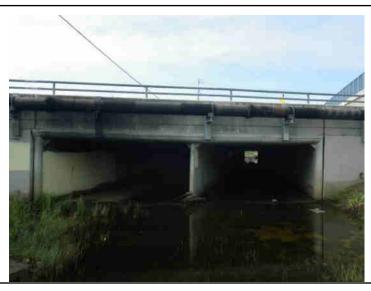
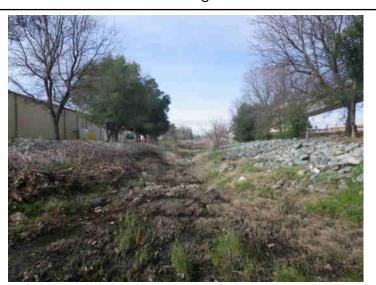
County: Sacramento Route: 99 Postmile: 14.32 Survey Date: 02/03/2016

Upstream Looking Upstream

Downstream Looking Upstream

Upstream Looking Downstream

Downstream Looking Downstream

Salmonid ESU/DPS			
ESU (Chinook and Coho Salmon) or DPS (Steelhe	ead)			
Central Valley Spring-Run Chinook				
Central Valley Fall_Late Fall-Run Chinook				
Central Valley Steelhead				
	Historic Anadromous Reach?			
Has the stream reach upstream of the crossing supp	ported an anadromous fish population? Unknown			
Source				
Crossing Type				
Crossing Type bridge w/o potential passage constraints ID 240018				
General Description: 99 bridge is paralleled by frontage road bridges on each side				
	Photos	7

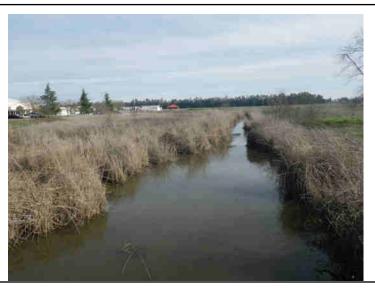
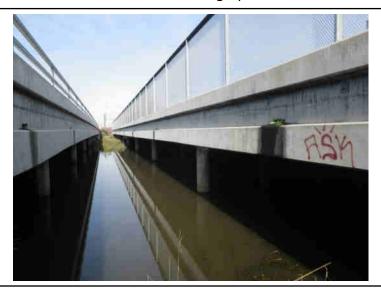
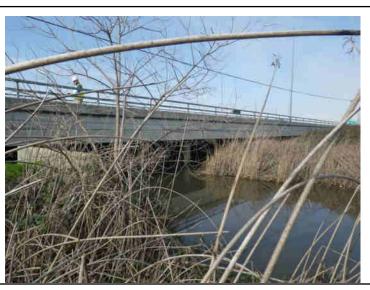
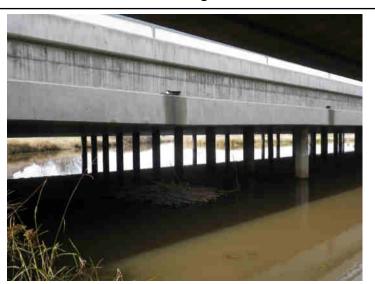
County: Sacramento Route: 99 Postmile: 14.63 Survey Date: 02/03/2016

Upstream Looking Upstream

Downstream Looking Upstream

Upstream Looking Downstream

Downstream Looking Downstream

•		•		dromous fish population		known	0	!b!-	
Source Outlet location unknown. Aerial imagery suggests historical upstream channel was diverted to Elk Grove Creek. Possible overflow channel.										
					Crossing Type					
Crossing Ty	ype Culver	t			ID 240017					
General Description	on: concre	te triple bay cul	vert							
Photos

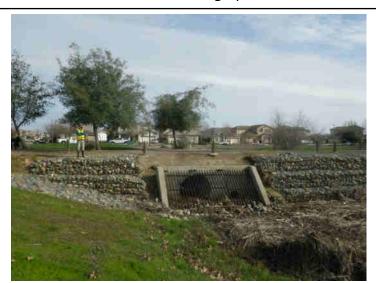
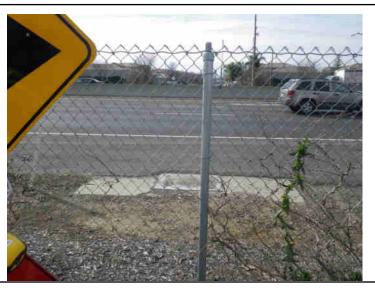
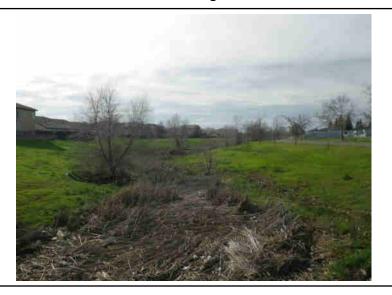
County: Sacramento Route: 99 Postmile: 16.36 Survey Date: 02/03/2016

Downstream Looking Upstream

Upstream Looking Downstream

Downstream Looking Downstream

Is the stream gradient < 20%?	Yes				
	Salmonid ESU/DPS				
ESU (Chinook and Coho Salmon) or DPS (Steelhe	ead)				
Central Valley Spring-Run Chinook					
Central Valley Fall_Late Fall-Run Chinook					
Central Valley Steelhead					
	Historic Anadromous Reach?				
Has the stream reach upstream of the crossing sup	·				
Source Tributary to Morrison Creek, which i					
Crossing Type					
Crossing Type Culvert	ID 240016				
General Description: Concrete 5-bay culvert.					
	Photos	7

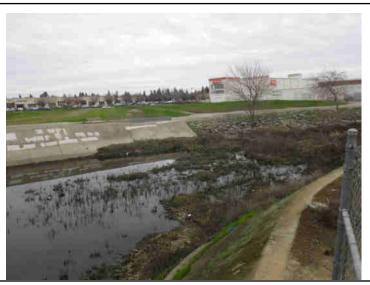
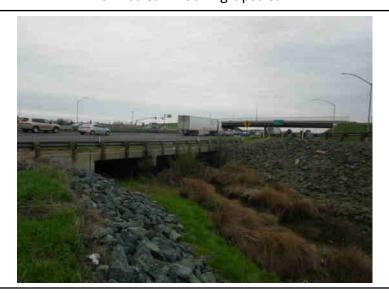
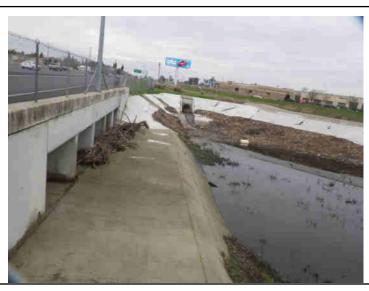
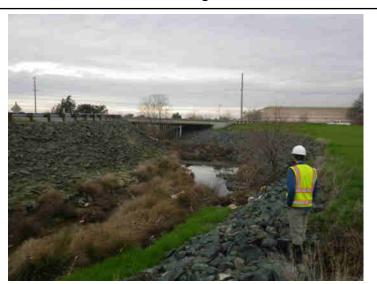
County: Sacramento Route: 99 Postmile: 16.78 Survey Date: 02/04/2016

Upstream Looking Upstream

Downstream Looking Upstream

Upstream Looking Downstream

Downstream Looking Downstream

Is the stream gradient < 20%?	Salmonid ESU/DPS				
ESU (Chinook and Coho Salmon) or DPS (Steelhea					
Central Valley Spring-Run Chinook					
Central Valley Fall_Late Fall-Run Chinook	\exists				
Central Valley Steelhead					
	Historic Anadromous Reach?				
Has the stream reach upstream of the crossing supp	orted an anadromous fish population?				
Source					
	Crossing Type				
Crossing Type Culvert	ID				
General Description: concrete pipe culvert					
Photos

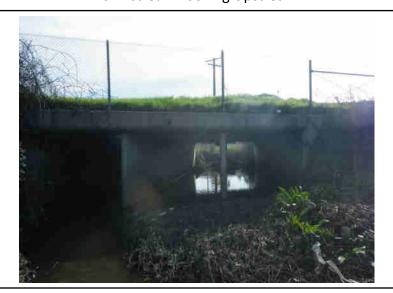
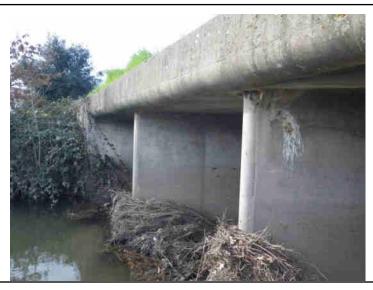
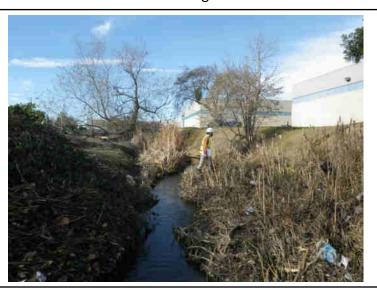
County: Sacramento Route: 99 Postmile: 17.33 Survey Date: 02/04/2016

Downstream Looking Upstream

Upstream Looking Downstream

Downstream Looking Downstream

Is the stream gradient < 20%?	Yes				
	Salmonid ESU/DPS				
ESU (Chinook and Coho Salmon) or DPS (Steelhead)					
Central Valley Spring-Run Chinook					
Central Valley Fall_Late Fall-Run Chinook					
Central Valley Steelhead					
	Historic Anadromous Reach?				
Has the stream reach upstream of the crossing supp	ported an anadromous fish population? Unknown				
Source Tributary to Strawberry Creek					
Crossing Type					
Crossing Type Culvert ID 240189					
General Description: Concrete triple bay culvert. Outlet under city/county frontage road.					
Od Hadron Lock H. J. St. J.	Photos	7

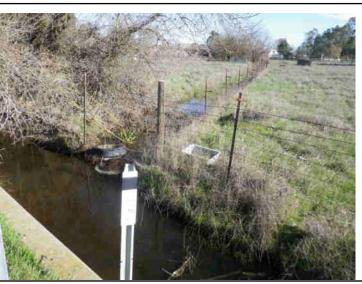
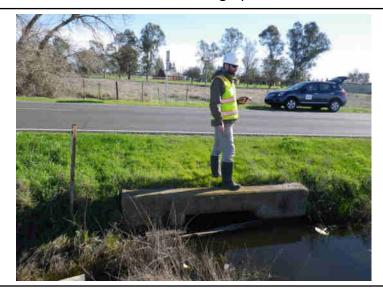
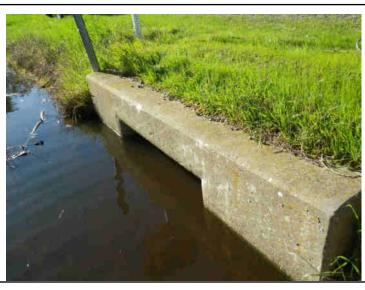
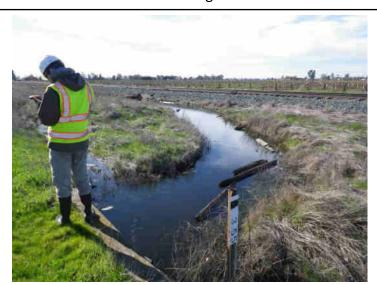
County: Sacramento Route: 104 Postmile: 3.56 Survey Date: 02/01/2016

Salmonid ESU/DPS	
ESU (Chinook and Coho Salmon) or DPS (Steelhea	ad)	
Central Valley Spring-Run Chinook	ᆜ	
Central Valley Fall_Late Fall-Run Chinook	ᆜ	
Central Valley Steelhead		
	Historic Anadromous Reach?	
Has the stream reach upstream of the crossing support	orted an anadromous fish population?	
Source		
	Crossing Type	
Crossing Type Culvert	ID	
General Description: concrete box culvert		
	Photos	_

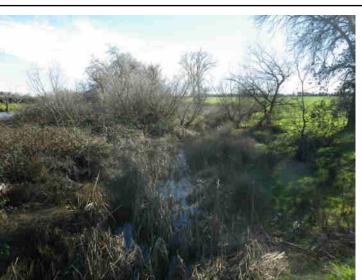
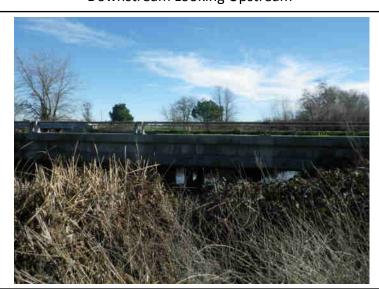
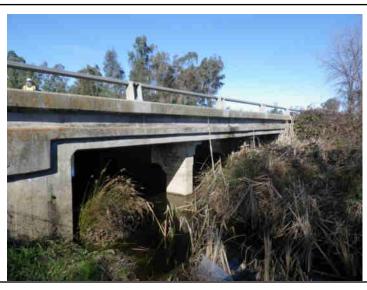
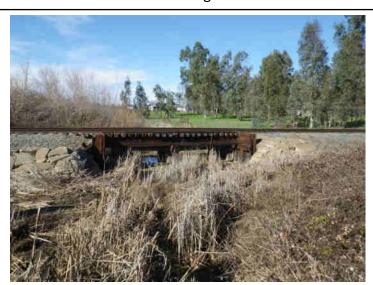
County: Sacramento Route: 104 Postmile: 4.30 Survey Date: 02/01/2016

ESU (Chinook and Coho Salmon) or DPS (Steelhe	ad)		
Central Valley Spring-Run Chinook	<u>_</u>		
Central Valley Fall_Late Fall-Run Chinook	_		
Central Valley Steelhead		.1.0	
	Historic Anadromous Read		
Has the stream reach upstream of the crossing supp	, ,		
Source Tributary to Cosumnes River, Histori		nonids in the Central Valley (NOAA 2005)	
Consolina Time Insidential and a standard and a sta	Crossing Type		
Crossing Type bridge w/o potential passage of General Description:	constraints ID 240042		
Concrat Description.	Photos

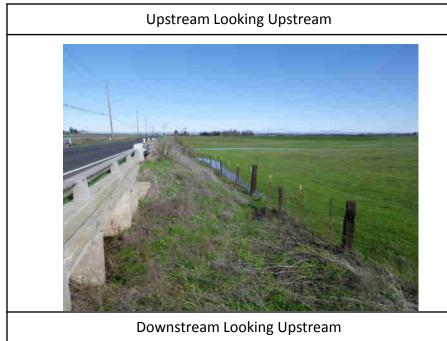
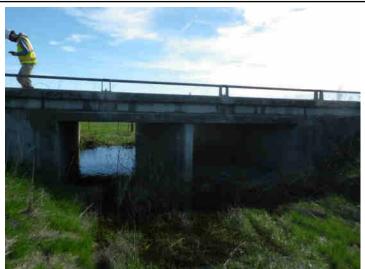
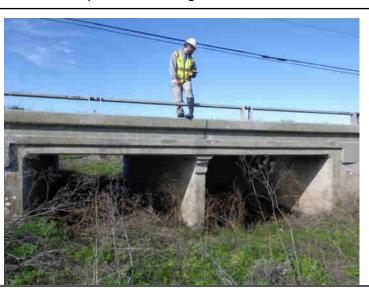
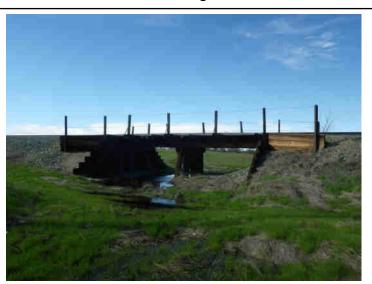
County: Sacramento Route: 104 Postmile: 5.44 Survey Date: 02/01/2016

Central Valley Spring-Run Chinook	
Central Valley Fall_Late Fall-Run Chinook	
Central Valley Steelhead Historic Anadromous Reach?	
	No
Has the stream reach upstream of the crossing supported an anadromous fish population? Source Aerial imagery; no upstream drainage basin	No No
Crossing Type	
Crossing Type Culvert ID	
General Description: concrete double box culvert	
Photos

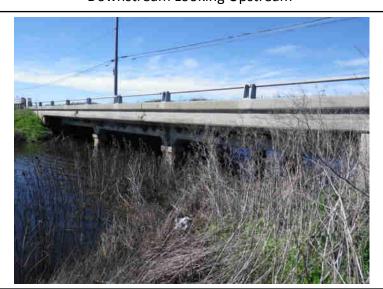
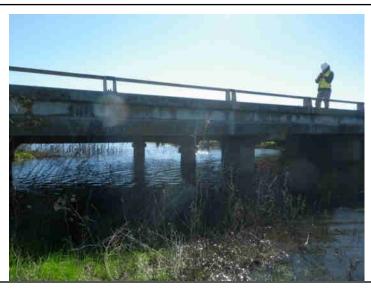
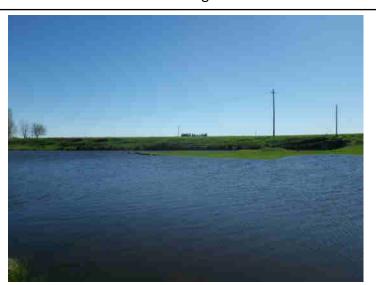
County: Sacramento Route: 104 Postmile: 5.78 Survey Date: 02/01/2016

Is the stream gradient < 20%?		Yes				
	Salmon	id ESU/DPS				
ESU (Chinook and Coho Salmon) or DPS (Steelh	ead)					
Central Valley Spring-Run Chinook						
Central Valley Fall_Late Fall-Run Chinook						
Central Valley Steelhead		<u> </u>				
		dromous Reach?				
Has the stream reach upstream of the crossing sup			-			
Source Tributary to Cosumnes River, Histo		of Pacific Salmor	iius in the Central	valley (NOAA 2005)		
Crossing Type bridge w/o potential passage		ID				
General Description: Bridge	CONSTIANTS	טו				
озлога возоприон.	DI.	notos

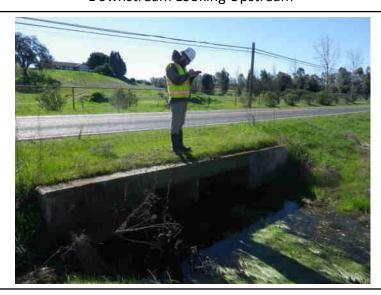
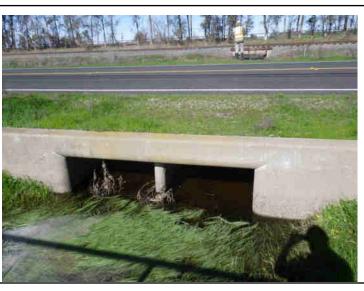
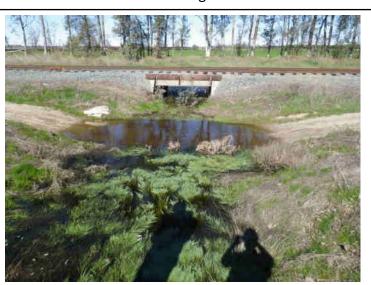
County: Sacramento Route: 104 Postmile: 8.84 Survey Date: 02/09/2016

Is the stream gradient < 20%?	Yes				
	Salmonid ESU/DPS				
ESU (Chinook and Coho Salmon) or DPS (Steelhead	<u>) </u>				
Central Valley Street Pur Chinael	」 ¬				
Central Valley Spring-Run Chinook	」 ¬				
Central Valley Fall_Late Fall-Run Chinook	Historic Anadromous Reac	h?			
Her the street week western as of the second					
Has the stream reach upstream of the crossing suppor	ieu an anadromous fish populatioi	n? No			
Source	Crossing Type				
Crossing Type	ID				
General Description:	15				
	Photos

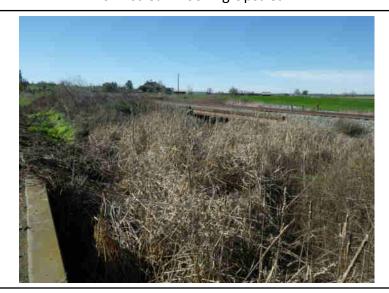
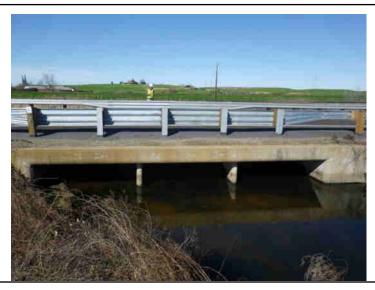
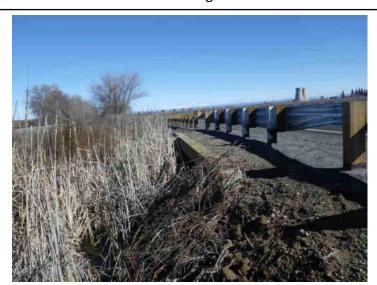
County: Sacramento Route: 104 Postmile: 9.70 Survey Date: 02/01/2016

ESU (Chinook and Coho Salmon) or DPS (Steelhe	ead)	
Central Valley Spring-Run Chinook		
Central Valley Fall_Late Fall-Run Chinook		
Central Valley Steelhead		
	Historic Anadromous Reach?	
Has the stream reach upstream of the crossing supp Source	ported an anadromous fish population?	
·	Crossing Type	
Crossing Type Culvert	ID	
General Description: concrete triple bay box culver	t	
	Photos

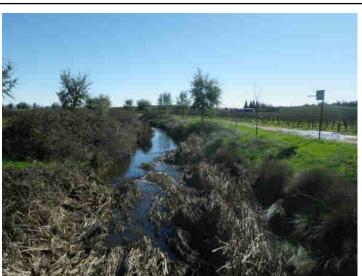
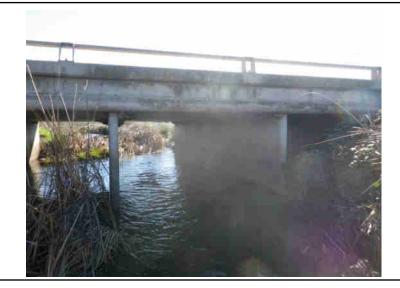
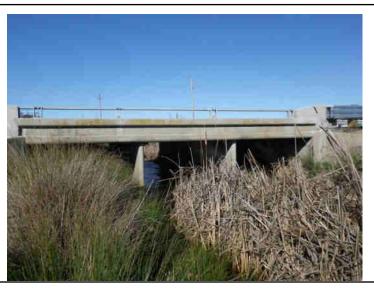
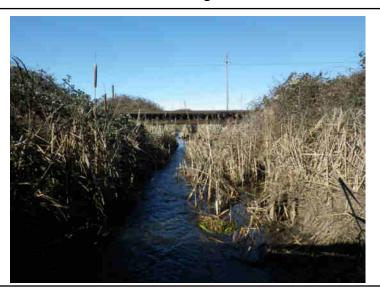
County: Sacramento Route: 104 Postmile: 9.94 Survey Date: 02/01/2016

Does the site contain an active channel widt	h >2 feet?	Yes						
Is the stream gradient < 20%?		Yes						
		Salmonid ESU/DPS						
ESU (Chinook and Coho Salmon) or DPS (Steelhead)							
Central Valley Spring-Run Chinook								
Central Valley Fall_Late Fall-Run Chinook								
Central Valley Steelhead	Listor	ic Anadromous Rea	ch?					
Hoo the atream wash waster as at the				20WD				
Has the stream reach upstream of the cross Source Tributary to Cosumnes Rive			'					
Source Tributary to Cosumnes Rive	, i iistoricai ariu Culle	Crossing Type	nomice in the Certific	ar valley (NOAA 2003)				
Crossing Type Bridge w/ potential pa	ssage constraints	ID						
General Description: bridge comprised of a	-		do not have flow; pa	ssage constarint is the	concrete bo	ottom		
Photos

RECONNAISSANCE SURVEY INFORMATION County: SAC Route: 104 PM: 9.94 **Access Information** Land Ownership: Upstream private Owner(s) Downstream private Owner(s) Accessible from road? Upstream? Yes Limitations Downstream? Yes Limitations **Vegetation Removal Required?** Upstream? (If "Yes", comment and take photograph) SAC_104_9.94_3. Photo ID Comments 1_2-01-2016 Downstream? (If "Yes", comment and take photograph) SAC_104_9.94_3. Photo ID Comments 4_2-01-2016 Maintenance Assistance Required? No Upstream? (If "Yes", comment and take photograph) Photo ID Comments Downstream? No (If "Yes", comment and take photograph) Photo ID Comments **Confined Space Assessment** If answer is "No" to any of the questions below, site must have confined spaces equipment for surveying. DO NOT ENTER CULVERT

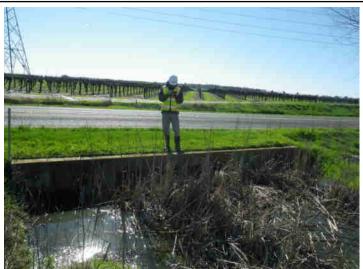
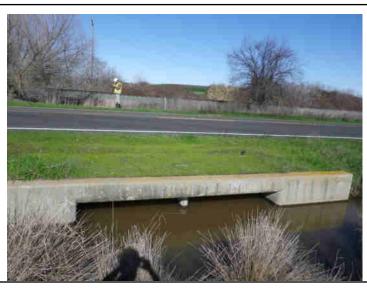
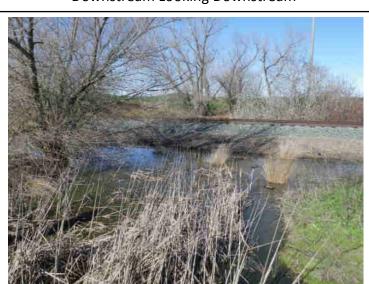
County: Sacramento Route: 104 Postmile: 10.46 Survey Date: 02/01/2016

Central Valley Spring-Run Chinook				
Central Valley Fall_Late Fall-Run Chinook				
Central Valley Steelhead				
	Historic Anadromous F	Reach?		
Has the stream reach upstream of the cross	sing supported an anadromous fish popu	ation?	0	
Source				
	Crossing Type			
Crossing Type Culvert	ID			
General Description: concrete double box				
	Photos

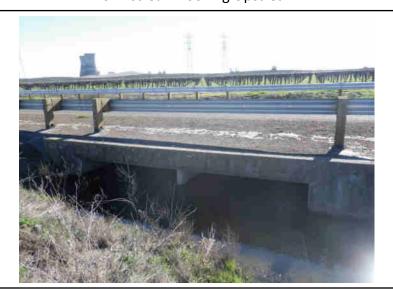
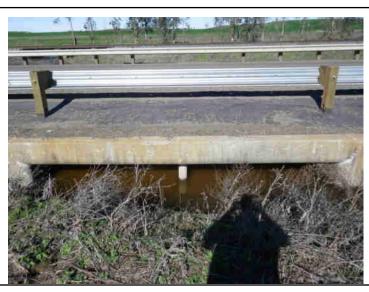
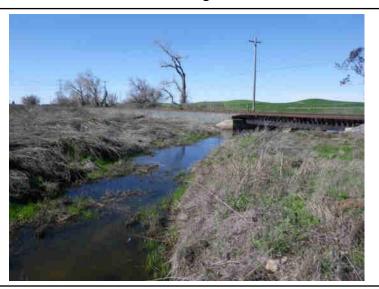
County: Sacramento Route: 104 Postmile: 10.60 Survey Date: 02/01/2016

Is the stream gradient < 20%?		Yes			
		almonid ESU/DPS			
ESU (Chinook and Coho Salmon) or DP	S (Steelhead)				
Central Valley Spring-Run Chinook					
Central Valley Fall_Late Fall-Run Chinool	(
Central Valley Steelhead					
	Historic	Anadromous Reach	?		
Has the stream reach upstream of the cro	ssing supported an anadro	omous fish population?	N	0	
Source					
		Crossing Type			
Crossing Type Culvert		ID			
General Description: concrete double bo	x culvert; no postmile mar				
	I Tava	Photos		,

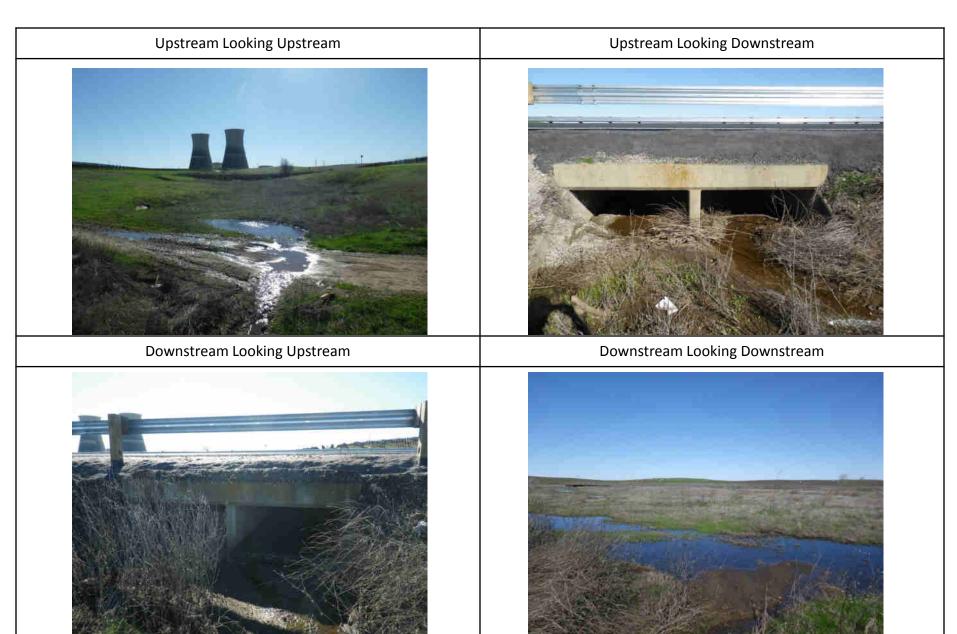
County: Sacramento Route: 104 Postmile: 11.25 Survey Date: 02/01/2016

Central Valley Steell	head							
				ic Anadromous Rea				
				Iromous fish population	<u></u>	known (NOAA 2225)		
Source Tribu	utary to C	osumnes River,	Historical and Curre		nonids in the Centi	ral Valley (NOAA 2005)		
One i T	- 10			Crossing Type				
Crossing Type General Description:			llvert: no nostrmile m	ID arker present				
Coneral Description.	. Concre	LO GOUDIO DOX CU	iivori, no postinine m	Photos

RECONNAISSANCE SURVEY INFORMATION County: SAC Route: 104 PM: 11.25 **Access Information** Land Ownership: Upstream unknown Owner(s) Downstream unknown Owner(s) Accessible from road? Upstream? Yes Limitations Yes Downstream? Limitations **Vegetation Removal Required?** Upstream? No (If "Yes", comment and take photograph) Photo ID Comments No (If "Yes", comment and take photograph) Downstream? Photo ID Comments **Maintenance Assistance Required?** Upstream? (If "Yes", comment and take photograph) Photo ID No Downstream? (If "Yes", comment and take photograph) Photo ID Comments **Confined Space Assessment** If answer is "No" to any of the questions below, site must have confined spaces equipment for surveying. DO NOT ENTER CULVERT Is culvert diameter > 60"? No

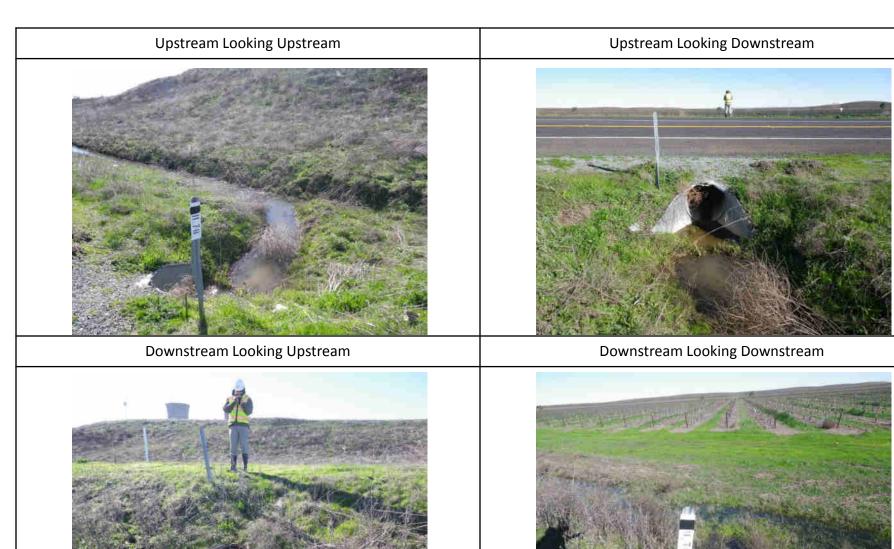
County: Sacramento Route: 104 Postmile: 11.78 Survey Date: 02/01/2016

Is the stream gradient <	20%?		Yes			
			Salmonid ESU/DPS			
•	o Salmon) or DPS (Steelhe	ad)				
Central Valley Spring-Ru		<u> </u>				
Central Valley Fall_Late		=				
Central Valley Steelhead		Histori	ic Anadromous Reac	.h2		
Has the street rock	astroom of the areasing a				No	
Source	ostream of the crossing supp	onteu an anad	romous usa populatioi	1111	NO.	
			Crossing Type			
Crossing Type C	ulvert	1	ID			
General Description:						
			Photos

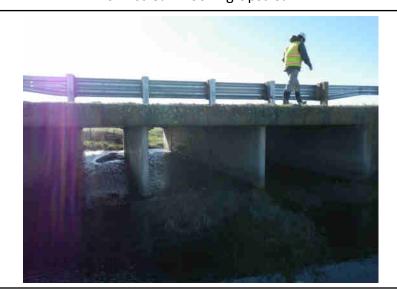
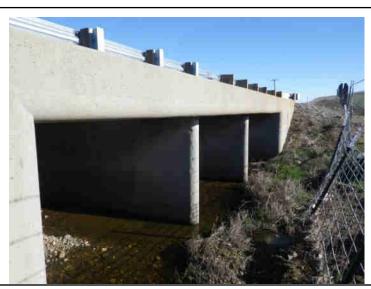
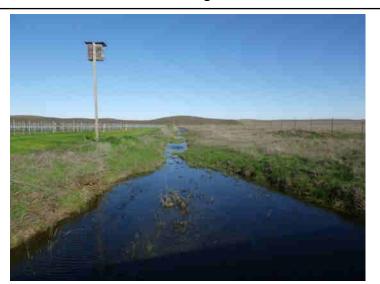
Is the stream gra	adient < 20	%?		Yes				
				Salmonid ESU/DPS				
		Salmon) or DPS (S	steelhead)					
Central Valley Sp								
Central Valley Fa		III-Run Chinook						
Central Valley St	eeinead		Histori	ic Anadromous Rea	ch2			
Lloo the store	anal	room of the				nown		
				romous fish population		al Valley (NOAA 2005)		1
		3555		Crossing Type				
Crossing T	Гуре Culve	ert	1	ID				
		rete triple bay box	culvert					
Photos

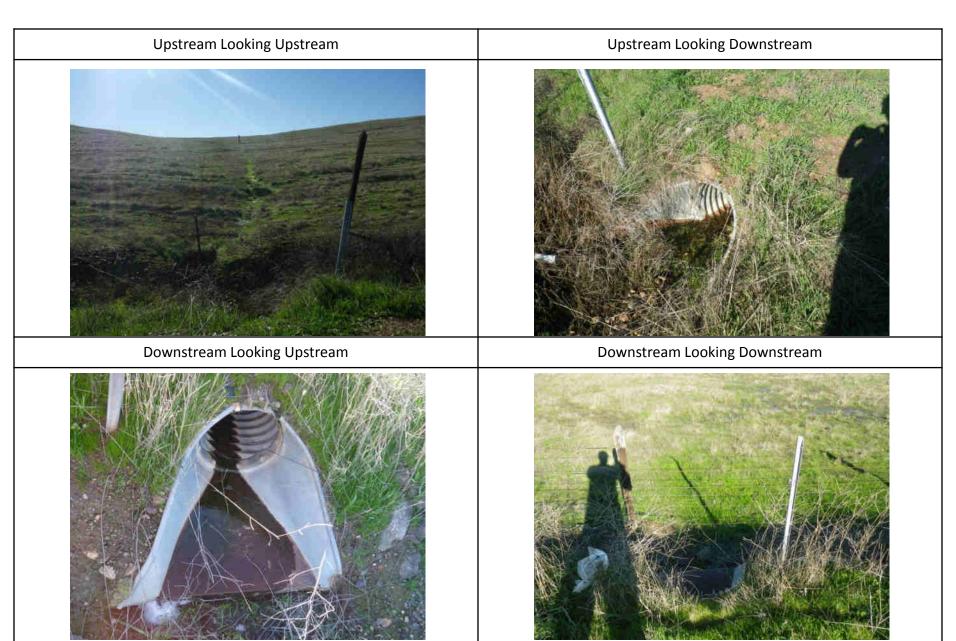
County: Sacramento Route: 104 Postmile: 13.15 Survey Date: 02/01/2016

ESU (Chinook and Coho Salmon) or DPS (Steelho	ead)	
Central Valley Spring-Run Chinook		
Central Valley Fall_Late Fall-Run Chinook		
Central Valley Steelhead		
	Historic Anadromous Reach?	
Has the stream reach upstream of the crossing sup	ported an anadromous fish population?	
Source		
	Crossing Type	
Crossing Type Culvert	ID	
General Description: CSP culvert		
	Photos

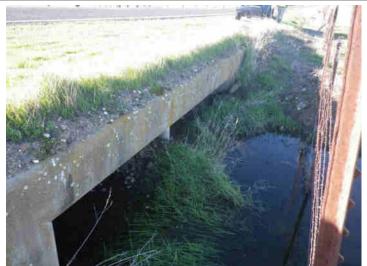
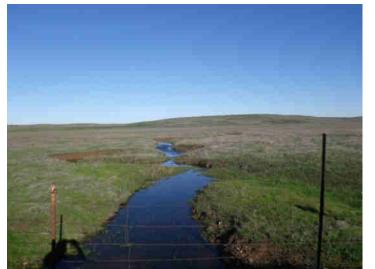
Upstream Looking Upstream Upstream Looking Downstream **Downstream Looking Upstream Downstream Looking Downstream**

County: Sacramento Route: 104 Postmile: 13.38 Survey Date: 02/01/2016
