Case Studies in Pipeline Spill Elimination

David McMasters

DOT/PIM Manager Chevron Pipe Line Company

February 27, 2019

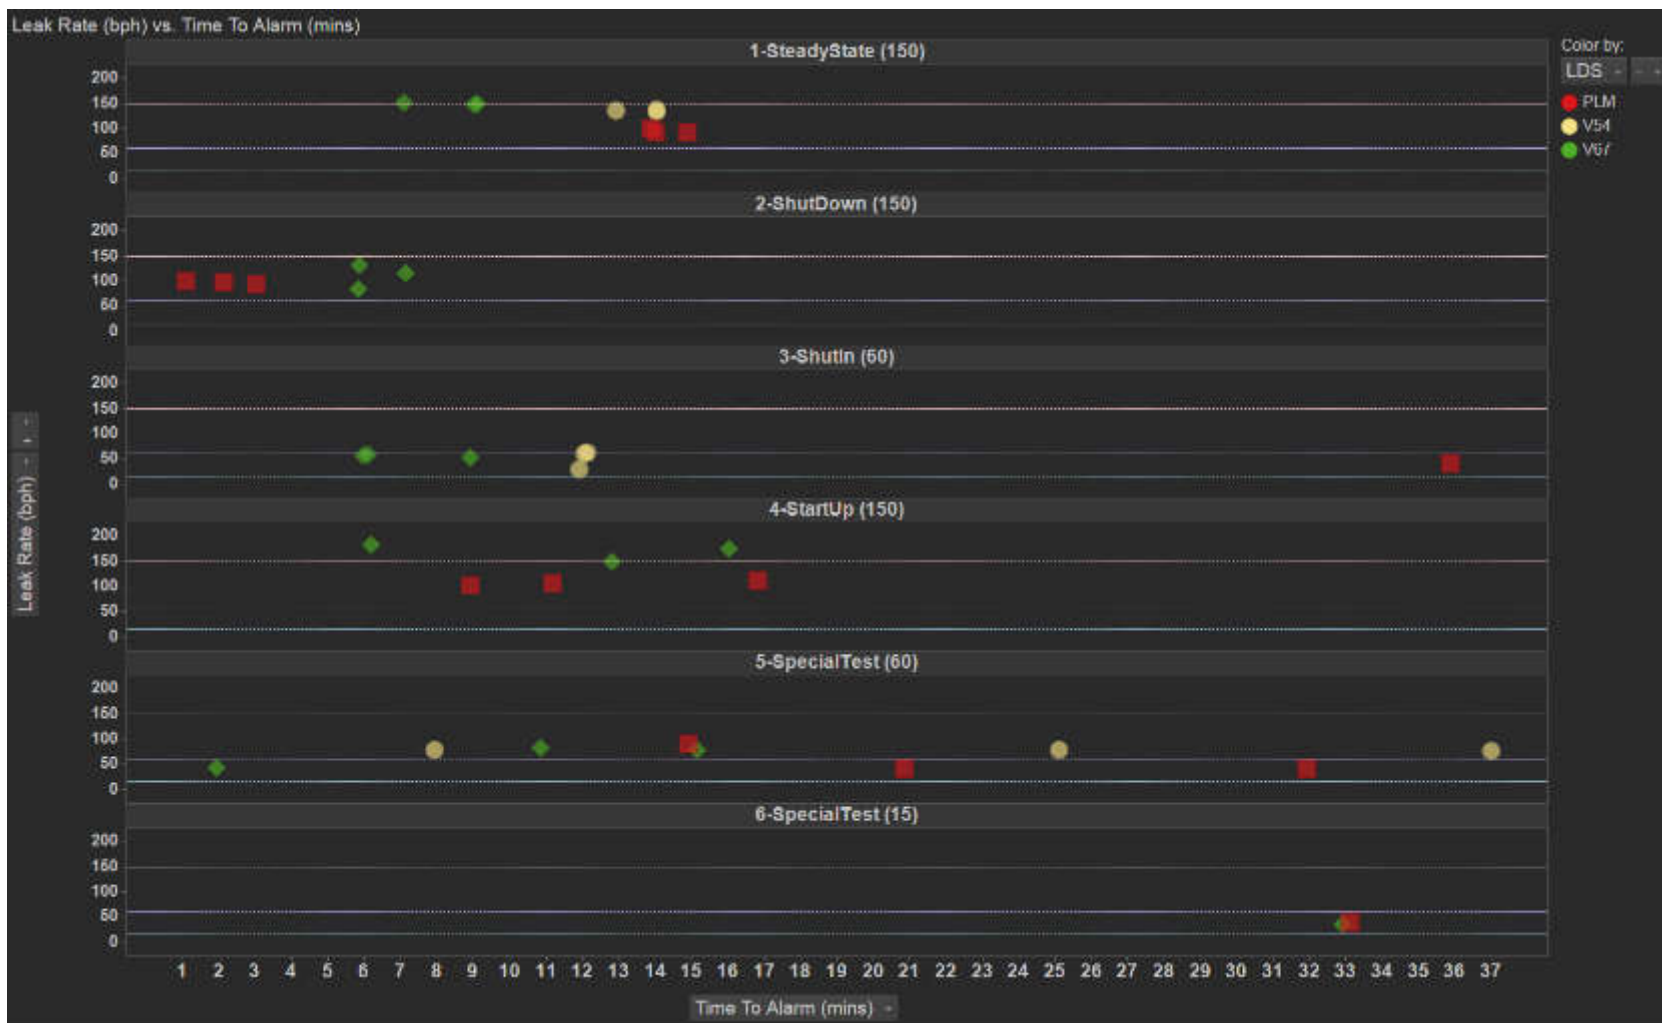
Results of the Test

Time to Detect Leak

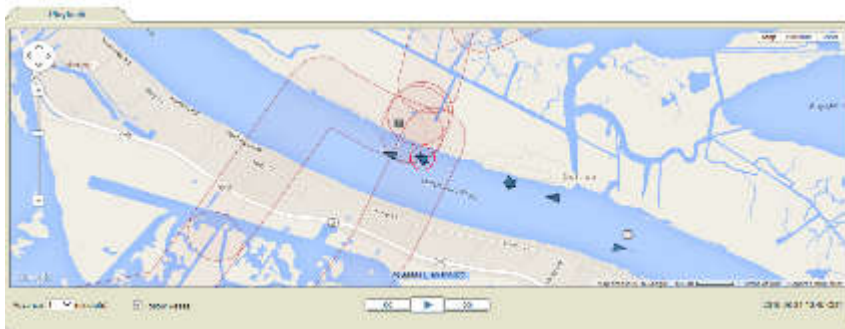
Maritime ROW protection

Marine Encroachment Monitoring

- Oceaneering's PortVision® AIS-based vessel-tracking service is being used to monitor vessel activities
- Overlay of vessel positions on maps with pipeline ROW
- Triggers to speed and position parameters alert console
- Contact ship, ship owner and other authorities
- Monitored 24/7 from the Chevron Pipeline Control Center-Leak and Intrusion Detection Support Center (LIDSC) console.

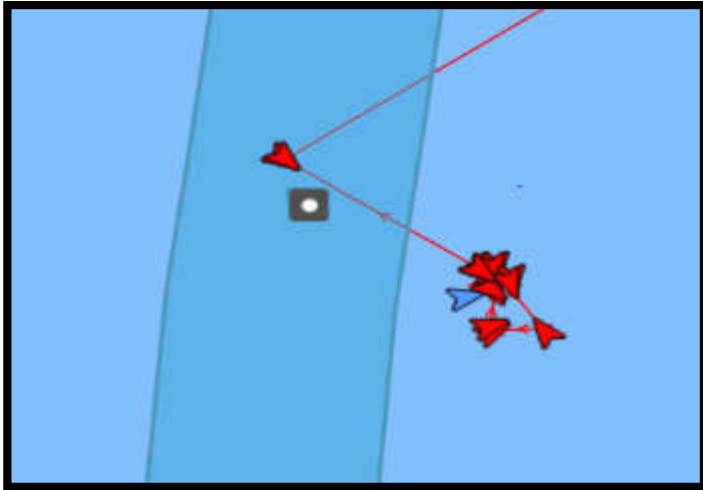
Maersk Viking – Encroachment (PortVision)

- Maersk Viking drifted into geo-fenced pipeline zone (PortVision®) triggering an alert at the LIDSC console
- At the time, winds measured 19.4 miles per hour (gusts up to 33.3 mph) resulting in the vessel to drift ~½ mile from its original anchored position

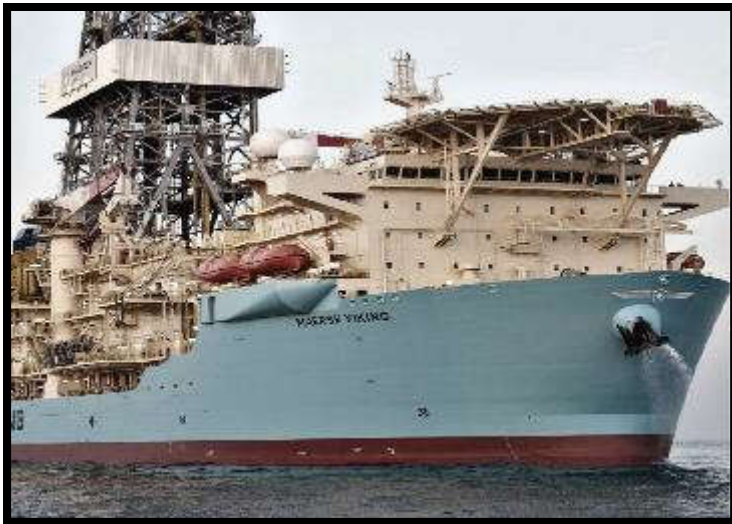
Maersk Viking – 748'L x 138'W x 62' Hull Depth

Encroachment Event – PortVision

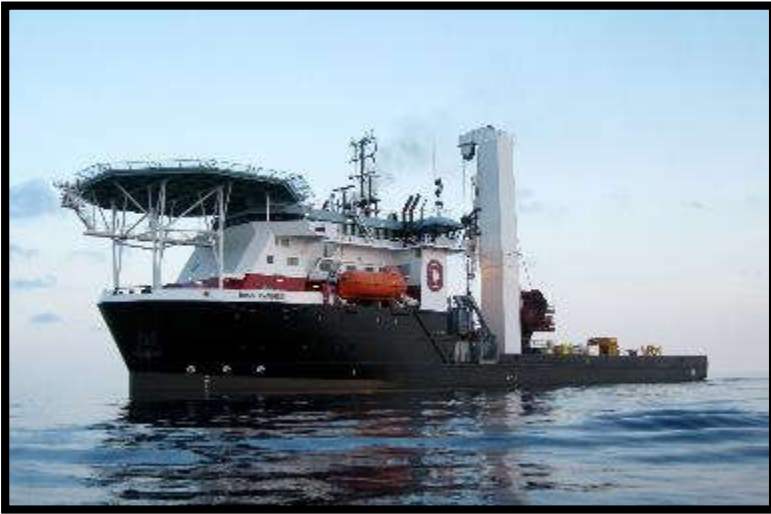
Maersk Viking & Oceaneering – Survey

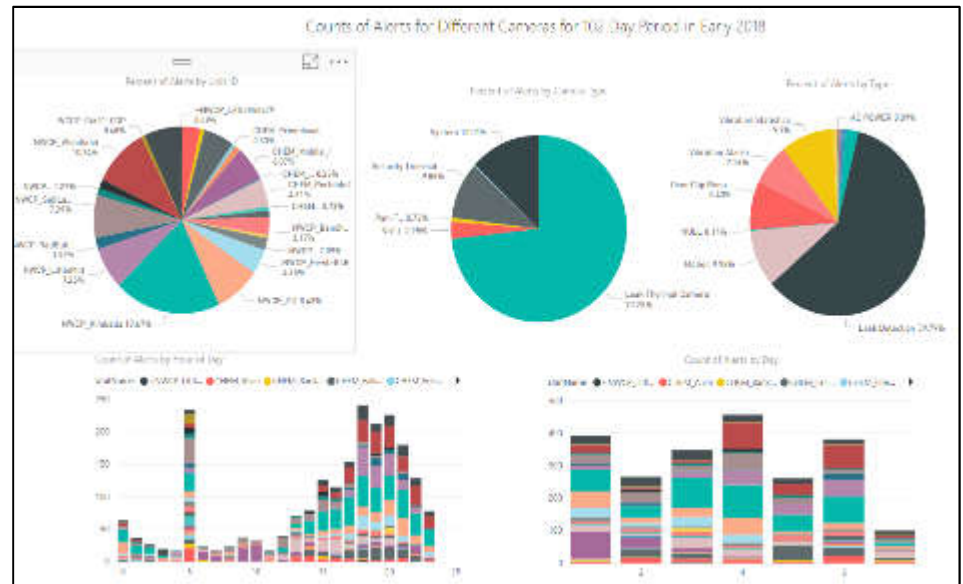
Data illustrates the value of incorporating machine learning to process data and imagery

A expanded data review was conducted in May 2018 incorporating all [31 active & pre-commissioned sites]

- 660 alerts produced each day
- 55 mins of each hour consumed by video clip review

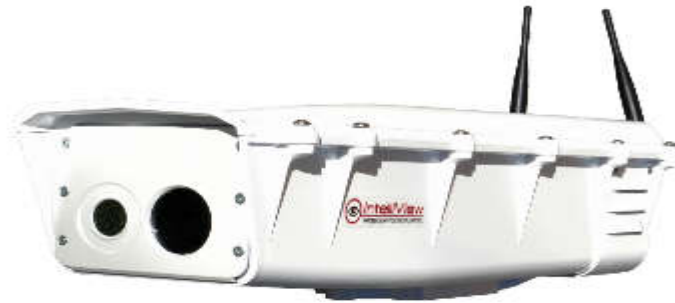
DCAM Artificial Intelligence Features

20 Dual Camera Analytic Module's [DCAM]
were installed in July 2018 providing

- Dual sensor [thermal & color] video feed
- Automated event detection and quantification
- Real-time leak visualization, analysis and qualification
- Low false alert rate and a variety of filters to address environmental factors (glare, shadow, rain, fog & snow) and camera movement
- Object Scene Counting [number of objects in the scene]
- Object Time in zone [time based alert trigger]
- Object Size Setting [triggers alert on basis of minimum object size]
- Object Speed Setting
- Object Temperature Setting
- Automatic Enabling/Disabling of Alarm Rules

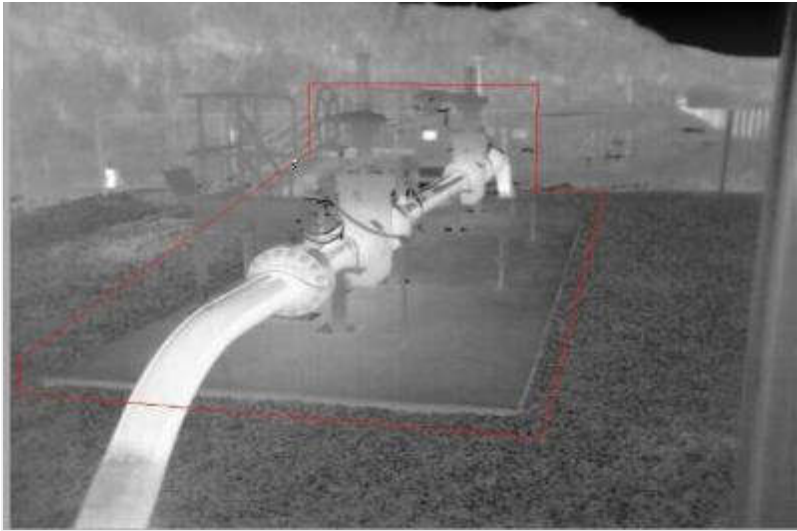
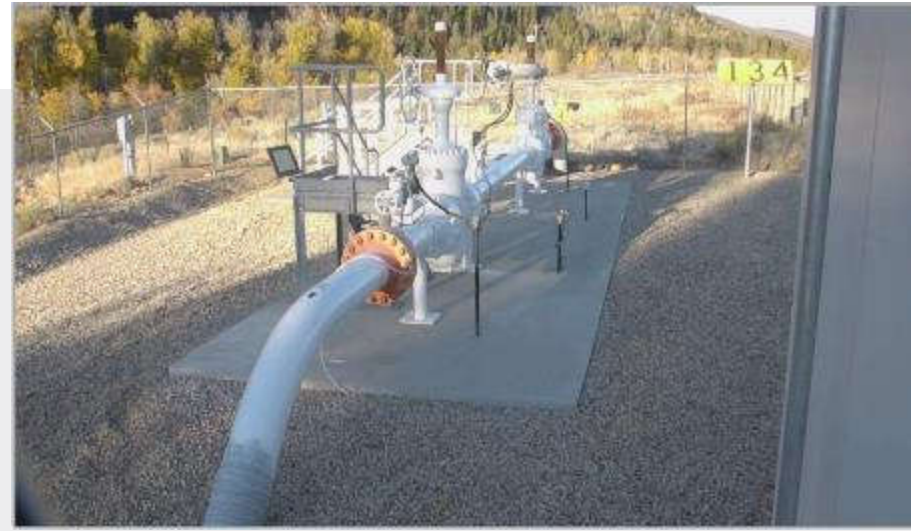
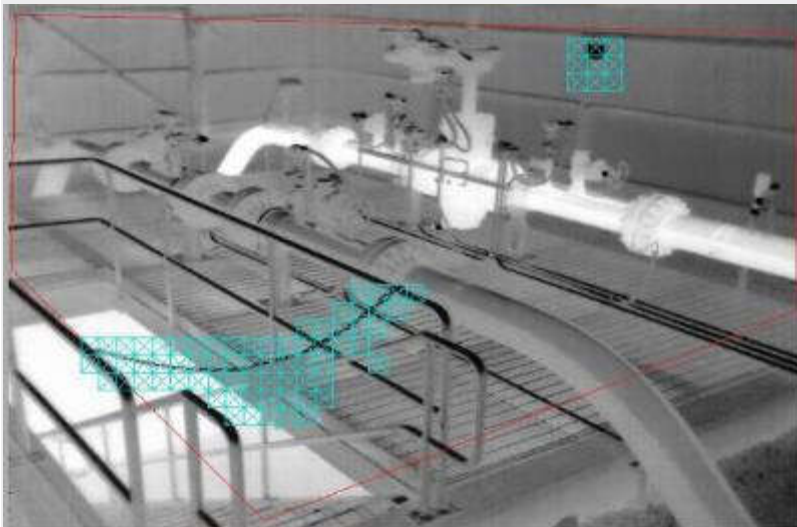
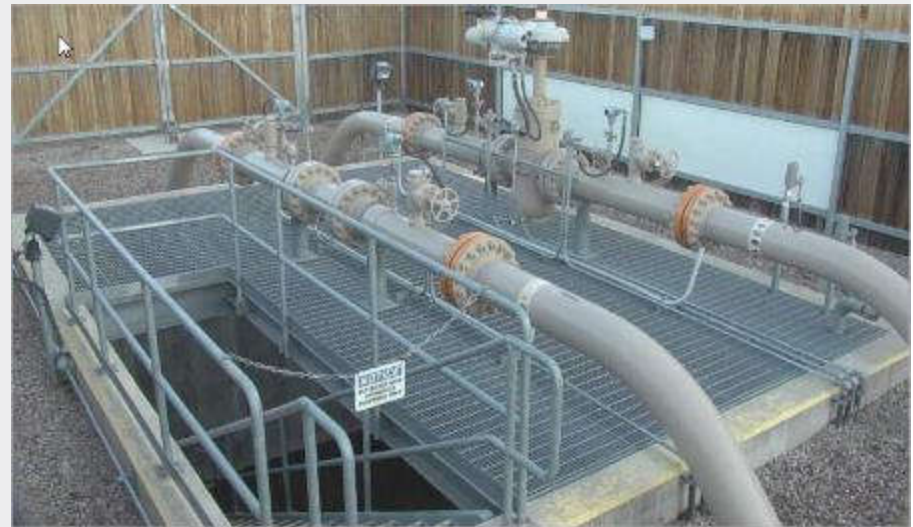
Customized Alert & Masking

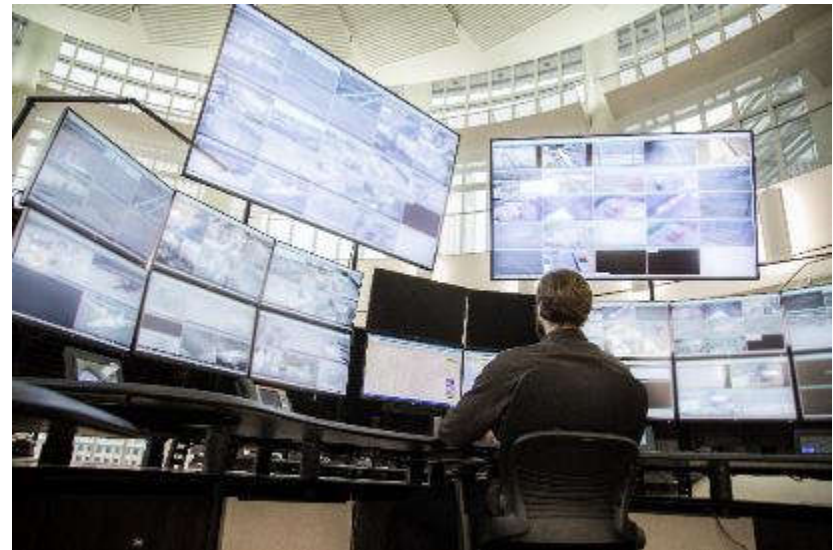
Results

July – September 2017 (37,626)

July – September 2018 (4,240)

89% reduction in alerts
