**RUSSIAN RIVER STREAM CROSSING INVENTORY AND FISH PASSAGE  
EVALUATION**

**FINAL REPORT**

**Ross N. Taylor, Thomas D. Grey, Anabel L. Knoche, and Michael Love**

**March 31, 2003**

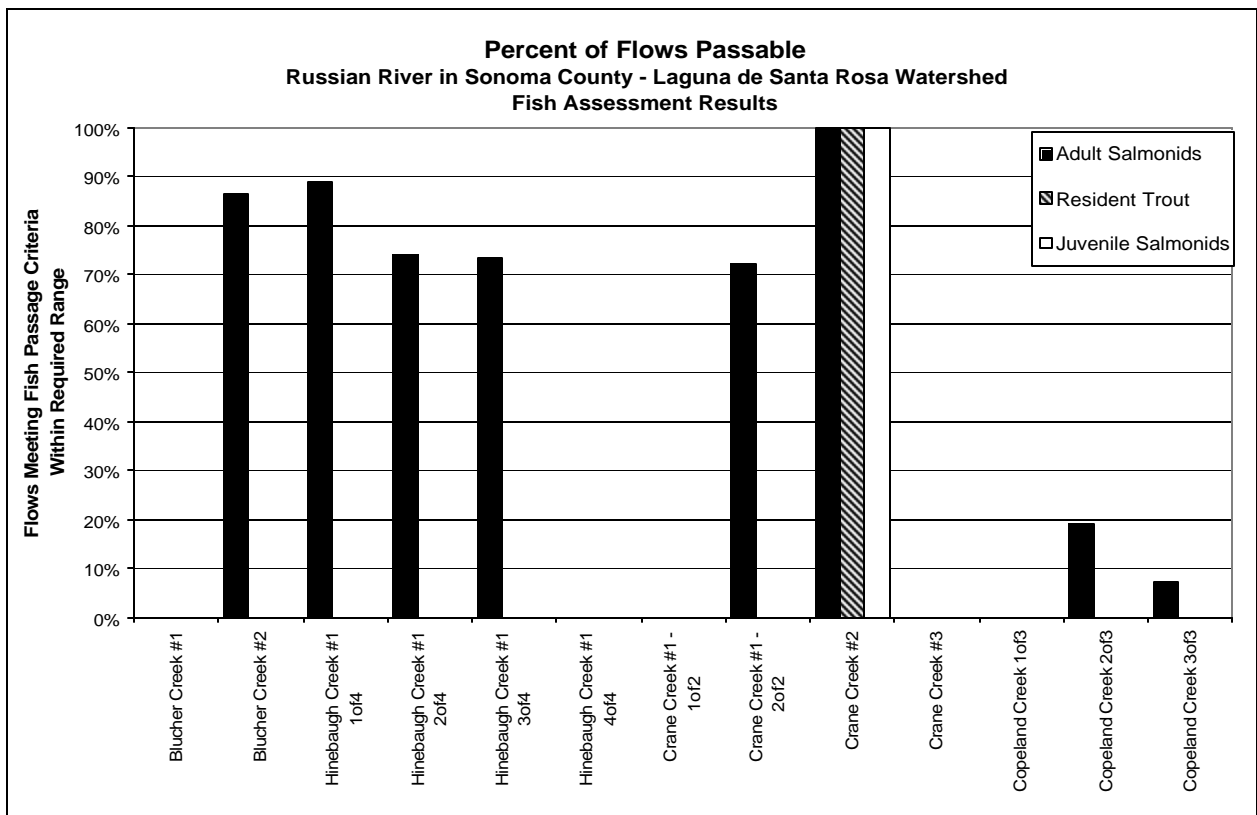
Figure 12. Percent passable as estimated by the Green-Gray-Red evaluation filter and FishXing for seven Sonoma County stream crossings within the Laguna de Santa Rosa sub-basin, by three groups of life-stages.

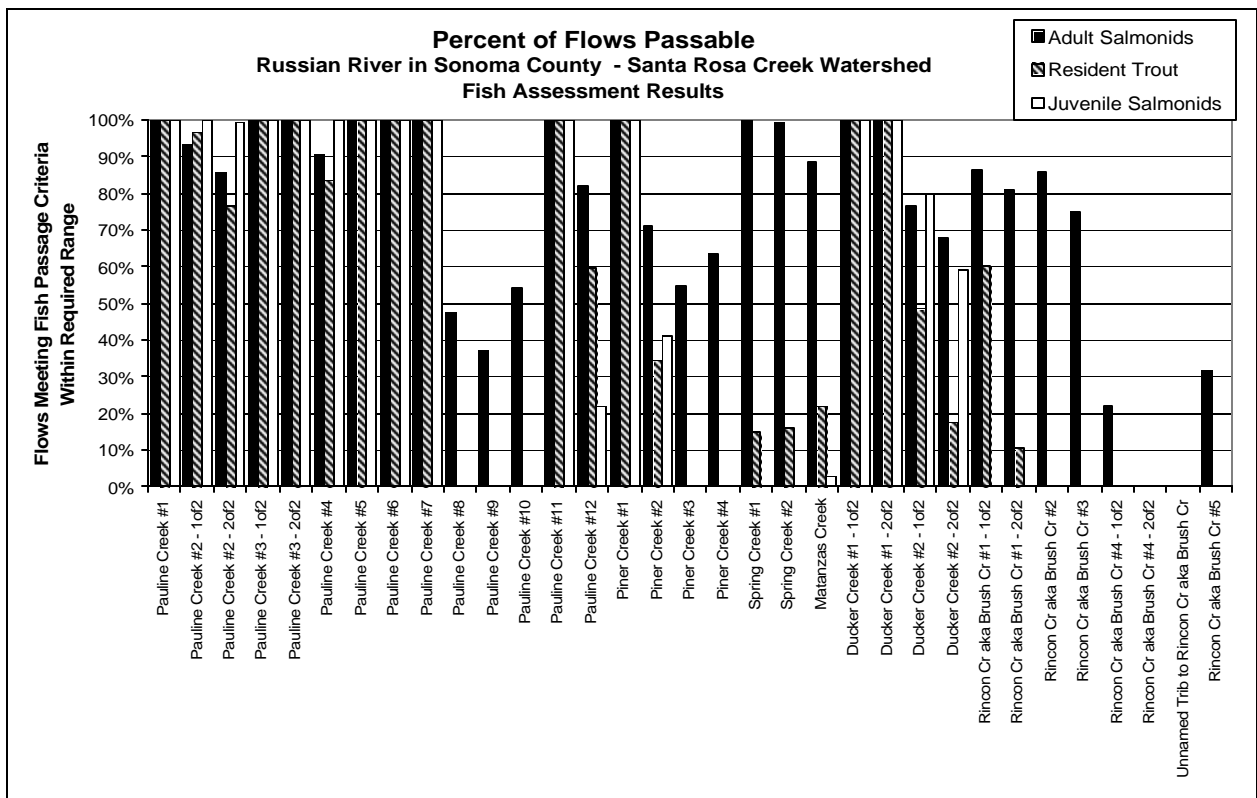
Figure 13. Percent passable as estimated by the Green-Gray-Red evaluation filter and FishXing for 27 Sonoma County stream crossings within the Santa Rosa Creek sub-basin, by three groups of life-stages.

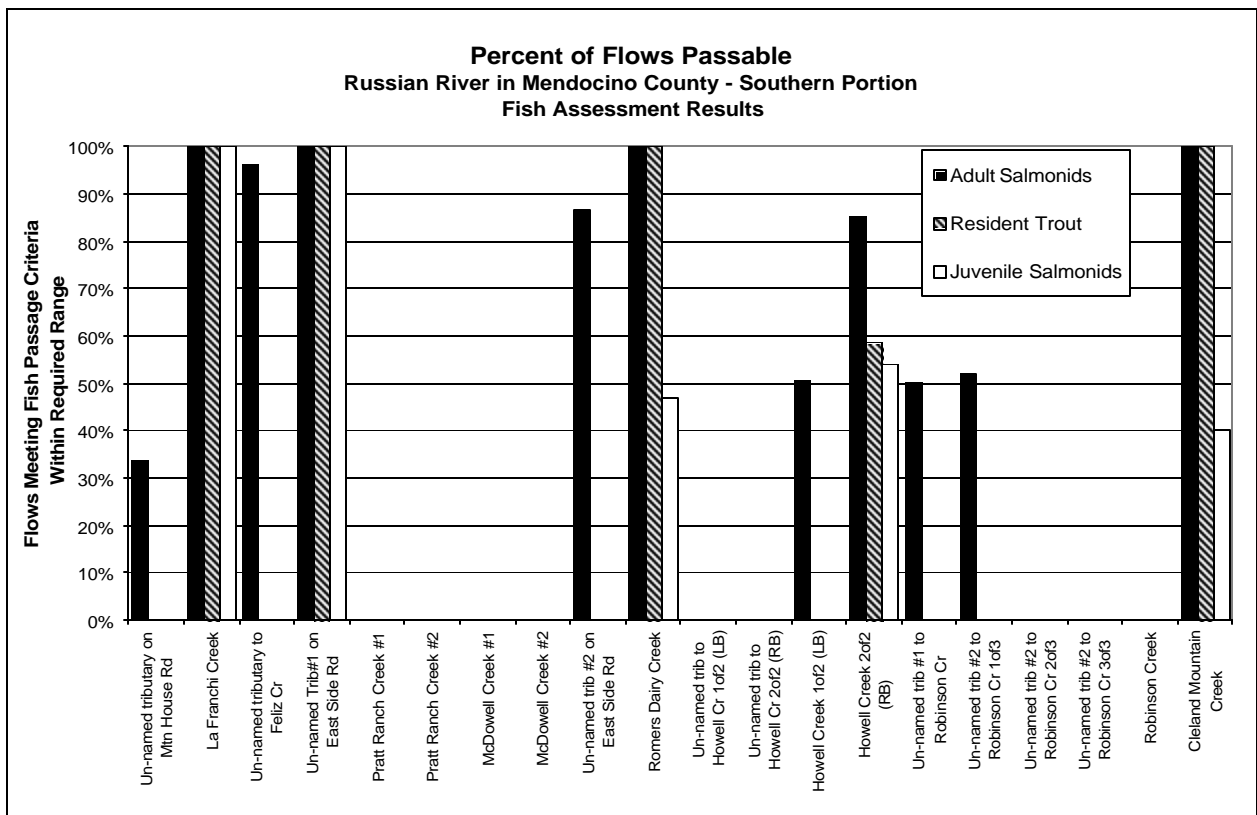
Figure 15. Percent passable as estimated by the Green-Gray-Red evaluation filter and FishXing for 16 Mendocino Co. stream crossings within the southern portion of Russian basin, by three groups of life-stages.
