# **STREAM INVENTORY REPORT**

## **Right Bank Tributary Two to Alder Creek**

A stream inventory was conducted beginning August 12 and ending August 20, 2003 on Right Bank Tributary Two to Alder Creek. The survey began at the confluence with Alder Creek and extended upstream 7,643 feet.

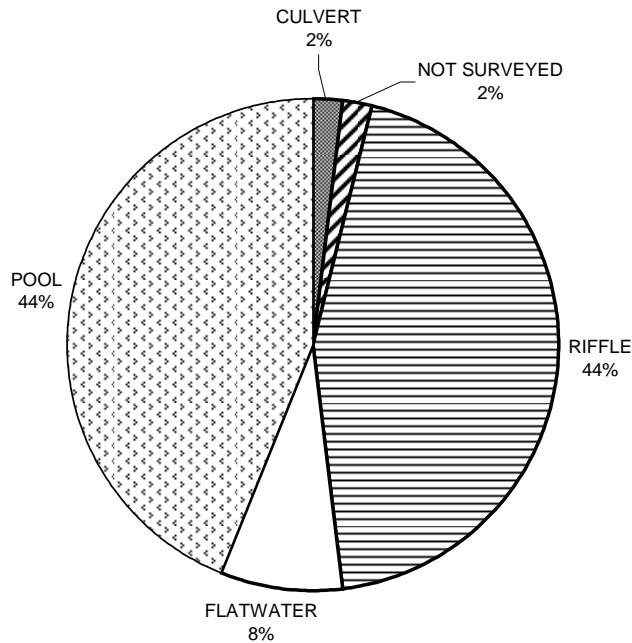
GRAPH 1

## ALDER CREEK, RIGHT BANK TRIBUTARY TWO HABITAT TYPES BY PERCENT OCCURRENCE

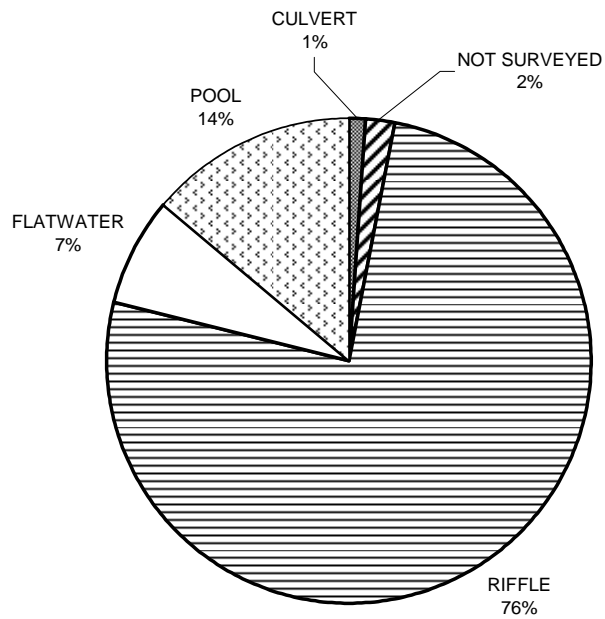
GRAPH 2

**ALDER CREEK, RIGHT BANK TRIBUTARY TWO  
HABITAT TYPES BY PERCENT TOTAL LENGTH**

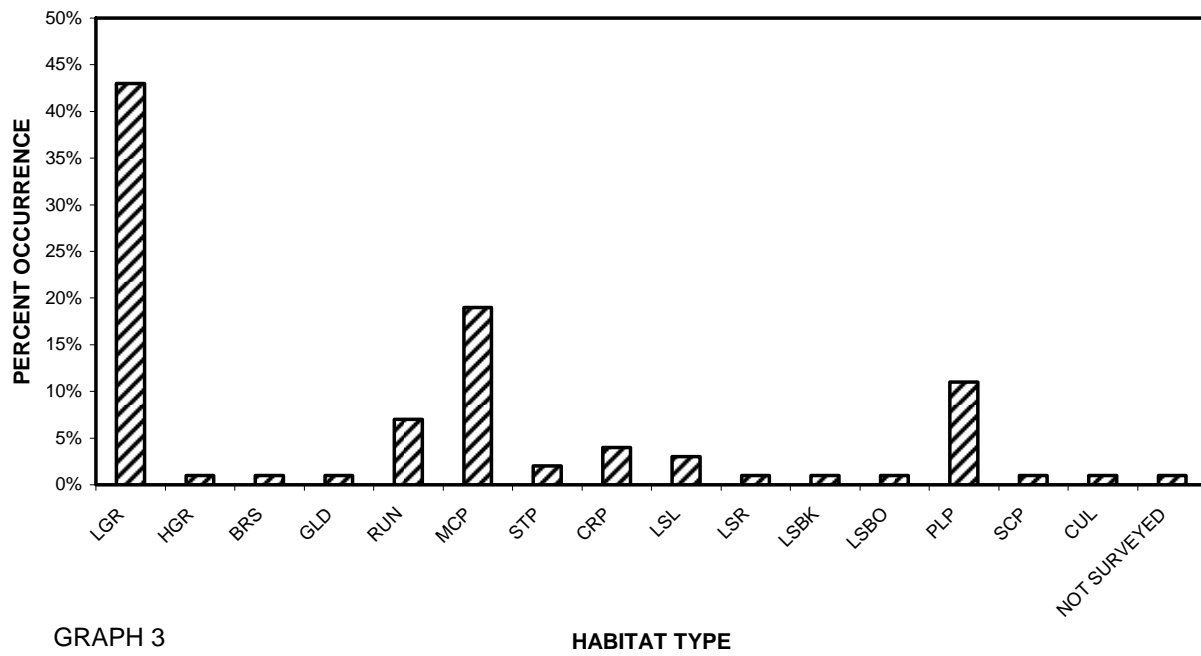
GRAPH 3

**ALDER CREEK, RIGHT BANK TRIBUTARY TWO  
HABITAT UNIT TYPES BY PERCENT OCCURRENCE**

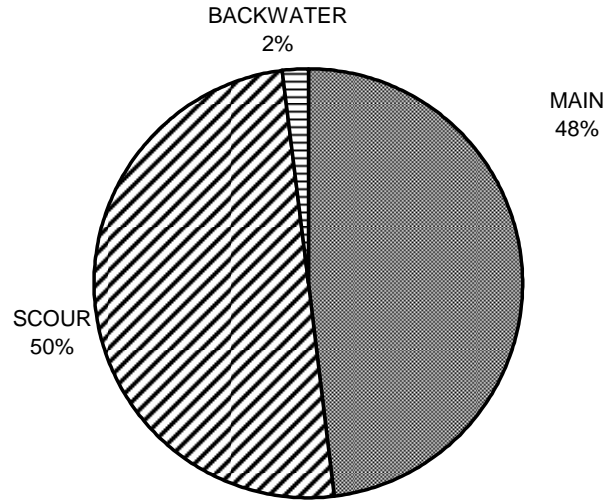
GRAPH 4

**ALDER CREEK, RIGHT BANK TRIBUTARY TWO  
POOL HABITAT TYPES BY PERCENT OCCURRENCE**

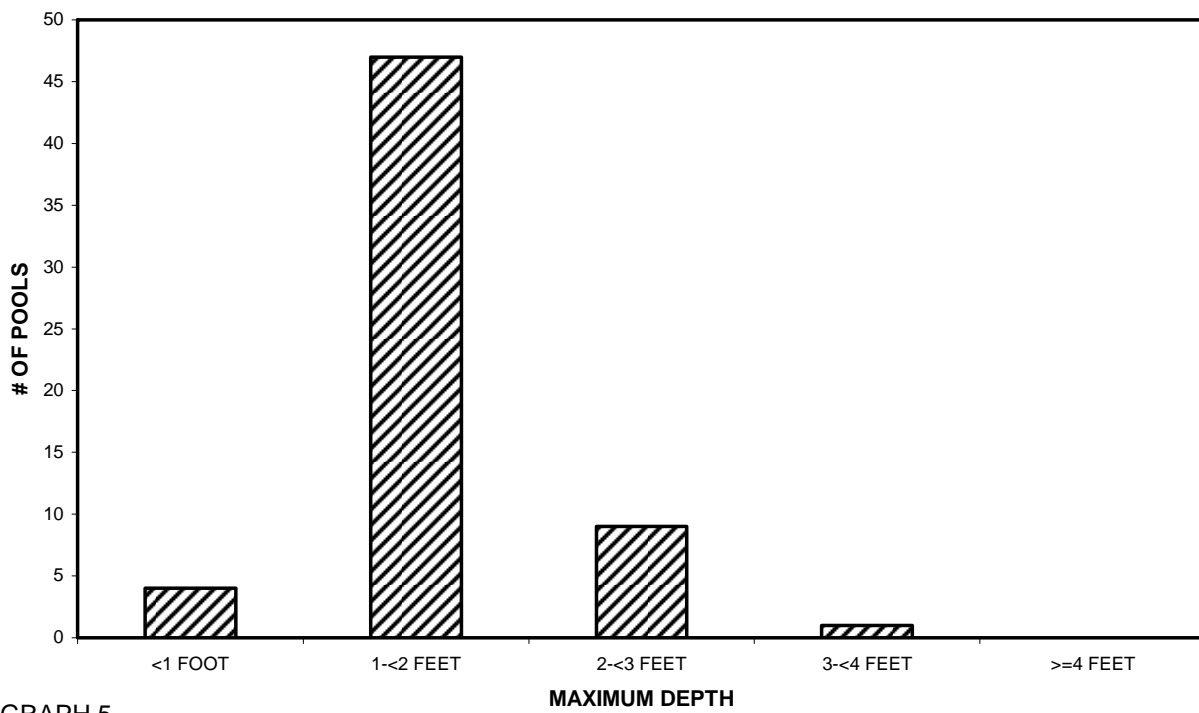
GRAPH 5

**ALDER CREEK, RIGHT BANK TRIBUTARY TWO  
MAXIMUM DEPTH IN POOLS**

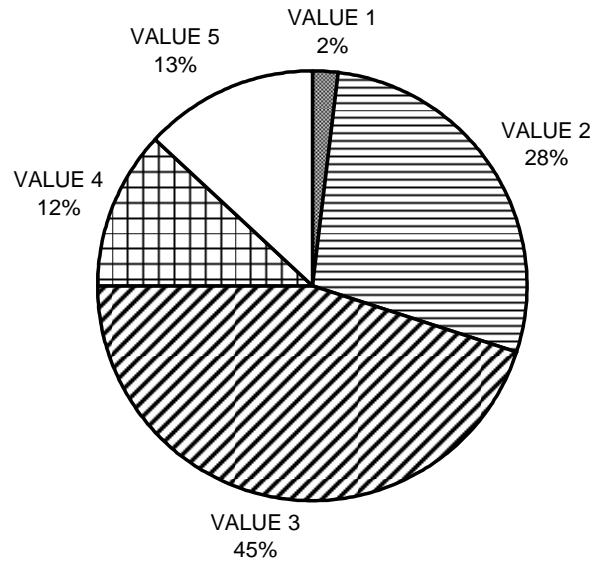
GRAPH 6

## ALDER CREEK, RIGHT BANK TRIBUTARY TWO PERCENT EMBEDDEDNESS

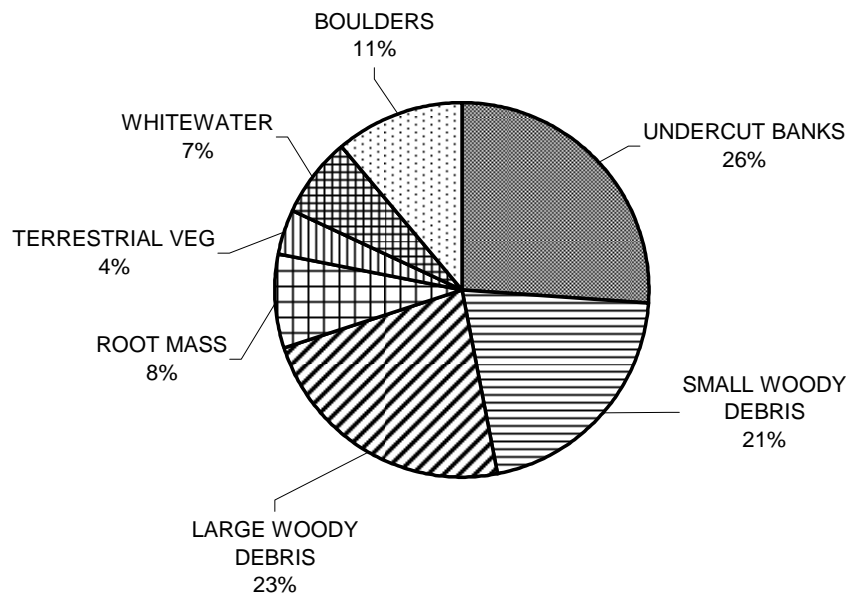
GRAPH 7

## ALDER CREEK, RIGHT BANK TRIBUTARY TWO MEAN PERCENT COVER TYPES IN POOLS

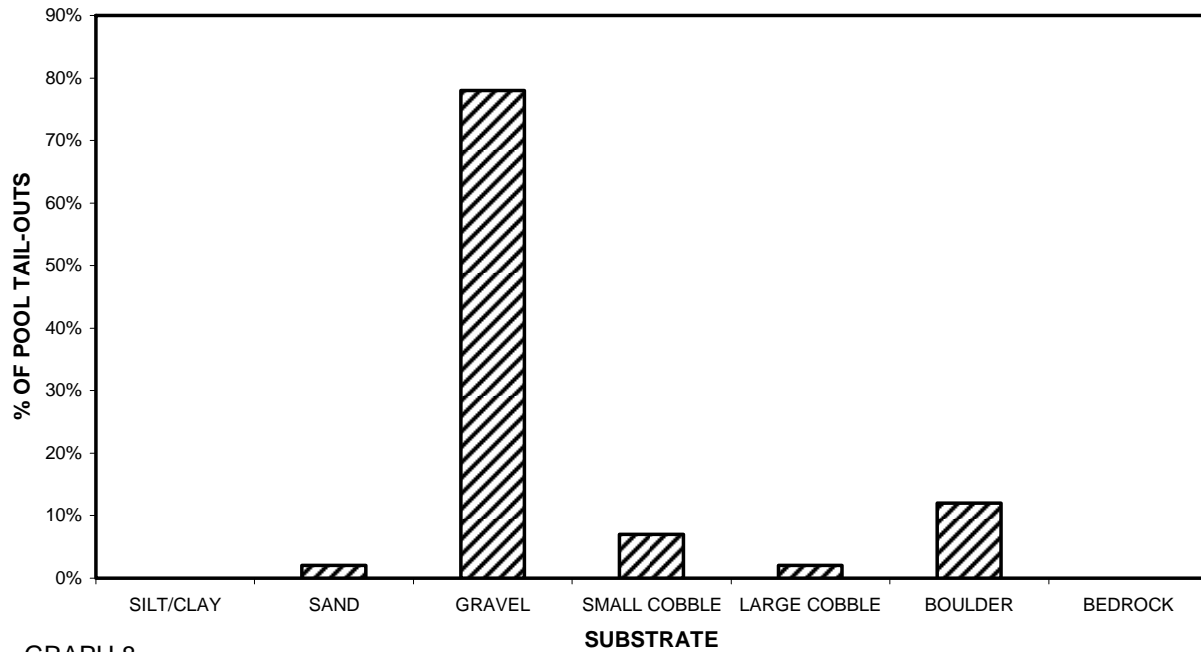
**ALDER CREEK, RIGHT BANK TRIBUTARY TWO  
SUBSTRATE COMPOSITION IN POOL TAIL-OUTS**

Table 6 summarizes the dominant substrate by habitat type. Graph 8 depicts the dominant substrate observed in pool tail-outs. Gravel was the dominant substrate observed in 78% of pool tail-outs while boulders were the next most frequently observed substrate type, at 12%.

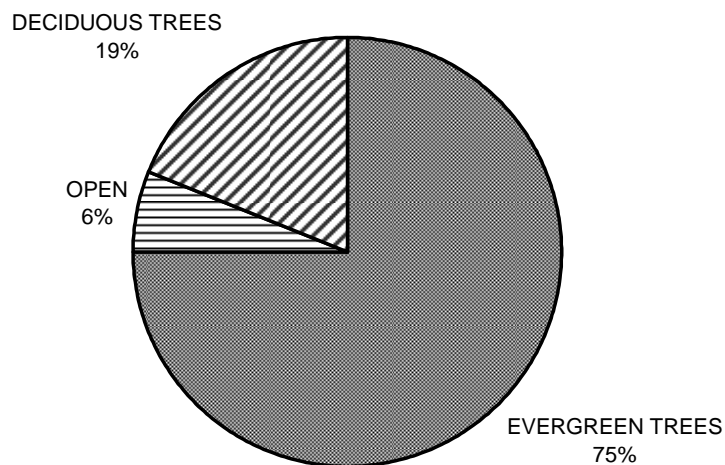
**ALDER CREEK, RIGHT BANK TRIBUTARY TWO  
MEAN PERCENT CANOPY**

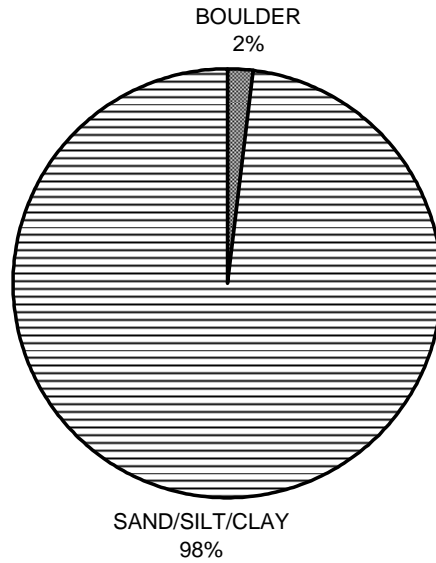
GRAPH 10

**ALDER CREEK, RIGHT BANK TRIBUTARY TWO  
DOMINANT BANK COMPOSITION IN SURVEY REACH**

For the stream reach surveyed, the mean percent right bank vegetated was 53%. The mean percent left bank vegetated was 53%. The dominant elements composing the structure of the stream banks consisted of 2% boulder and 98% sand/silt/clay (Graph 10). Coniferous trees were the dominant vegetation type observed in 79% of the units surveyed. Additionally, 12% of the units surveyed had deciduous trees as the dominant vegetation type, 8% had brush, and 1% had grass as the dominant vegetation (Graph 11).

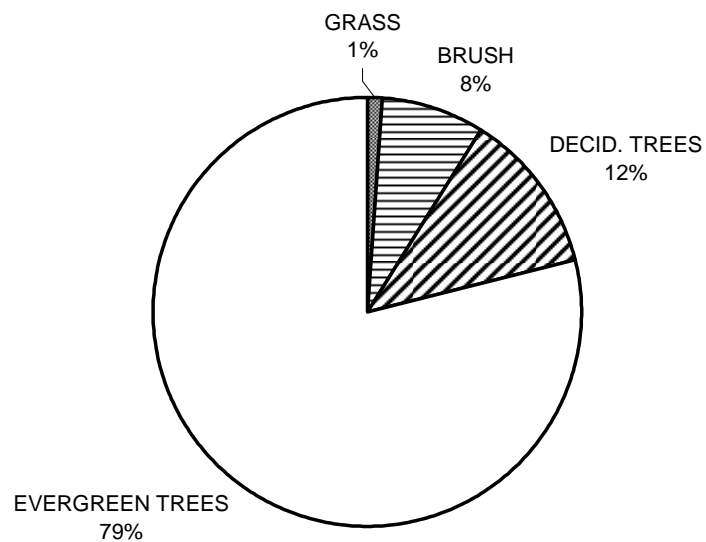
GRAPH 11

**ALDER CREEK, RIGHT BANK TRIBUTARY TWO  
DOMINANT BANK VEGETATION IN SURVEY REACH**
