# STREAM INVENTORY REPORT

## Arvola Gulch

A stream inventory was conducted during the summer of 1997 on Arvola Gulch beginning at the confluence of Chamberlain Creek. The inventory was conducted in two parts: habitat inventory and biological inventory. The objective of the habitat inventory was to document the habitat available to anadromous salmonids in Arvola Gulch. The objective of the biological inventory was to document the presence and distribution of juvenile salmonid species.

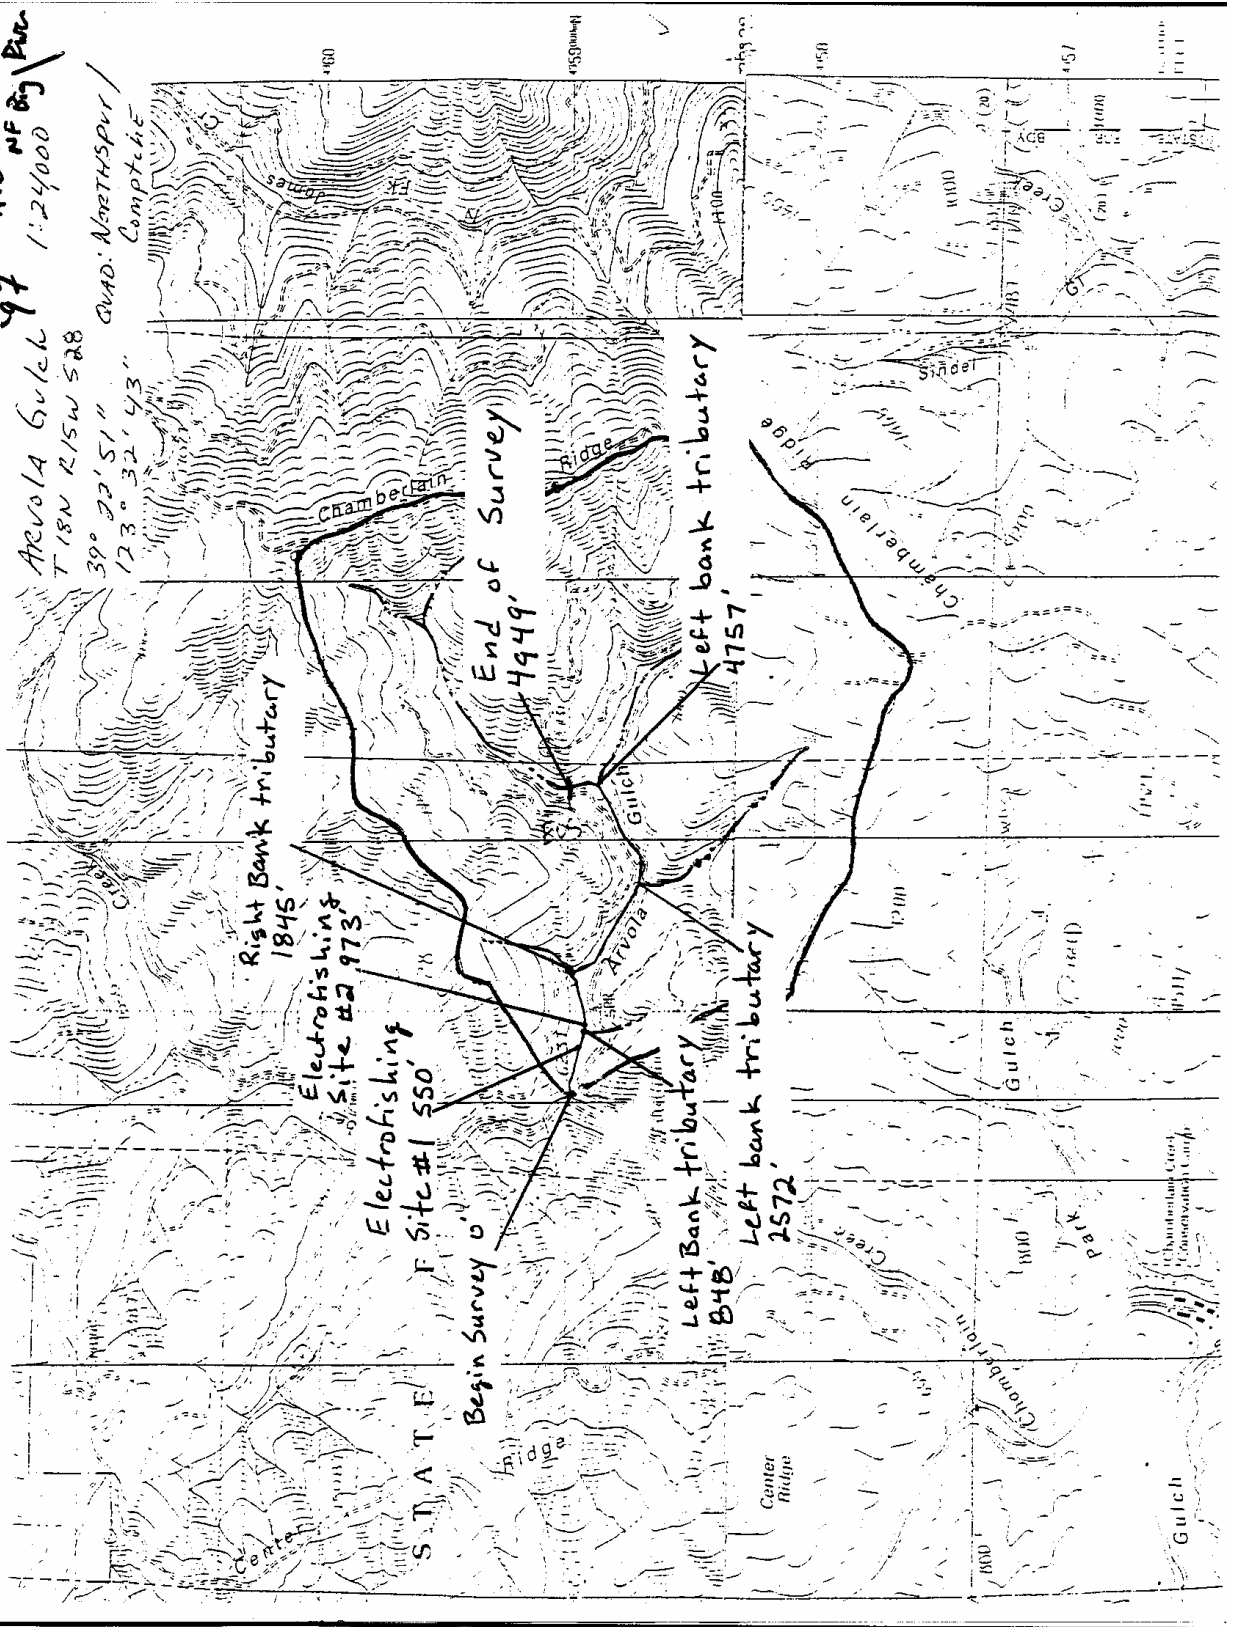
97  
ARVOLA GULCH  
T 18N R 15W S 28  
39° 22' 51" QUAD: NORTHERN  
123° 32' 43" COMPLETE

Trib to MF 87 / Pur  
1:24000

Arvola Gulch is tributary to the Chamberlain Creek, tributary to the North Fork Big River, tributary to Big River, tributary to the Pacific Ocean located in Mendocino County, California (Map 1). Arvola Gulch's legal description at the confluence with Chamberlain Creek is T18N R15W S28. Its location is 39°22'52" north latitude and 123°32'45" west longitude. Arvola Gulch is a second order stream and has approximately 0.75 miles of blue line stream according to the USGS Northspur 7.5 minute quadrangle. Arvola Gulch drains a watershed of approximately 1.5 square miles. Elevations range from about 580 feet at the mouth of the creek to 1900 feet in the headwater areas. Mixed conifer forest dominates the watershed. The watershed is entirely within Jackson Demonstration State Forest and is managed for timber production. Vehicle access exists via State Highway 20.
