Site Name: Circular culvert with gabion pool and ineffective fish ladder

Stream Name: Wilson Creek

PAD ID: [707822](#)

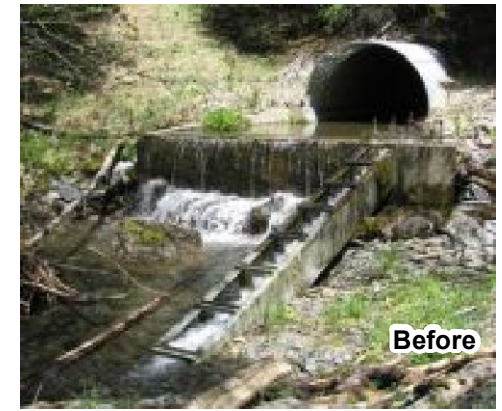
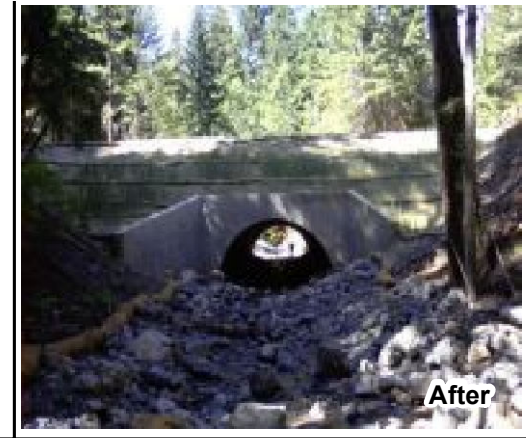
Notes: An open-bottom 19-foot by 8-foot, 3-inch x 96-foot, 6-inch open bottom multip-plate arch was built to replace the 7-foot diameter x 110' corrugated metal pipe culvert and fishway that were barriers to fish passage. Before: Total barrier per professional judgment by USFS. Fishway present but needs work. Site visited by CDFW and USFS staff on April 24, 2013 down to the anadromous limit area and upstream Wilson a ways. Site visit comments: Wilson Creek is a small creek in a beautiful, old growth Douglas Fir forest with many Yew trees. The fish ladder is definitely one of the old ramps. In higher flows, if a steelhead got up there, they wouldn't have much problem passing it. Small, resident trout were seen in pools above and below the culvert, but no areas which looked disturbed recently due to steelhead.
