**Site Name:** Masonite Road Culvert

**Stream Name:** Little Jack Creek

**Year Remediated:** 2012

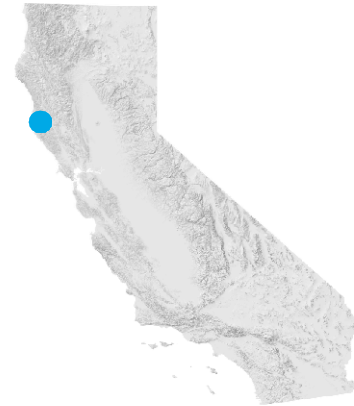
**Notes:** The undersized culvert which was a barrier to fish passage was replaced by a 89-foot railcar bridge. A snorkel survey was conducted prior to removal of the culvert and no fish (e.g., steelhead/trout, coho, chinook salmon) were observed above or below the barrier. After replacement with the bridge, electrofishing and spawner surveys were conducted from 2010-2014 and no steelhead/trout, coho or chinook salmon or redds were observed. Before: 722114, Little Jack Creek - Masonite Road crossing (fish passage improvement). This was a total barrier per professional judgment by the Mendocino Redwood Company. Species blocked by the culvert: Coho Salmon. Culvert was a total barrier to adults and juveniles (unspec).
