STREAM INVENTORY REPORT  
Unnamed Tributary #6 to Martin Slough

Unnamed Tributary #6 to Martin Slough

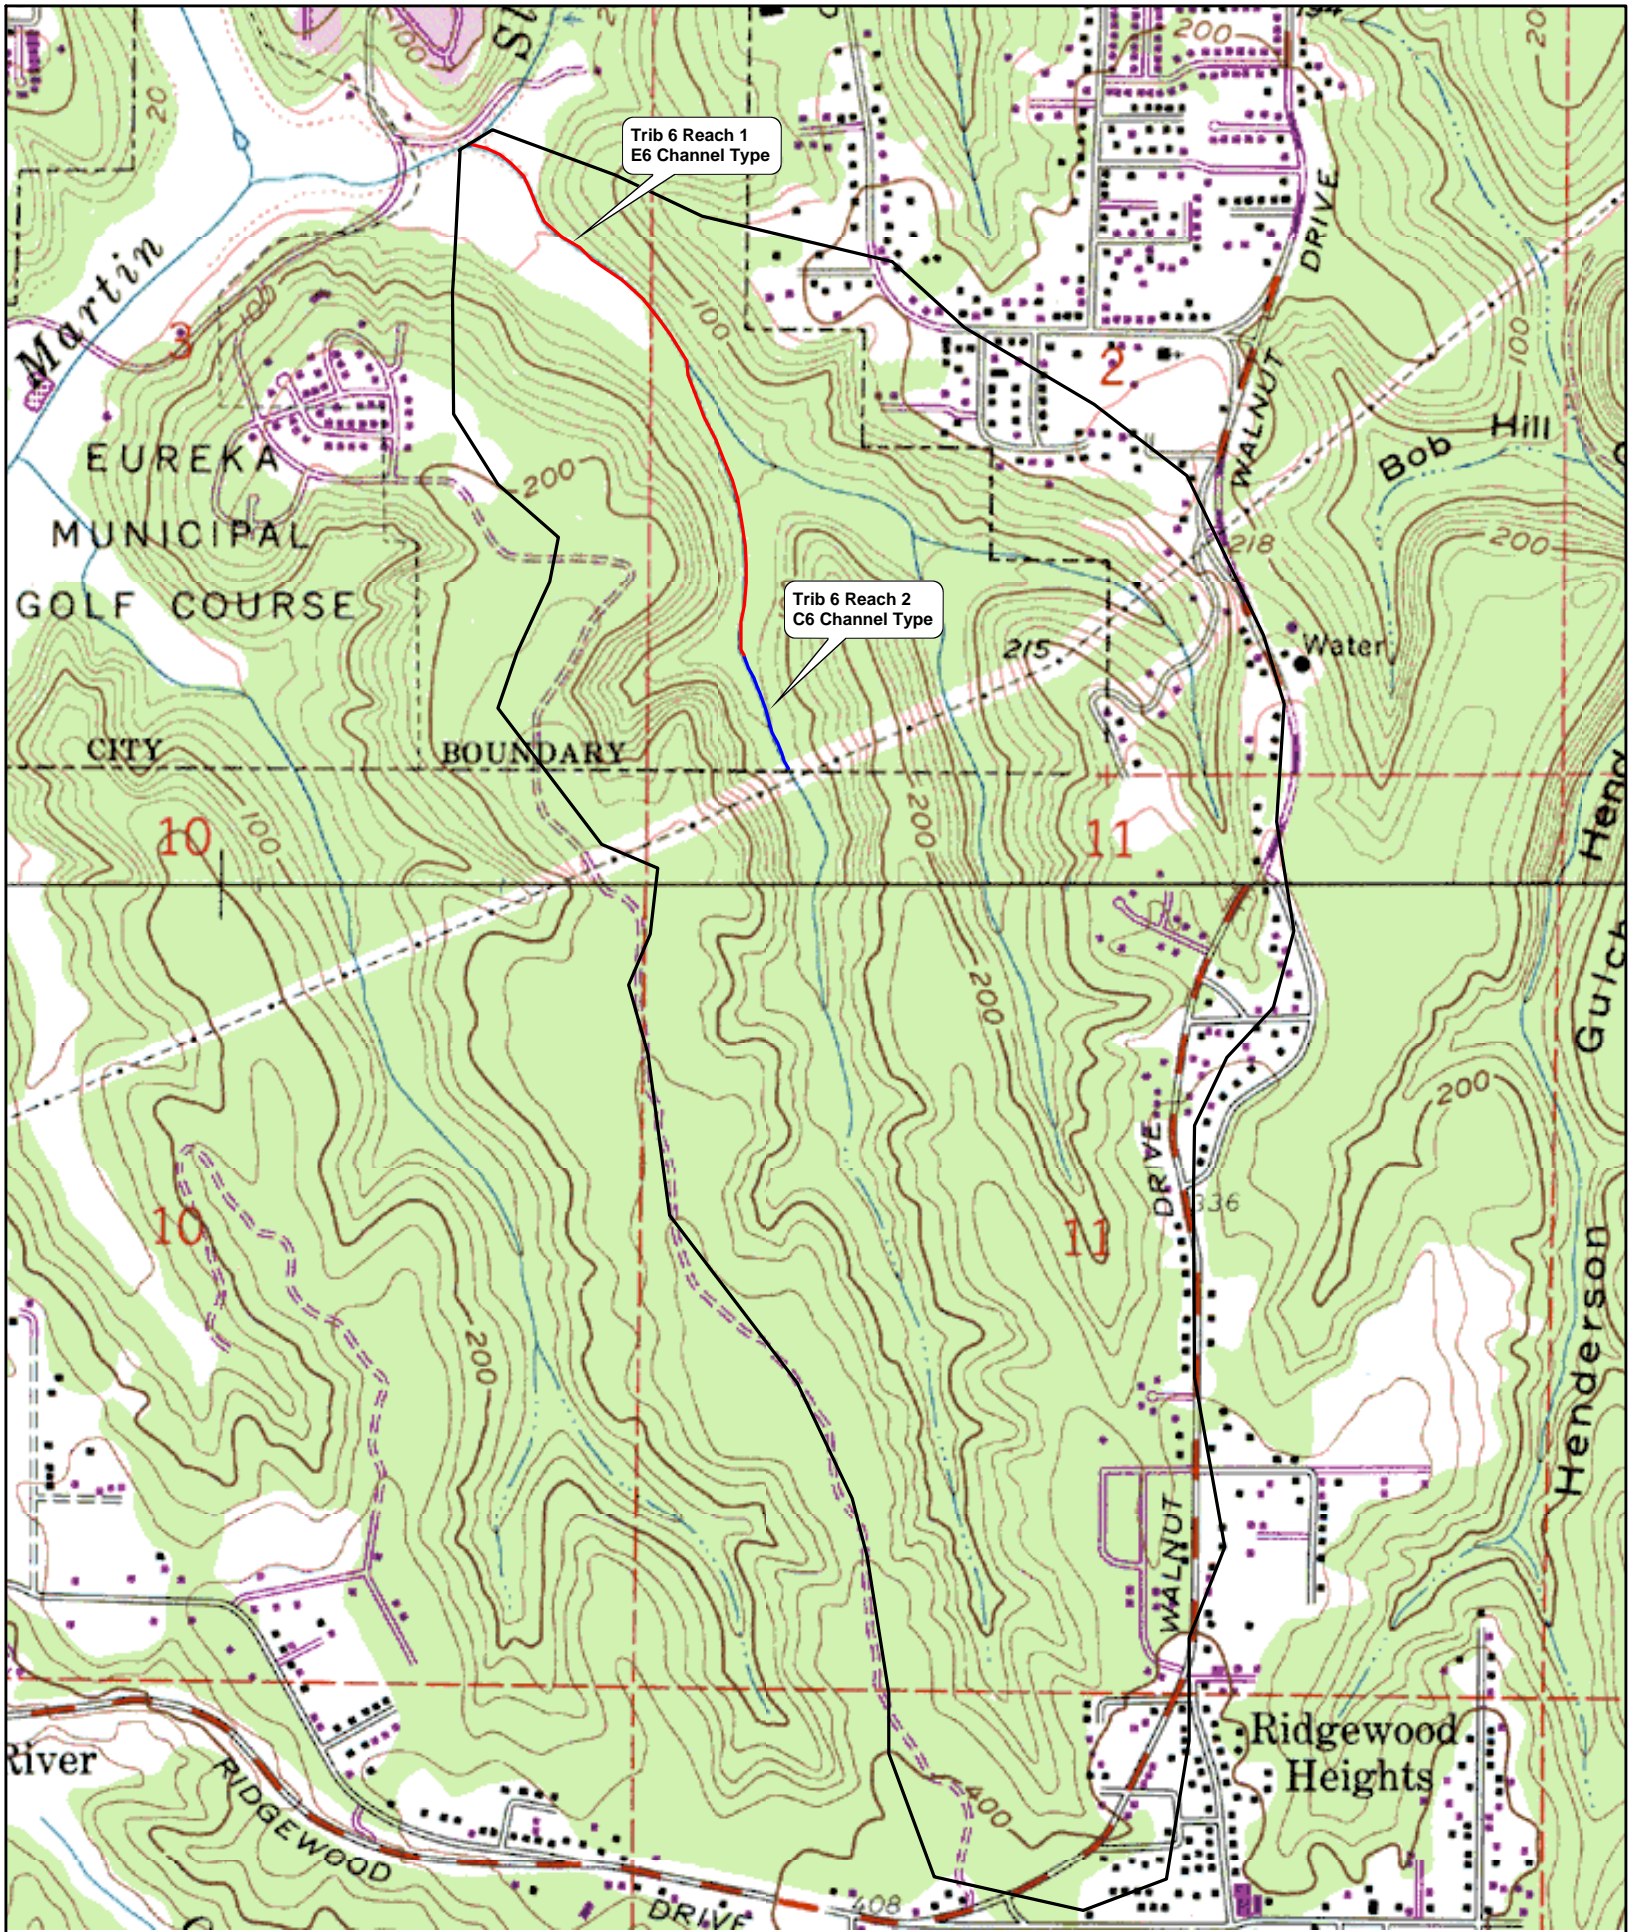
Trib 6 Reach 1  
E6 Channel Type

Trib 6 Reach 2  
C6 Channel Type

Location: 040.7485795° N 124.1542458° W  
Caption: Trib #6 of Martin Slough

Unnamed tributary is an E6 channel type for 3,715 feet of the stream surveyed (Reach 1), and a C6 channel type for 873 feet of the stream surveyed (Reach 2).

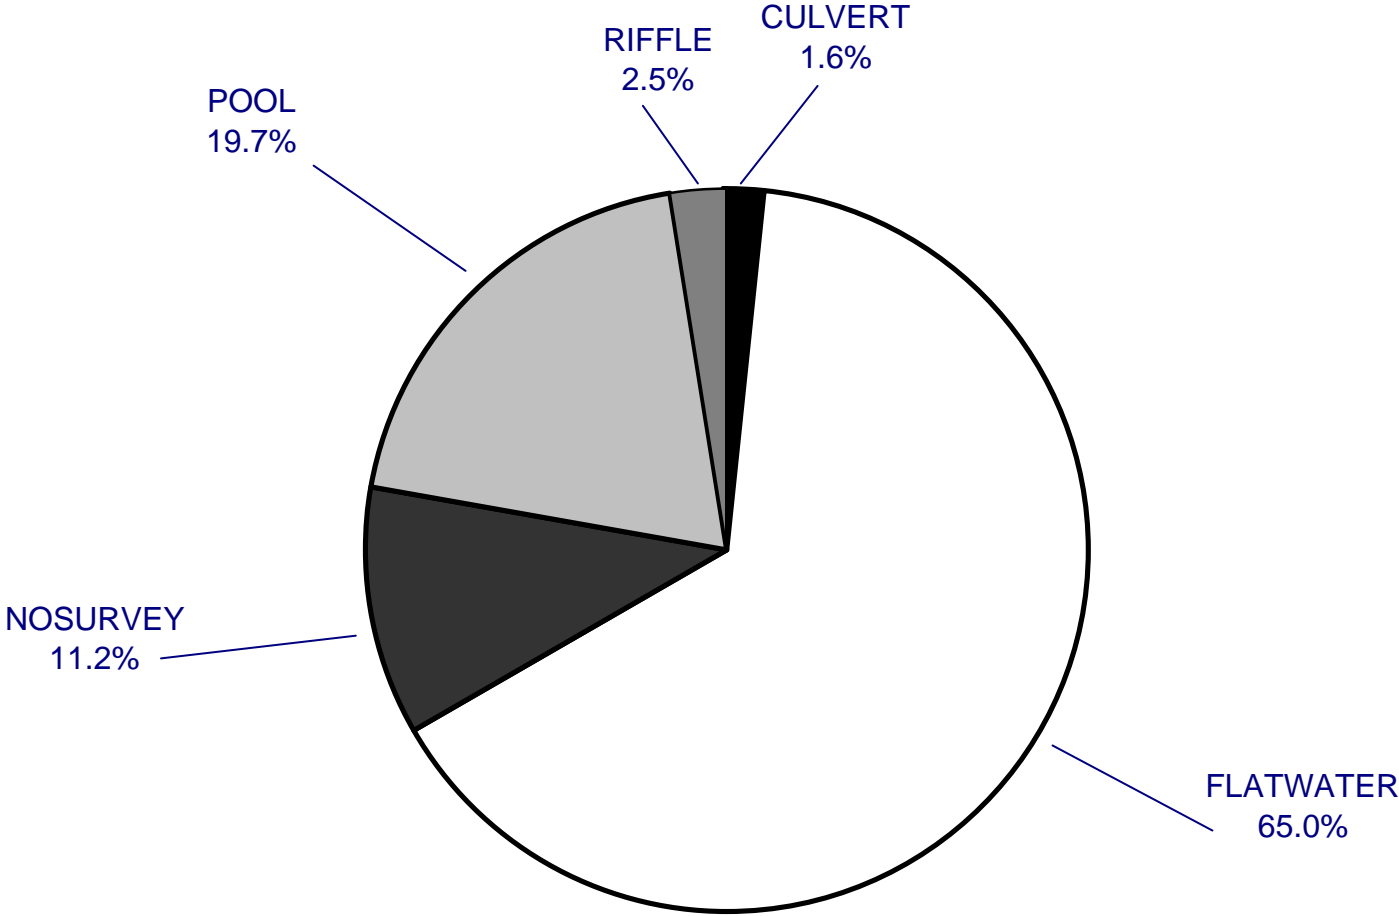
GRAPH 2

**1241616407617 2006**  
**HABITAT TYPES BY PERCENT TOTAL LENGTH**

Based on the total length of this survey, Level II habitat units consisted of 65% flatwater units, 20% pool units, 11% no-survey units, 2% culvert units and 2% riffle units. The pools are relatively shallow, with only 10 of the 34 pools having a maximum residual depth greater than 2 feet.

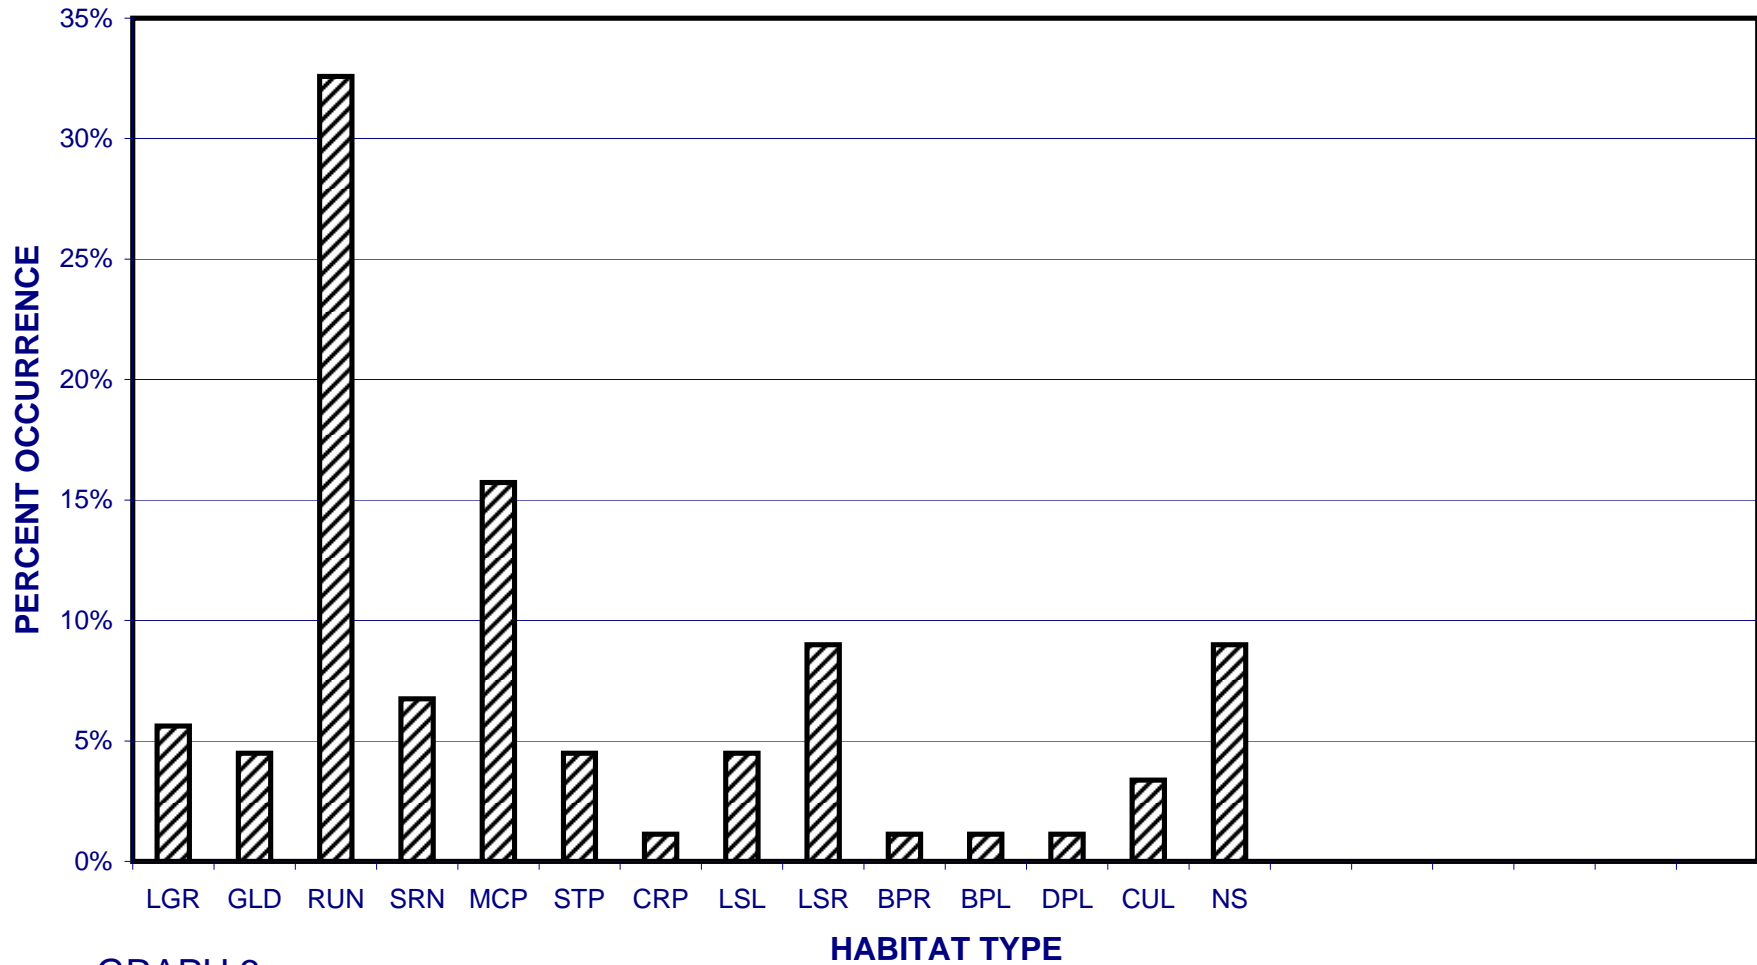
GRAPH 3

**1241616407617 2006**  
**HABITAT TYPES BY PERCENT OCCURRENCE**

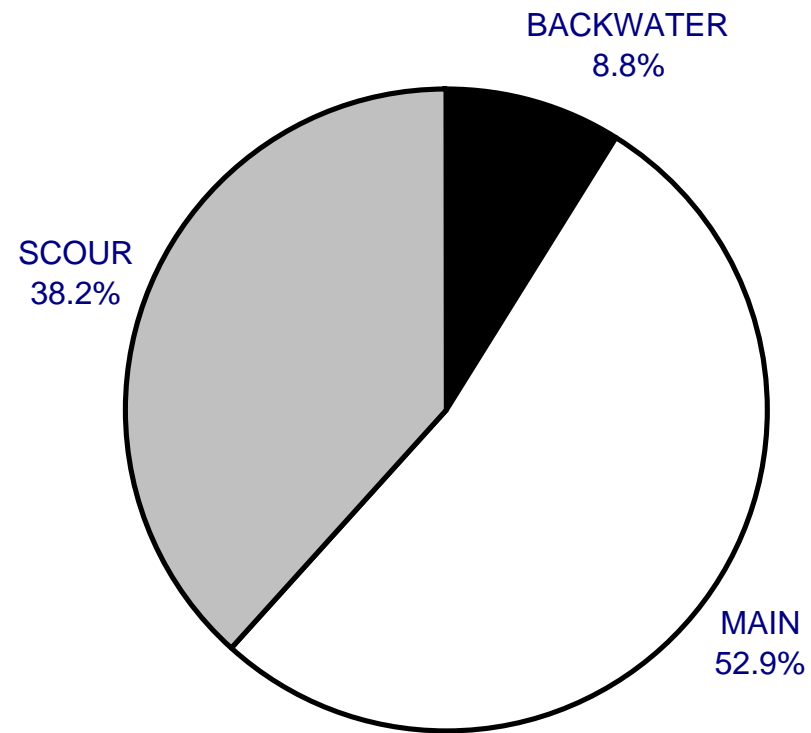
GRAPH 4

**1241616407617 2006**  
**POOL TYPES BY PERCENT OCCURRENCE**

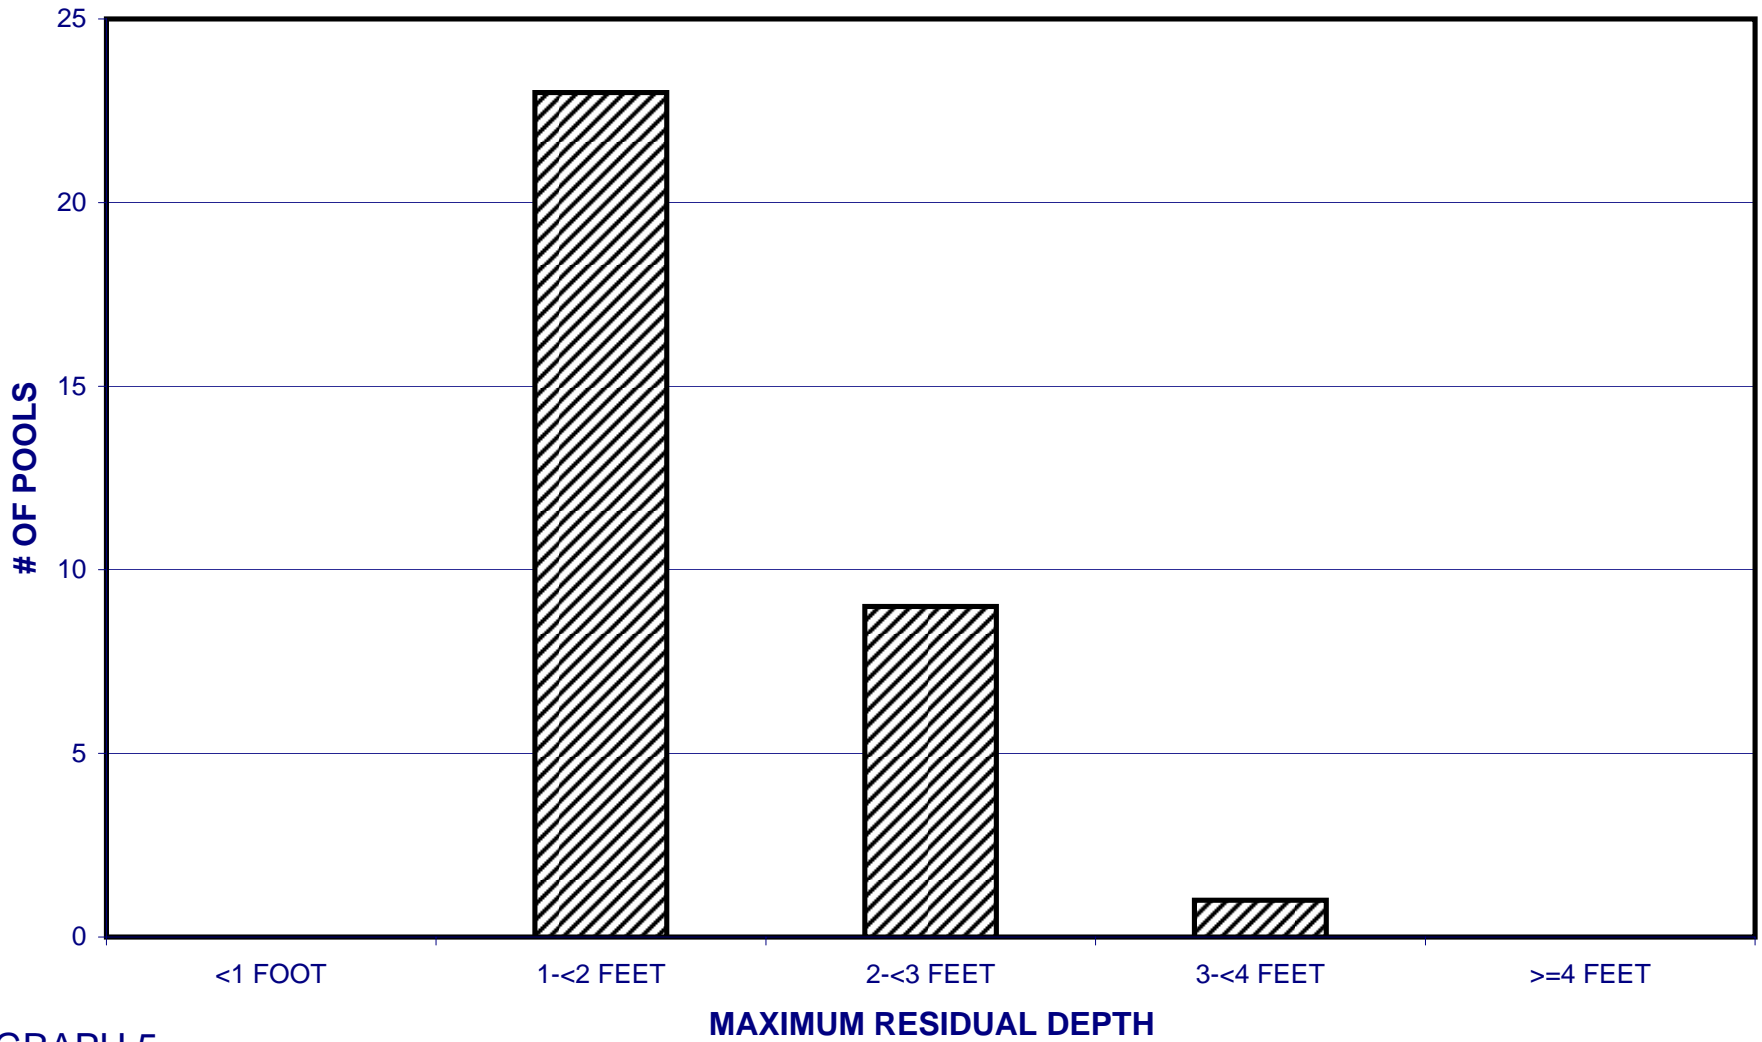
GRAPH 5

**1241616407617 2006  
MAXIMUM DEPTH IN POOLS**

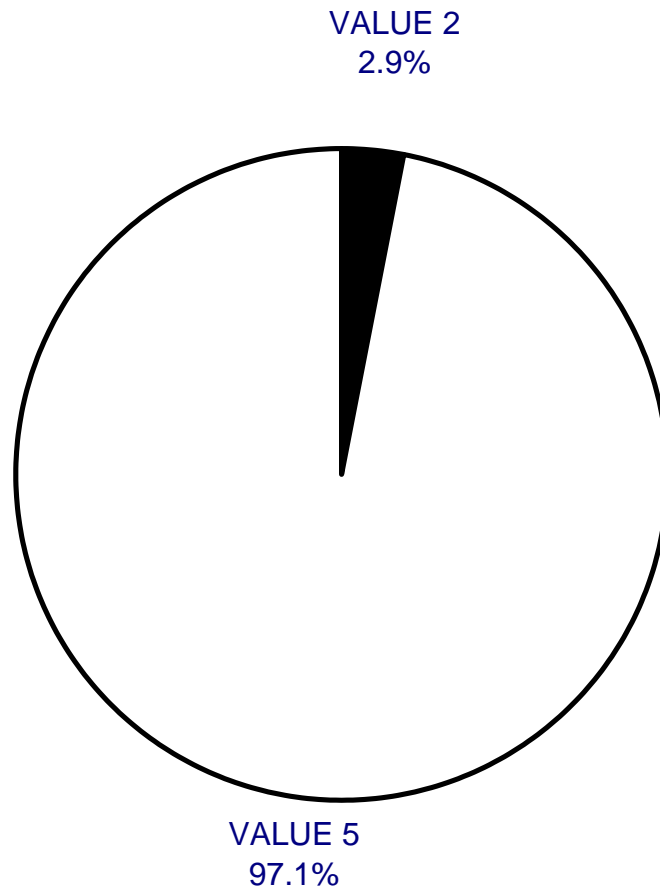
GRAPH 6

**1241616407617 2006  
PERCENT EMBEDDEDNESS**

One of the 34 pool tail-outs measured had embeddedness ratings of 1 or 2. None of the pool tail-outs had embeddedness ratings of 3 or 4. Cobble embeddedness of 25% or less, a rating of 1, is considered best for the needs of salmon and steelhead. In Unnamed Tributary #6, sediment sources should be mapped and rated according to their potential sediment yields, and control measures should be taken.

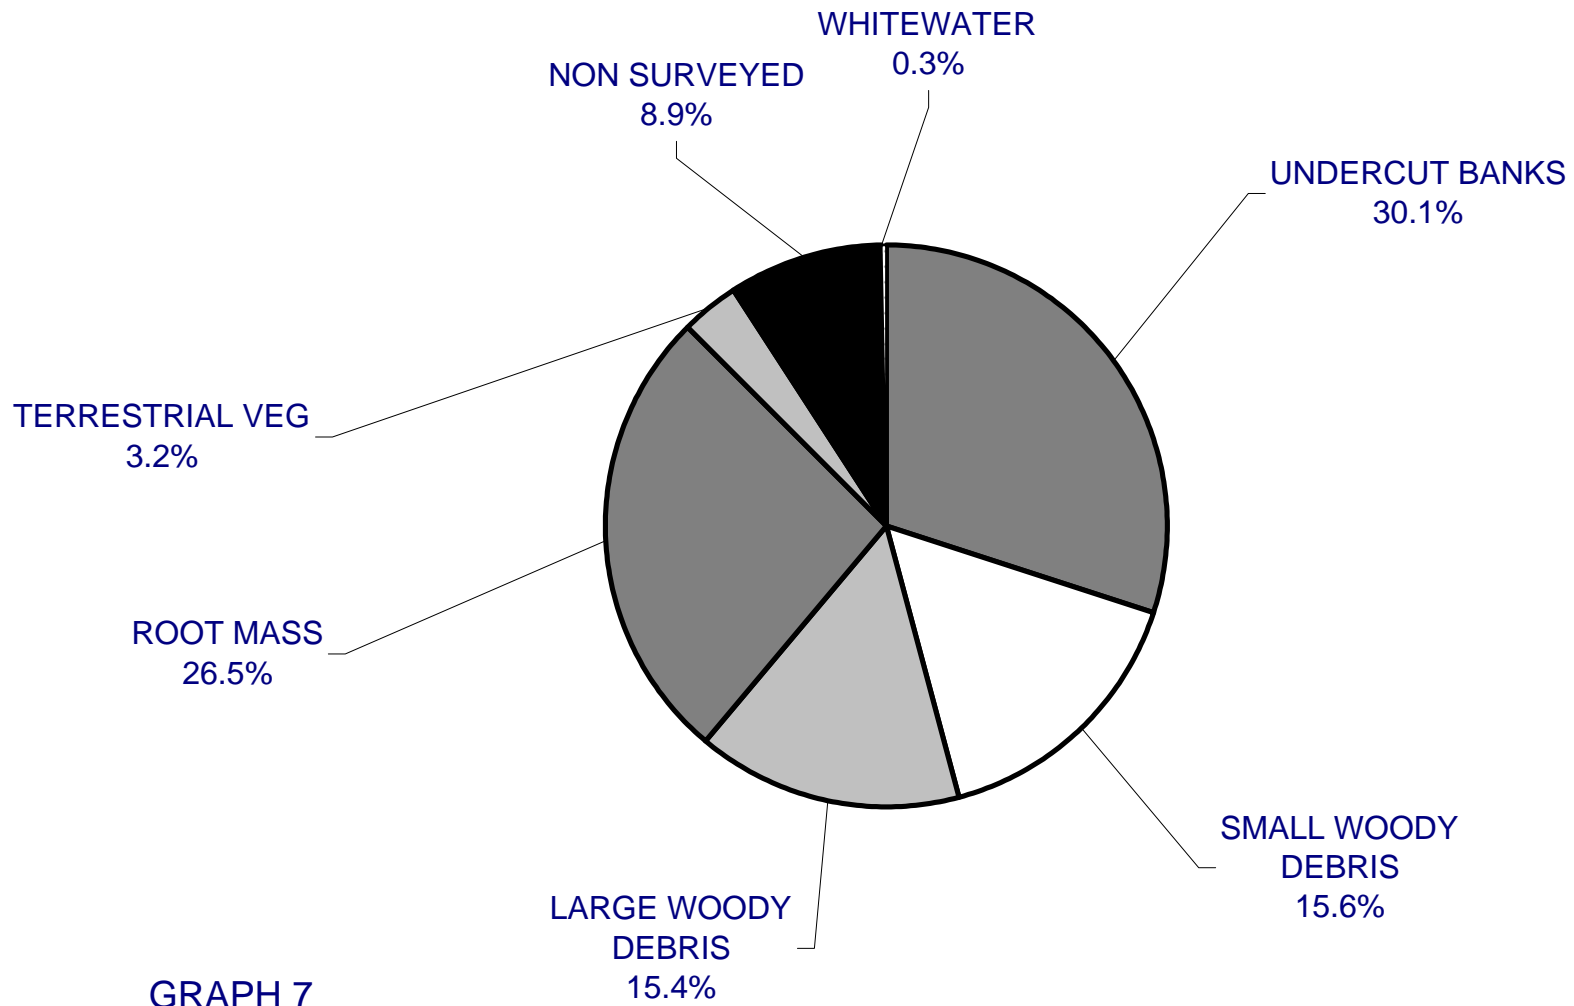
**GRAPH 7**

**1241616407617 2006**  
**MEAN PERCENT COVER TYPES IN POOLS**

The mean shelter rating for pools was 27. The shelter rating in the flatwater habitats was 24. A pool shelter rating of approximately 100 is desirable.

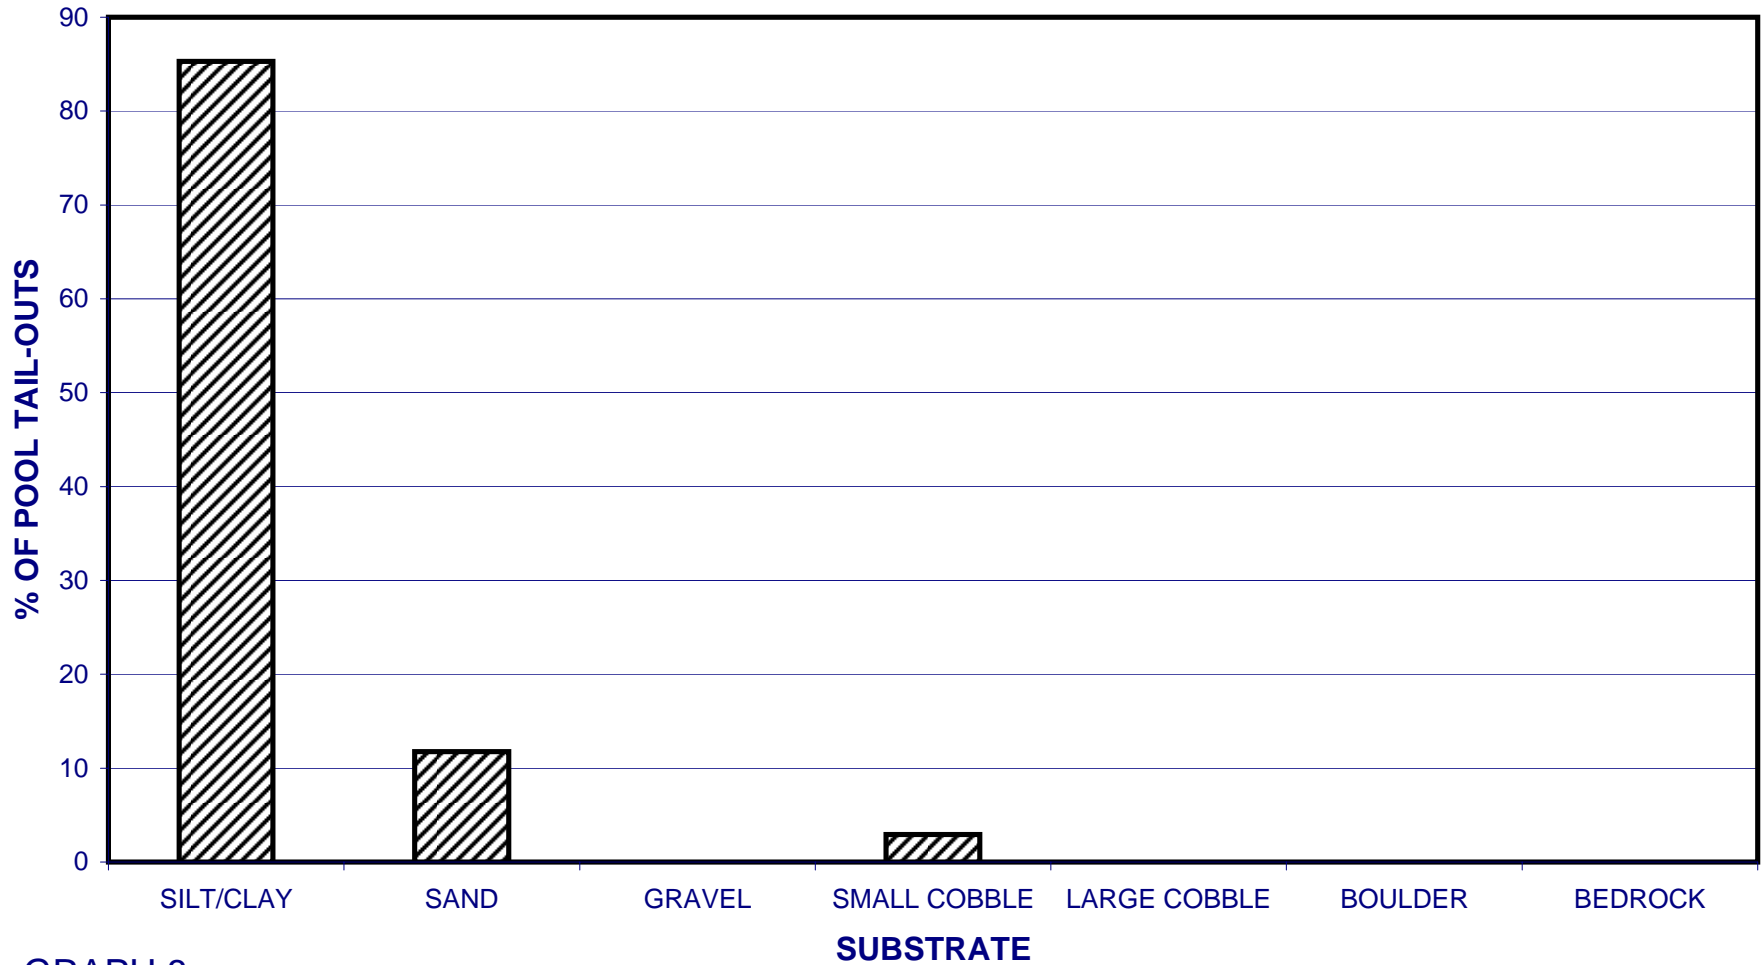
GRAPH 8

**1241616407617 2006**  
**SUBSTRATE COMPOSITION IN POOL TAIL-OUTS**

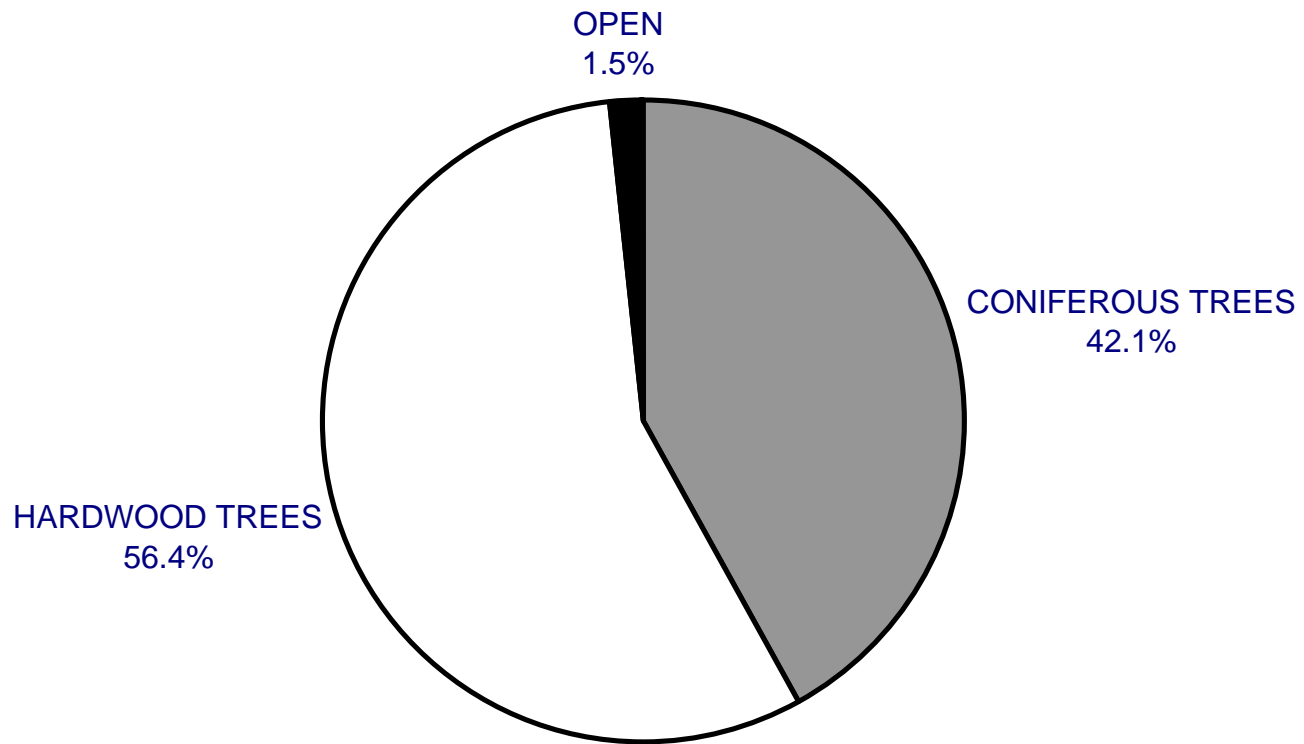
GRAPH 9

**1241616407617 2006  
MEAN PERCENT CANOPY**

The mean percent canopy density for the stream was 98%. In general, revegetation projects are considered when canopy density is less than 80%. The percentage of right and left bank covered with vegetation was 98% and 94%, respectively.

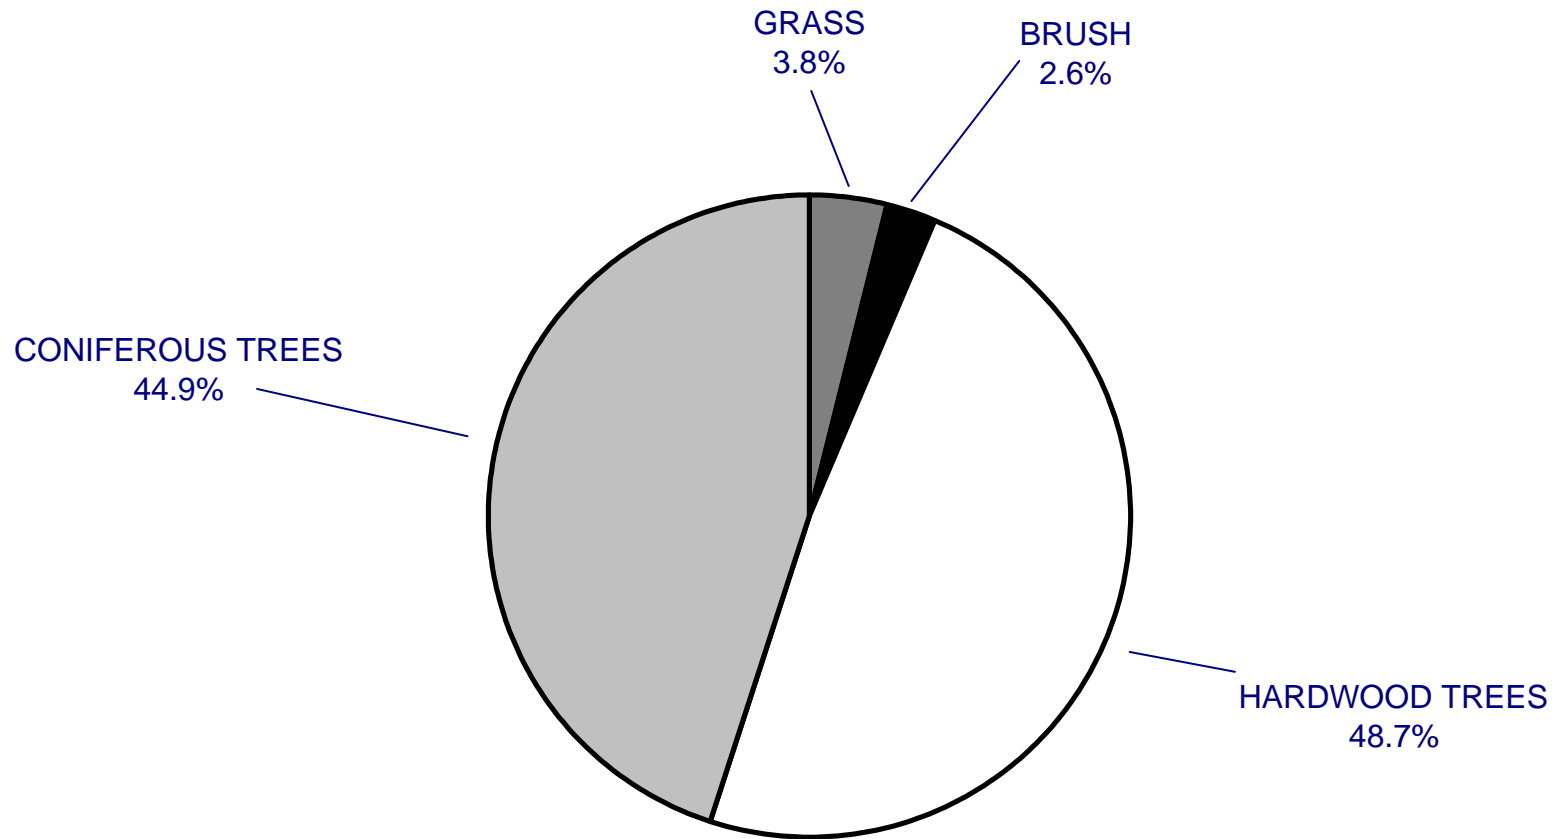
GRAPH 11

**1241616407617 2006**  
**DOMINANT BANK VEGETATION IN SURVEY REACH**
