**CALIFORNIA DEPARTMENT OF FISH AND GAME
STREAM INVENTORY REPORT**

Mount Jackson Creek
Report Revised April 14, 2006
Report Completed 2005
Assessment Completed 2000

A stream inventory was conducted during the summer of 2000 on Mount Jackson Creek beginning 273 feet downstream of the Westside Road Bridge. The inventory was conducted in two parts: habitat inventory and biological inventory. The objective of the habitat inventory was to document the amount and condition of available habitat to fish, and other aquatic species with an emphasis on anadromous salmonids in Mount Jackson Creek. The objective of the biological inventory was to document the salmonid and other aquatic species present and their distribution.

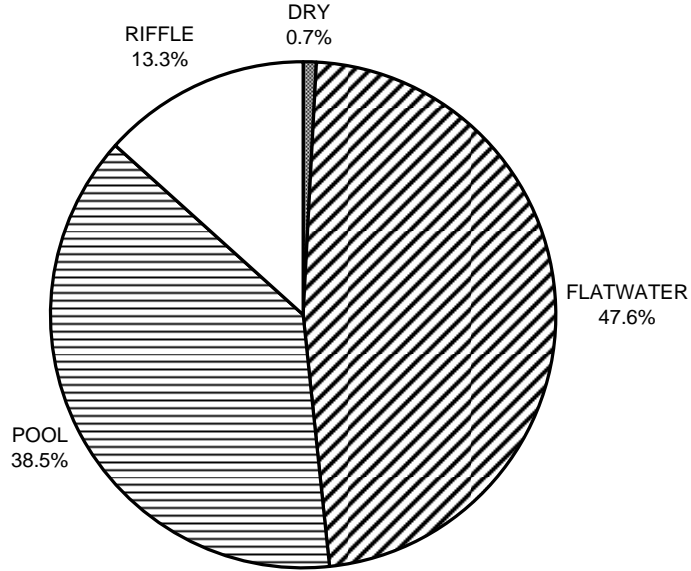
GRAPH 1: Level II habitat types by percent occurrence

**MOUNT JACKSON CREEK 2000
HABITAT TYPES BY PERCENT OCCURRENCE**

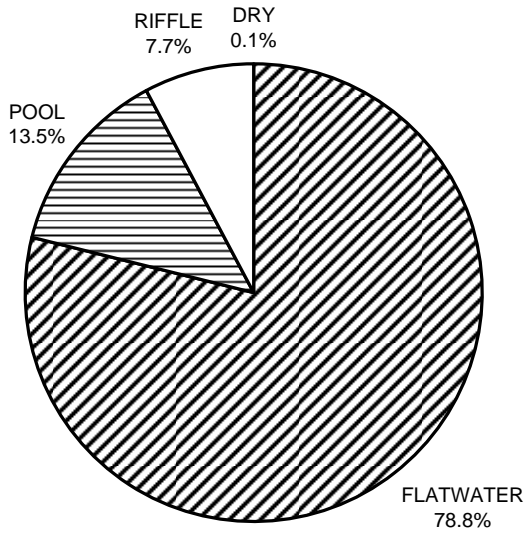
GRAPH 2: Level II habitat types by percent total length

**MOUNT JACKSON CREEK 2000
HABITAT TYPES BY PERCENT TOTAL LENGTH**

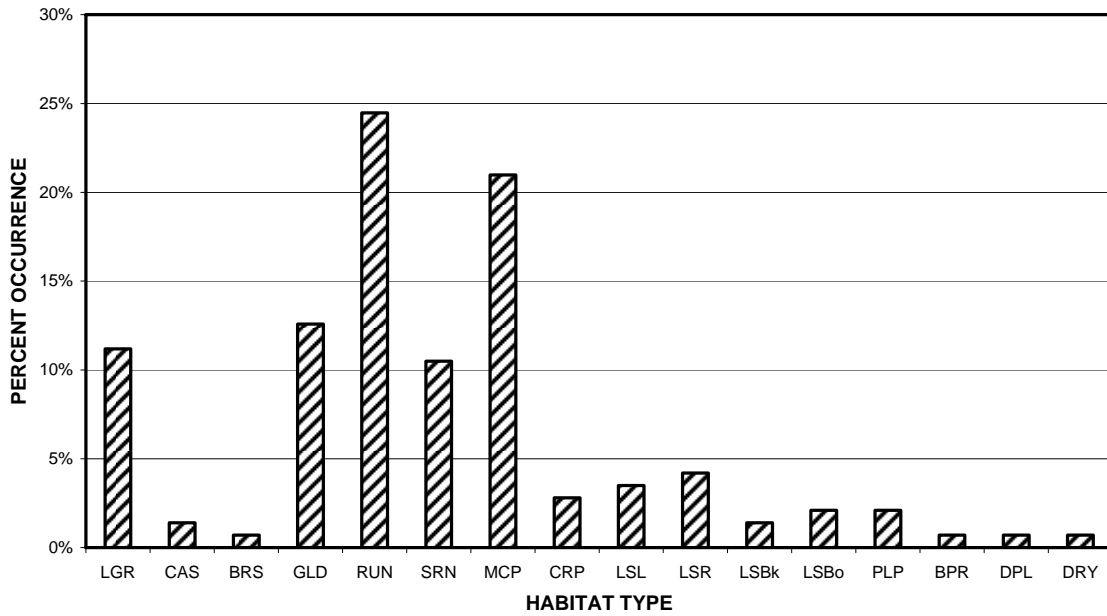
GRAPH 3: Level IV habitat types by percent occurrence

**MOUNT JACKSON CREEK 2000
HABITAT TYPES BY PERCENT OCCURRENCE**

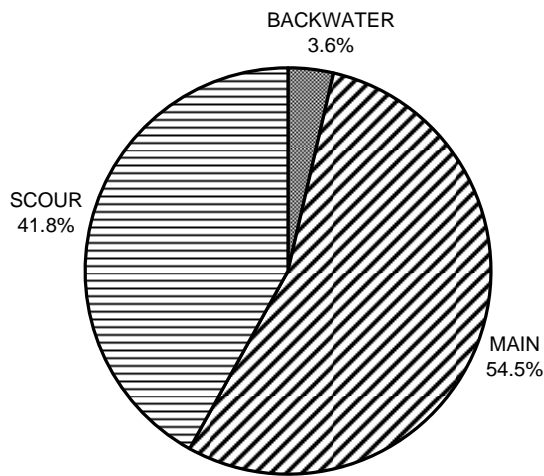
GRAPH 4: Level I pool types by percent occurrence

**MOUNT JACKSON CREEK 2000
POOL TYPES BY PERCENT OCCURRENCE**

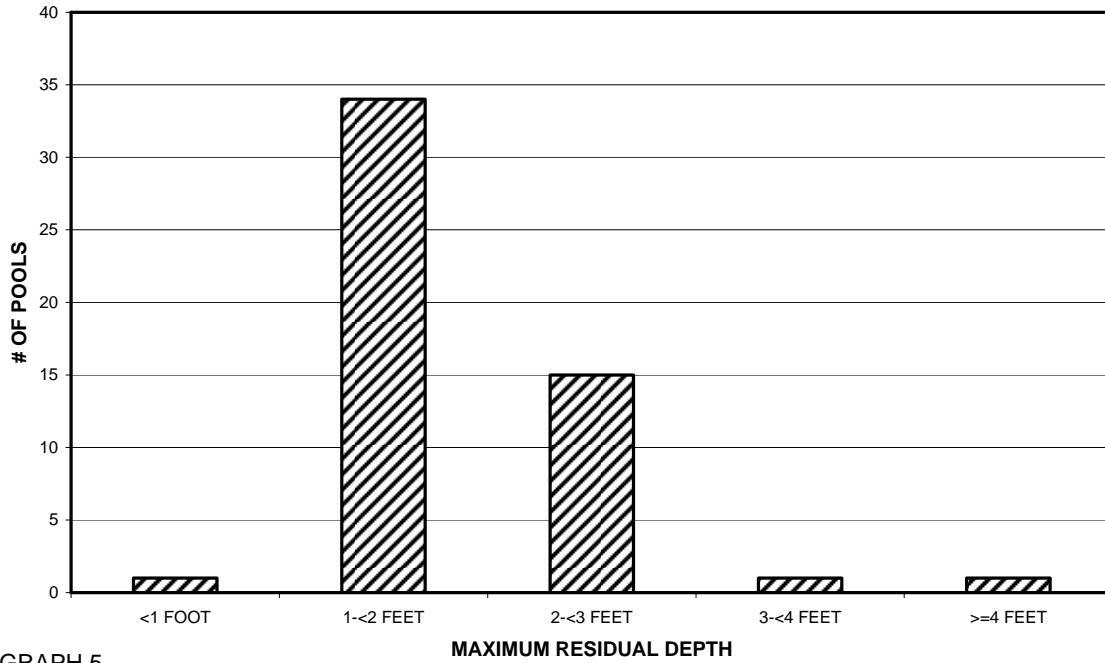
GRAPH 5

**MOUNT JACKSON CREEK 2000
MAXIMUM DEPTH IN POOLS**

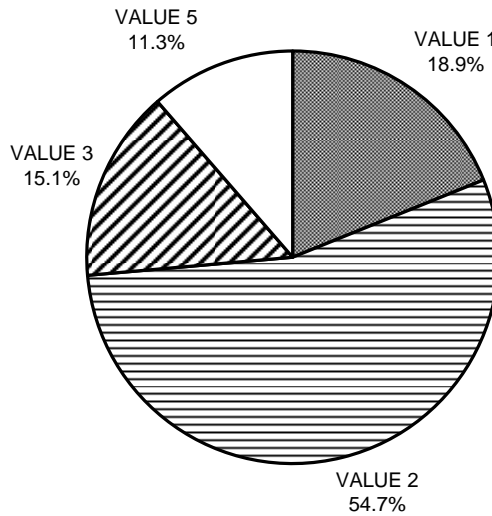
GRAPH 6

**MOUNT JACKSON CREEK 2000
PERCENT EMBEDDEDNESS**

The depth of cobble embeddedness was estimated at pool tail-outs. Of the 53 pool tail-outs measured, ten had a value of 1 (19%); twenty nine had a value of 2 (55%); eight had a value of 3 (15%); and none had a value of 4 (0%). Six (11%) riffles rated a 5 (Graph 6). On this scale, a value of 1 indicates the best spawning conditions and a value of 4 the worst. Additionally, a value of 5 was assigned to tail-outs deemed unsuited for spawning due to inappropriate substrate like bedrock, log sills, or boulders.

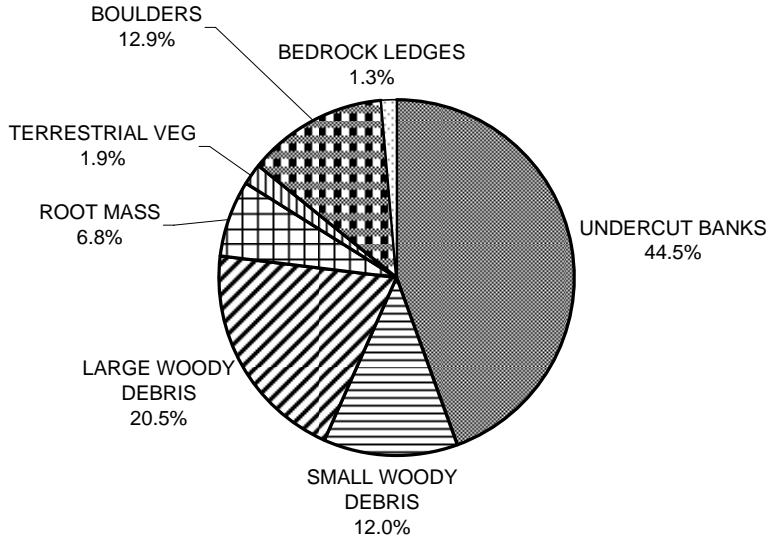
GRAPH 7

**MOUNT JACKSON CREEK 2000
MEAN PERCENT COVER TYPES IN POOLS**

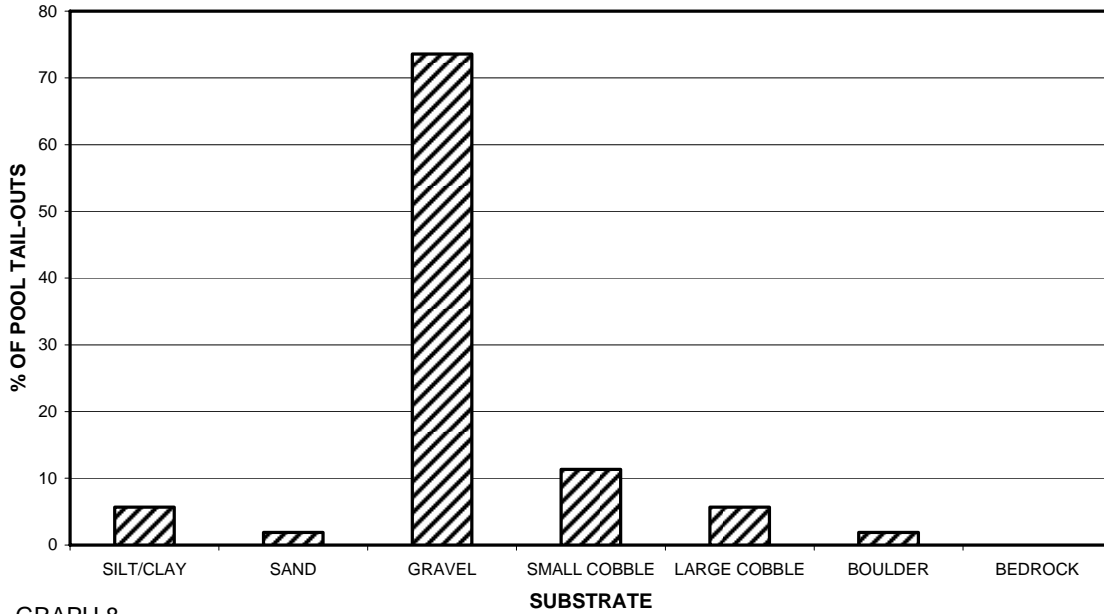
GRAPH 8

**MOUNT JACKSON CREEK 2000
SUBSTRATE COMPOSITION IN POOL TAIL-OUTS**

Table 6 summarizes the dominant substrate by habitat type. Graph 8 depicts the dominant substrate observed in pool tail-outs. Gravel was the dominant substrate observed in 74% of pool tail-outs while small cobble was the next most frequently observed substrate type at 11%.

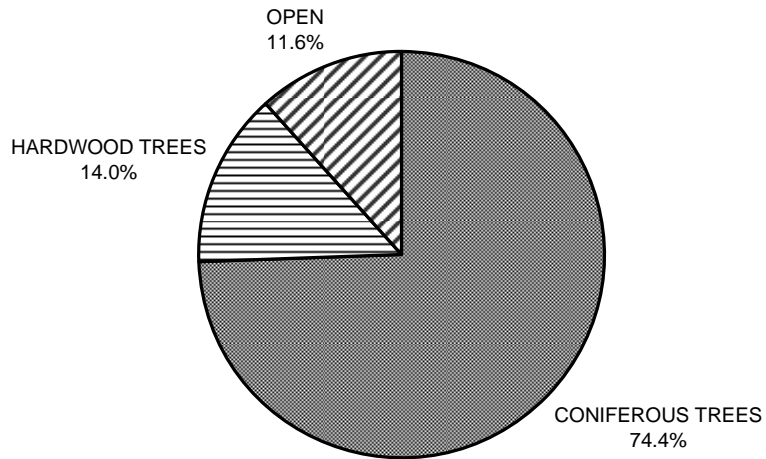
GRAPH 9

**MOUNT JACKSON CREEK 2000
MEAN PERCENT CANOPY**

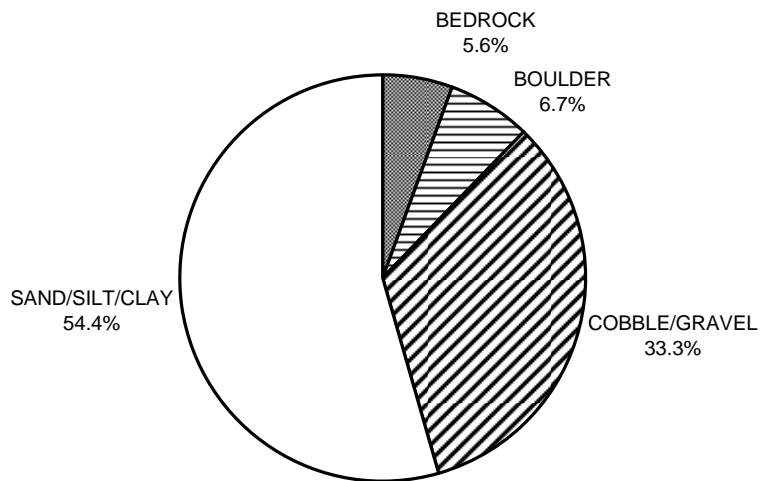
GRAPH 10

**MOUNT JACKSON CREEK 2000
DOMINANT BANK COMPOSITION IN SURVEY REACH**

For the stream reach surveyed, the mean percent right bank vegetated was 49% and the mean percent left bank vegetated was 53%. The dominant elements composing the structure of the stream banks consisted of 54% silt/clay/sand, 33% cobble/gravel, 7% boulder and 6% bedrock (Graph 10). Evergreen trees were the dominant vegetation type observed in 61% of the units surveyed. Additionally, 13% of the units surveyed had brush as the dominant vegetation type and 13% had deciduous trees as the dominant vegetation (Graph 11).

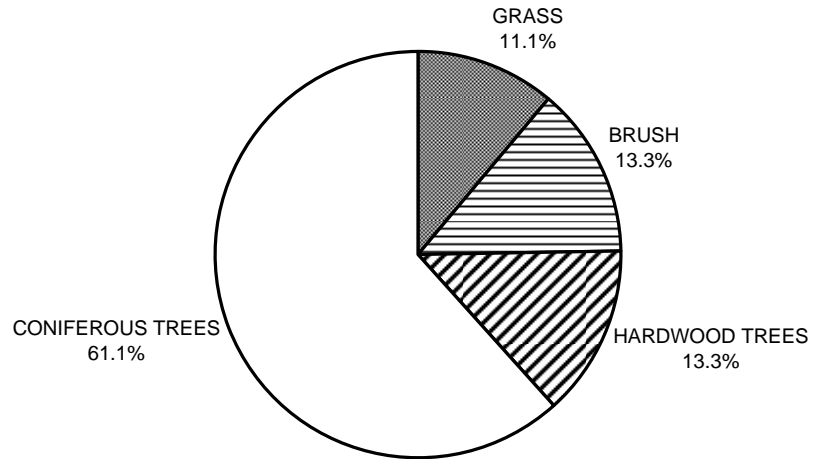
GRAPH 11

**MOUNT JACKSON CREEK 2000
DOMINANT BANK VEGETATION IN SURVEY REACH**
