CALIFORNIA DEPARTMENT OF FISH AND GAME  
STREAM INVENTORY REPORT  
Feliz Creek  
*Report Completed June 9, 2006*  
*Assessment Completed 2001*

A stream inventory was conducted beginning July 11 and ending July 19, 2001 on Feliz Creek. The survey began at the confluence with the Russian River and extended upstream 24,764 feet. Not all of Feliz Creek was assessed in 2001. For a comprehensive evaluation of the entire stream a new assessment should be completed.

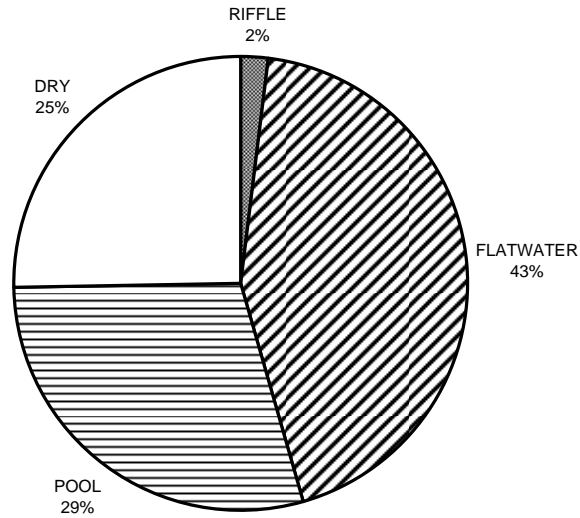
**FELIZ CREEK**  
**HABITAT TYPES BY PERCENT OCCURRENCE**

GRAPH 1: Level II habitat types by percent occurrence

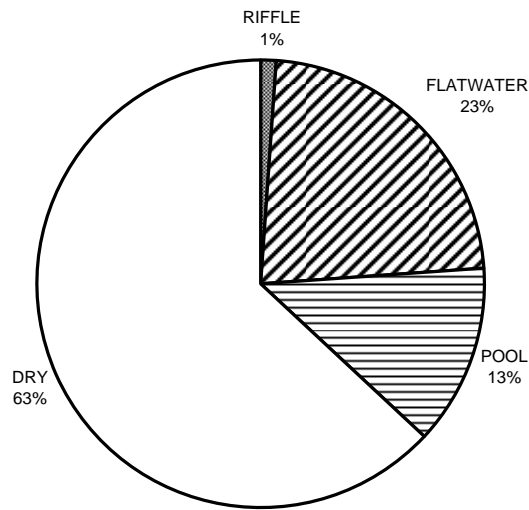
**FELIZ CREEK**  
**HABITAT TYPES BY PERCENT TOTAL LENGTH**

GRAPH 2: Level II habitat types by percent total length

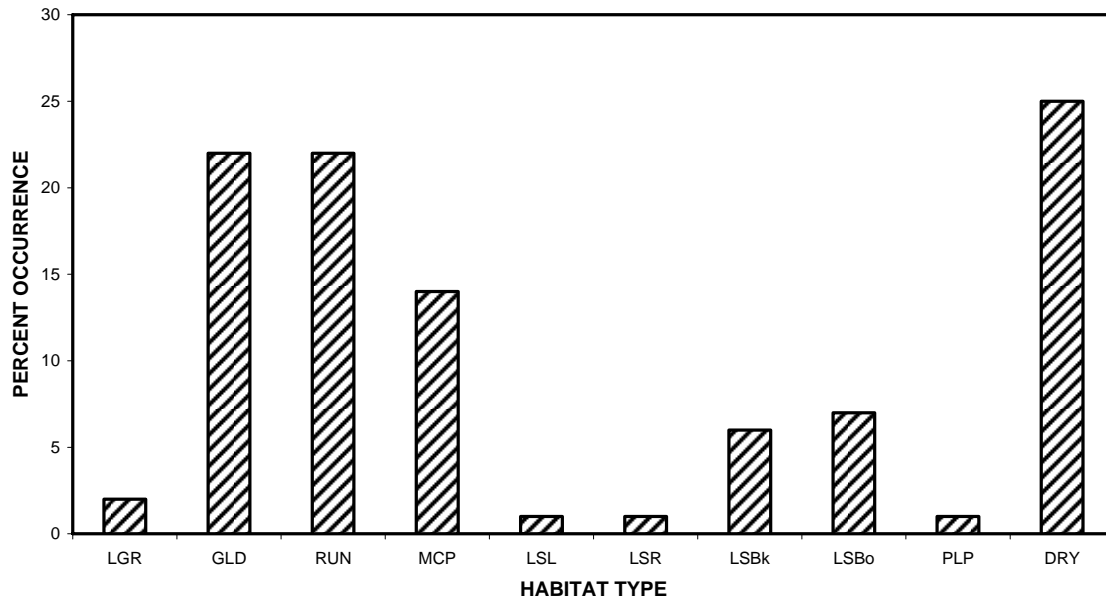
## FELIZ CREEK HABITAT TYPES BY PERCENT OCCURRENCE

GRAPH 3: Level IV habitat types by percent occurrence

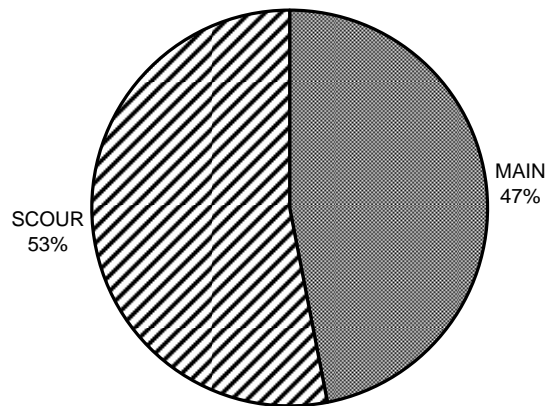
## FELIZ CREEK POOL HABITAT TYPES BY PERCENT OCCURRENCE

GRAPH 4: Level I pool habitat types by percent occurrence

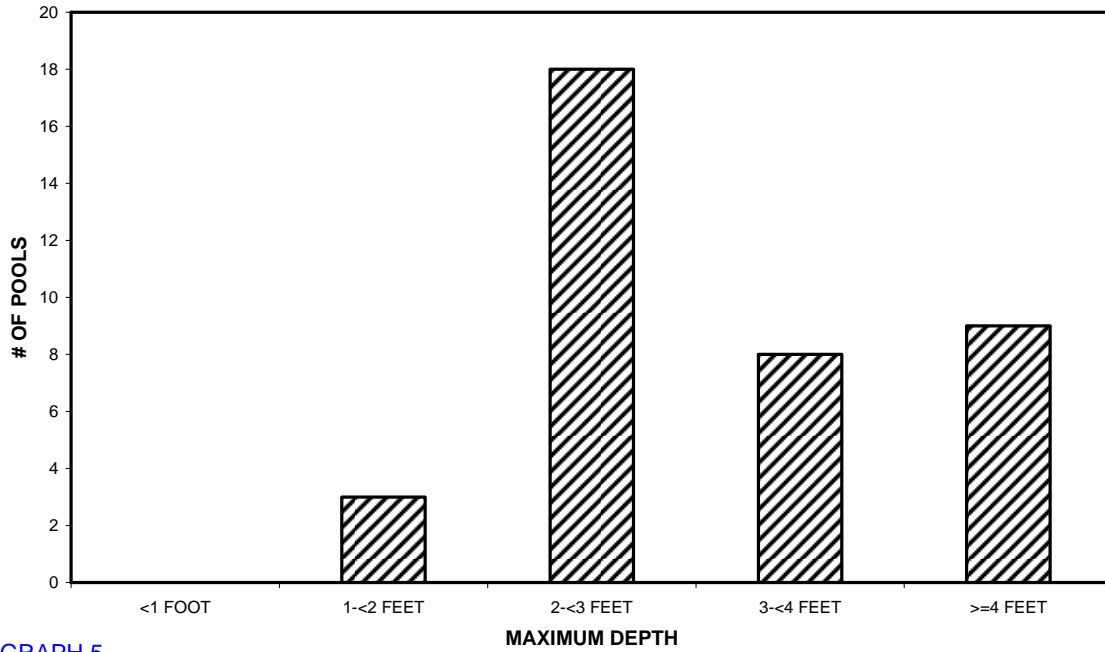
GRAPH 5

### FELIZ CREEK MAXIMUM DEPTH IN POOLS

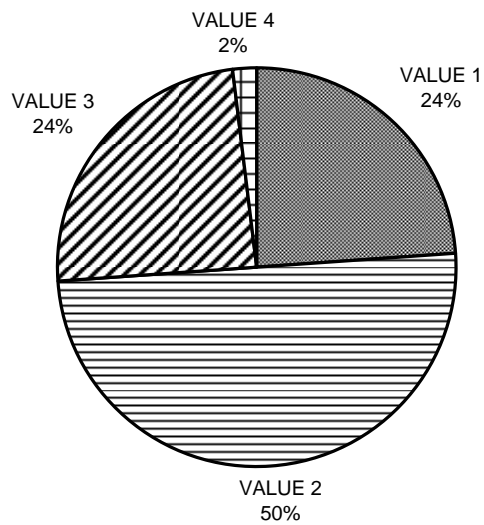
GRAPH 6

### FELIZ CREEK PERCENT EMBEDDEDNESS

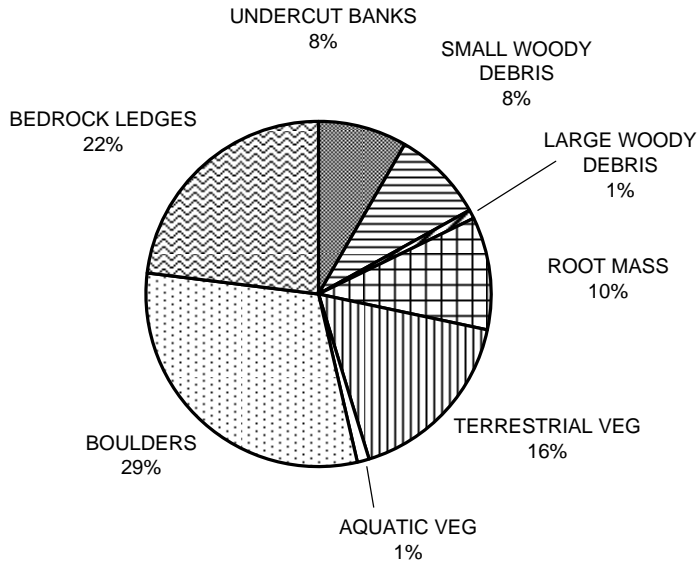
GRAPH 7

## FELIZ CREEK MEAN PERCENT COVER TYPES IN POOLS

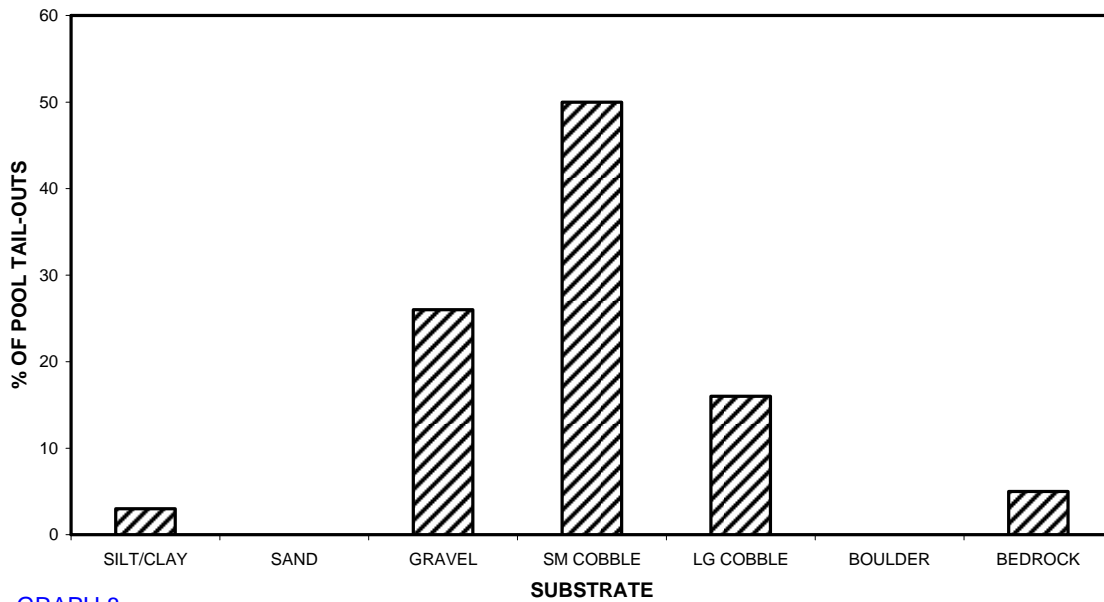
GRAPH 8

## FELIZ CREEK SUBSTRATE COMPOSITION IN POOL TAIL-OUTS

Table 6 summarizes the dominant substrate by habitat type. Graph 8 depicts the dominant substrate observed in pool tail-outs. Small cobble was the dominant substrate observed in 50% of pool tail-outs while gravel was the next most frequently observed substrate type, at 26%.

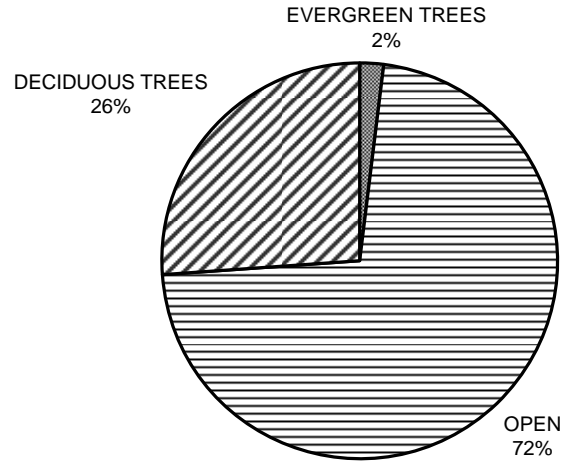
GRAPH 9

# FELIZ CREEK MEAN PERCENT CANOPY

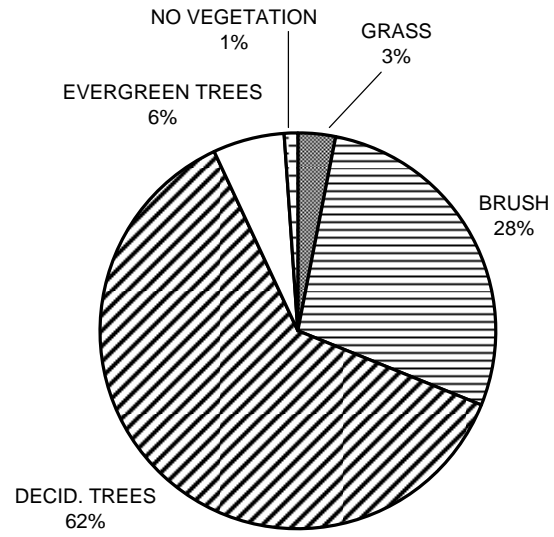
GRAPH 11

# FELIZ CREEK

## DOMINANT BANK VEGETATION IN SURVEY REACH

For the stream reach surveyed, the mean percent right bank vegetated was 50%. The mean percent left bank vegetated was 55%. The dominant elements composing the structure of the stream banks consisted of 21.3% bedrock, 7.4% boulder, 34.0% cobble/gravel, and 37.2% sand/silt/clay (Graph 10). Deciduous trees were the dominant vegetation type observed in 58.5% of the units surveyed. Additionally, 27.7% of the units surveyed had brush as the dominant vegetation type, and 8.5% had evergreen trees as the dominant vegetation (Graph 11).
