CALIFORNIA DEPARTMENT OF FISH AND GAME  
STREAM INVENTORY REPORT

Wine Creek

*Report Revised April 14, 2006*

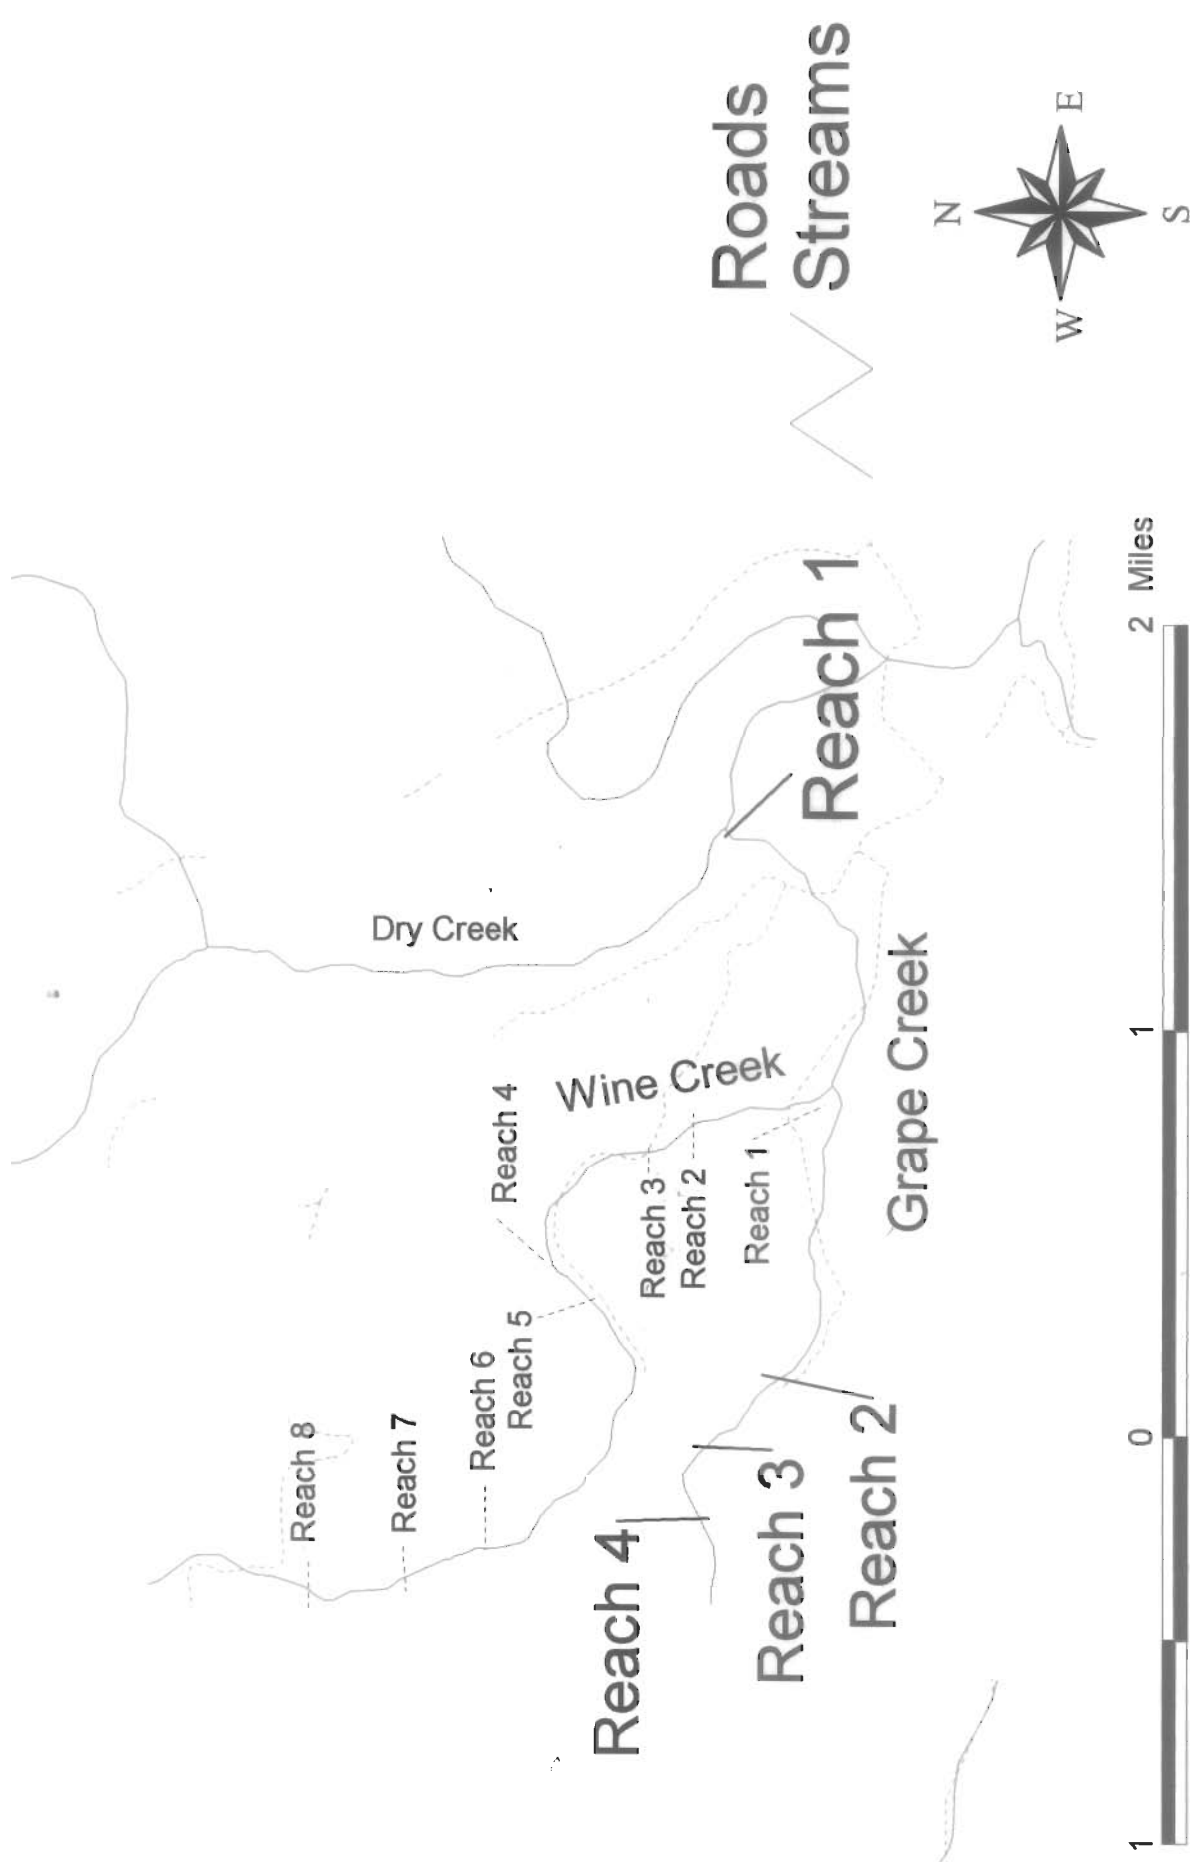
# Grape\ Wine Creek Habitat Inventory

Wine Creek

Drainage: Grape Creek, Dry Creek, Russian River

Wine Creek is a tributary to Grape Creek which flows into Dry Creek, a tributary of the Russian River, located in Sonoma County, California (see Wine Creek map, page 2). The legal description at the confluence with Grape Creek is T9N, R10W, S3. Its location is 38°39'20" N. latitude and 122°56'44" W. longitude. Year round vehicle access exists from Highway 101 near Healdsburg, via Westside Road.
