Philip Williams and Associates, Ltd., "Memorandum Regarding Channel Geomorphic Assessment of Chiquito Canyon" (June 12, 2007; 2007a)

Date:	June 12, 2007
То:	Matt Carpenter and Corey Harpole
Organization:	Newhall Land and Farming Company
From:	Andrew Collison
PWA Project #:	1820.02
PWA Project Name: Subject:	Newhall Ranch
U	Channel geomorphic assessment of Chiquito Canyon
Copy(ies) To:	Lisa Austin, File

Chiquito Canyon

Geomorphic Reconnaissance

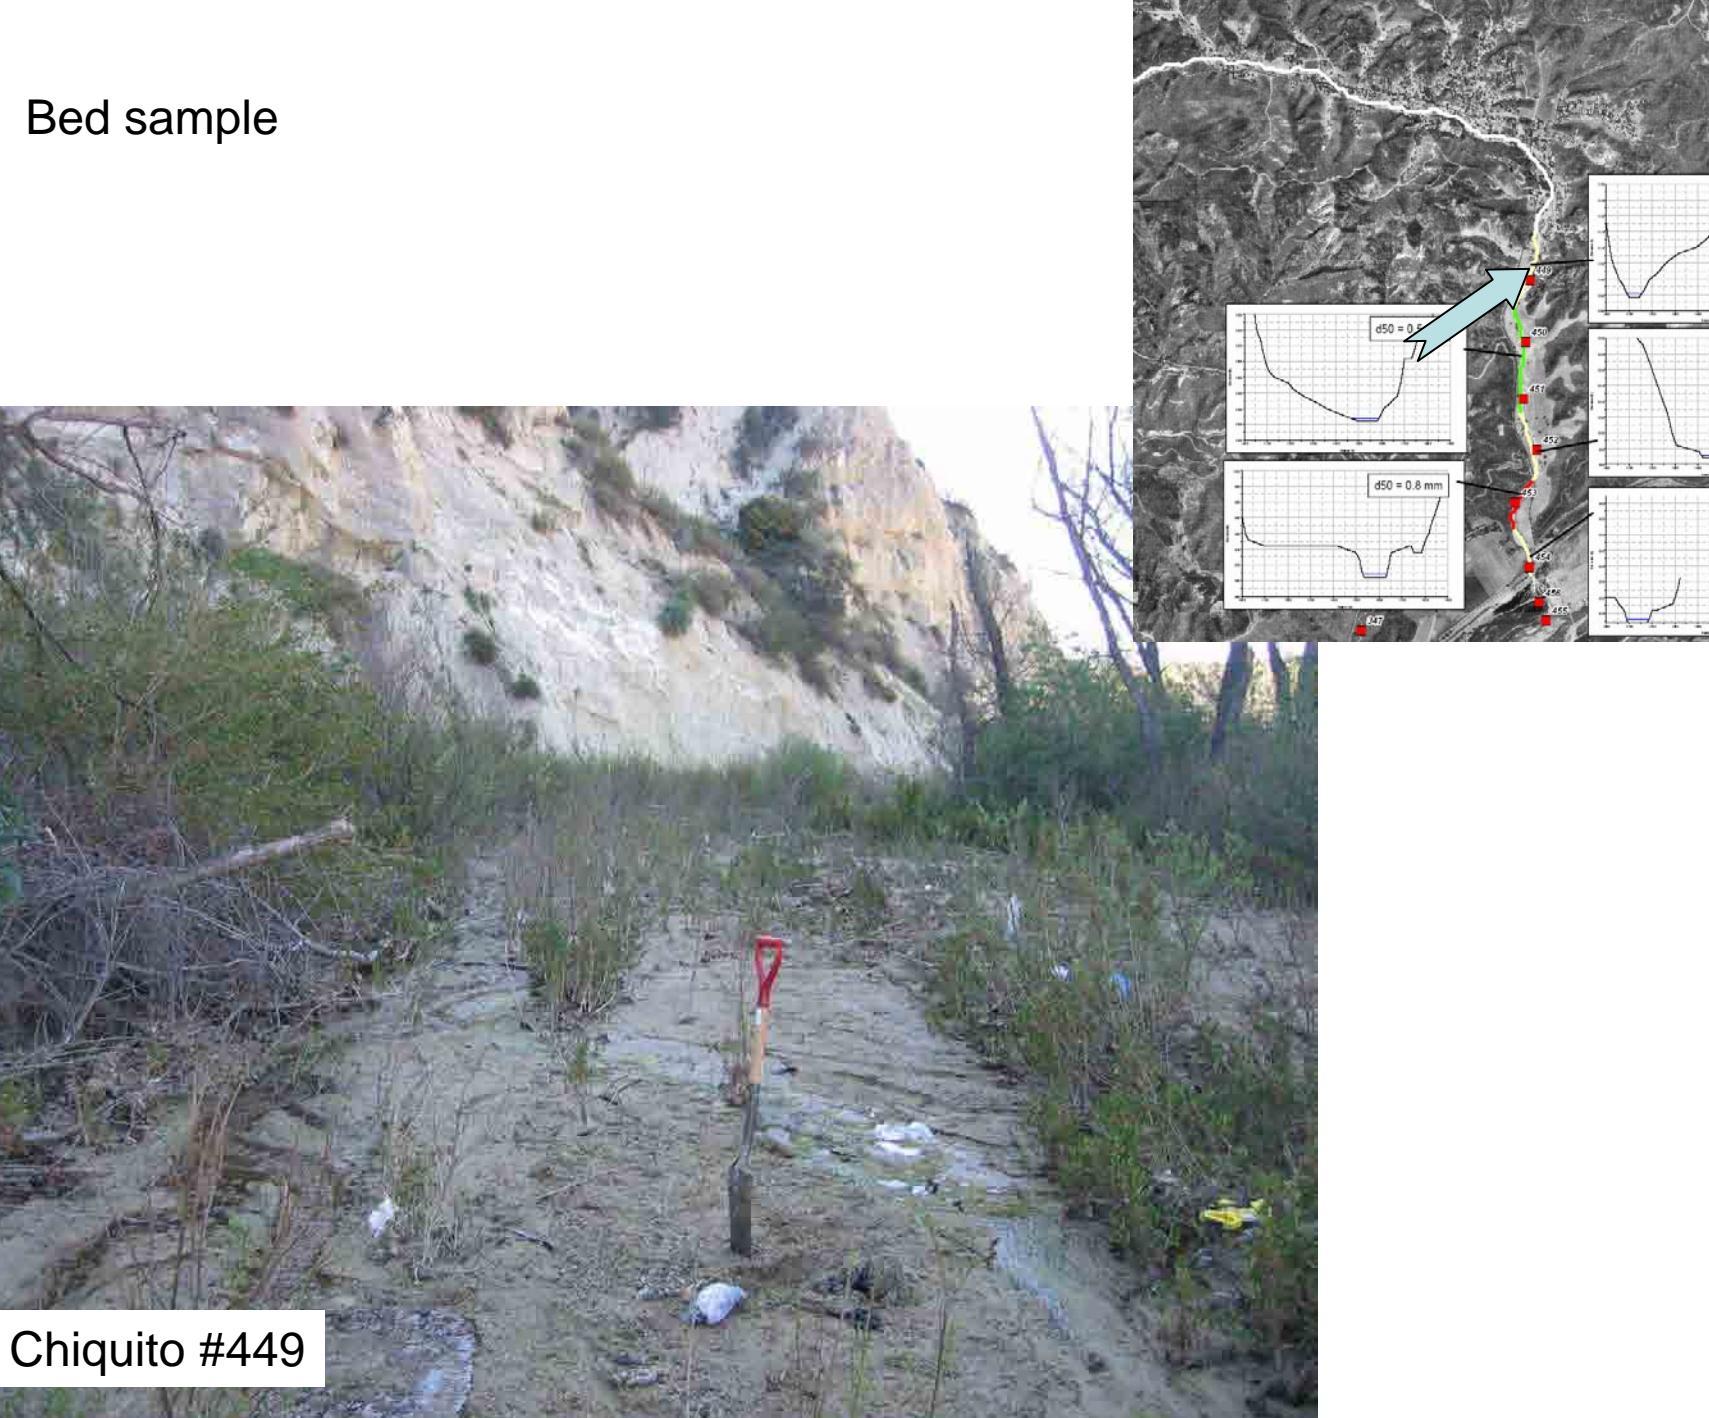
The sample locations and particle size distribution curves are shown in the attached figure, with typical sediment sizes and channel geomorphic assessment for context. A reconnaissance-level geomorphic assessment was conducted, primarily focused on the degree of channel incision (disconnection between the bankfull channel and floodplain). This was assessed by running a HEC-RAS model with the 5-year flow (model and data supplied by PACE) to determine the extent to which the 5-year flow was confined in a well defined bankfull channel or not. This was based on the observation of SCCWRP (Coleman et. al. 2005) that stable channels in this area contain the 5-year flow. Where the 5-year flow did not fill what appeared to be the bankfull channel and qualitative geomorphic evidence supported the assessment the channel was classified as incised or widening. Figures from the reconnaissance are attached to this memo.

d50 = 1.5 n

d50 = 0.35 mn

d50 = 0.75 mm

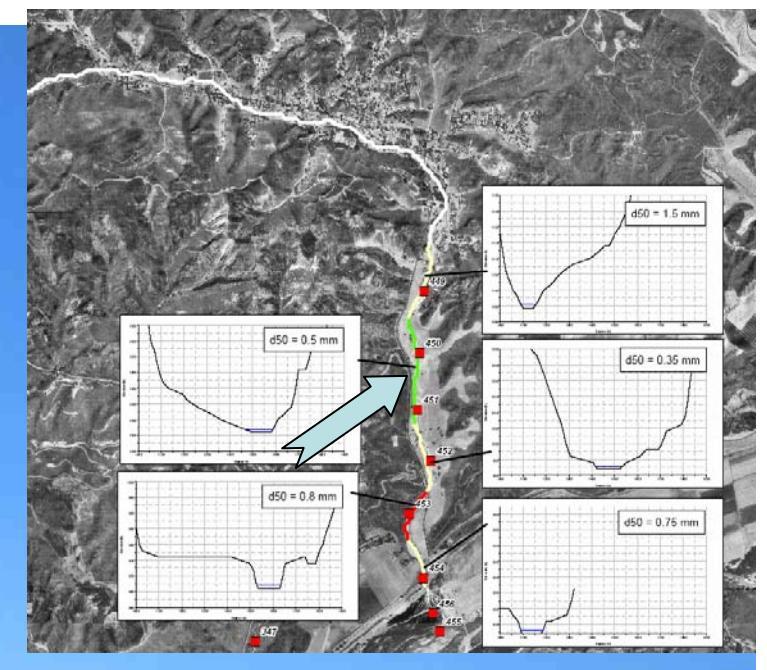
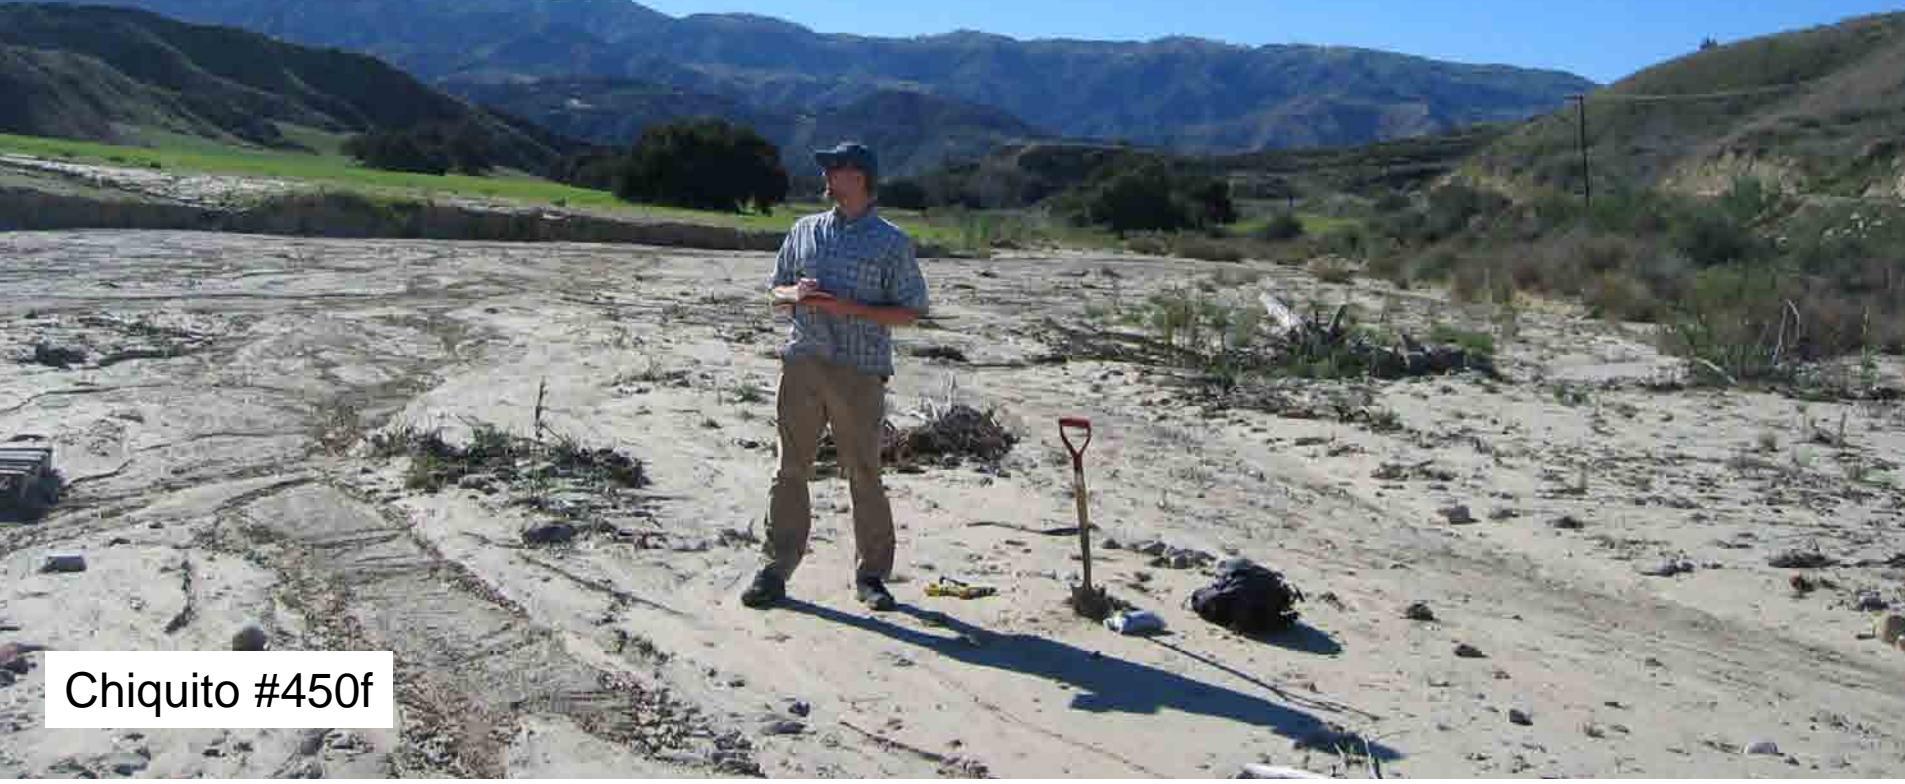
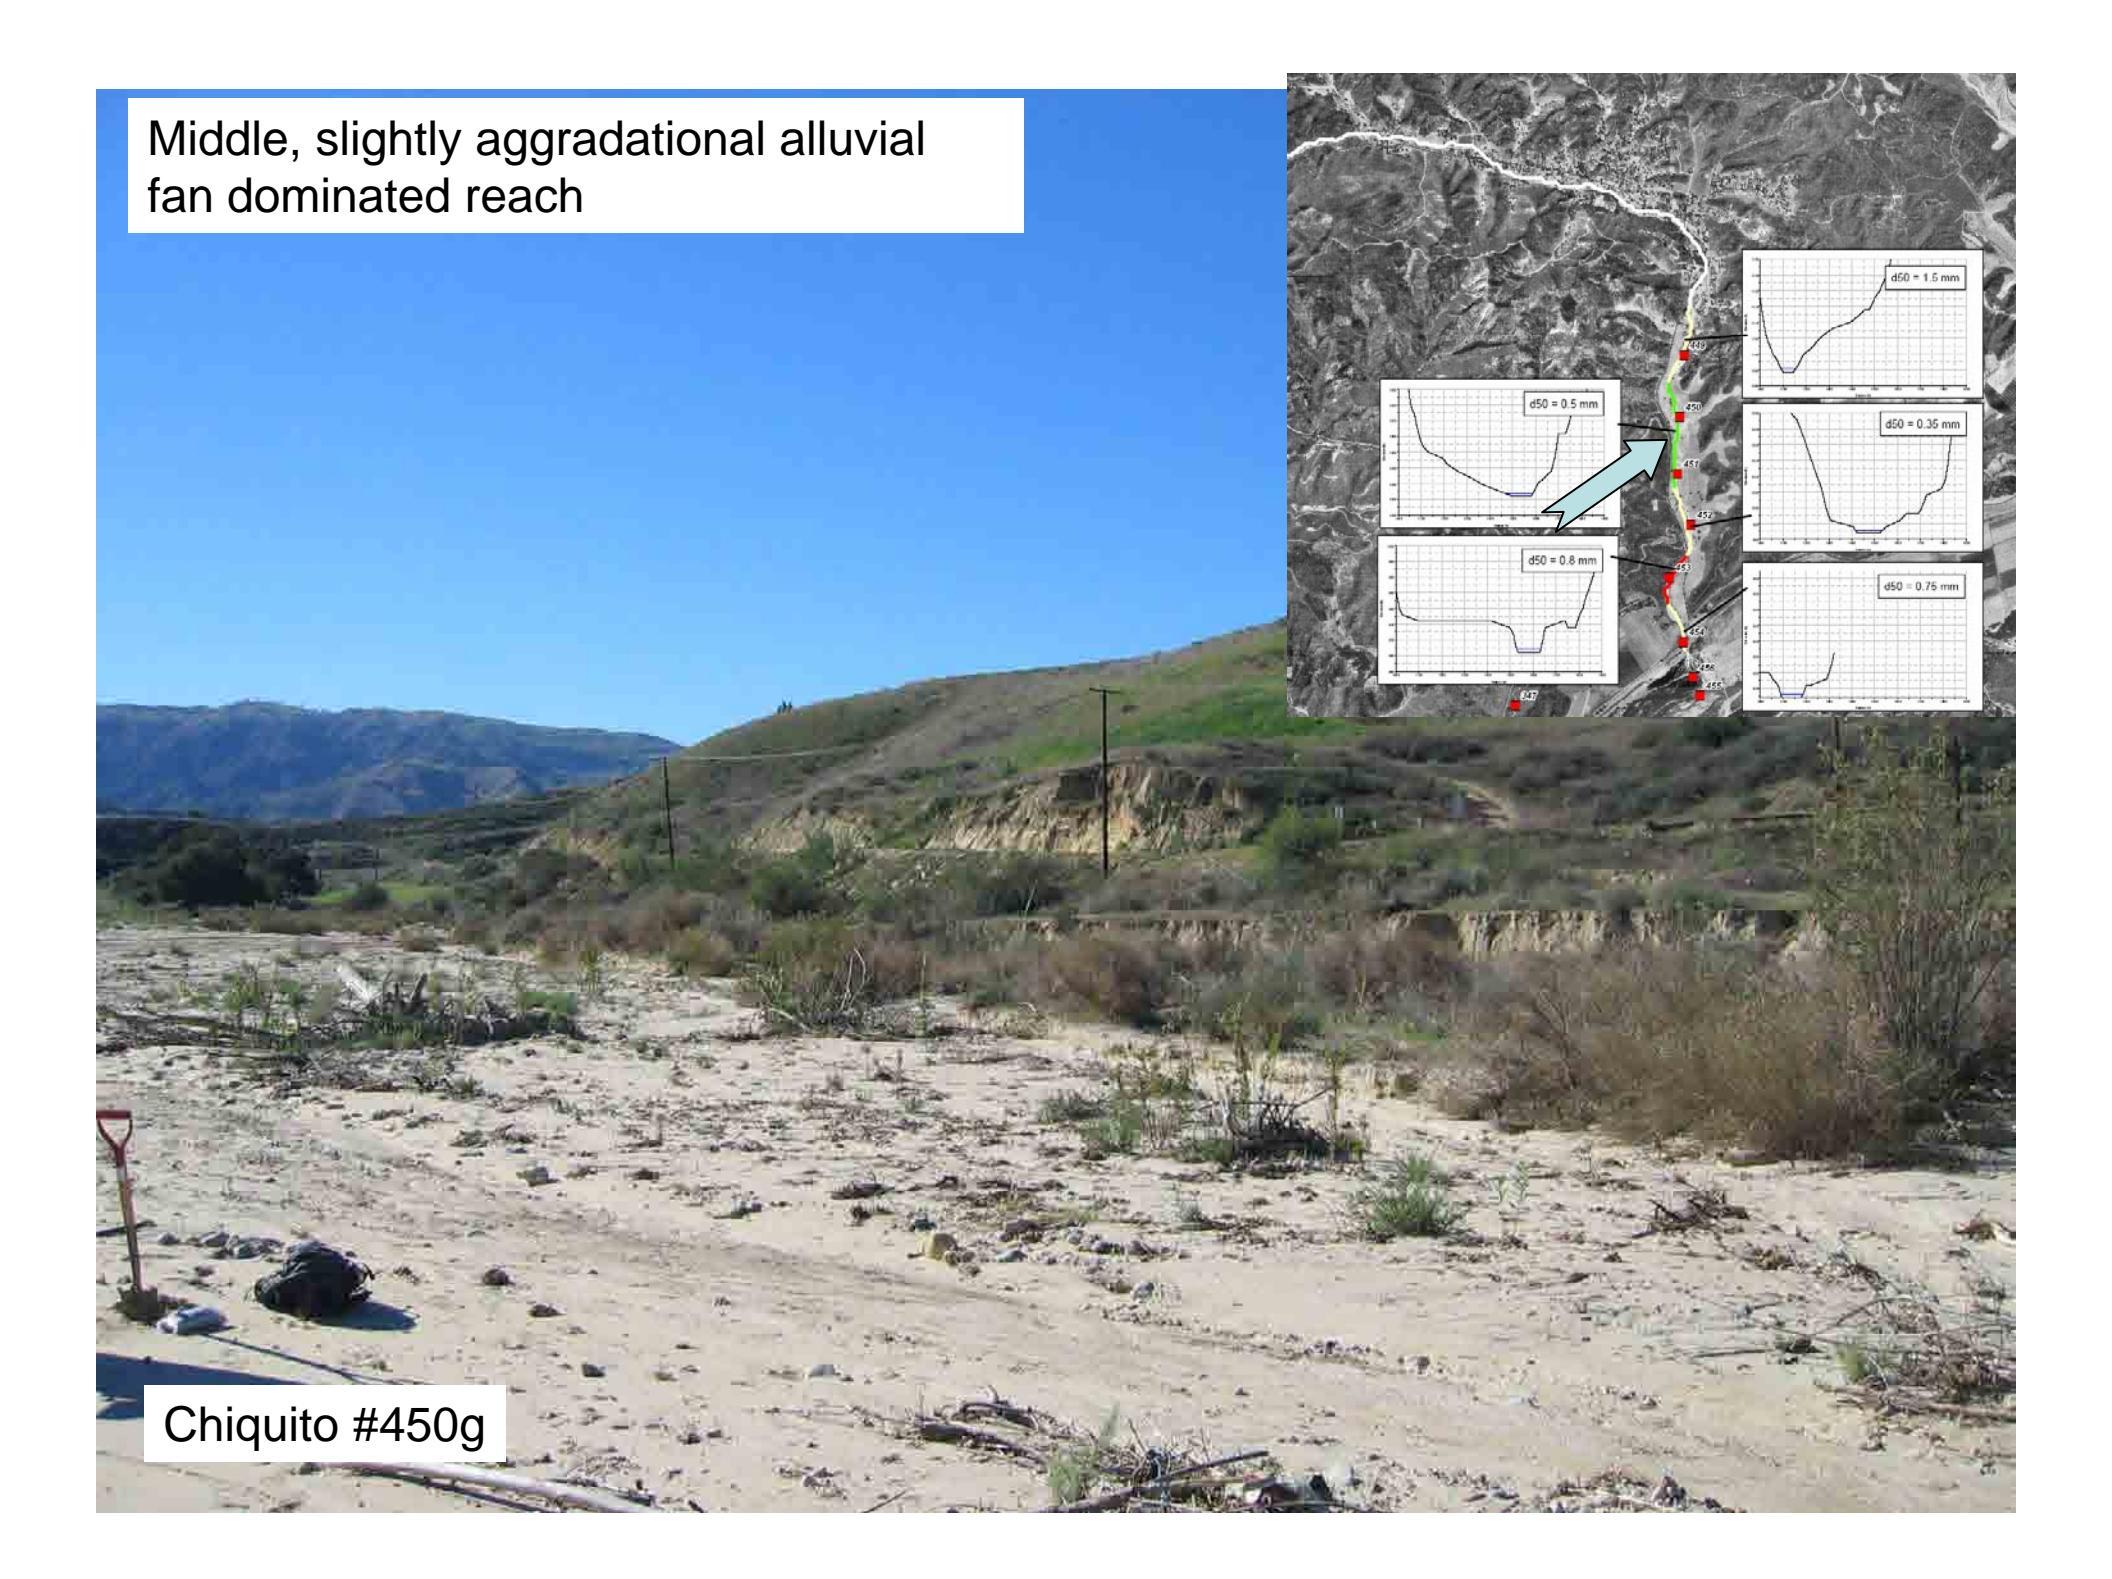
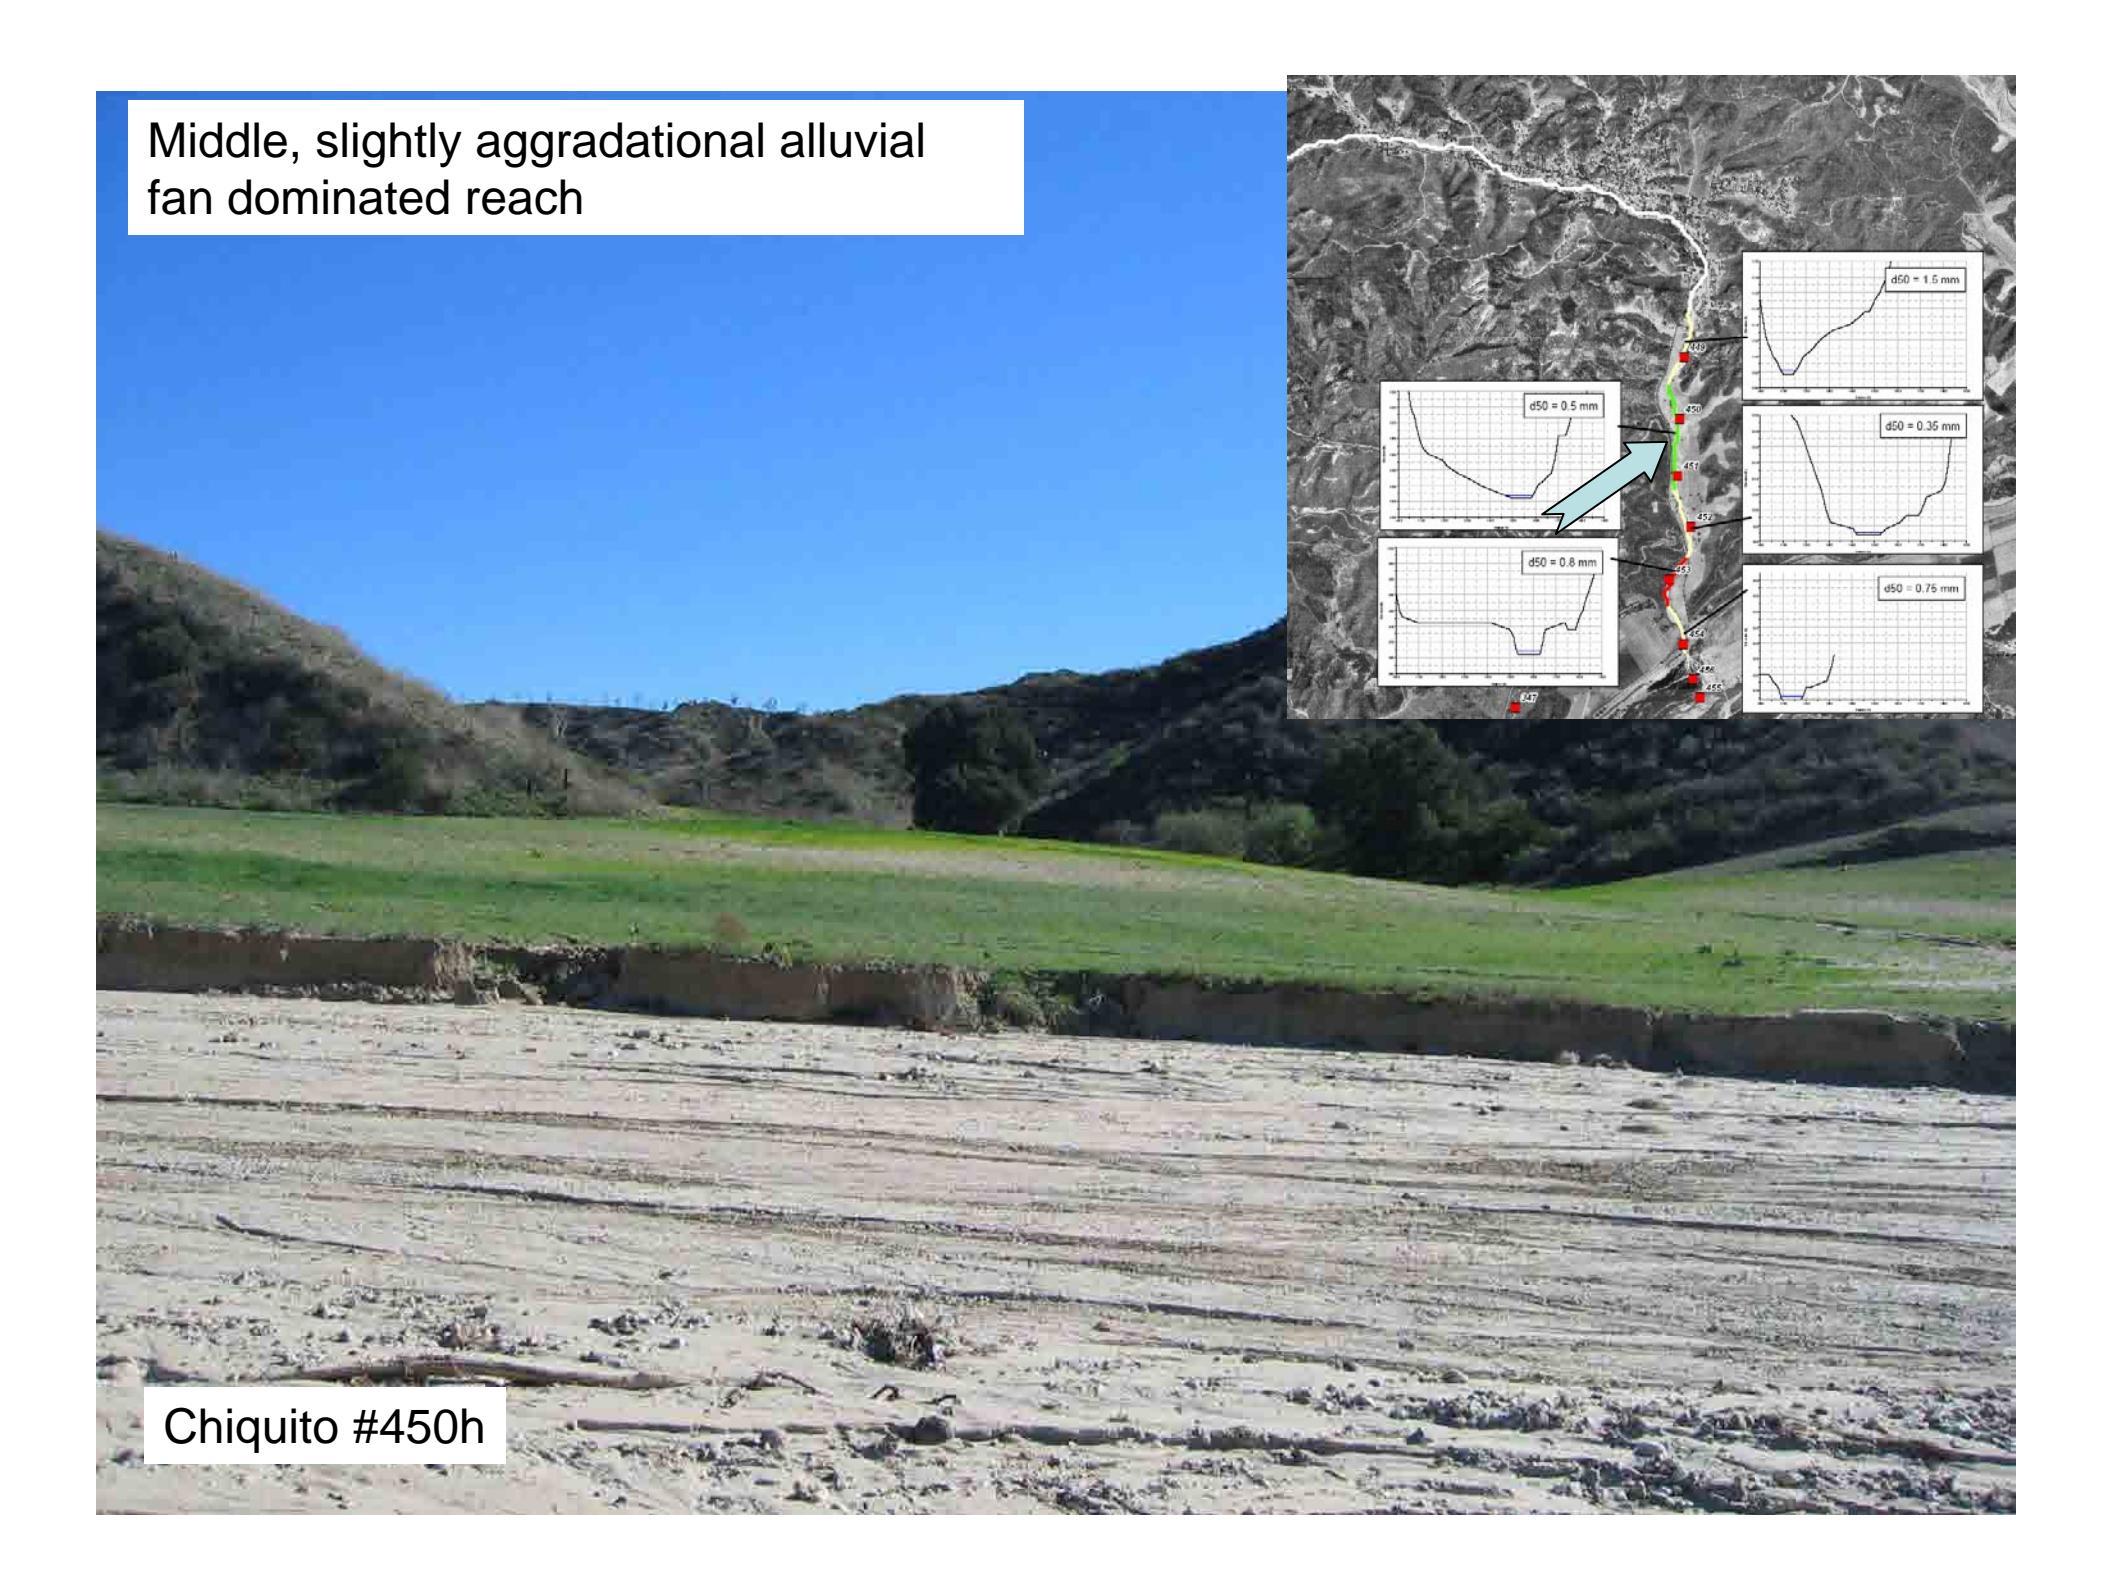
Chiquito Canyon enters the project area in a confined reach with very high, unstable banks (Images 449, 449b). Further downstream it exits its confined canyon and enters a long reach that is dominated by a series of large alluvial fans on the east bank (Images 450a through 452c). These fans are supplying abundant sand to the creek and the channel has formed low banks in the toe of the fan that have little erosion resistance, in part due to the arable landuse and lack of woody vegetation. As a result this reach is aggrading and widening (map classification of this reach as "stable" reflects an initial objective of classifying the channel for potential vertical channel incision). Further downstream (Images 453 through 453b) the channel becomes slightly incised as it cuts through the alluvial fans, leaving abandoned terraces on the banks that are actively eroded on outside bends. Towards the downstream end of the tributary (Images 454 and beyond) the channel remains slightly confined and has been modified by a series of bridges, culverts and artificial channel sections. In places these appear to cause local backwaters and sediment deposition (e.g. Image 453-4b).

Middle, slightly aggradational alluvial fan dominated reach

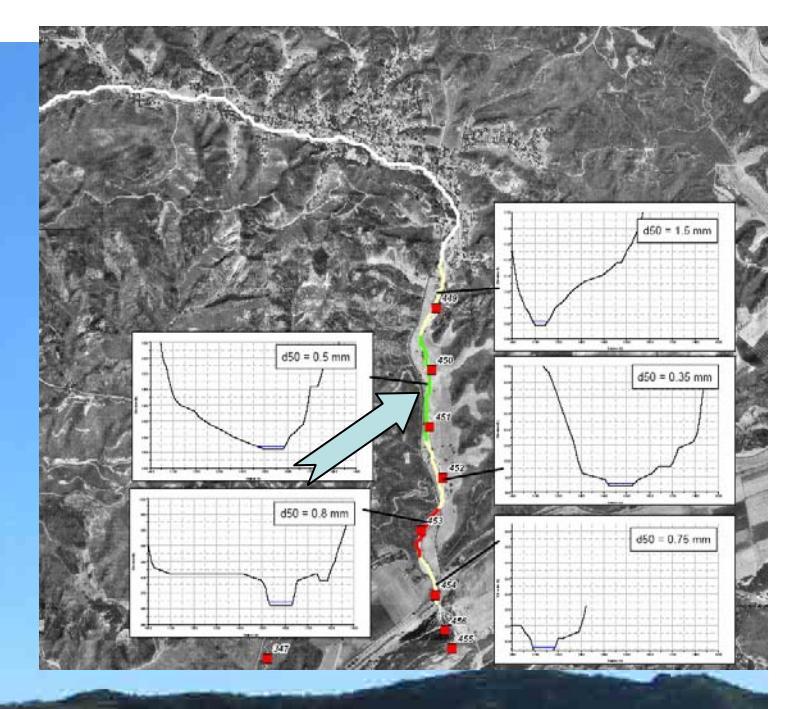
Middle, slightly aggradational alluvial fan dominated reach
