Restoration & Enhancement of Beachfront Shoreline Access: Final Programmatic Report (AMENDED)

Recipient Organization/Agency: Marine Science Institute Date Submitted: July 30, 2019 (Final Submission) Award Amount: \$120,000 Matching Contributions: \$825.67 Total Disbursements: \$120,000 Project Number: 8006.12.033634

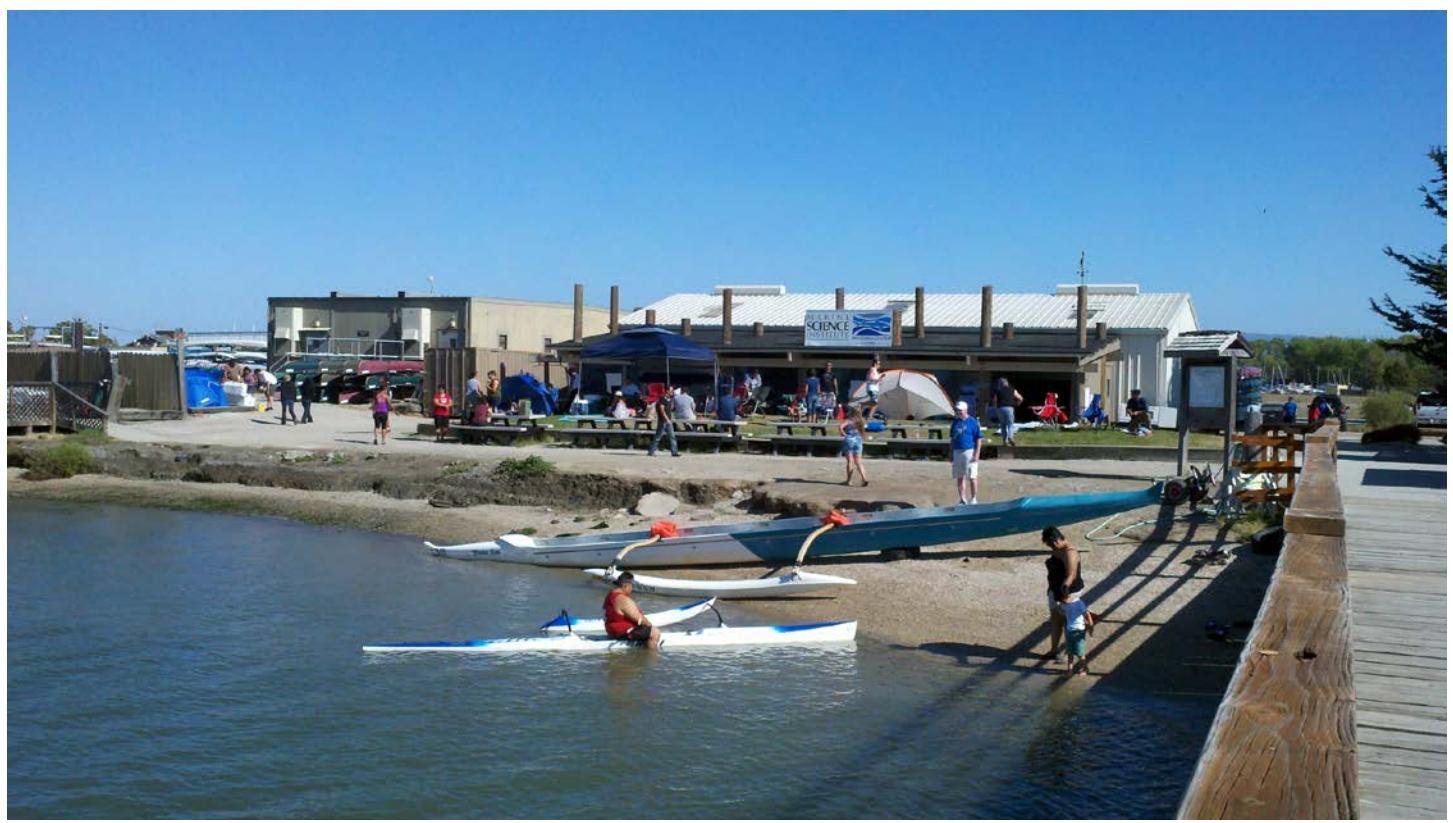
Image 1: Eroded beach and old pier railing, BEFORE PROJECT (photo by Marine Science Institute)

Proposed Activity: Over the decades our beach had eroded to the point that it was severely limiting safe access to the water. Pipes, concrete blocks, and remnants of previous structures were surfacing through the beach area and causing safety hazards for visitors. The disappearing shells made launching boats and enjoyment of the shoreline difficult. San Francisco Bay Conservation and Development Committee (BCDC) had originally advised us that they supported us going forward with this project to restore the beach using the substrate that was originally at the beach. We proposed that we would restore the eroded beach back to its original dimensions, using locally mined oyster shells provided by Jericho Products who are experts in shoreline restoration.

Actual Activity: We hired Lind Marine to restore our eroded beach to its original dimensions. BCDC disallowed the use of oyster shells for restoration material despite their original recommendation. Per the

final BCDC permit instructions, the beach was restored using sand from the bay. (See 2.1.2. Primary Activities Discrepancies)

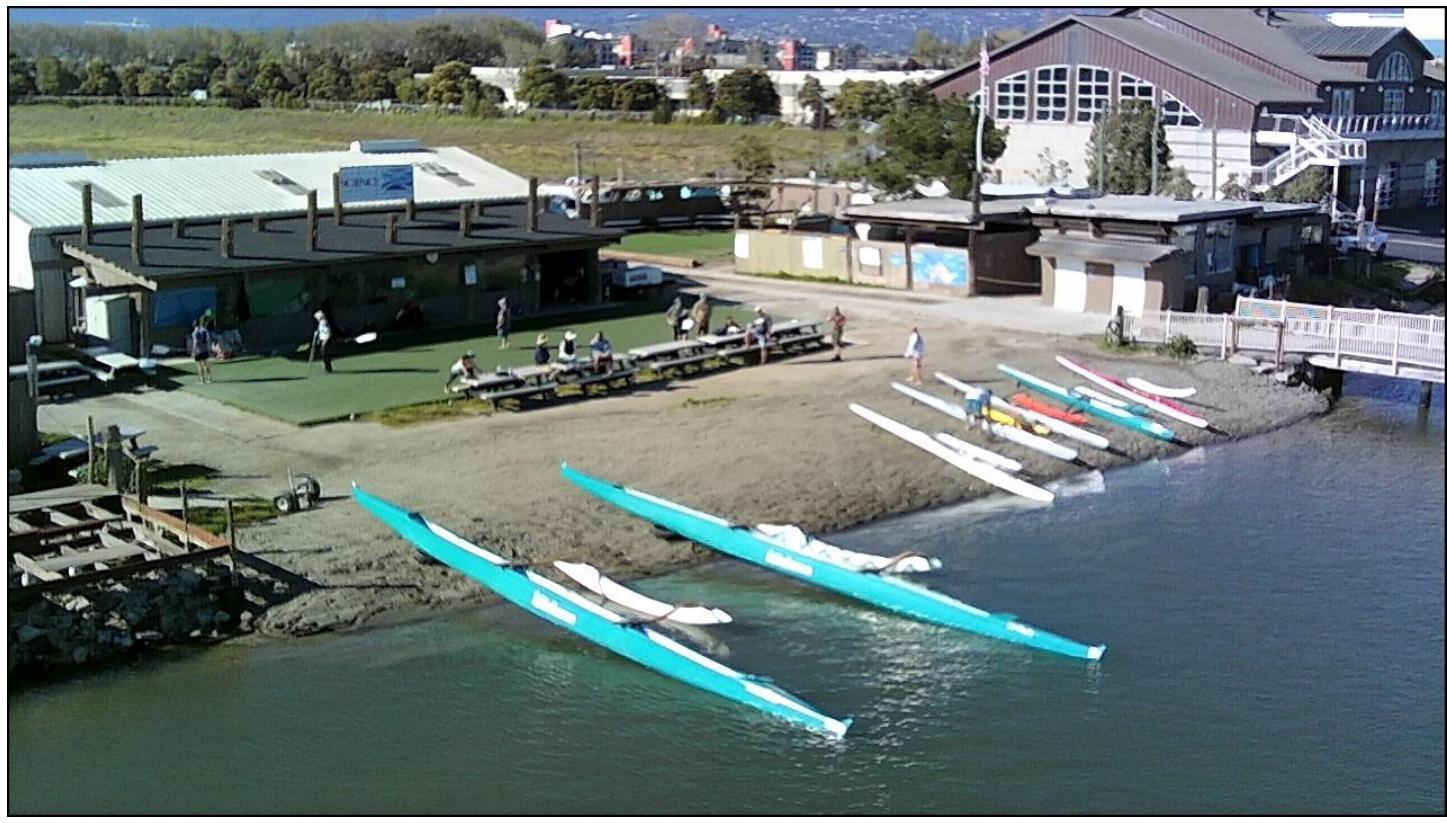
Image 2: Restored beach, AFTER PROJECT (Photo by Marine Science Institute)

After a 6-year struggle to obtain the BDCD permit for the beach restoration, and after numerous time extension requests to NFWF, the beach restoration finally took place March 25-27, 2019. The primary discrepancy in the beach restoration activity is that BDCD rescinded their recommendation of use of oyster shells for the restoration. They instead permitted the beach restoration with the use of sand.

MSI's new beach is stunningly beautiful! Beach access to the San Francisco Bay for recreation, kayak/canoe launching, and human enjoyment is rare, especially in San Mateo County. By restoring our beach, which had eroded significantly and become a trepidatious 3-foot cliff drop, the public (and the thousands of students who come to our beach annually to engage in marine science) now have direct and safe access to the bay at all tide levels. The sand has made it easier for people to launch their canoes, kayaks and row boats than from the previous bay mud. This has expanded the water access for all humans, and immediately there was an increase in boating activity from local rowing paddling and kayaking clubs, solo rowers, and schools. MSI has the only beach stretch of San Mateo County bay shoreline that is accessed via Seaport Blvd. It is the closest boat launch for exploration of the Bair Island Refuge National Wildlife Refuge. This Refuge will surely report more paddlers exploring their marshes.

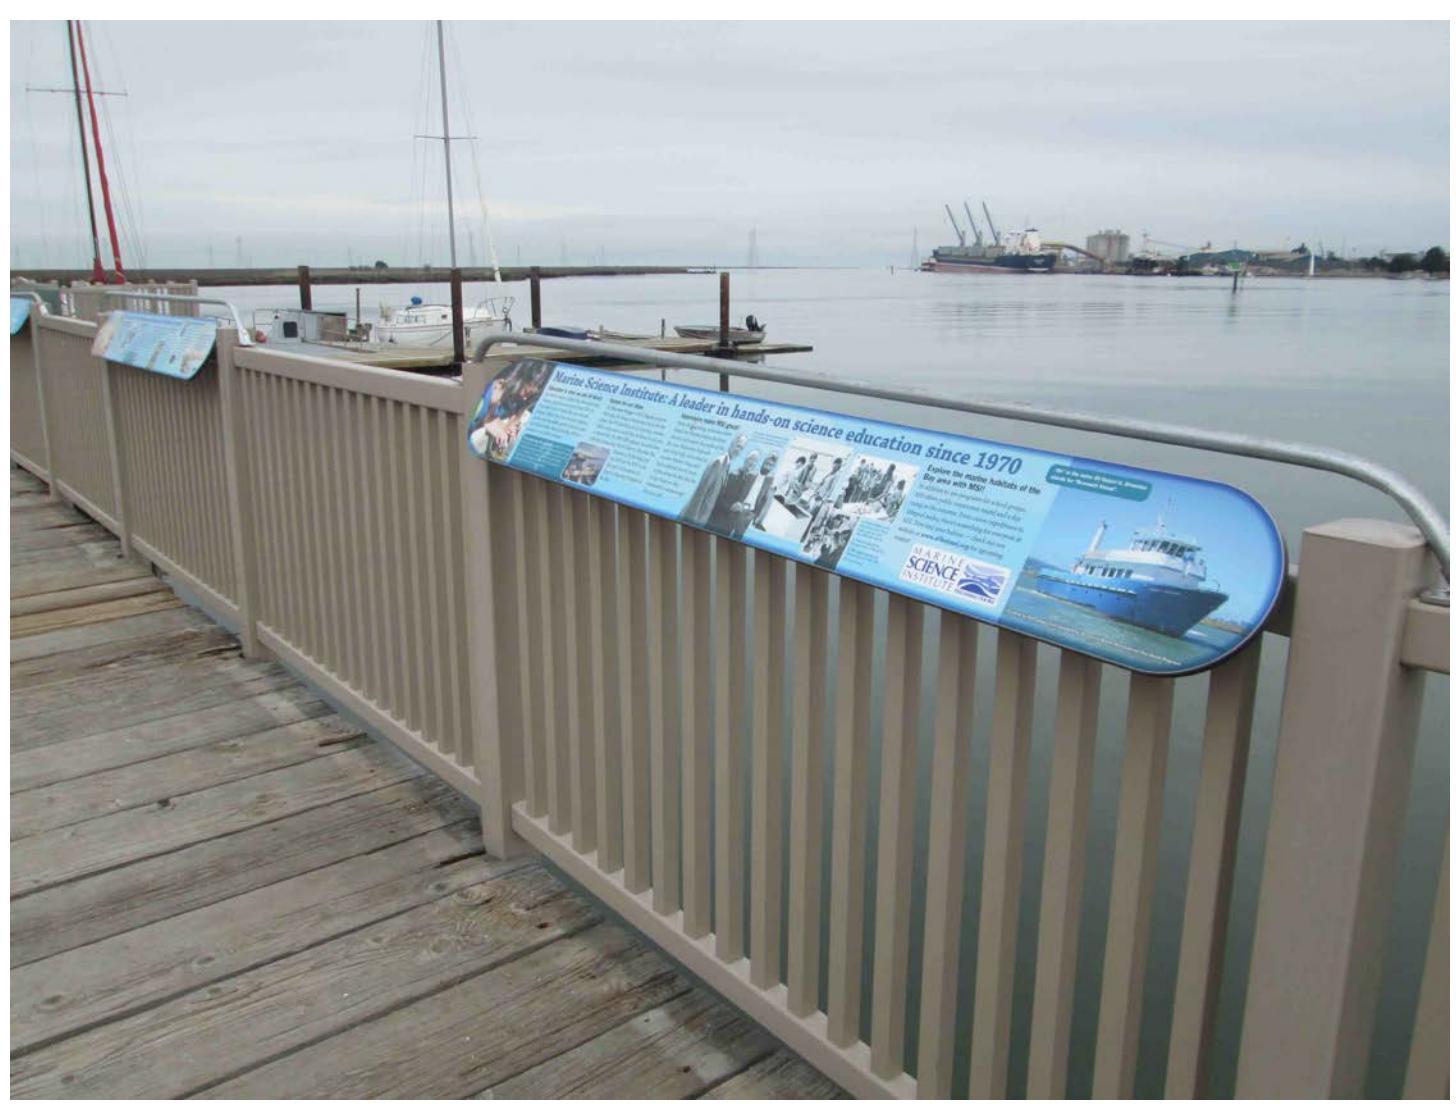
Image 3: New interpretive signage on new protective pier railing, AFTER PROJECT (Photo by Marine Science Institute)

Actual Activity: We replaced our dilapidated wooden dock handrails with sturdy vinyl railings and metal reinforcements. On these rails, as well as on our wildlife viewing deck, we installed interpretive panels so visitors may learn about the surrounding ecosystem at their leisure.

The new handrails are of metal and plastic composite. Now that they've been installed and in use for 6 years, we have witnessed that our pier visitors are safer and splinter-free. Four interpretive panels were professionally designed and installed. Hundreds of students, teachers and visitors come to our campus every day. They linger on the pier and read the panels as they look out over the water to Bair Island and the

Interpretive handrails were constructed with non-corrosive and UV stable materials so require no maintenance except the occasional wiping down with a wet sponge.

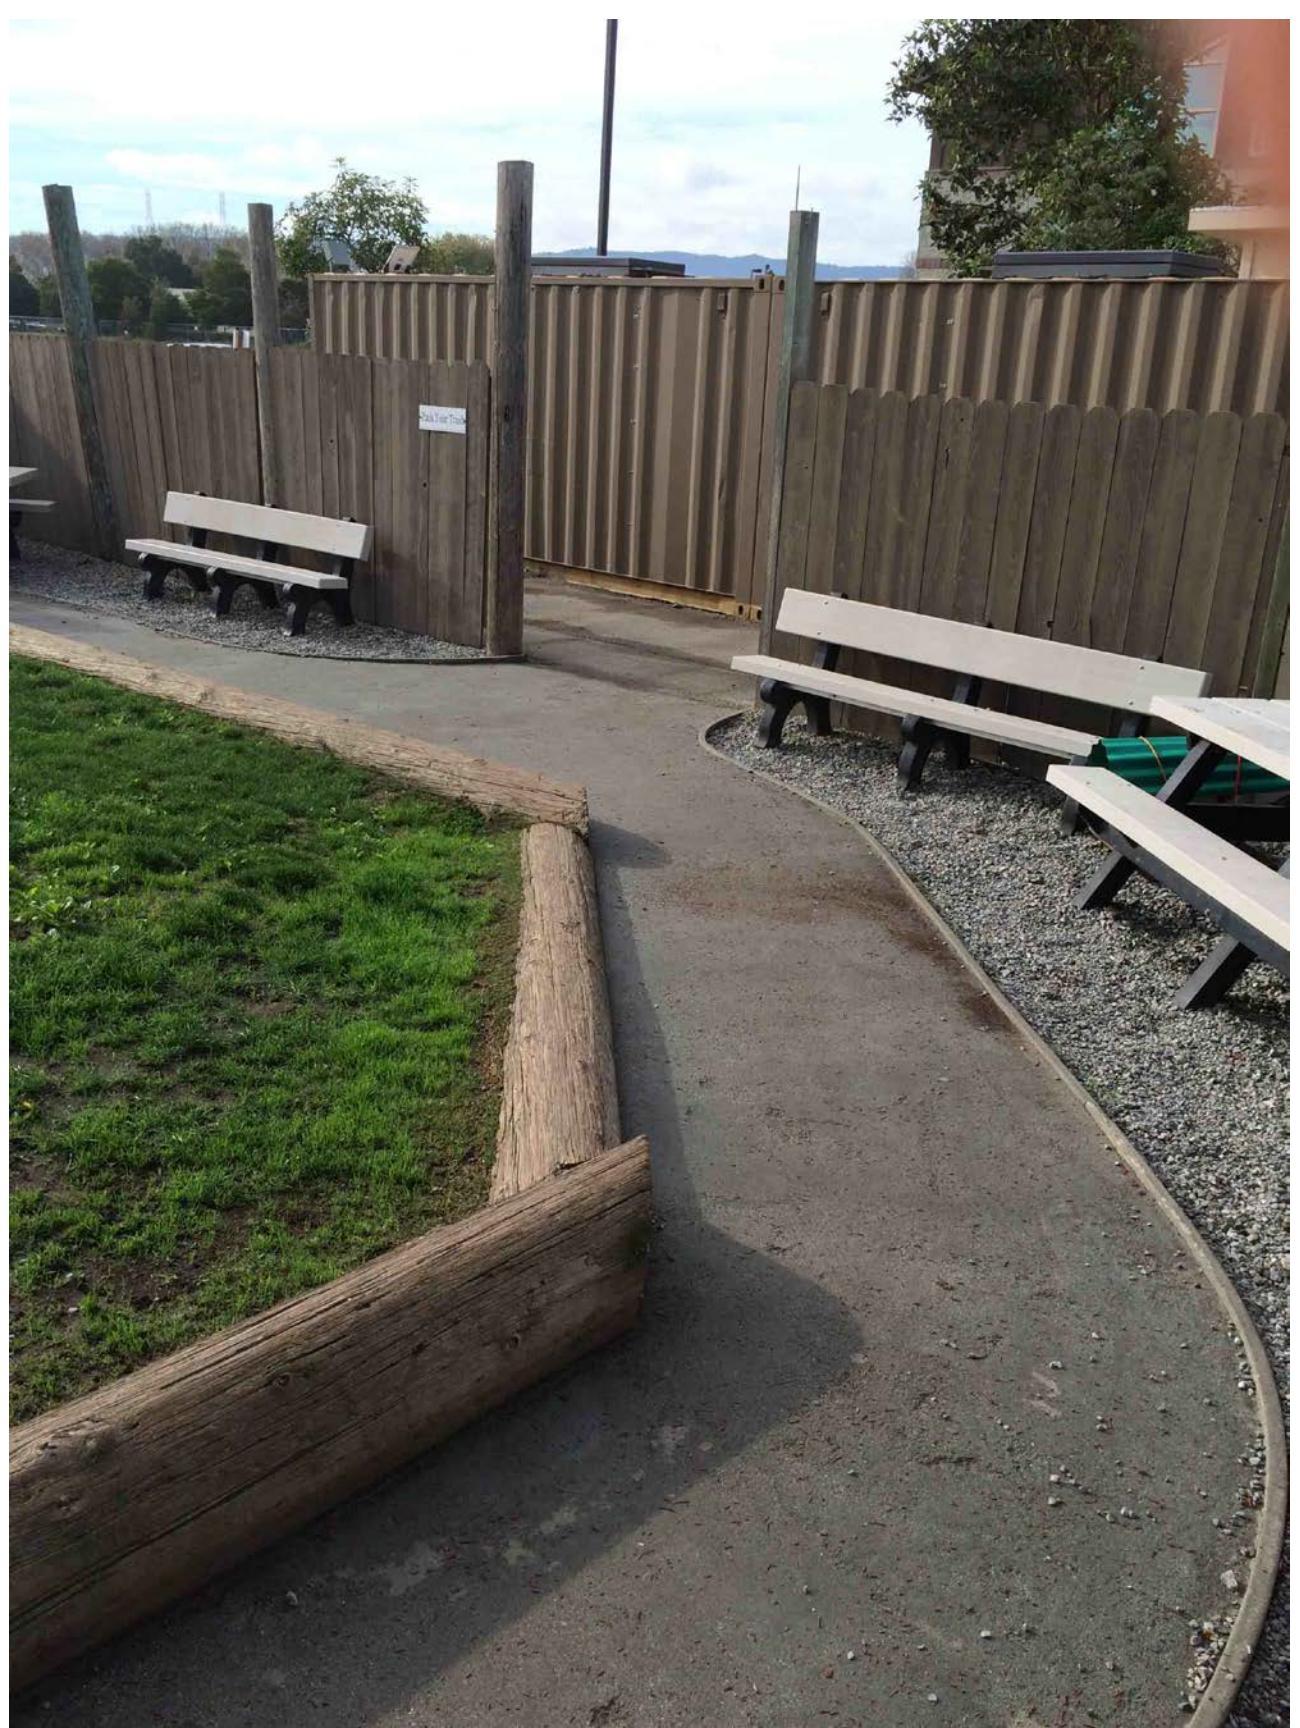
Image 4: New paved pathway leading to restroom facilities (Photo by Marine Science Institute)

Actual Activity: We complied with ADA regulations by completing the paving and joining eco-friendly paths to each area of our site. The parking lot has been leveled, potholes filled, new gravel laid down, cement parking stops installed, and handicapped parking spots are established.

Paved pathways were installed by mixing an ecofriendly soil binder with decomposed granite and compacting to form a solid surface. These require only occasional work to repair minor damage caused by high traffic. A substantial supply of both soil binder and pathway fines are kept on site to perform any necessary repairs or maintenance to the pathways.

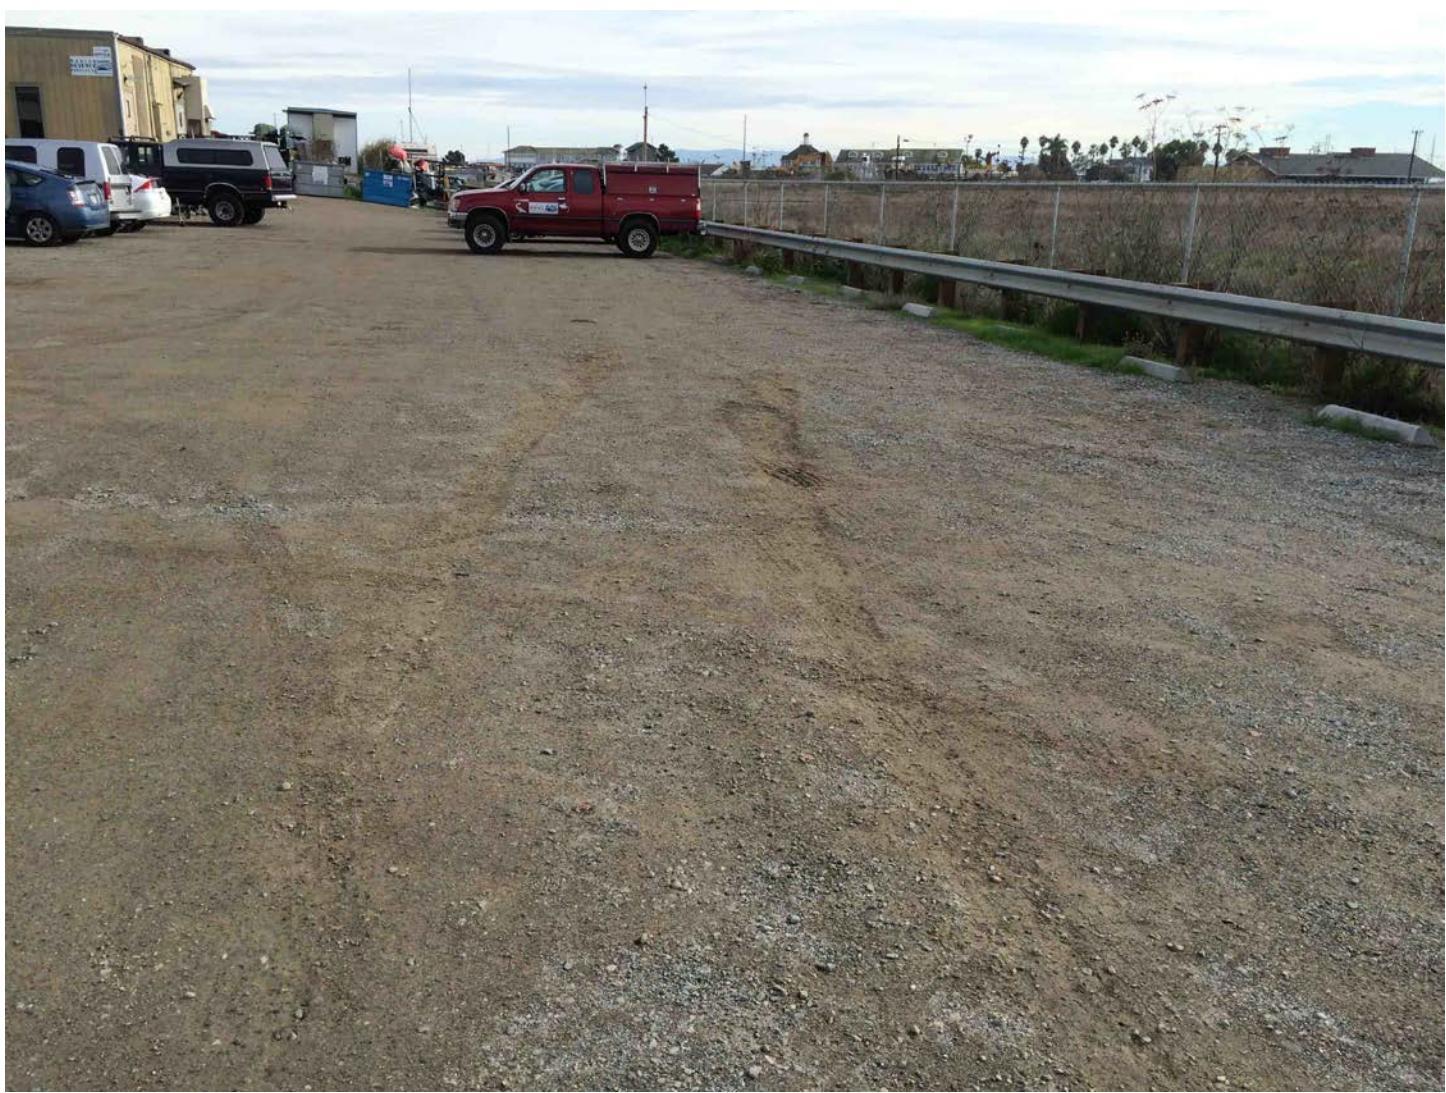
Image 5: Upgraded parking lot with cement parking stops (Photo by Marine Science Institute)

The primary benefit of installing paved paths throughout our site is to provide safe and unobstructed access for all visitors to all sections of our campus. We achieved this benefit by using ADA regulations as a starting point. We provided further ease for our visitors by leveling and laying out new gravel, thereby removing the cause of potholes in our parking lot. We provided protection for visitors' cars by installing cement parking stops. We established handicapped parking spots.

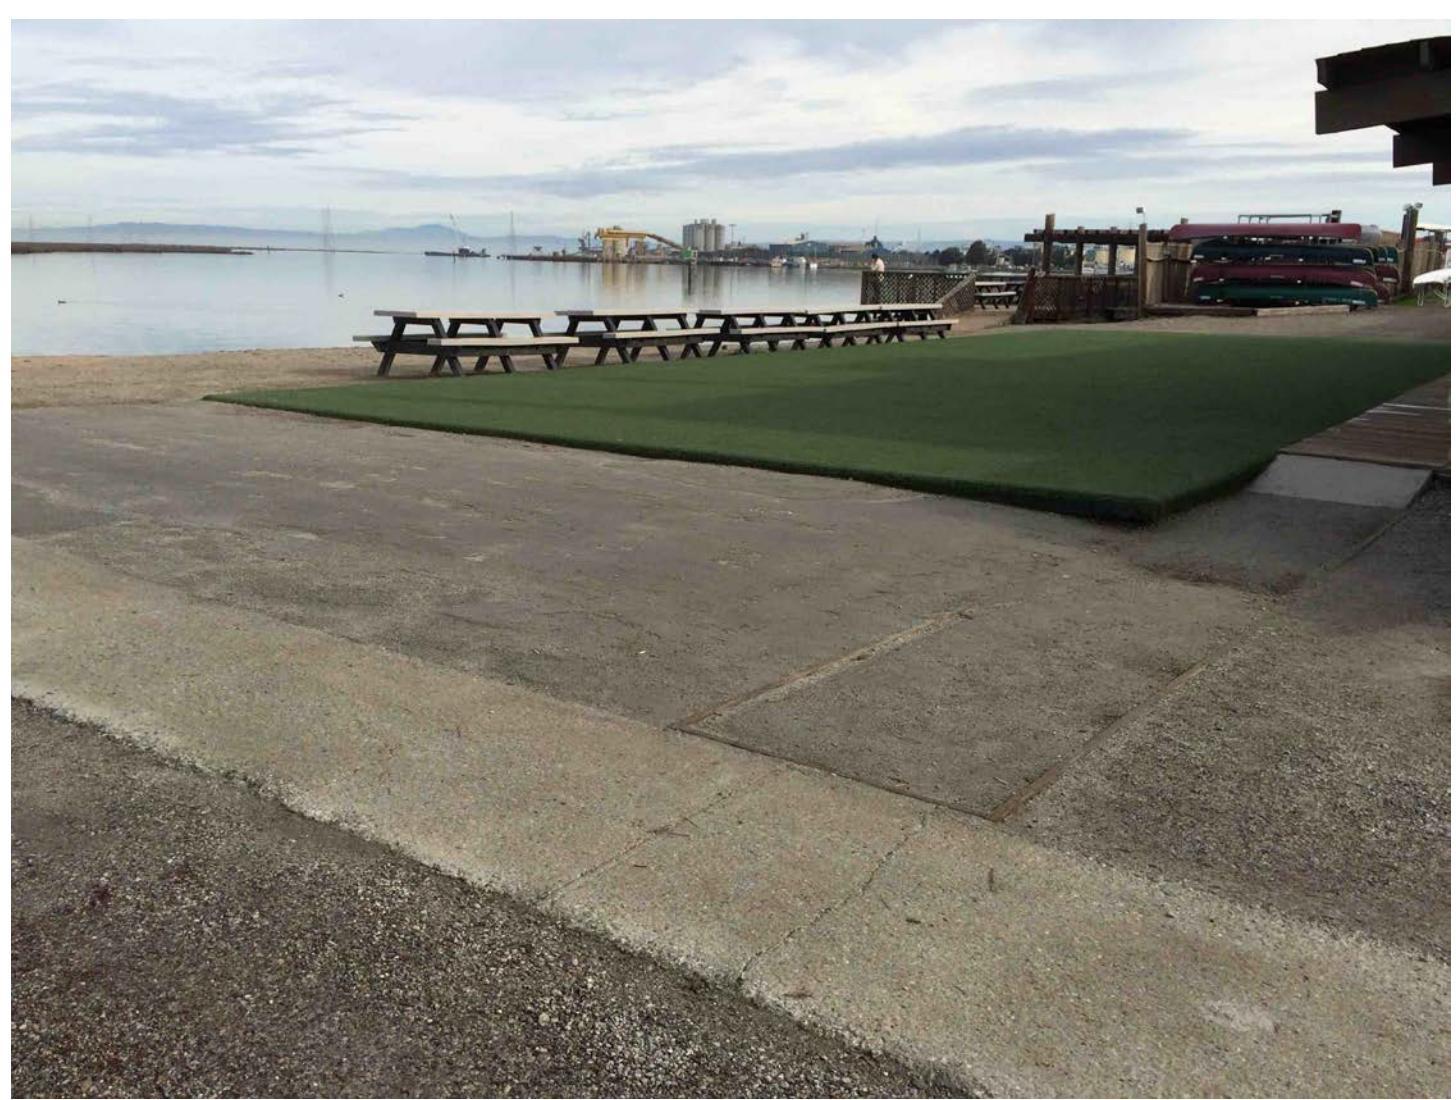
Image 6: New, level synthetic lawn and one section of newly paved pathway leading to MSI's Discovery Aquarium and Marine Science Center (Photo by Marine Science Institute)

Actual Activity: We took out the raised-bed grass structure. We then flattened and rebuilt the grass area and installed new synthetic turf.

The new turf area is now level to the ground providing all visitors with unobstructed access to the lawn, and it is now a level playground for children and picnic area for families. This is a synthetic turf that no longer requires watering. This has severely cut down our use of water, which is essential during the drought seasons. Since water is no longer necessary, there is no more run-off to add to the beach erosion. The lawn no longer requires the use of fertilizer and is weed-free.

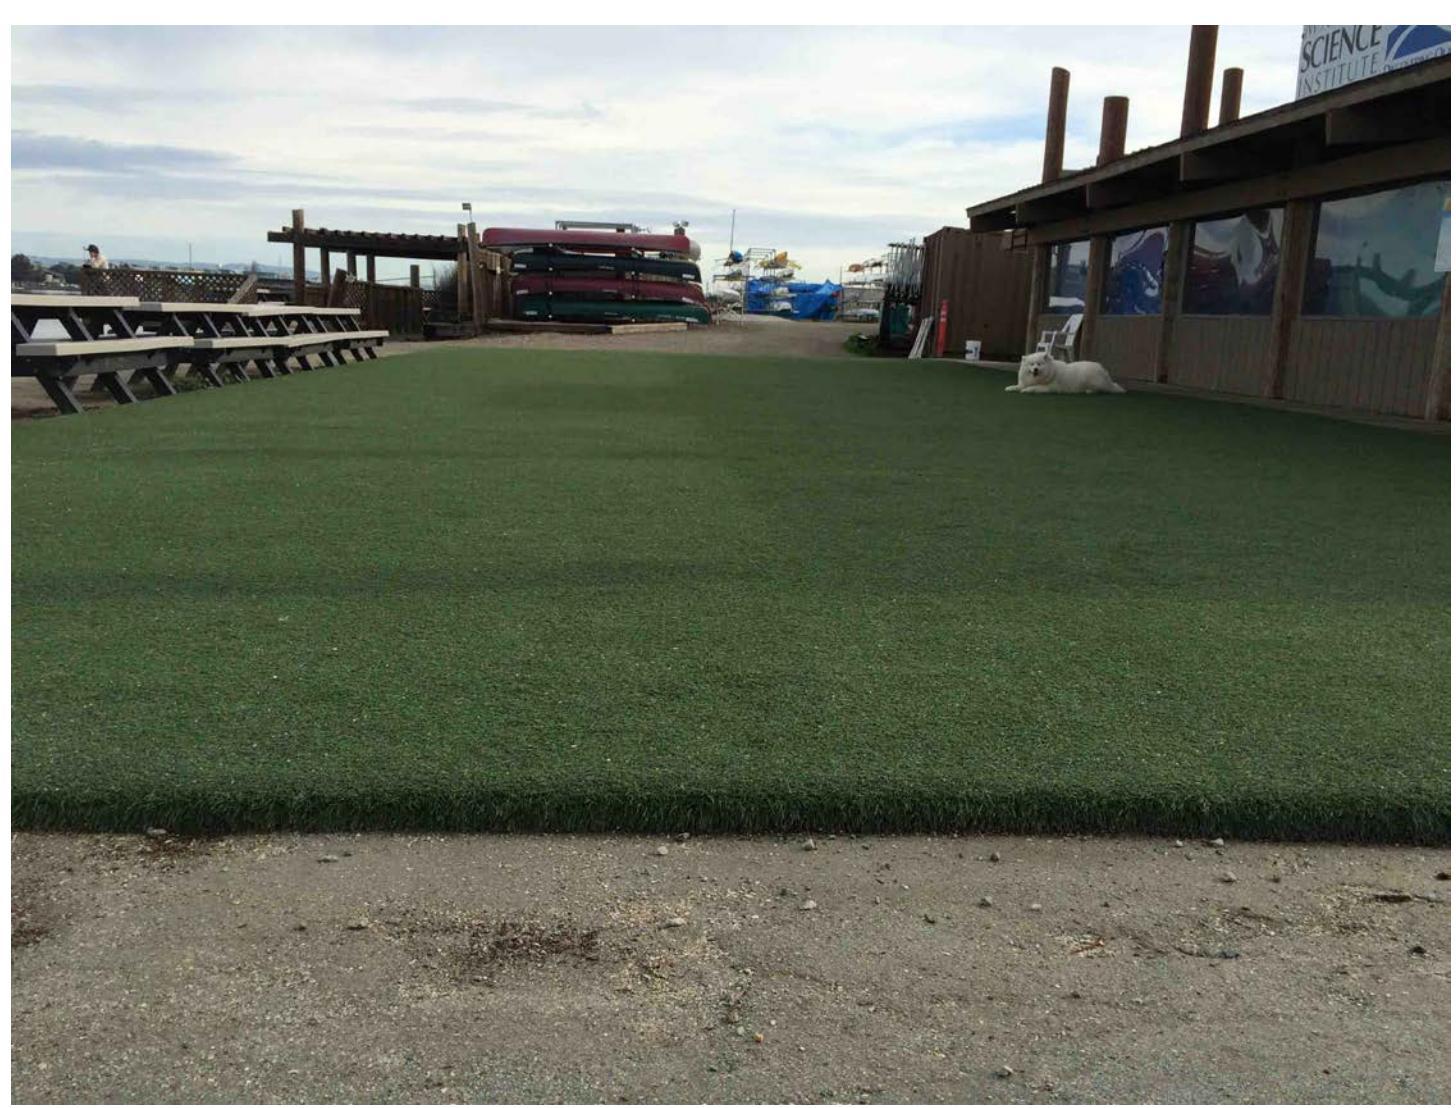
Image 7: New, level synthetic lawn (Photo by Marine Science Institute)

The artificial grass is serviced once a month using a special motorized bristle brush attachment on a weedwhacking motor. Brushing the grass helps to both lift the individual grass blades, as well as remove a lot of the sand and shell that accumulates within the grass blades.

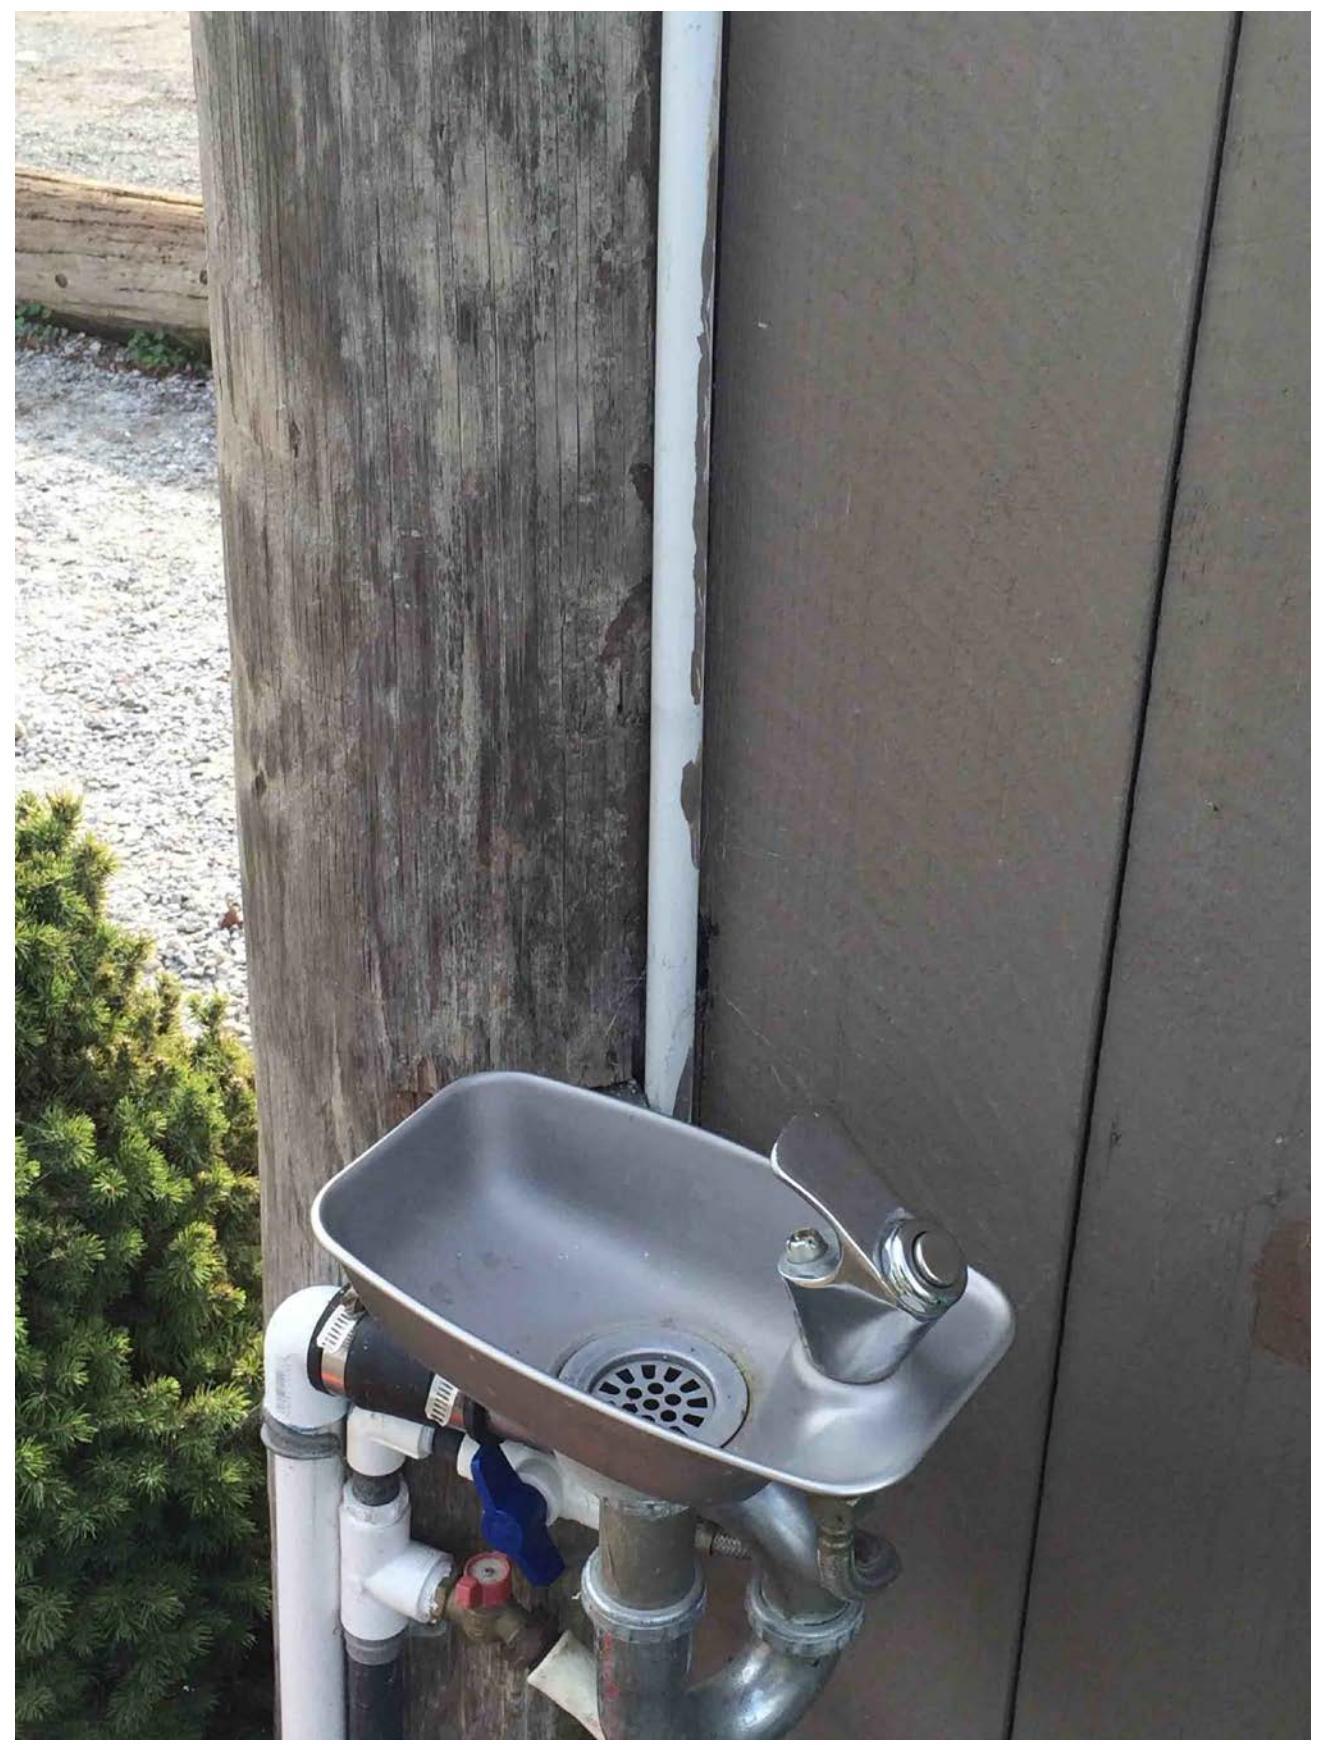
Image 8: Newly installed water fountain, located on a paved walkway near restrooms (Photo by Marine Science Institute)

• *Construction of a designated boat wash station for recreational boaters and water fountains* When MSI drafted the grant proposal in 2012, we intended to install one wash station for recreational boats and multiple water fountains for human consumption. We have successfully installed the wash station. However, due to cost constraint, we are only able to one water fountains rather than multiple ones.

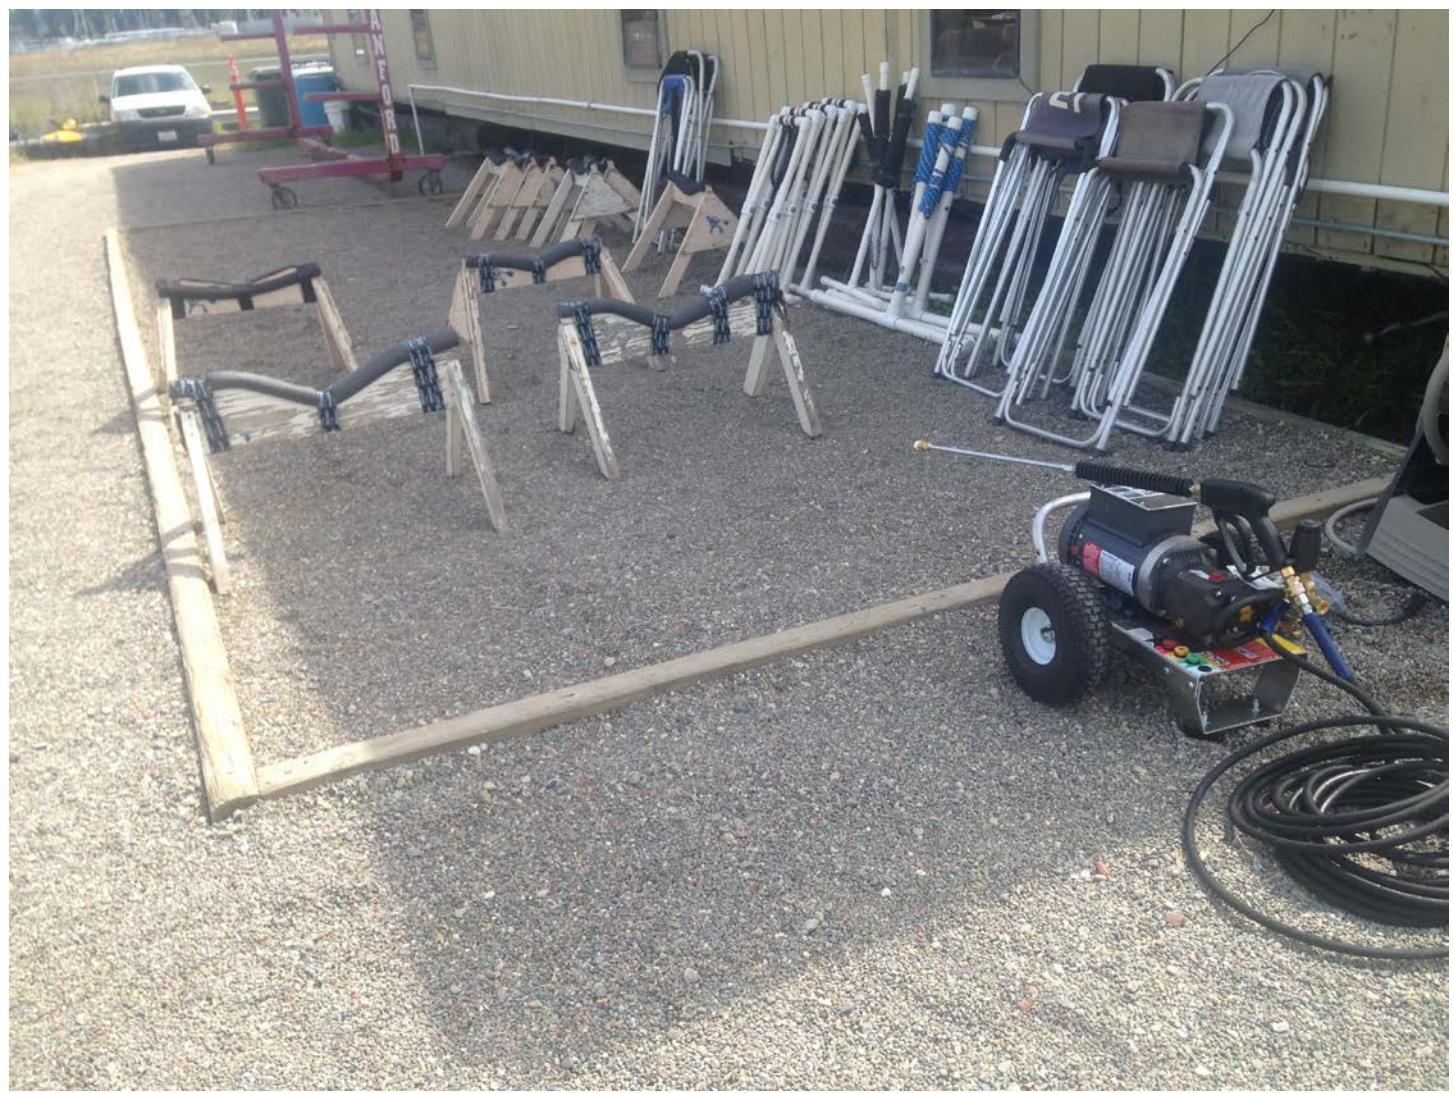
Image 9: New boat wash station with pressure washer (Photo by Marine Science Institute)

Actual Activity: We created a boat washing station on the side of our building. The station is positioned a sufficient distance from the beach, preventing further beach erosion.

With the installations of the dedicated boat wash station with pressure washer far away from the beach, we have witnessed measurably reduced run-off and associated erosion to the beach. The boat wash activity no longer conflicts with recreation activities as it is now located on the boat storage side of the campus. There is more room to spread out both activities which greatly enhances the experience for all. Fresh water is now available to visitors via the newly installed water fountain that replaced what was once the hose that served both purposes of boat washing and drinking.

Due to the increased use of the boat washing station over the last several years, the amount of rinse water became too much for the French drains that were originally installed with the wash station. Excess rinse water would begin to overflow from the rinse station and run downhill towards the shoreline where it began to slowly erode the beach. If left unresolved, this problem would present a serious erosion problem to our new beach in the near future.

The pressure washer was purchased from watercannon.com, who specialize in commercial pressure washers for various applications. We spoke extensively with Water Cannon's tech support team before deciding on the specifications of the pressure washer we purchased. Our main objectives were to conserve as much water as possible while making sure not to operate at such a high pressure that we would damage a boat's gelcoat or paint. The pressure washer we purchased operates at an extremely efficient 1.0 gallons per minute, which is a huge improvement over the 25+ gallons per minute that we were using directly from the garden hose before. Less water being used to rinse boats means less water that will run off and make its way down to the shoreline to cause erosion problems.
