Mill Creek Dam Removal Implementation and Monitoring Project (amended)

Recipient: Sempervirens Fund. Project Period: 05/01/2021 – 4/30/2022 Award Amount: \$25,000 Matching Funds: \$425,000 Project Number: #8006.21.072171

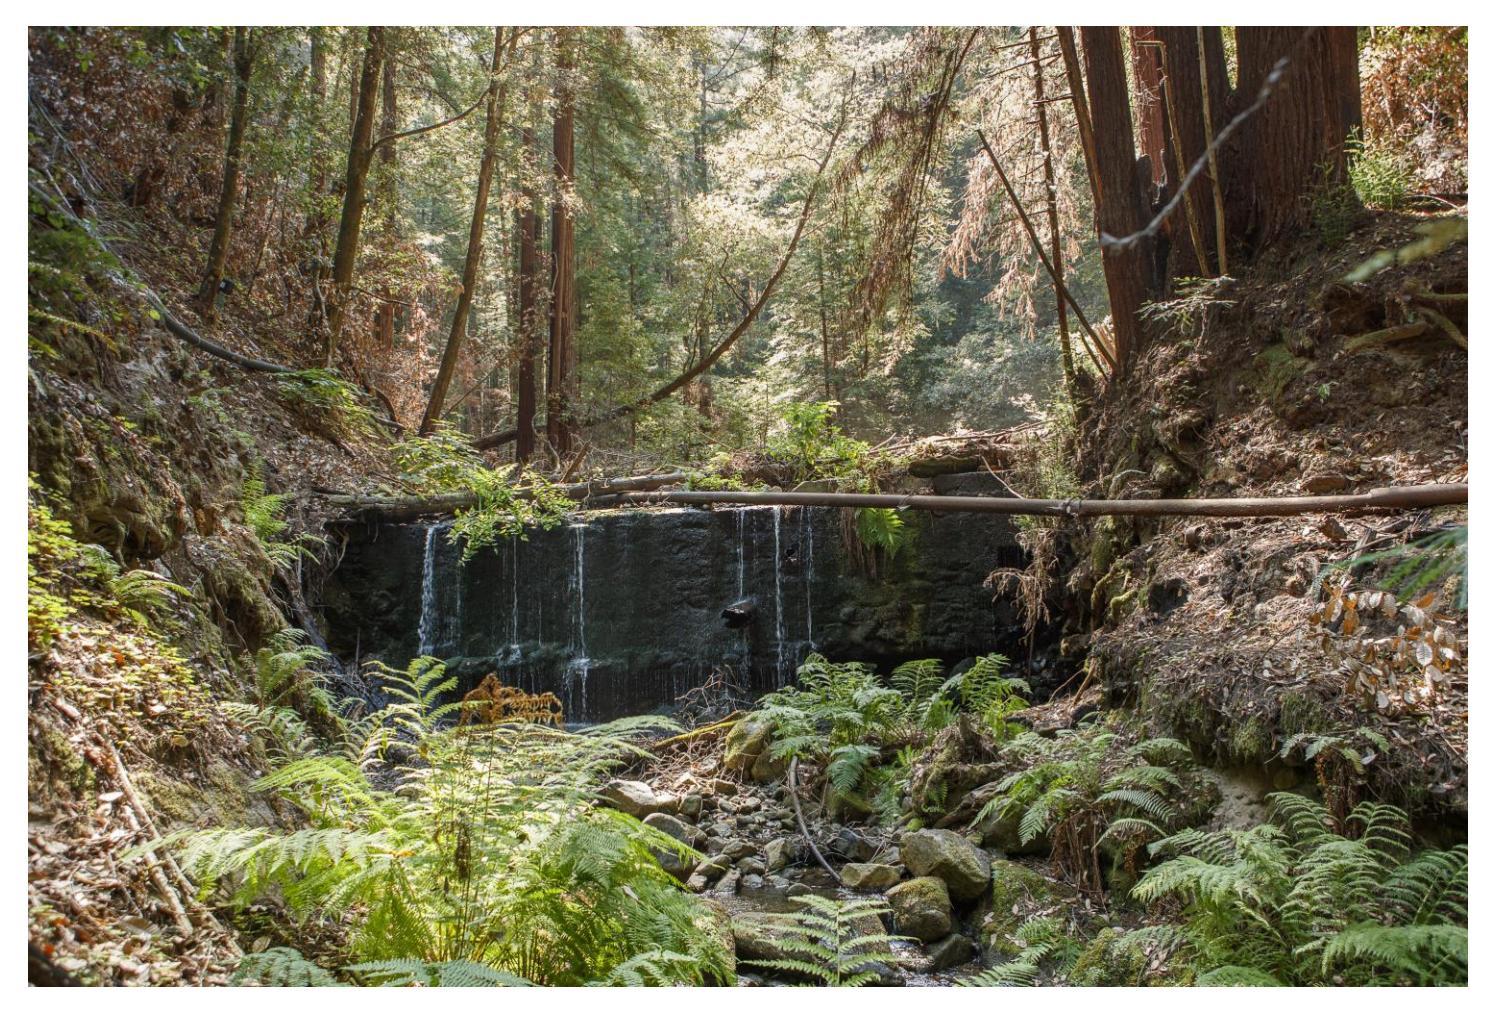
Image 1: Below lower Mill Creek Dam, look upstream prior to dam removal.

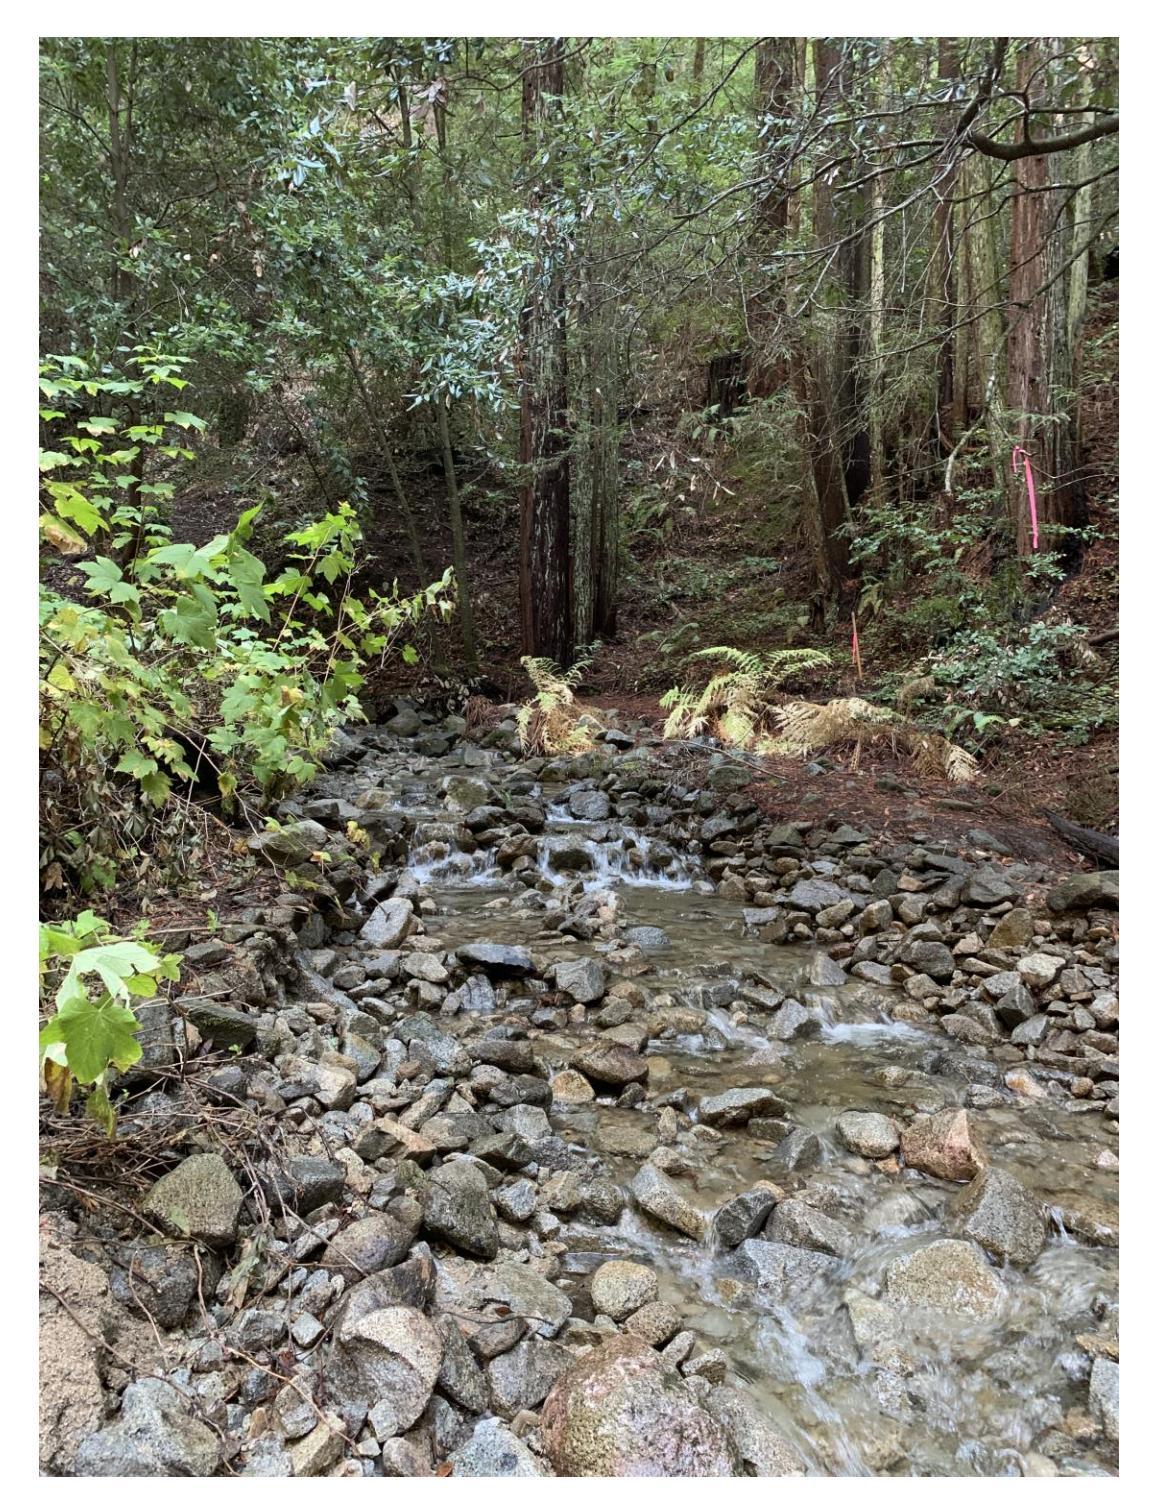
Image 2: Above former lower Mill Creek Dam, looking upstream in mid-November after removal, showing sediment mobilization from significant early season storms reaching above limit of construction disturbance.

Since the dam removal project ended, two major storm events at the site occurred in October and December 2021 that provided an opportunity to observe the viability of the dam removal and stream restoration goals for the project. The storms accelerated sediment movement that was anticipated to occur over several years and instead took place over just a few months. A new gravel bar has formed from the sediment that had accumulated behind the dam, creating important spawning habitat for both fish species in the watershed. Mill Creek is flowing into the historic floodplain which was a longer-term goal for the project, and now connects into San Vicente Creek at two locations.
