# Berkeley South Sailing Cove Restroom Project: Final Programmatic Report (AMENDED)

*Recipient Organization/Agency: City of Berkeley*  
*Date Submitted: May 31, 2019 (Final Submission)*  
*Award Amount: \$600,000*  
*Matching Contributions: \$194,430*  
*Total Disbursements: \$600,000*  
*Project Number: #8006.12.033631*

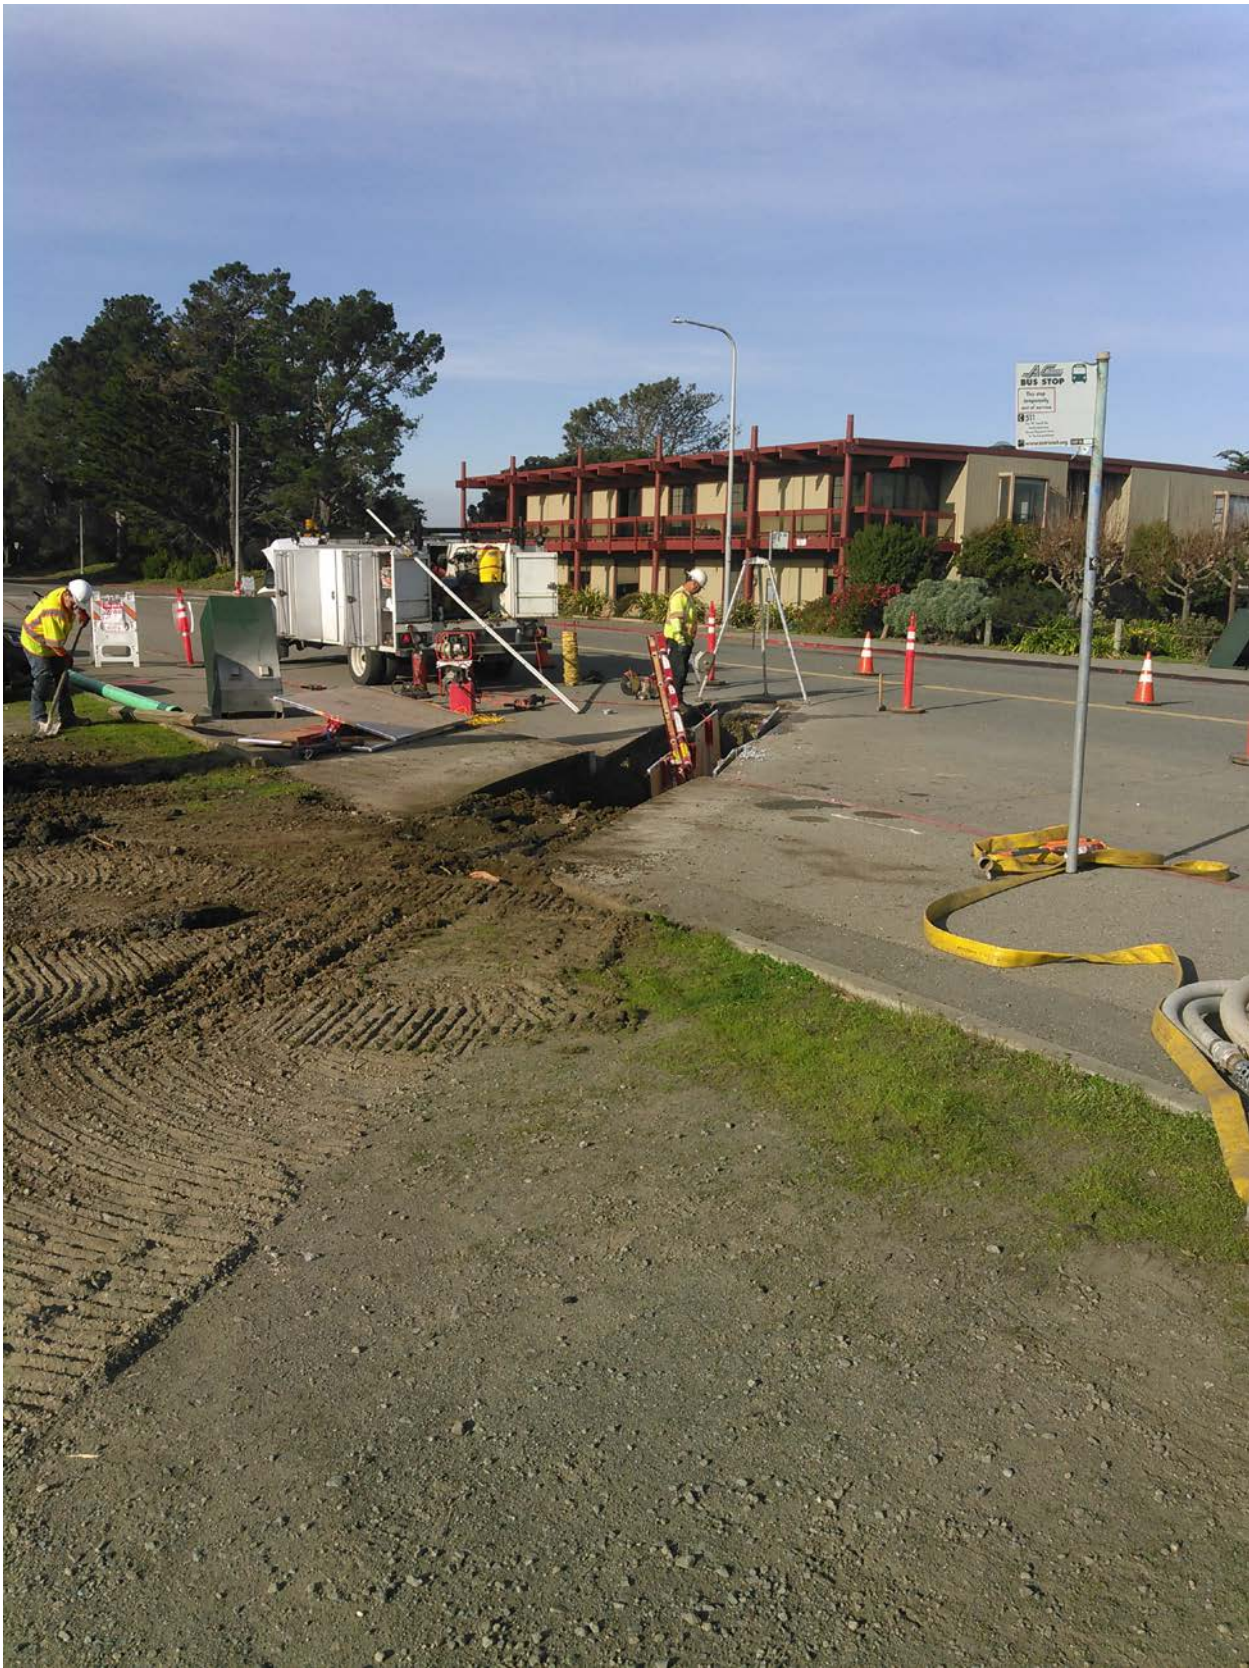
*Image 1: South Cove East Parking Lot – Excavating the new sanitary sewer line for the new public restroom, starting at the mainline manhole at University Ave, 10 feet below grade (Photo by D. Sheils).*

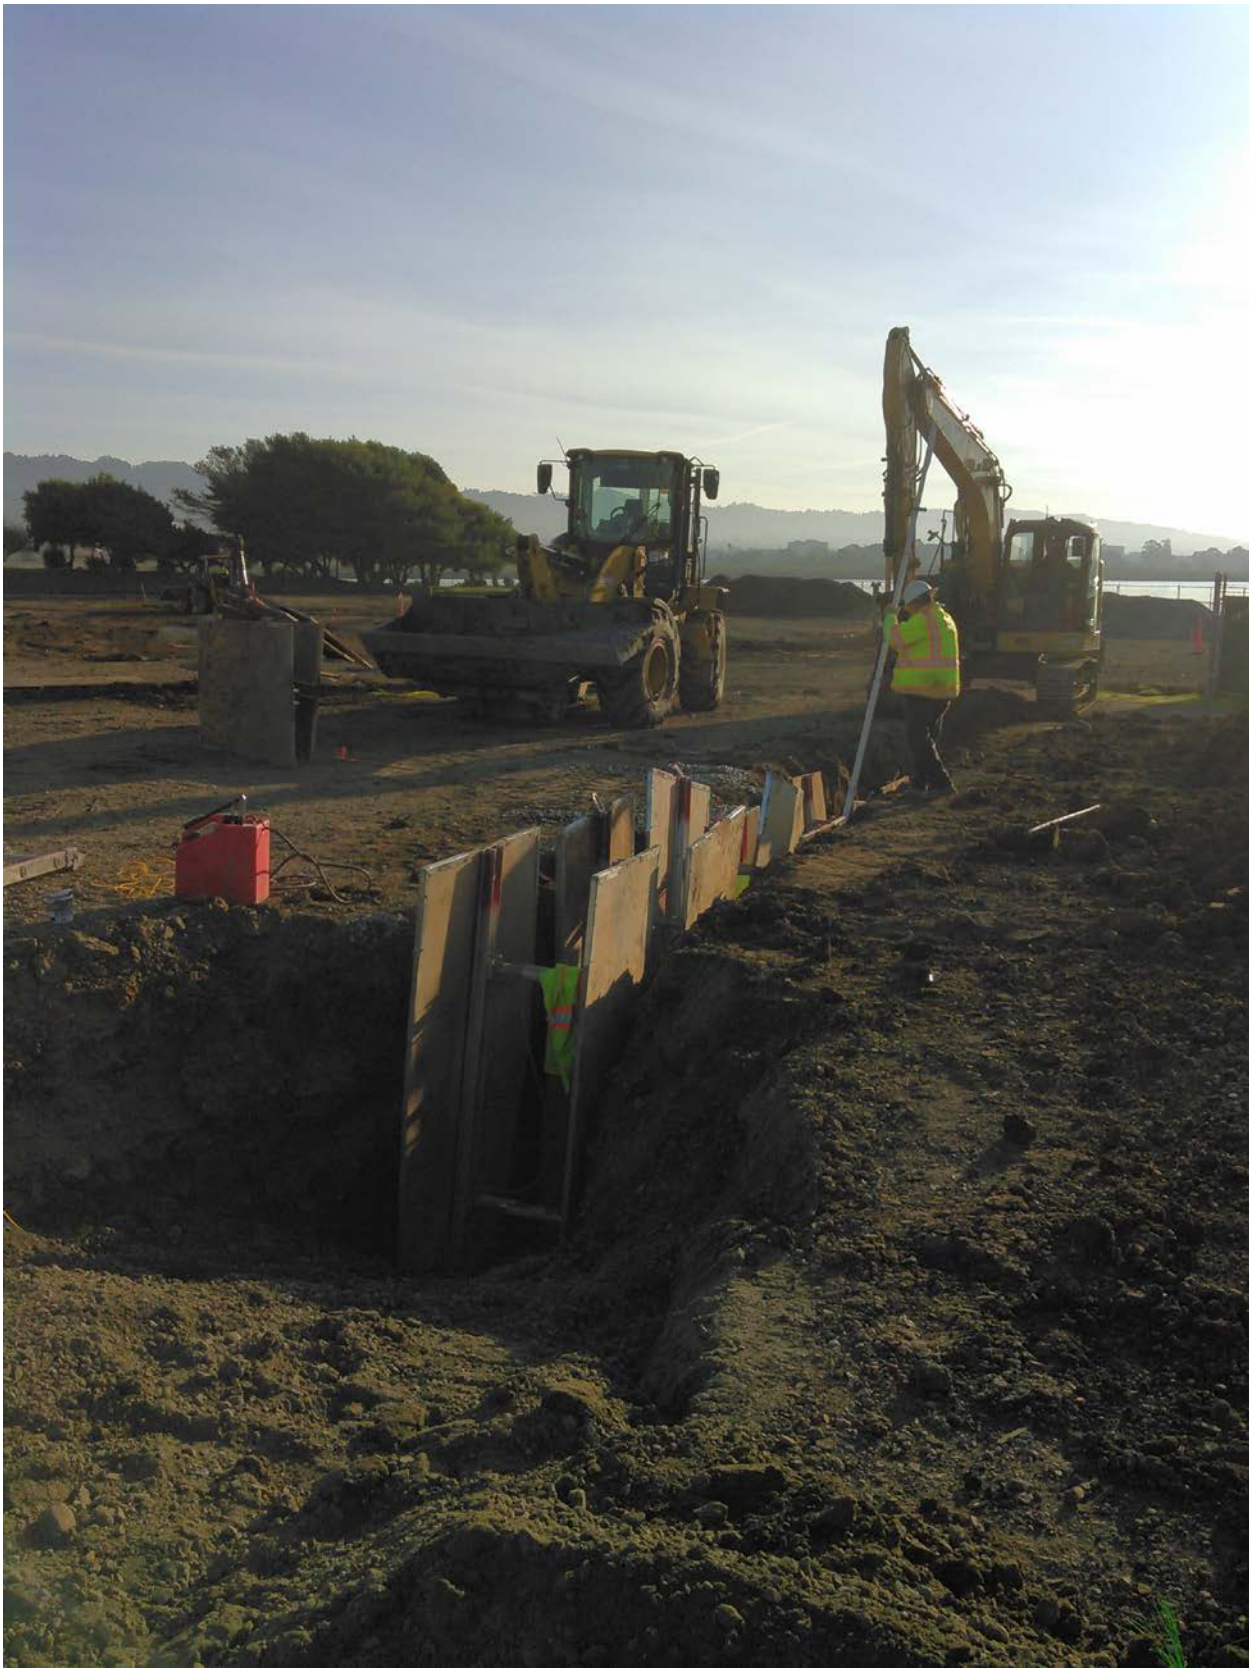
*Image 2: South Cove East Parking Lot – Trenching southward from University Ave to the location of the new public restroom adjacent to the Bay Trail (Photo by D. Sheils).*

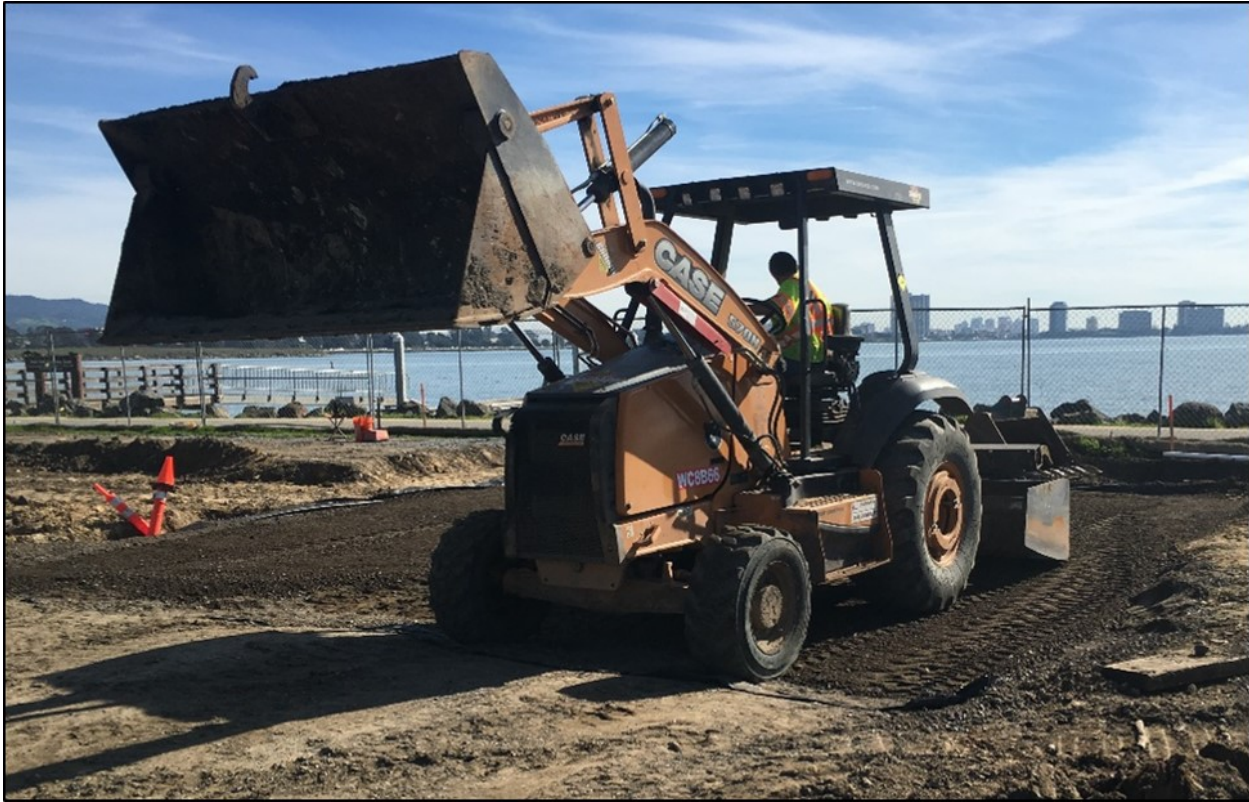
*Image 3: South Cove East Parking Lot – Compacting and stabilizing existing subsoils atop Bay muds  
(Photo by D. Sheils).*

- **Discrepancy:** Despite a thorough geotechnical investigation of the site during the design phase, the grading and compaction operation encountered locations where the underlying water-saturated Bay mud soils were close to the surface. This situation required some unexpected off-haul of Bay mud soils to install the deep bioswale and its storm drain lines, as well as additional compaction by heavy

equipment in selected areas, including the location of the new public restroom (these change orders were covered by City contingency funds).

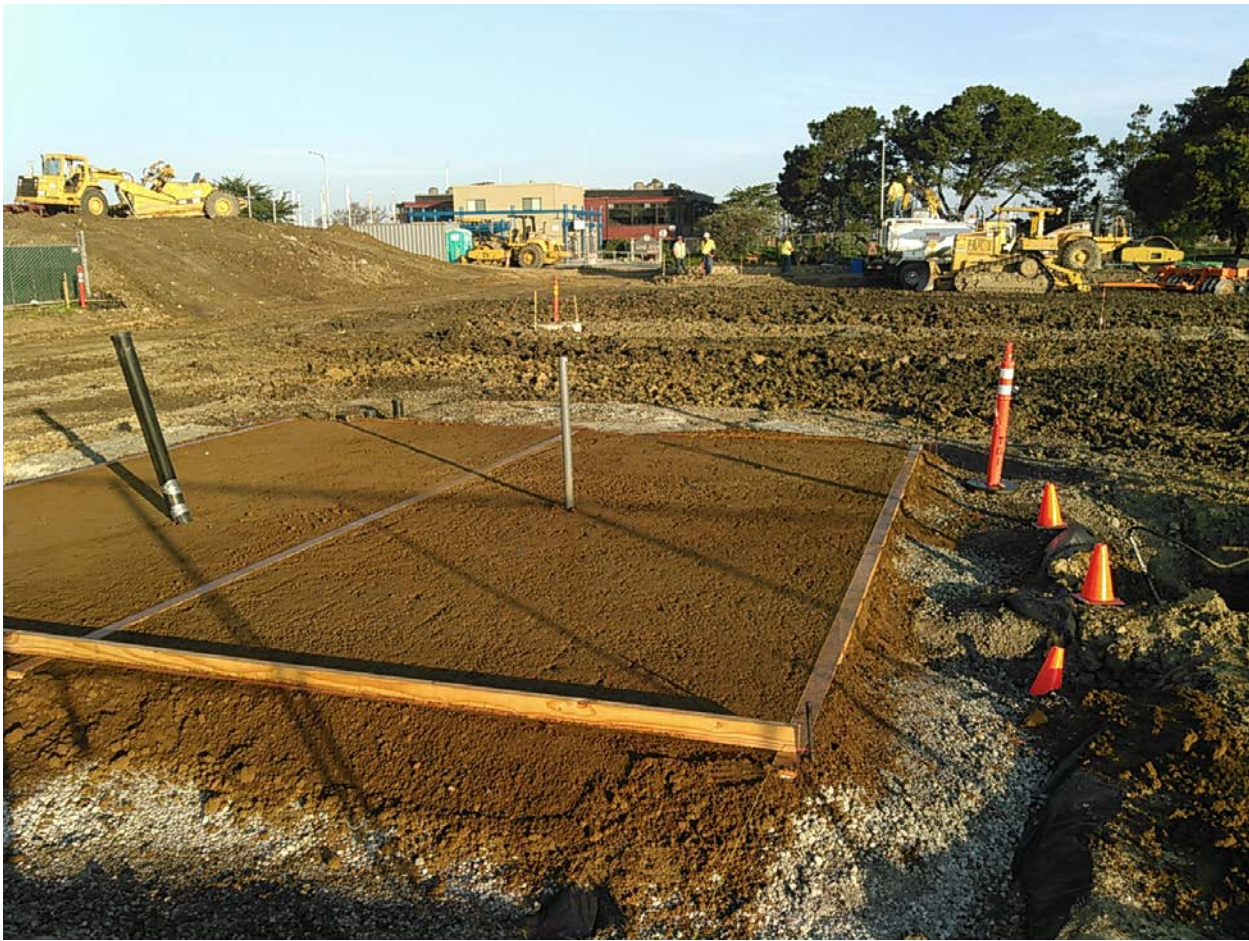
*Image 4: South Cove East Parking Lot – Complete final base layer for new restroom (Photo by D. Sheils).*

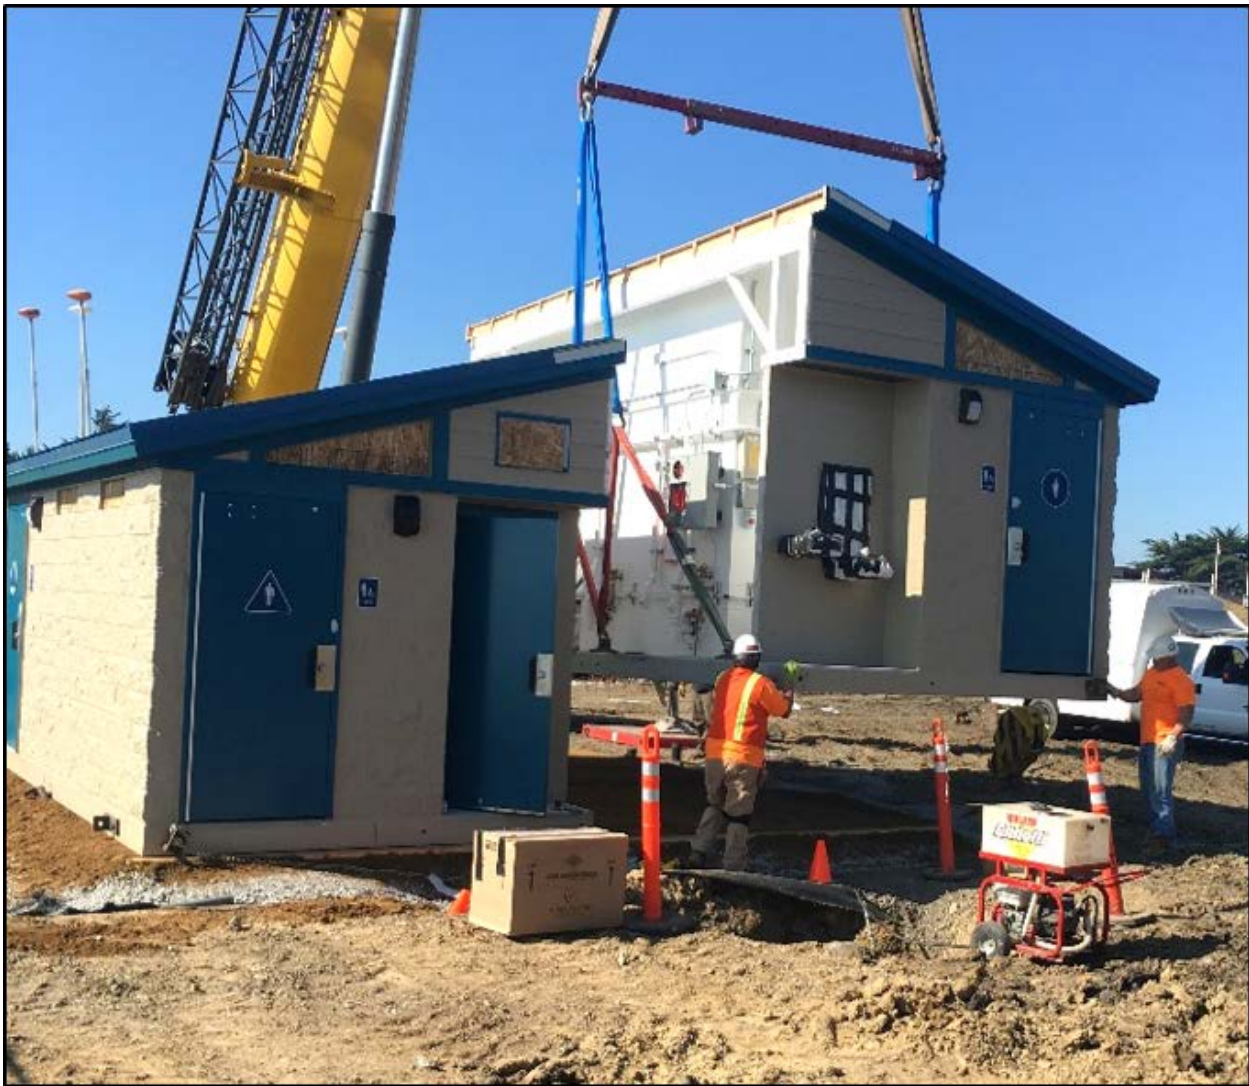
*Image 5: South Cove East Parking Lot – Installing the new pre-fabricated restroom by crane at the site. The restroom building is constructed in two sections in order to meet highway transportation requirements (Photo by D. Sheils).*

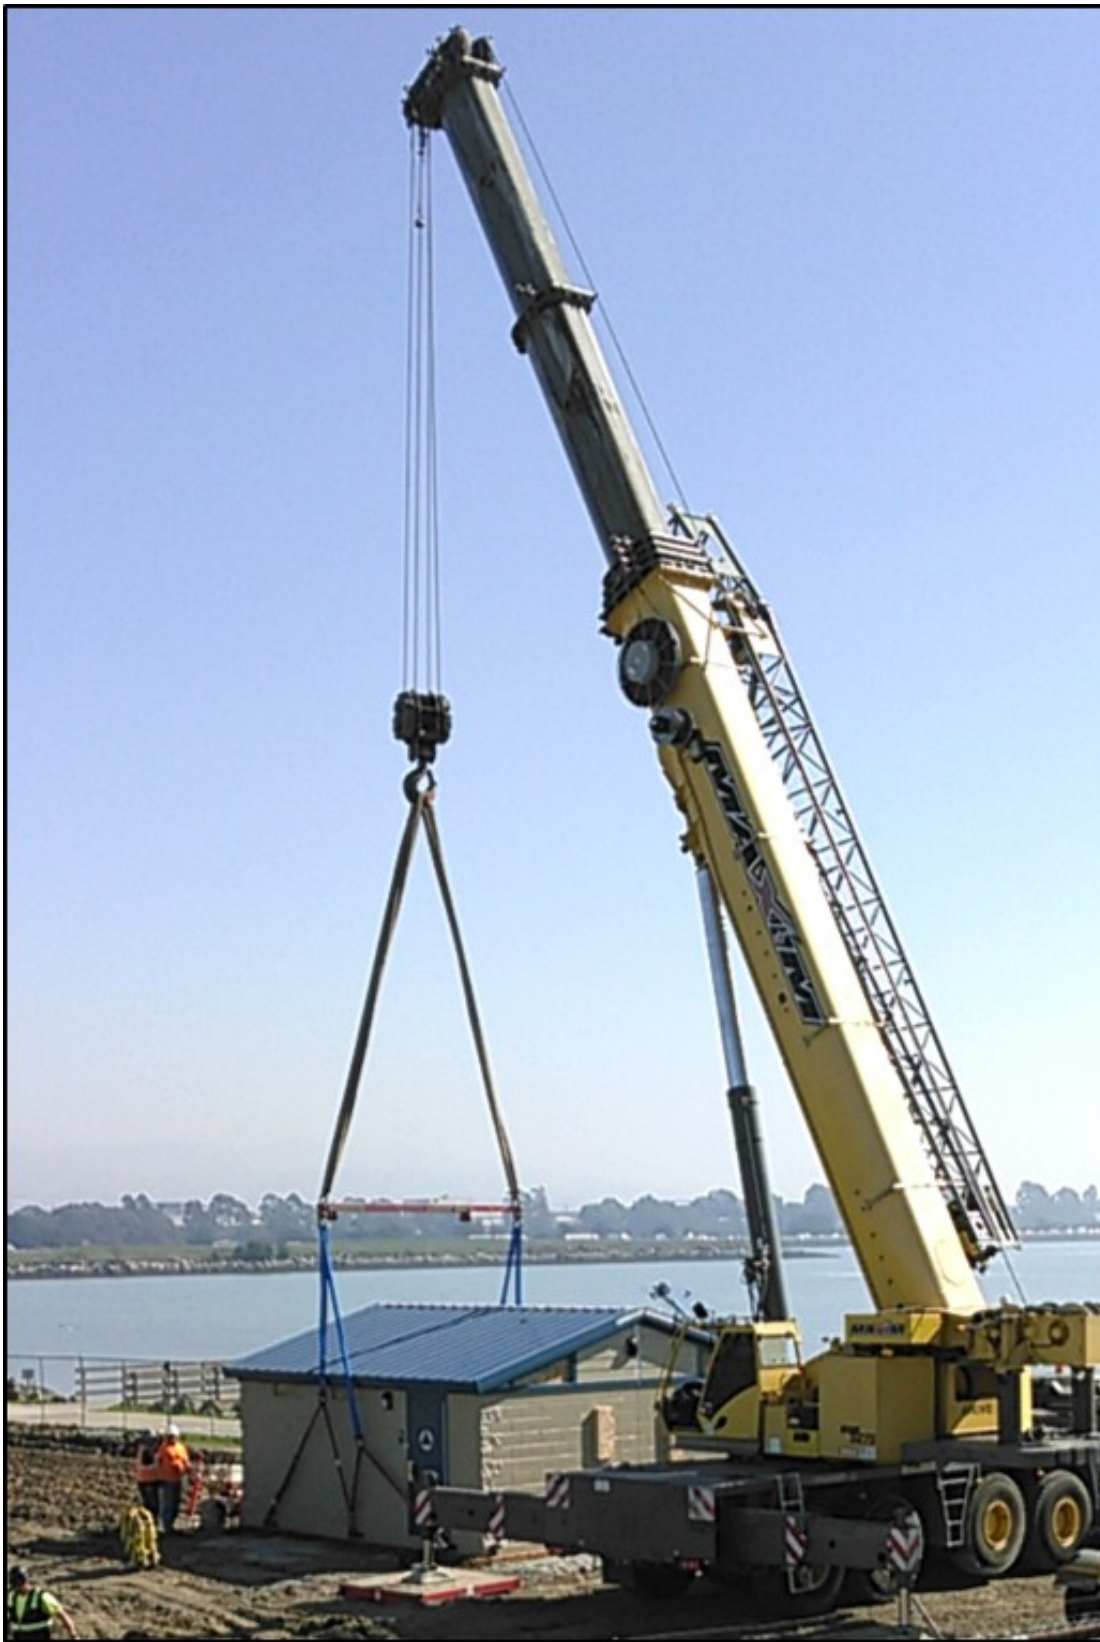
*Image 6: South Cove East Parking Lot – Installing the new pre-fabricated public restroom by crane at the site (Photo by D. Sheils).*

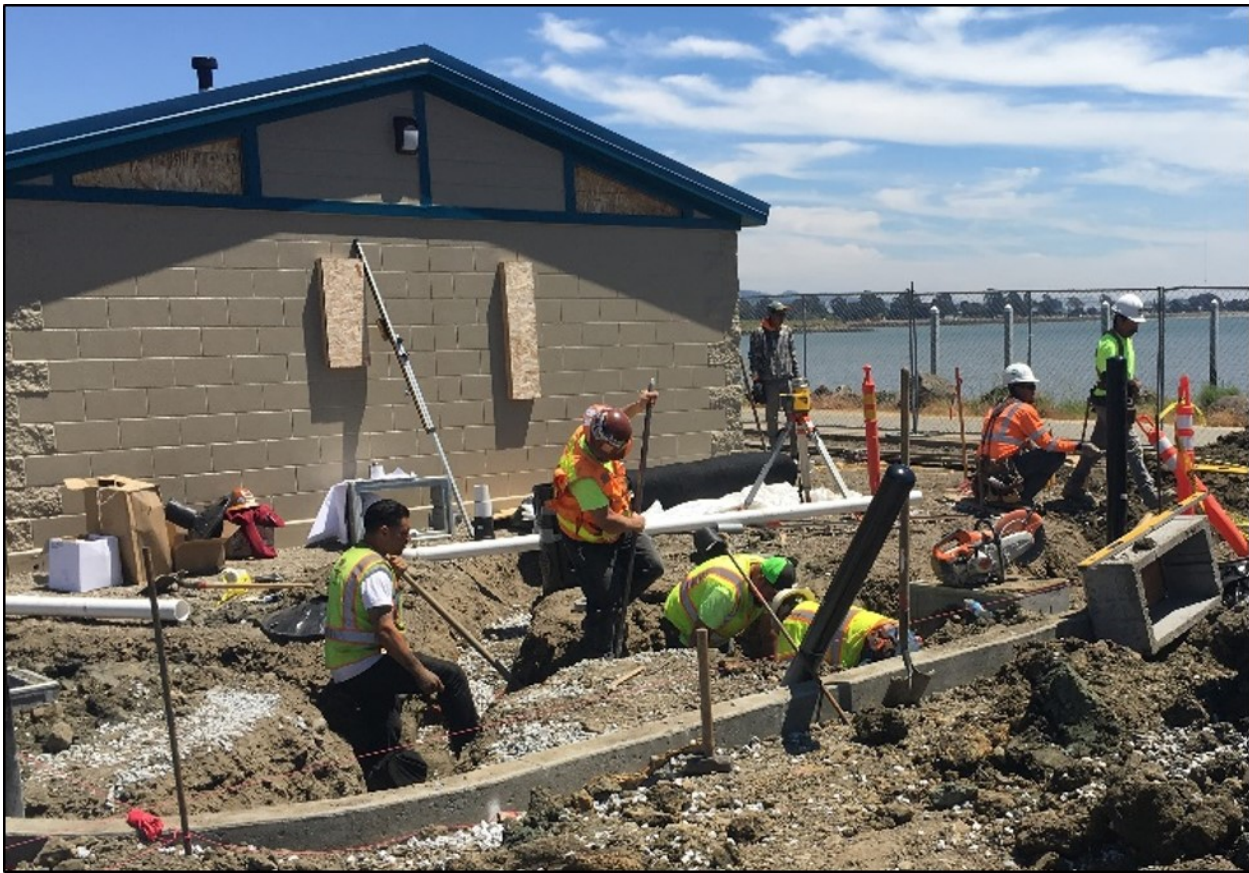
*Image 7: South Cove East Parking Lot – Installing the drainage system for the new concrete restroom plaza area and outdoor washdown area at the restroom (Photo by R. Miller).*

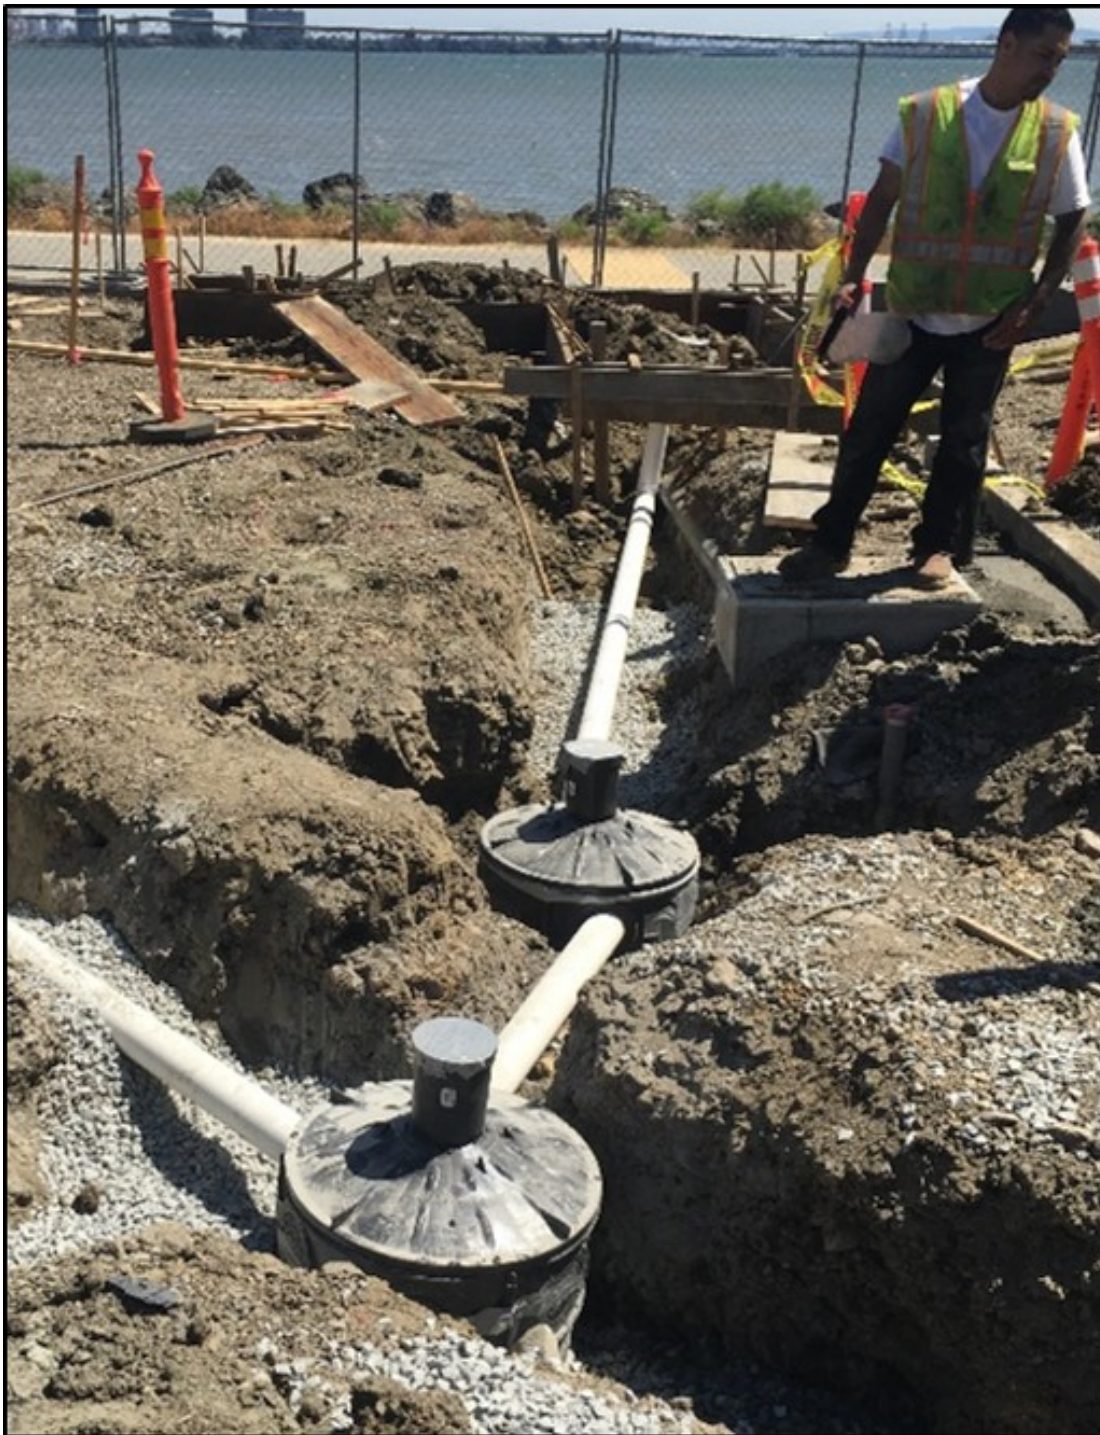
*Image 8: South Cove East Parking Lot – Installing the drainage system for the new concrete restroom plaza area and outdoor washdown area at the restroom (Photo by R. Miller).*

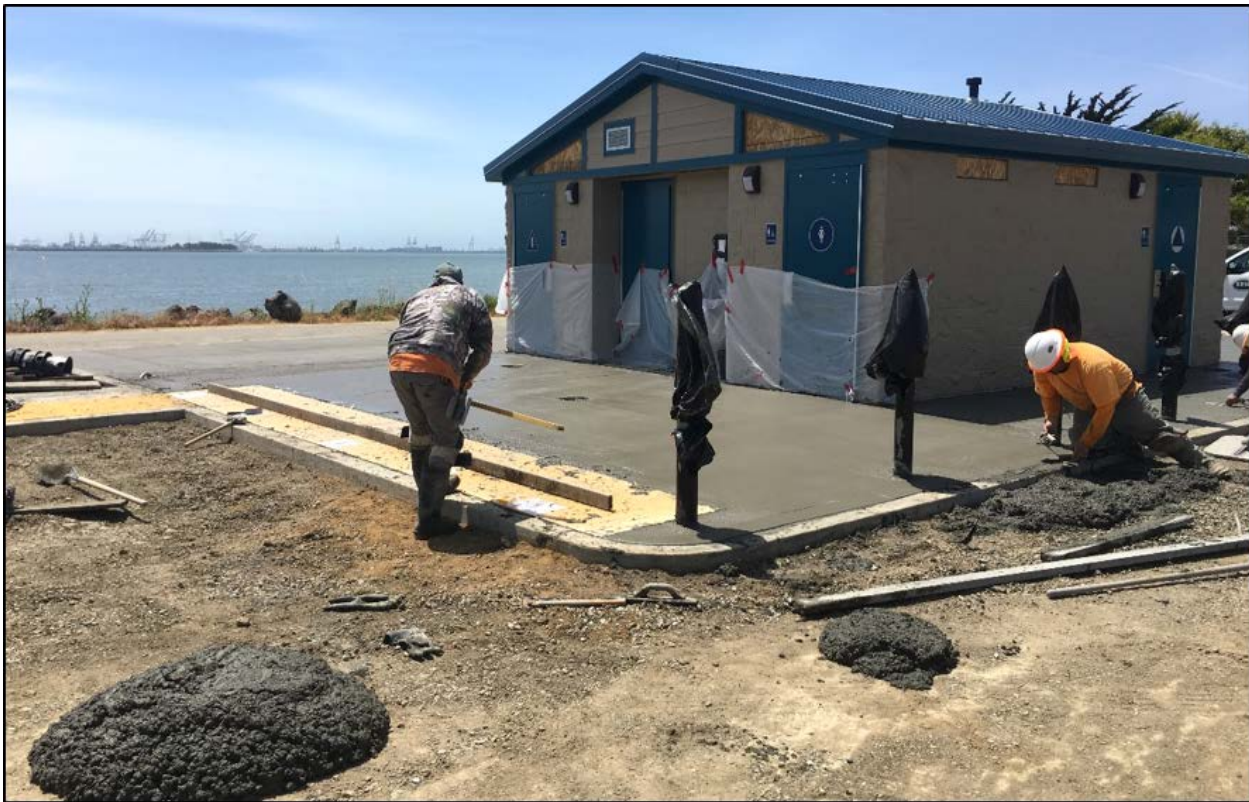
*Image 9: South Cove East Parking Lot – Installing the new concrete restroom plaza adjacent to the new ADA accessible parking slots with accessible path of travel to the new public restroom (Photo by D. Sheils).*

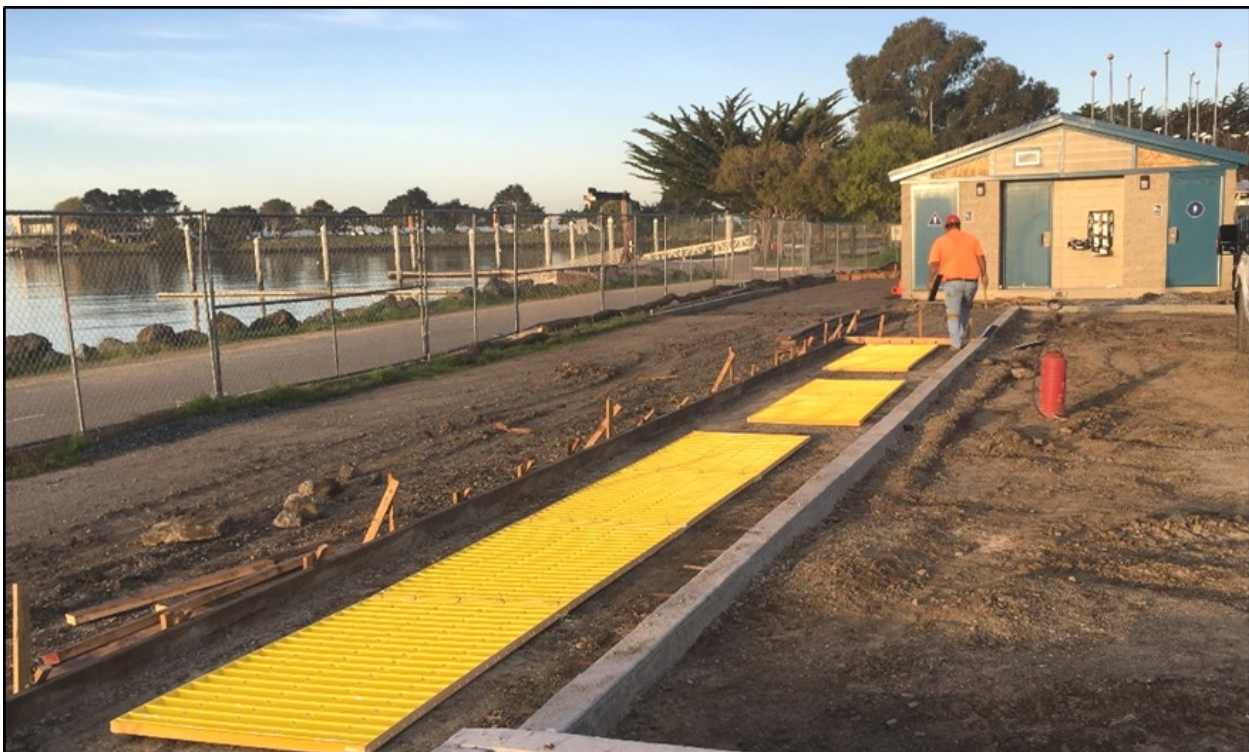
*Image 10: South Cove East Parking Lot – Installing truncated dome detectable surfaces for the new accessible concrete sidewalk path of travel to the new public restroom (Photo by D. Sheils).*

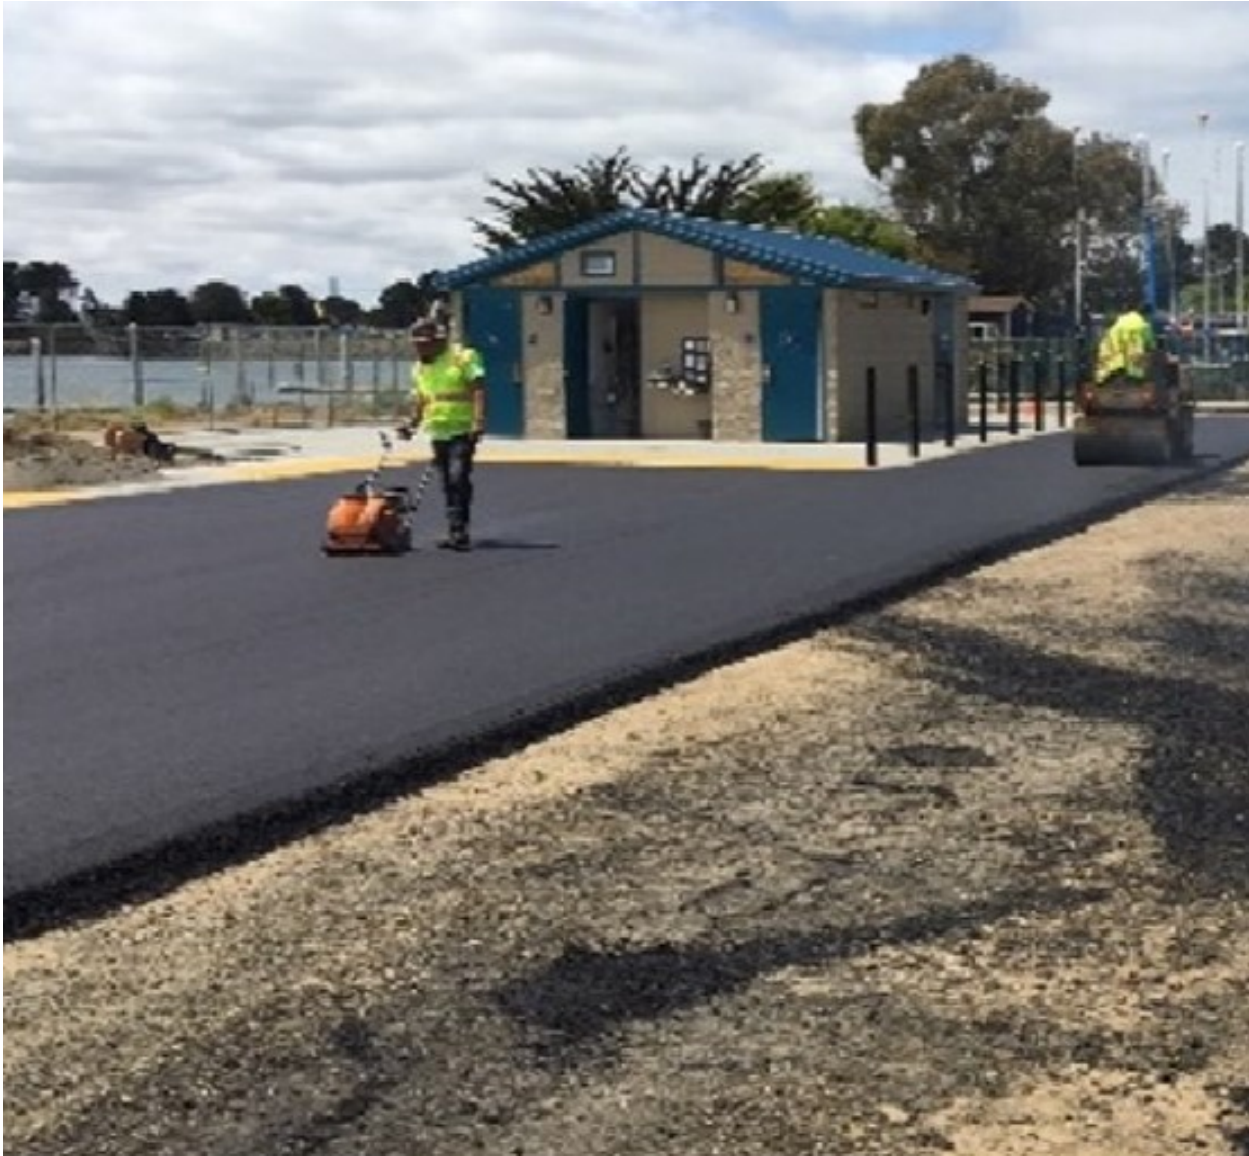
*Image 11: South Cove East Parking Lot – New asphalt paving atop the stabilized base layer to provide ADA accessible parking slots adjacent to the new public restroom (Photo by D. Sheils).*

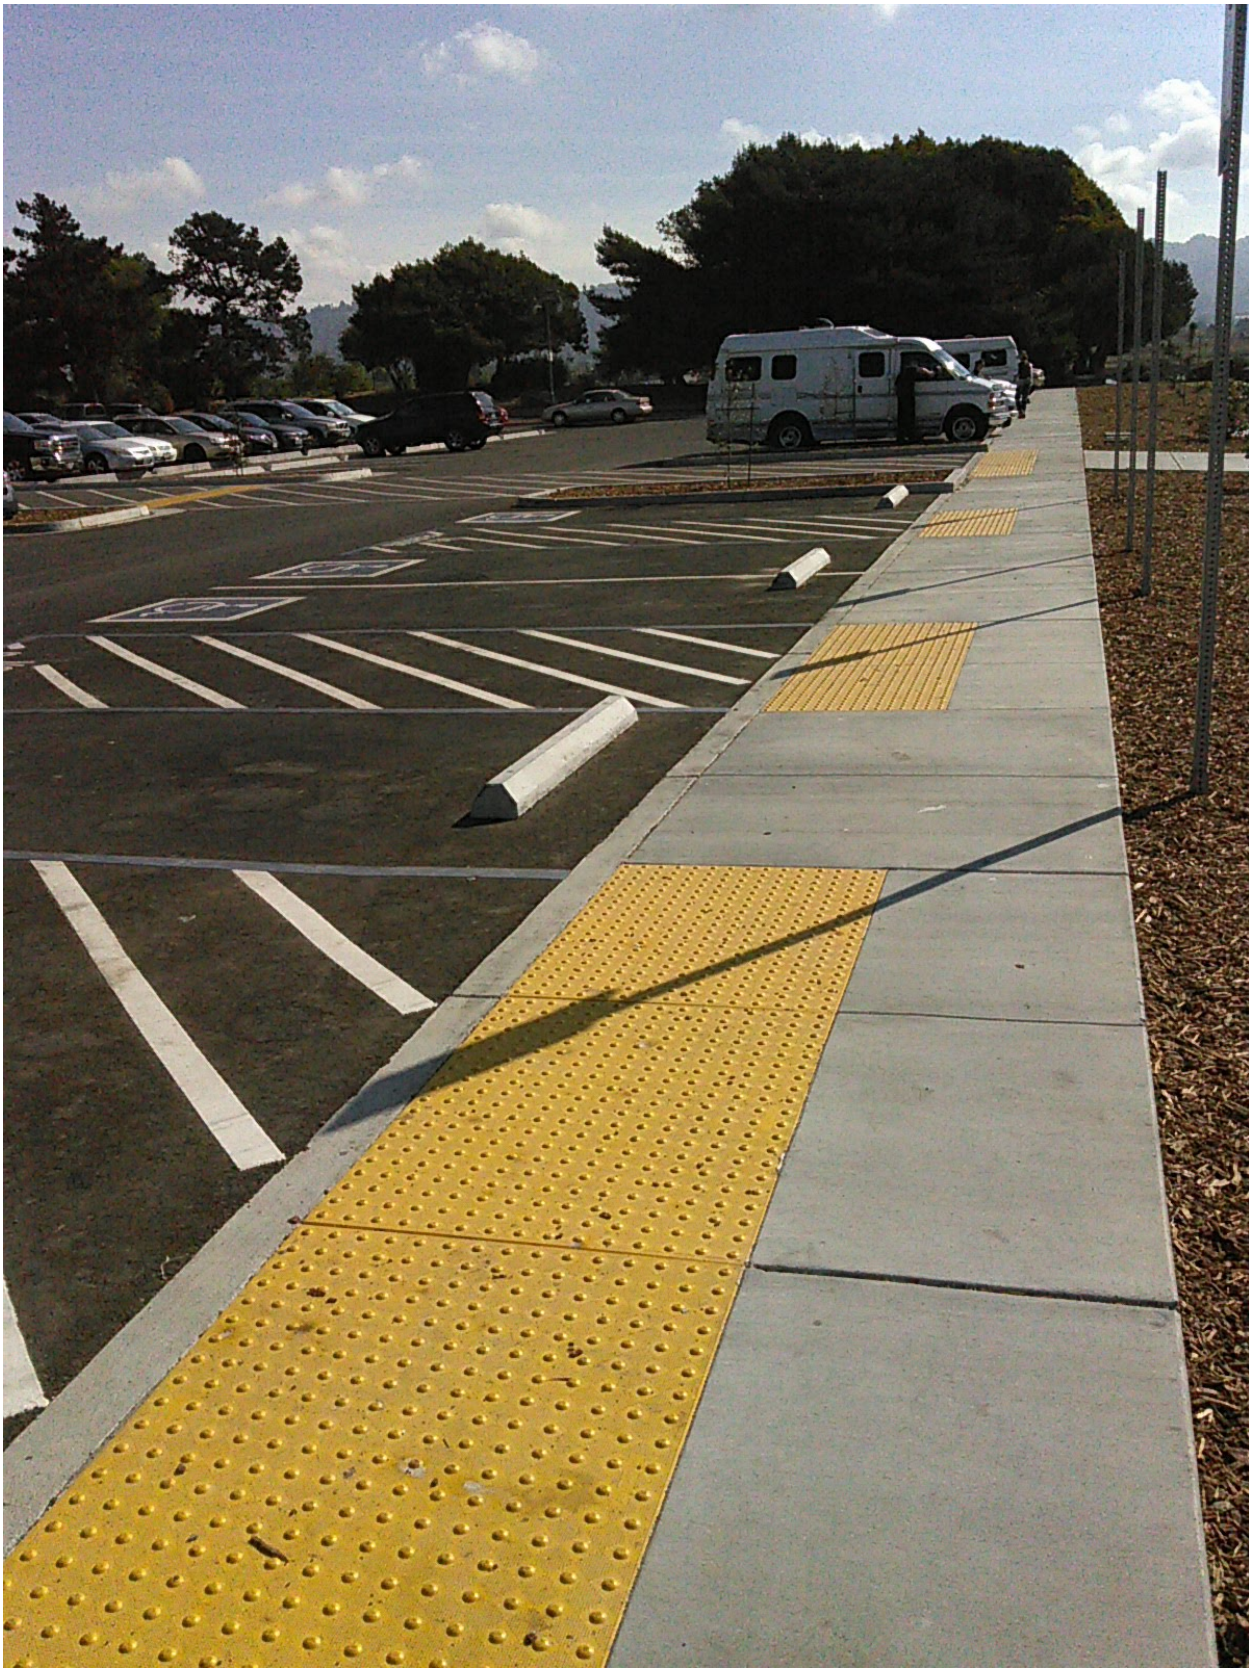
*Image 12: South Cove East Parking Lot – The fully asphalted and striped accessible path of travel from the ADA parking slots to the new public restroom (Photo by D. Sheils).*

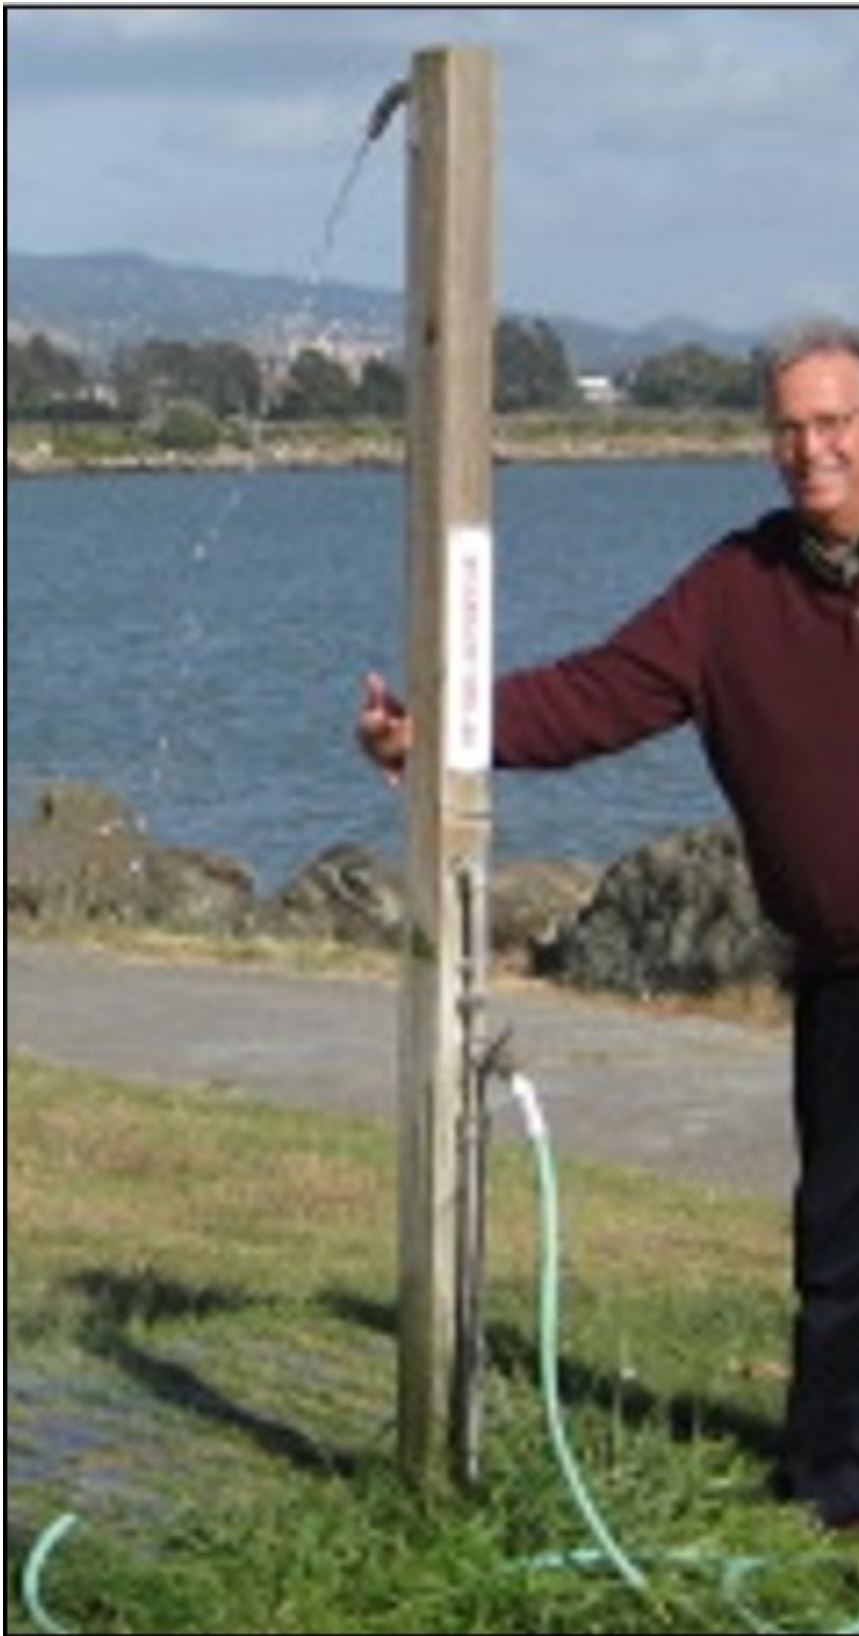
*Image 13: South Cove East Parking Lot – Before renovation, the shower consisted of an old outdoor shower head with a garden hose (Photo by R. Miller).*

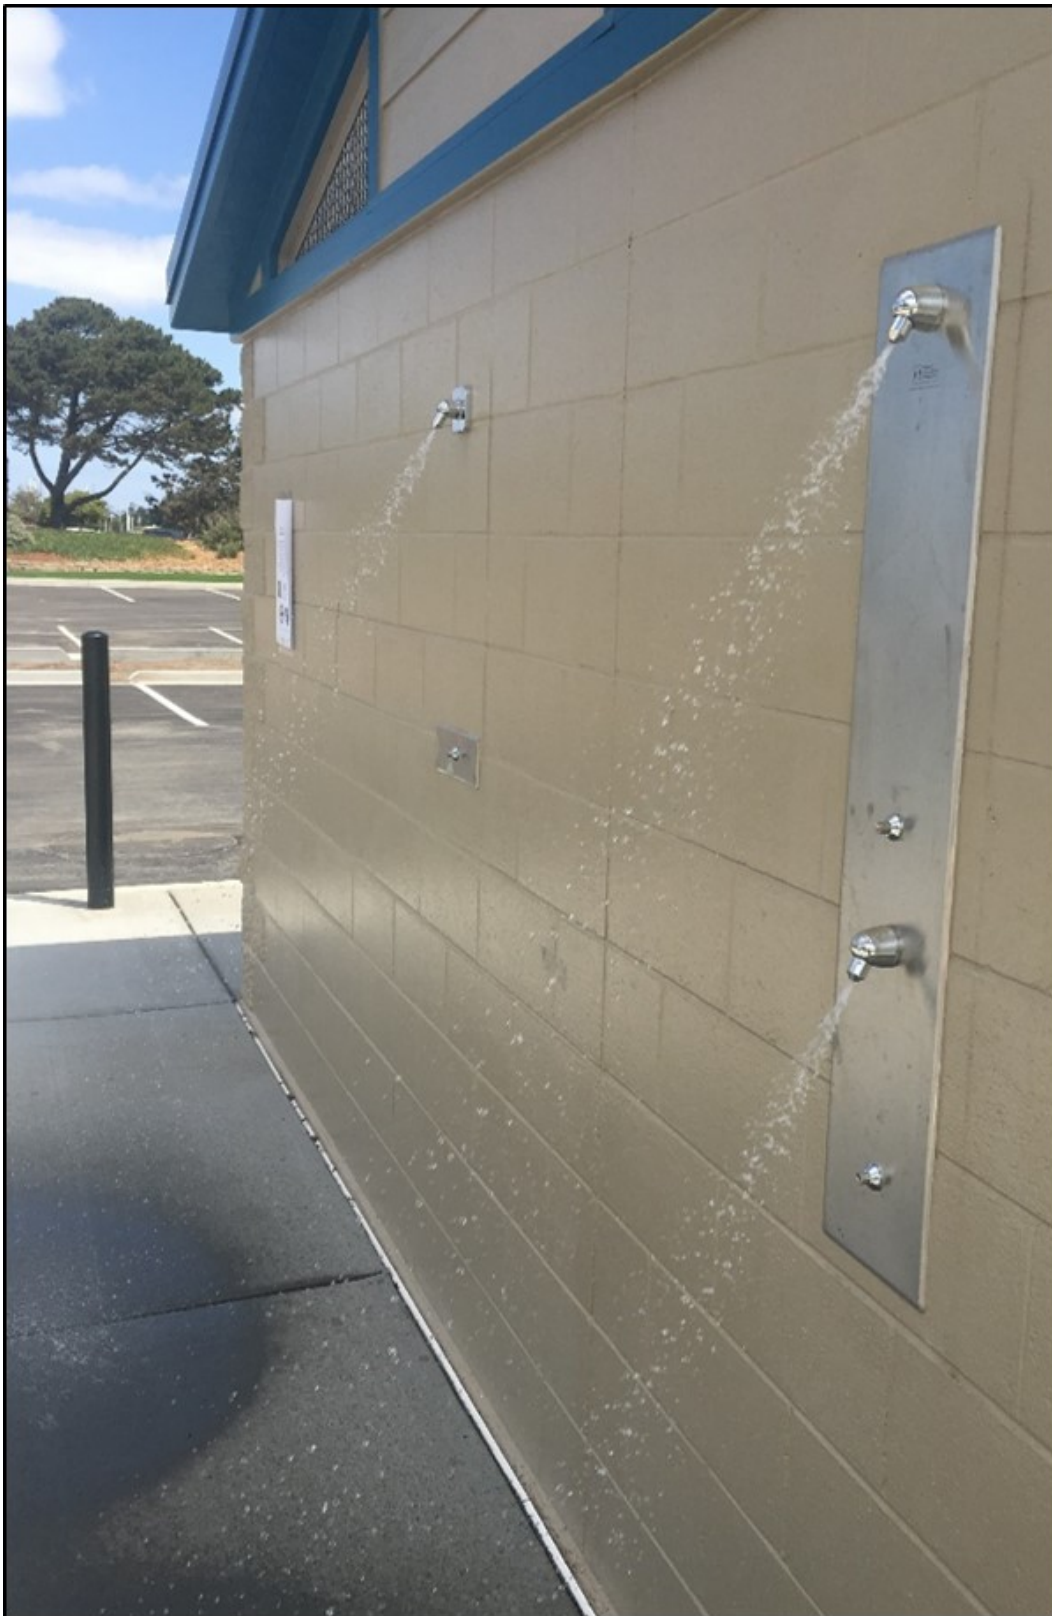
*Image 14: South Cove East Parking Lot – Post renovation, there is a new outdoor washdown at the new public restroom with time-limited pushbuttons for water savings. There is also an ADA accessible pushbutton (Photo by D. Sheils).*
