## Chapter 4 Current Program Activities

### Fish Passage Improvement at DWR

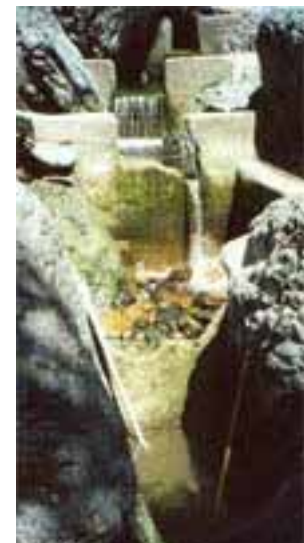
**Photo 4-3 Big Chico Creek—Iron Canyon's worn concrete and collapsed floor /DWR photo**

At Iron Canyon, a fish ladder with 17 small concrete weirs was built in the 1950s. The weirs were built to help fish ascend a 35-foot vertical climb through large boulders along a 270-foot horizontal stretch of creek. Numerous repairs have been made to the original weirs that are mostly founded on basalt boulders of various sizes. Concrete was poured between boulders in the floors to provide a sealed pool in some of the ladder sections. Some of these pool floors have collapsed or leaked over the years and have been repaired periodically (**Photo 4-3**). Numerous leaks occur along the base of pool walls at the contact points between concrete and basalt. A few concrete plugs (concrete bags and walls) have been added in the upper ladder section to seal leaking pools. Sections of the weirs and walls throughout the ladder have either partially blown out or are worn to expose rebar. The preliminary engineering investigation includes assessing the condition of the existing fish ladder and developing alternatives that include repairing the existing structures and constructing new structures. DWR Northern District recently completed a technical analysis on the Iron Canyon fish ladder and solutions are currently being addressed. Presently, DFG is continuing to

make repairs as needed until another resolution is made (Ward 2004 Jul 28 pers comm).
