Site Name: Arnold Drive Private (Stuart Creek Run Barrier)

Stream Name: Stuart Creek

Barrier Remediation By: Sonoma Land Trust

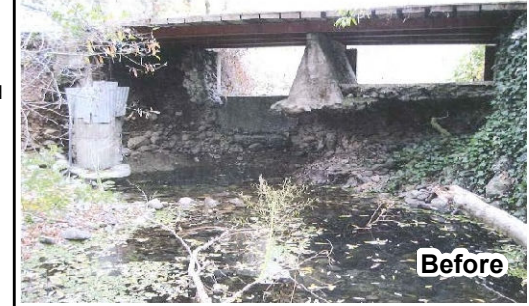
Barrier Description Prior to Remediation: Partial

Notes: In 2014, a concrete bridge foundation was removed and a chute-pool channel was constructed. Before: Partial barrier per DFG Restoration Manual per Sonoma Ecology Center. One culvert RED filter result, second culvert GREY filter result. Eroding bridge on Sonoma Creek.

Year Remediated: 2014

Site Status After Remediation: Remediated, fish response unconfirmed
