Humboldt Bay Water Control Structure Inventory, Assessment, and Mapping

**Humboldt Bay Water Control Structure Inventory,
Assessment, and Mapping Project
Final Report**

October 30, 2007

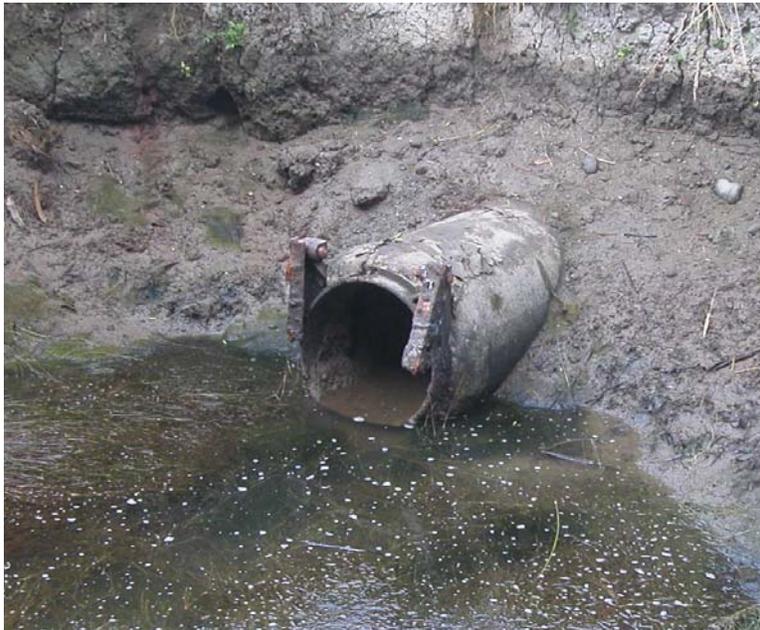
Figure 1. Example of a concrete pipe culvert with failed (missing) tidegate.

The resulting database includes a total of 371 point features each representing a water control structure. Of these, 164 were field inventoried using the GPS techniques described above and photographed by FWS biologists (Figure 1). A total of 12 point features were identified from the RCAA dataset. Data obtained from Oscar Larson and Associates included 11 structures in the McDaniel Slough area of Arcata Bay. The remaining 184 points were imported from the Caltrans dataset. These imported features were lacking some of the FWS attribute data, as well as photographs.
