NPS Cosco Busan Recreational Use Program

Waterfront Railings at Fort Mason Center: Final Programmatic Report

Recipient Park Unit: Golden Gate National Recreation Area
Project Location: Lower Fort Mason, San Francisco, CA
Date Approved: January 8, 2013
Project Period: March 2013 – February 2016
Award Amount: \$344,000
Funding Allocations: FY2013 \$180,000
FY2015 \$164,000
Total Expended: \$343,997
Matching Contribution: \$127,000
Fund Source: Fort Mason Center for Arts and Culture
Project Number: PHP0202335

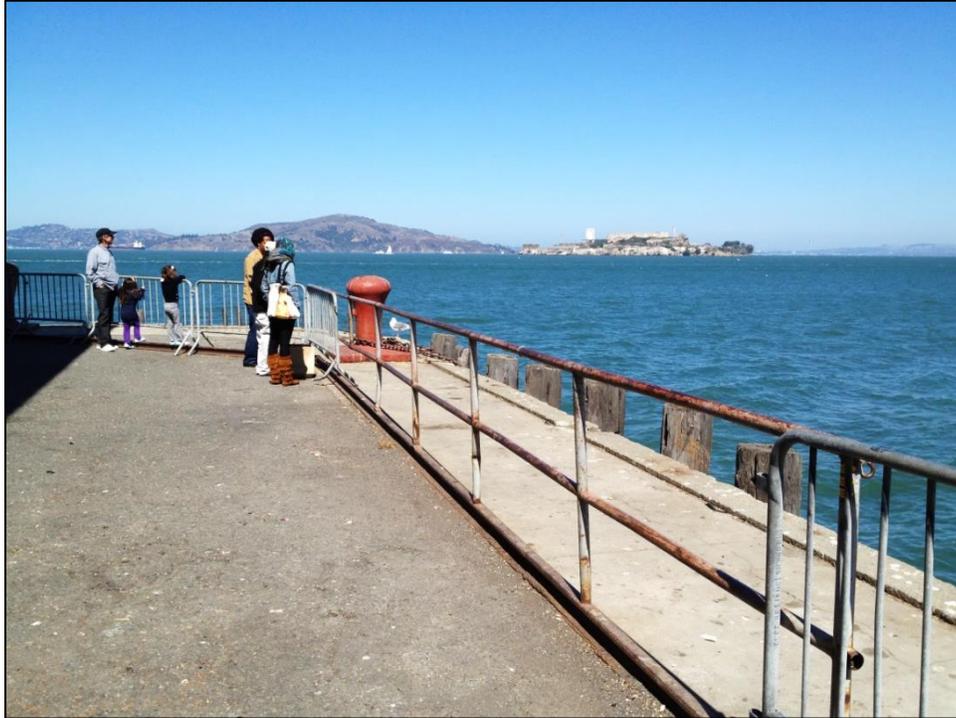
Figure 2. Before: failing galvanized pipe railings and temporary barricades at the end of Pier 3, with view of Alcatraz Island.

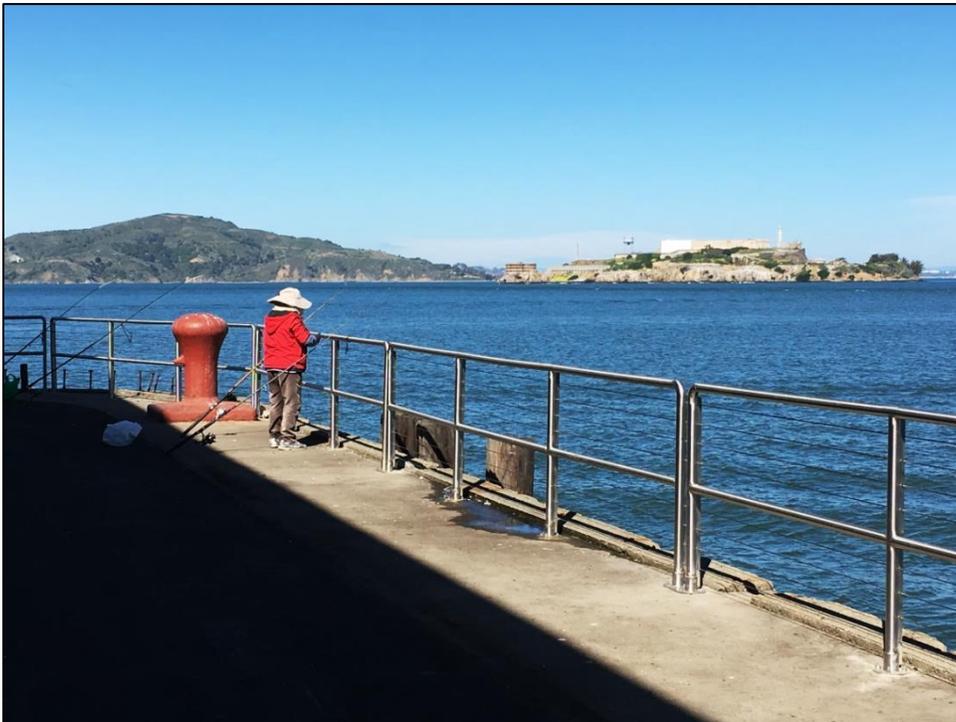
Figure 3. After: new modular stainless steel pipe and cable guardrail system at the end of Pier 3, with view of Alcatraz Island.

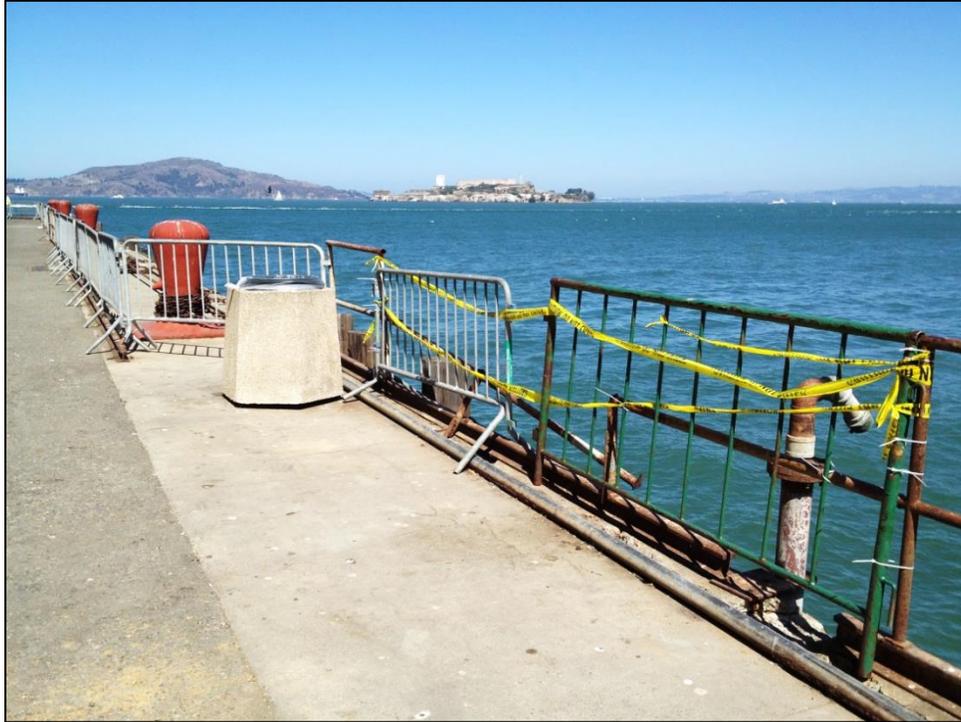
Figure 4. Before: temporary barricades placed where galvanized pipe railings failed on the east side of Pier 3.

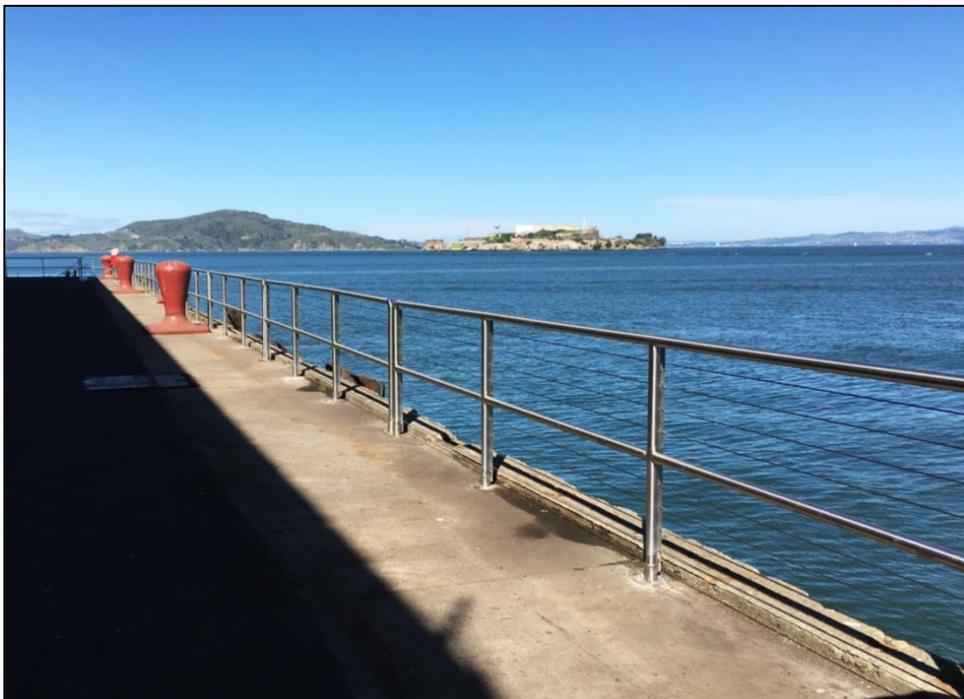
Figure 5. After: new modular stainless steel pipe and cable guardrail system along the east side of Pier 3.

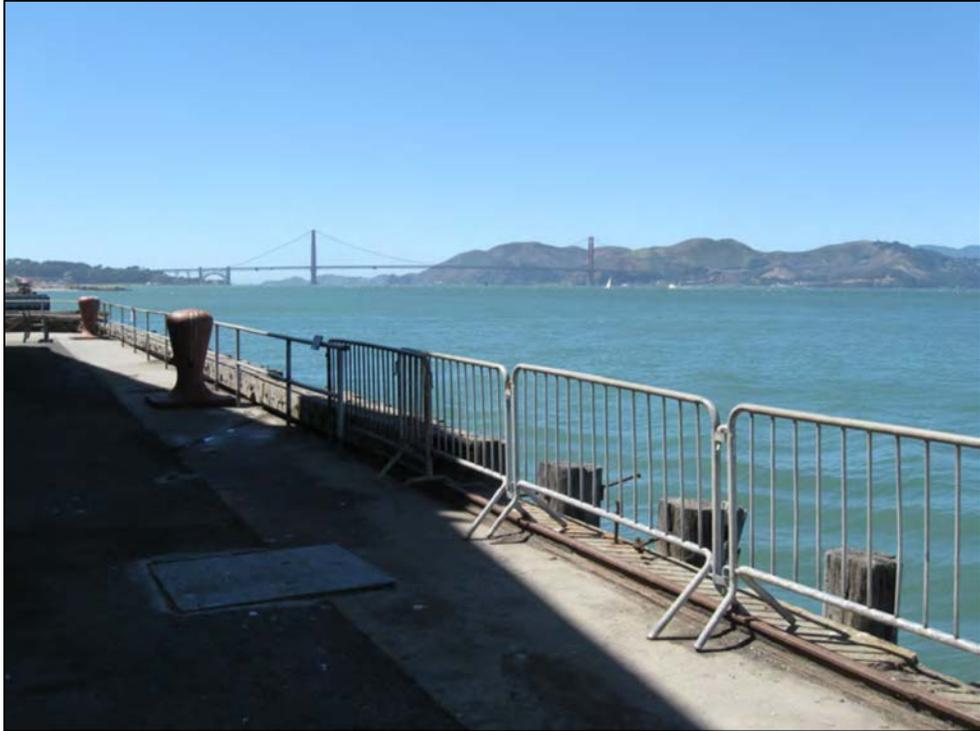
Figure 6. Before: temporary barricades and failing galvanized pipe railings on the north side of Pier 3, with the Golden Gate Bridge in the background.

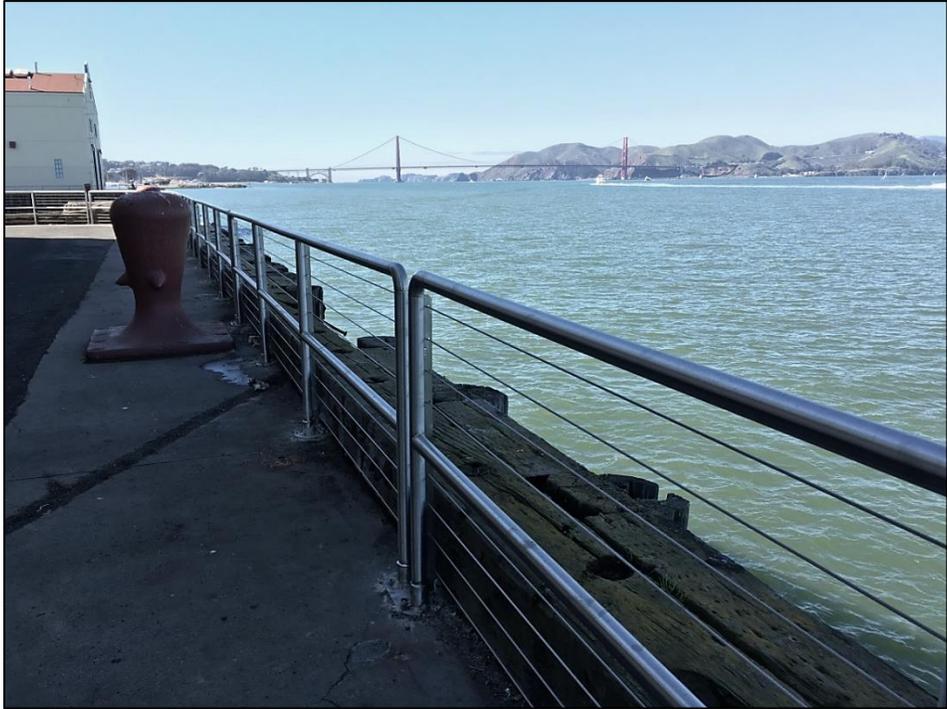
Figure 7. After: new modular stainless steel pipe and cable guardrail system along the north side of Pier 3, with view of Golden Gate Bridge in the background.

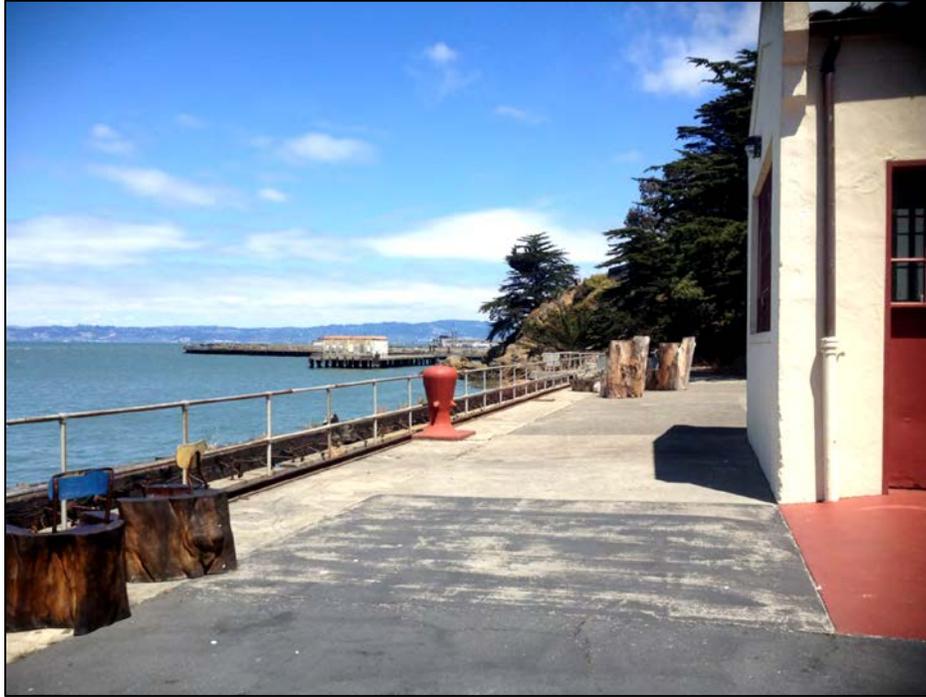
Figure 8. Before: Obsolete galvanized pipe railing along the seawall at the east end of Lower Fort Mason, with Pier 4 and Aquatic Park Pier visible in the background.

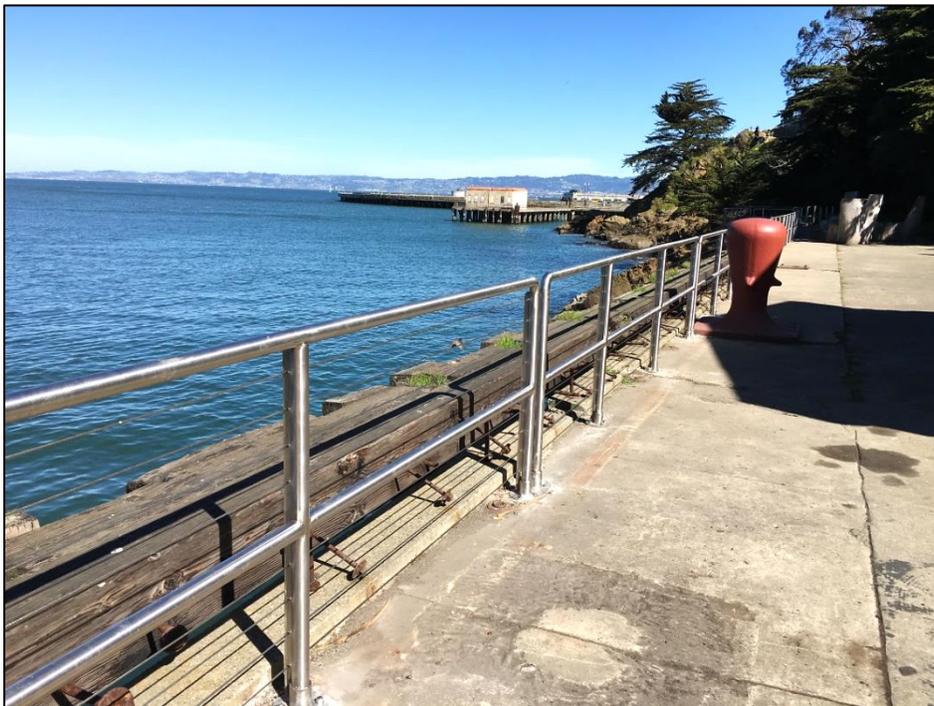
Figure 9. After: new modular stainless steel pipe and cable guardrail system along the seawall at the east end of Lower Fort Mason, with Pier 4 and Aquatic Park Pier visible in the background.

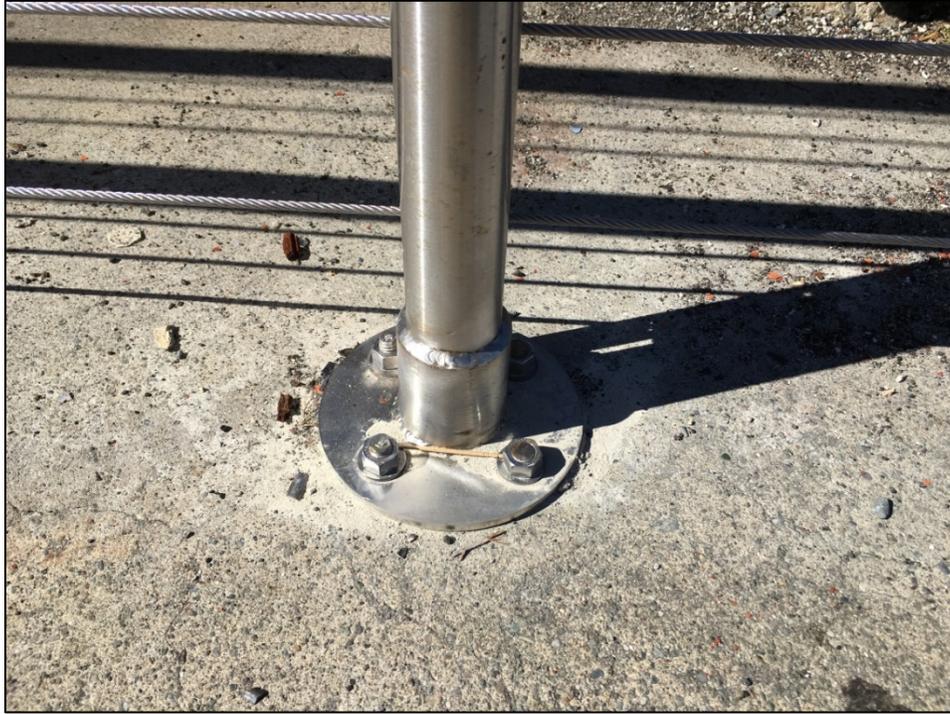
Figure 10. After: flange attachment system for new stainless steel pipe and cable guardrail system, used to protect the historic integrity of the piers.

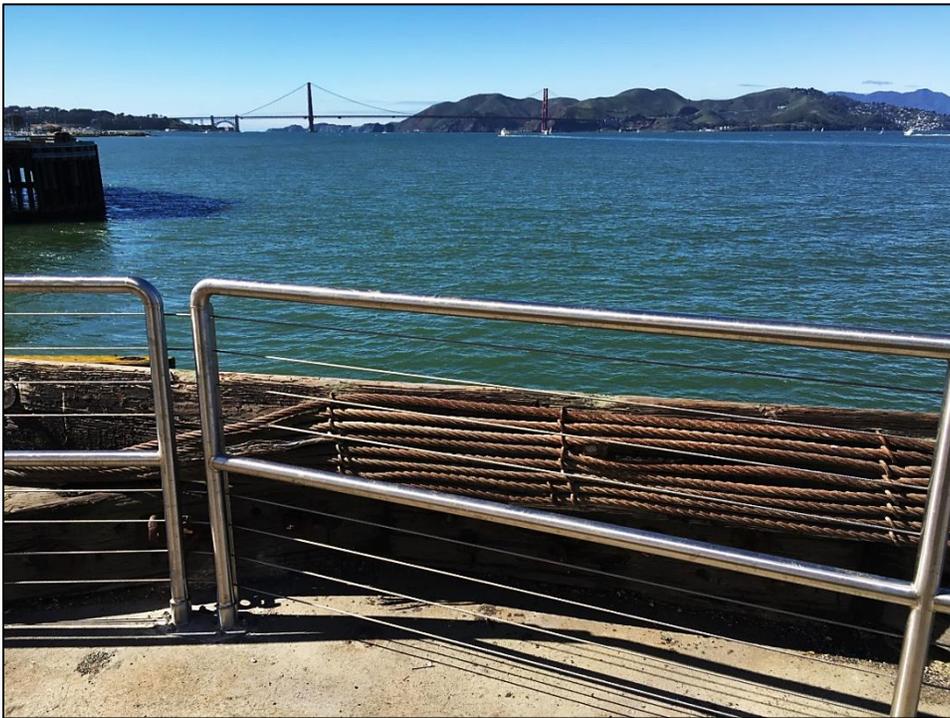
Figure 11. After: new guardrail system installed in a manner that protects historic bollards, cleats and other marine appurtenances.

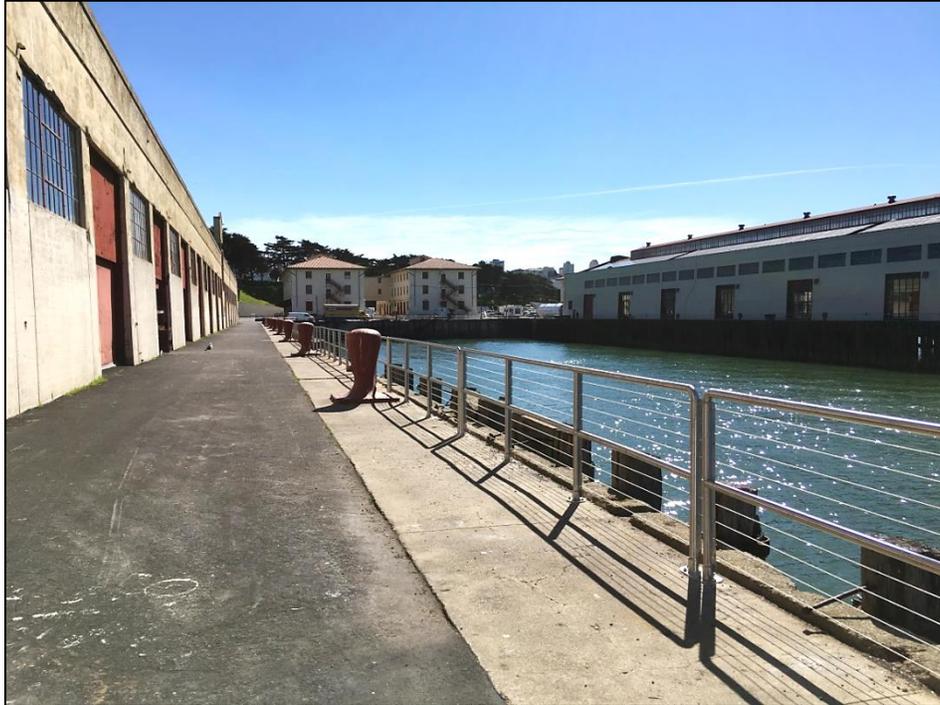
Figure 12. After: The new stainless steel pipe and cable guardrail system along the west side of Pier 2, designed to maintain the historic character of the NHL.

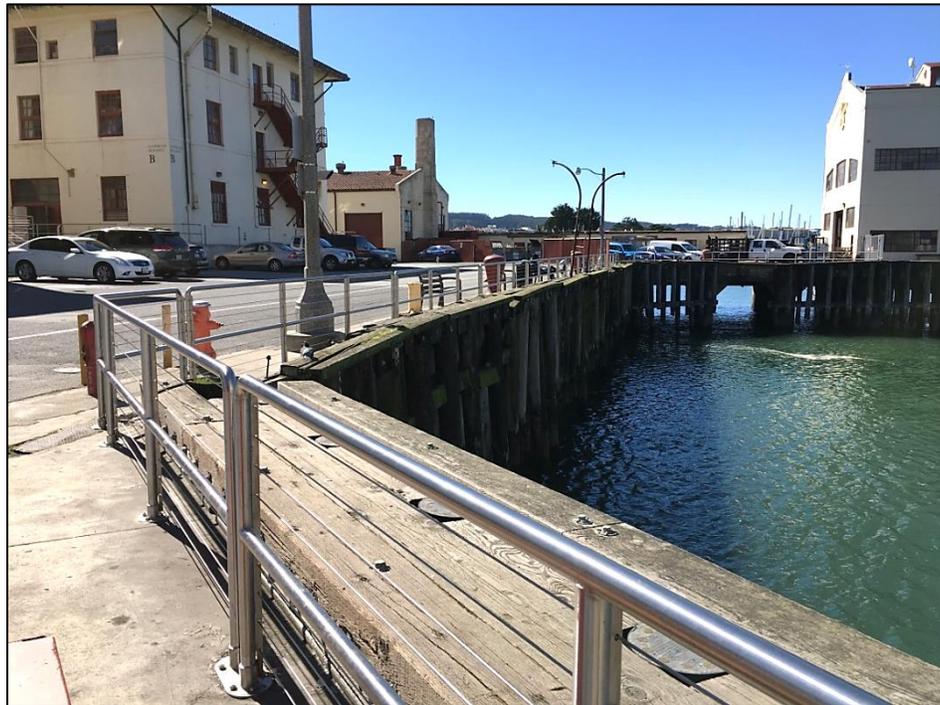
Figure 13. After: The new stainless steel pipe and cable guardrail system along the seawall between Piers 2 and 3, designed to maintain the historic character of the NHL.

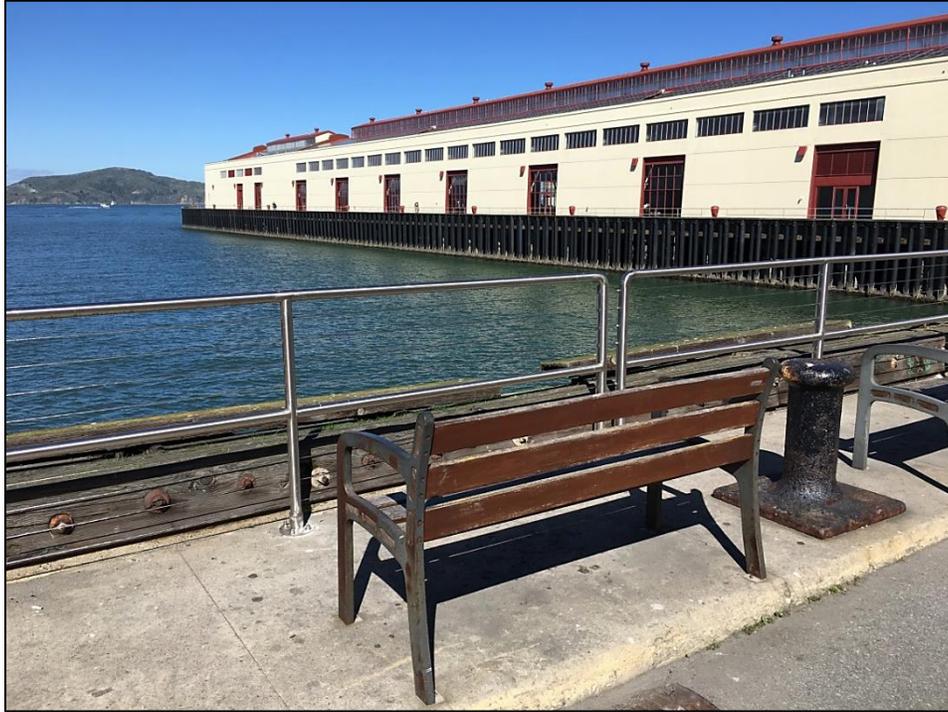
Figure 14. After: public bench along the seawall between Piers 2 and 3, with a view of San Francisco Bay through the new guardrail system.

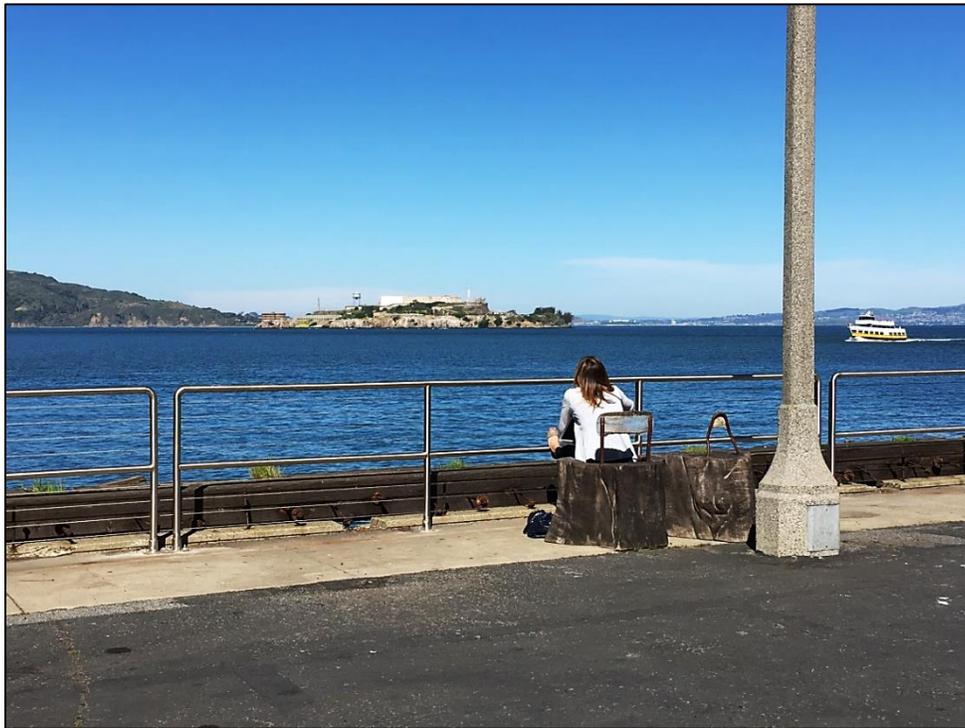
Figure 15. After: waterfront visitor enjoying the view of Alcatraz over the new pipe and cable guardrail system.
