CCR 679 Wildlife Rehabilitation

Attachment 10

Compilation of Photographic Evidence
Meeting or Exceeding Current
Regulations.

California Department of Fish and Wildlife 2024

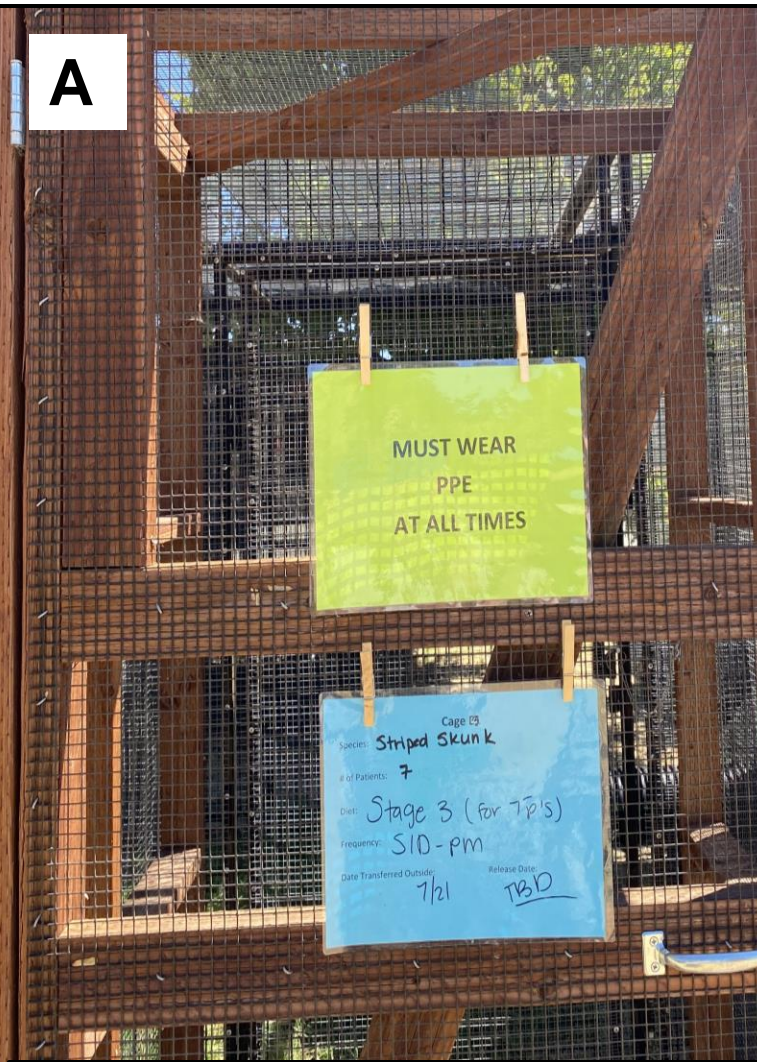
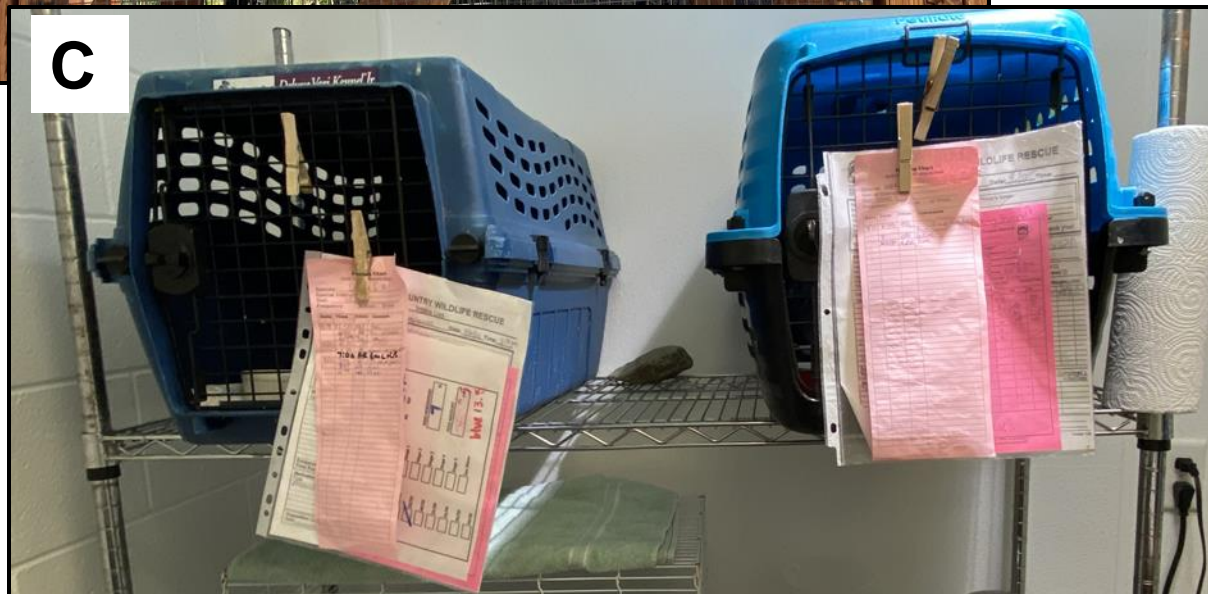
Figure 2. Images show properly labeled enclosures at Gold Country Wildlife Rescue: skunk (A), neonate squirrels (B), and triage patients (C).

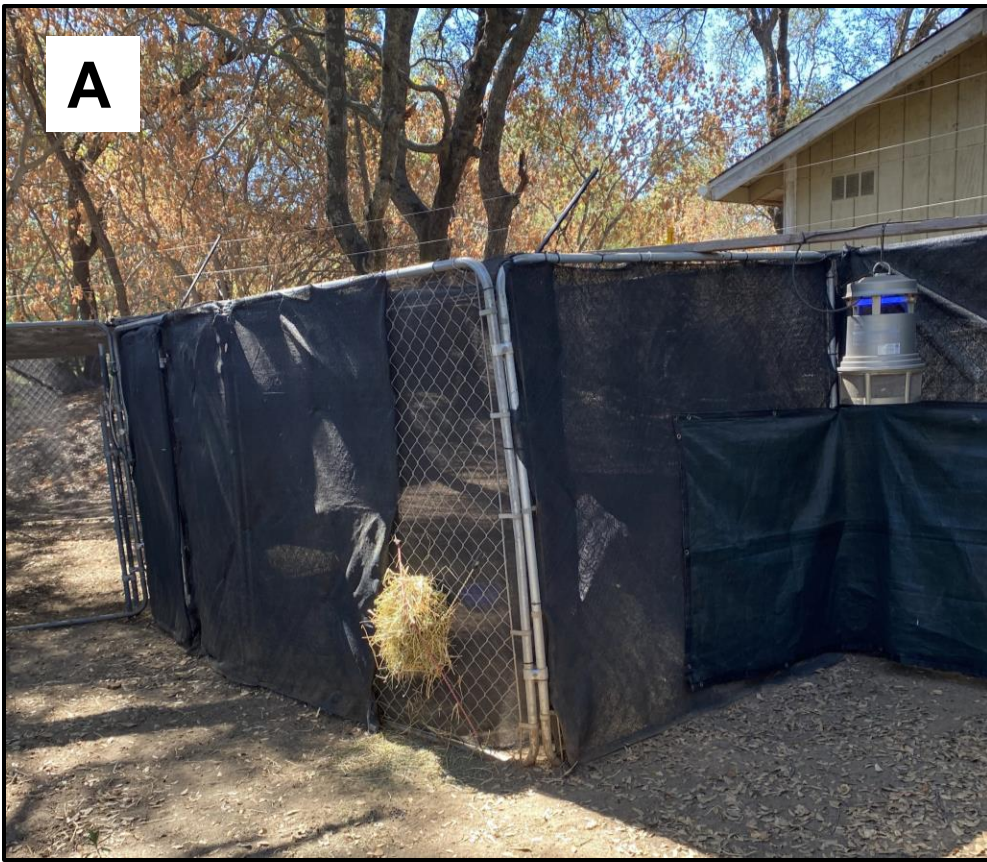
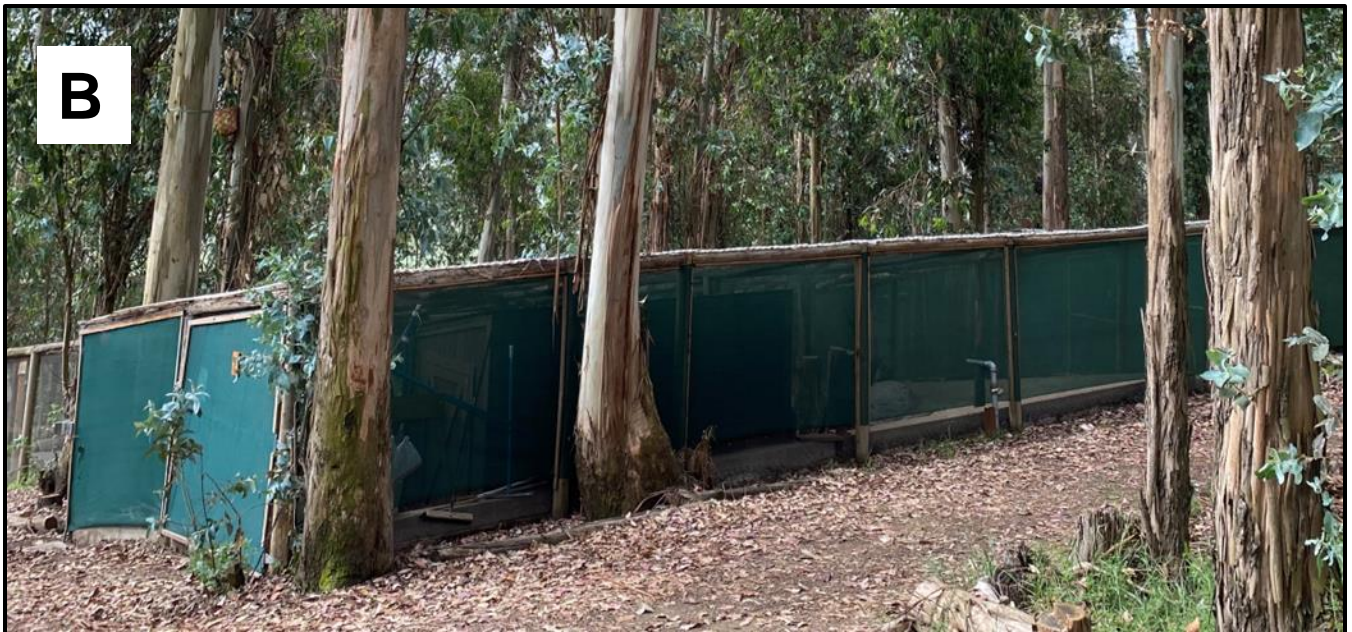
Figure 3. Images showing shade cloth as a visual barrier to prevent an animal from becoming habituated to people: deer fawns (A: Kindred Spirit Fawn Rescue) and coyotes (B: Sonoma County Wildlife Rescue).

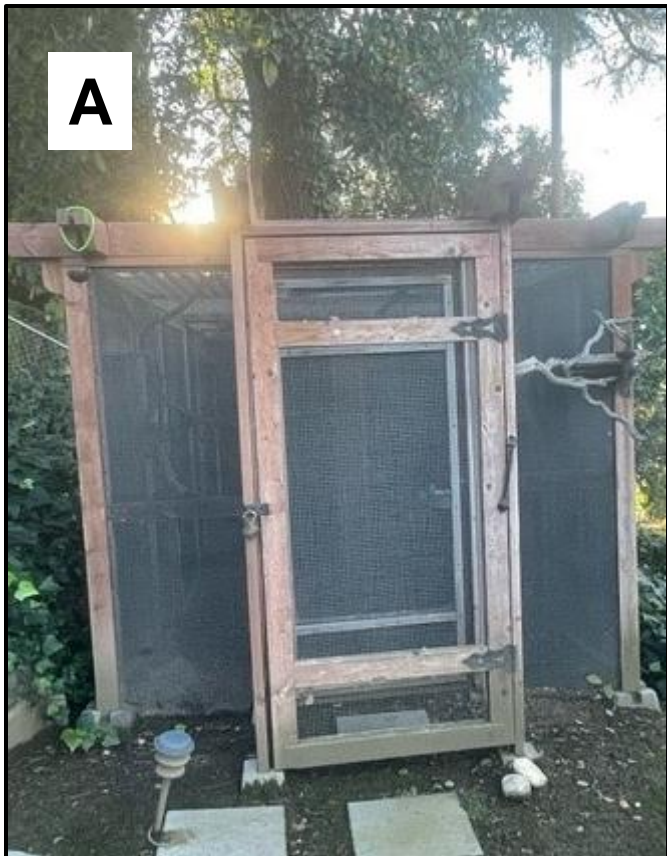
Figure 4. Images showing an enclosure double door entry: hummingbird (A: Orangewood Wildlife) and skunk (B: Gold Country Wildlife Recue).

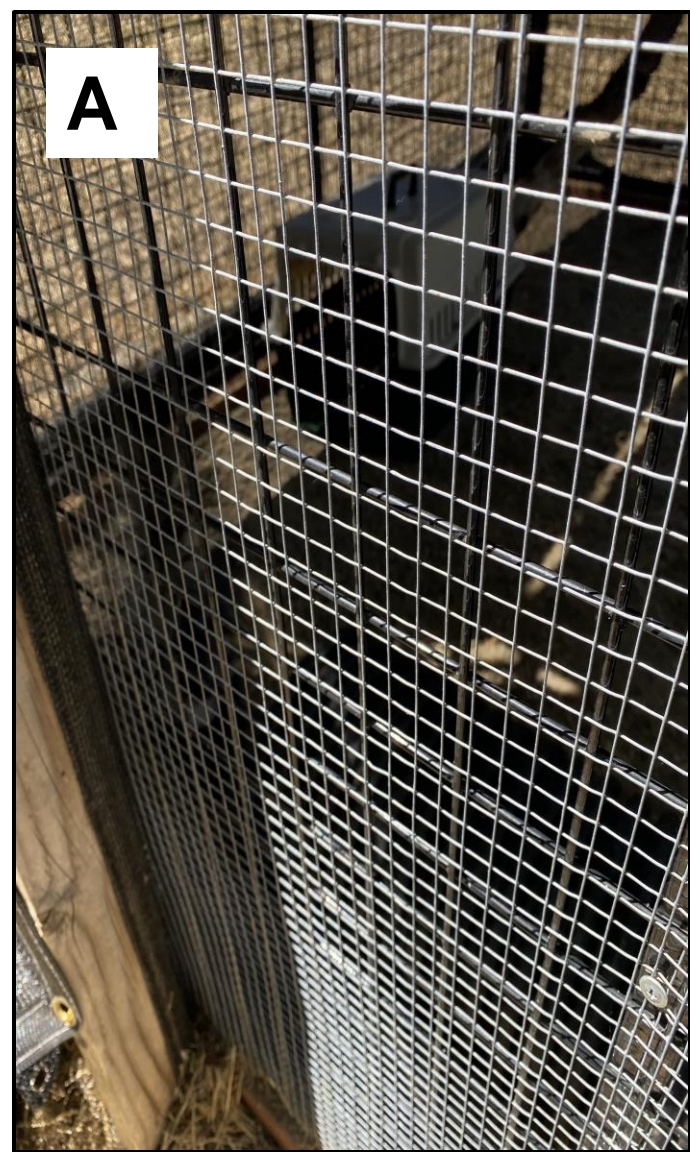
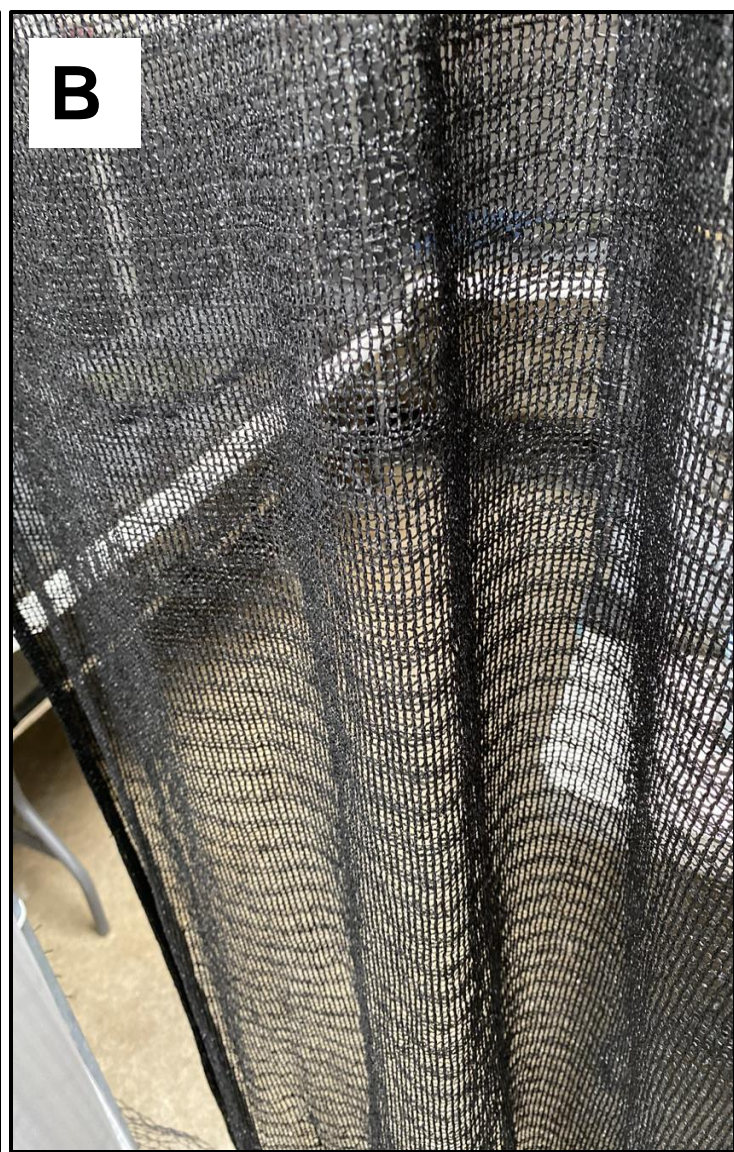
Figure 5. Appropriate enclosure materials – hardware cloth (A), shade cloth (B)

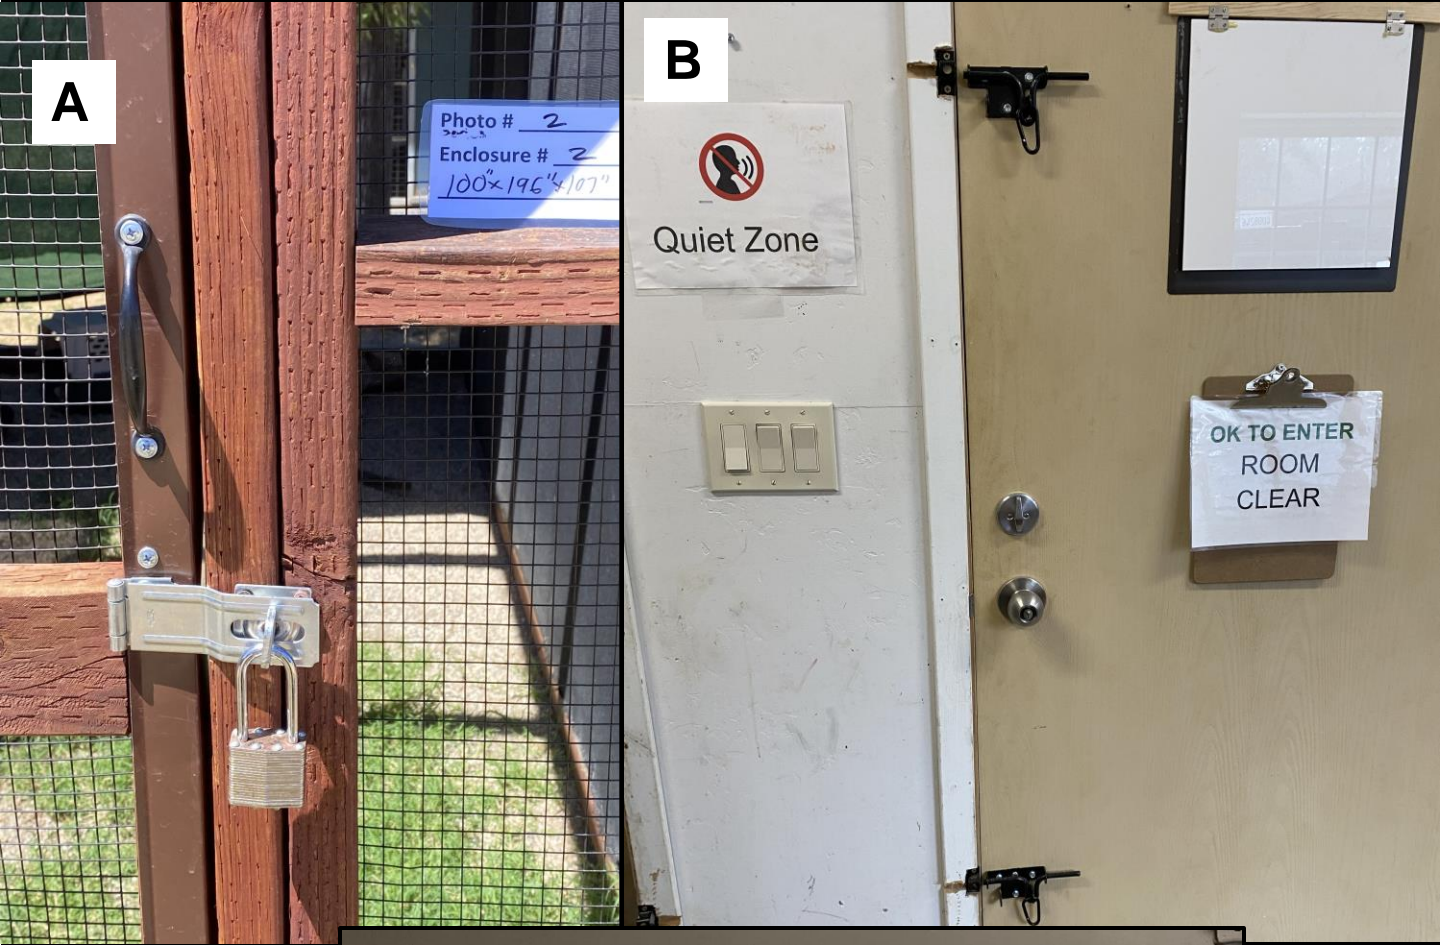
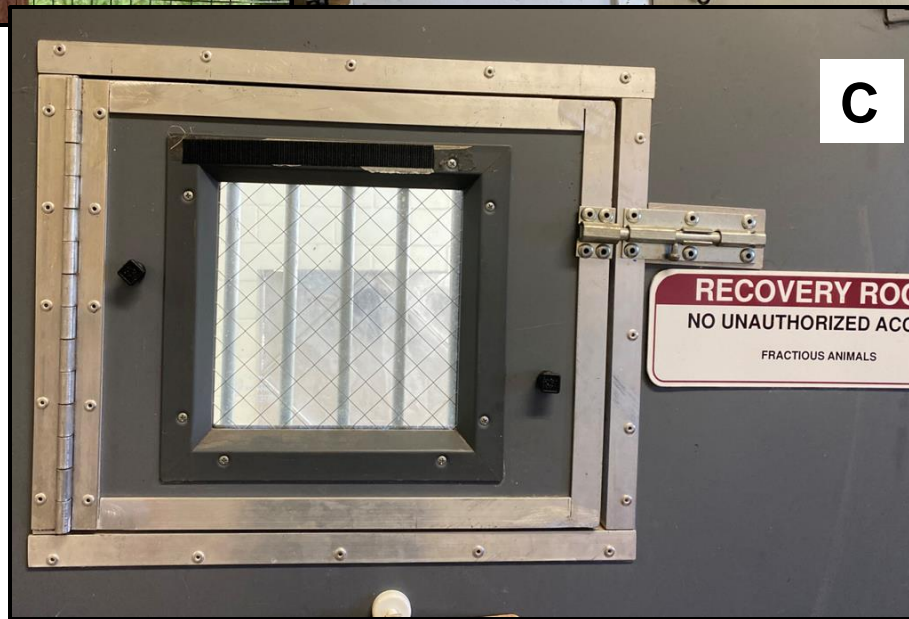
Figure 6. Security measures: Outdoor small mammal (A: Gold Country Wildlife Rescue); black bear access includes double lock, window for viewing, signage (B: Lake Tahoe Wildlife Care); large carnivore hospital enclosure locked viewing window and signage (C: Project Wildlife Ramona)

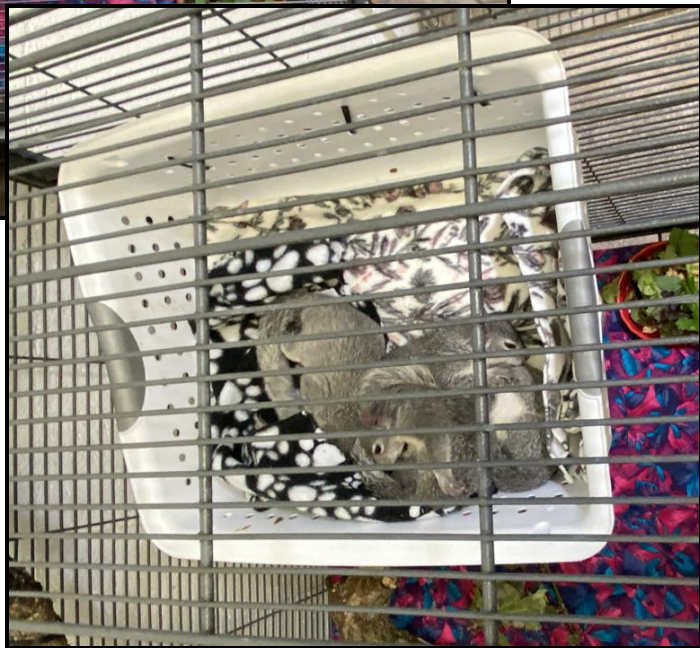
Figure 7. Gold Country Wildlife Rescue neonate squirrel enclosure, demonstrates proper caging, artificial nests, proper bedding, and enrichment. Inset photo is enlarged to show artificial nest.

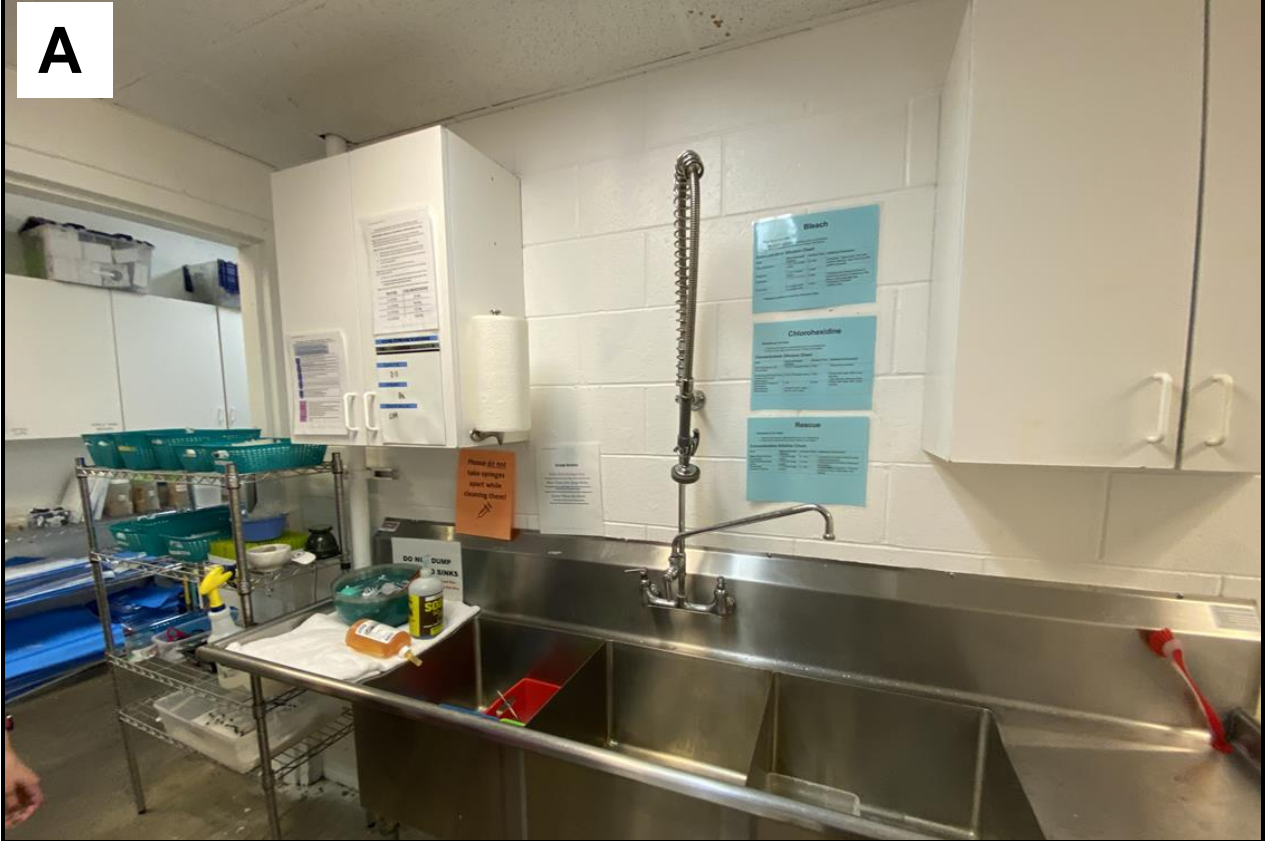
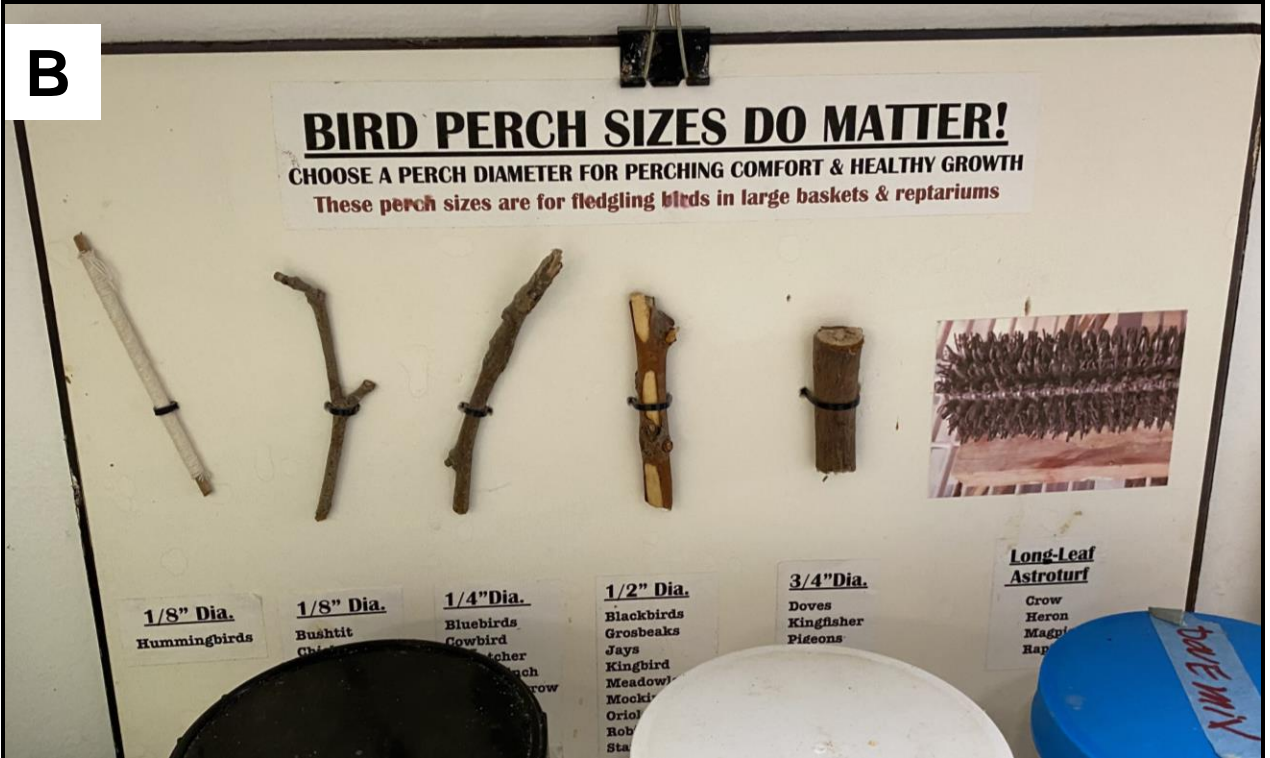
Figure 8. Clearly posted protocols in food prep (A) and enclosure set up area (B) for staff and volunteers at Gold Country Wildlife Rescue.

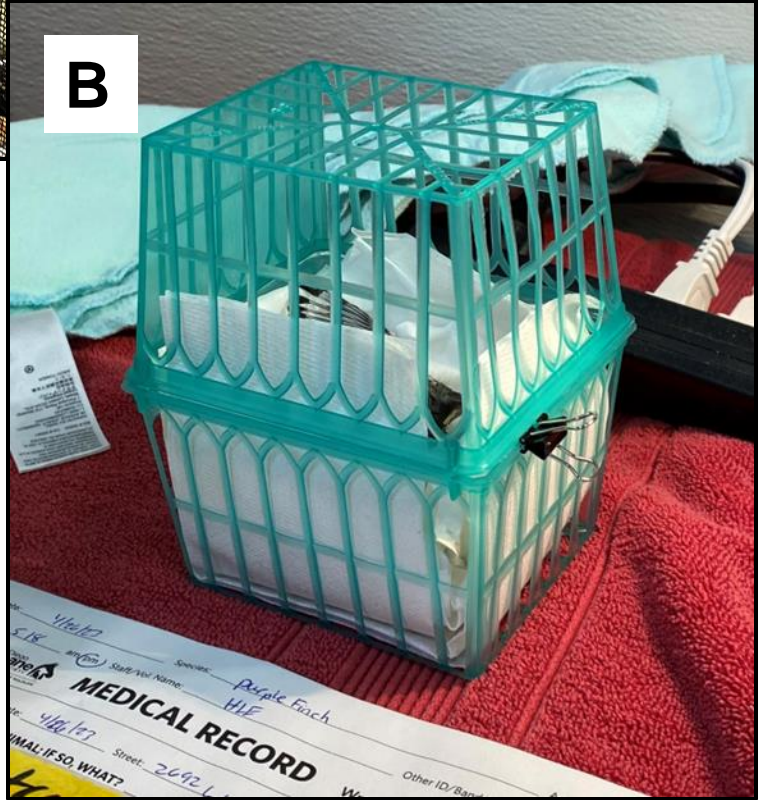
Figure 9. Avian enclosure options: fledgling with perches and free feeding (A: Gold Country Wildlife Rescue) and nestling on heating pad in artificial nest that limits animal's ability to escape (B: Project Wildlife San Diego).

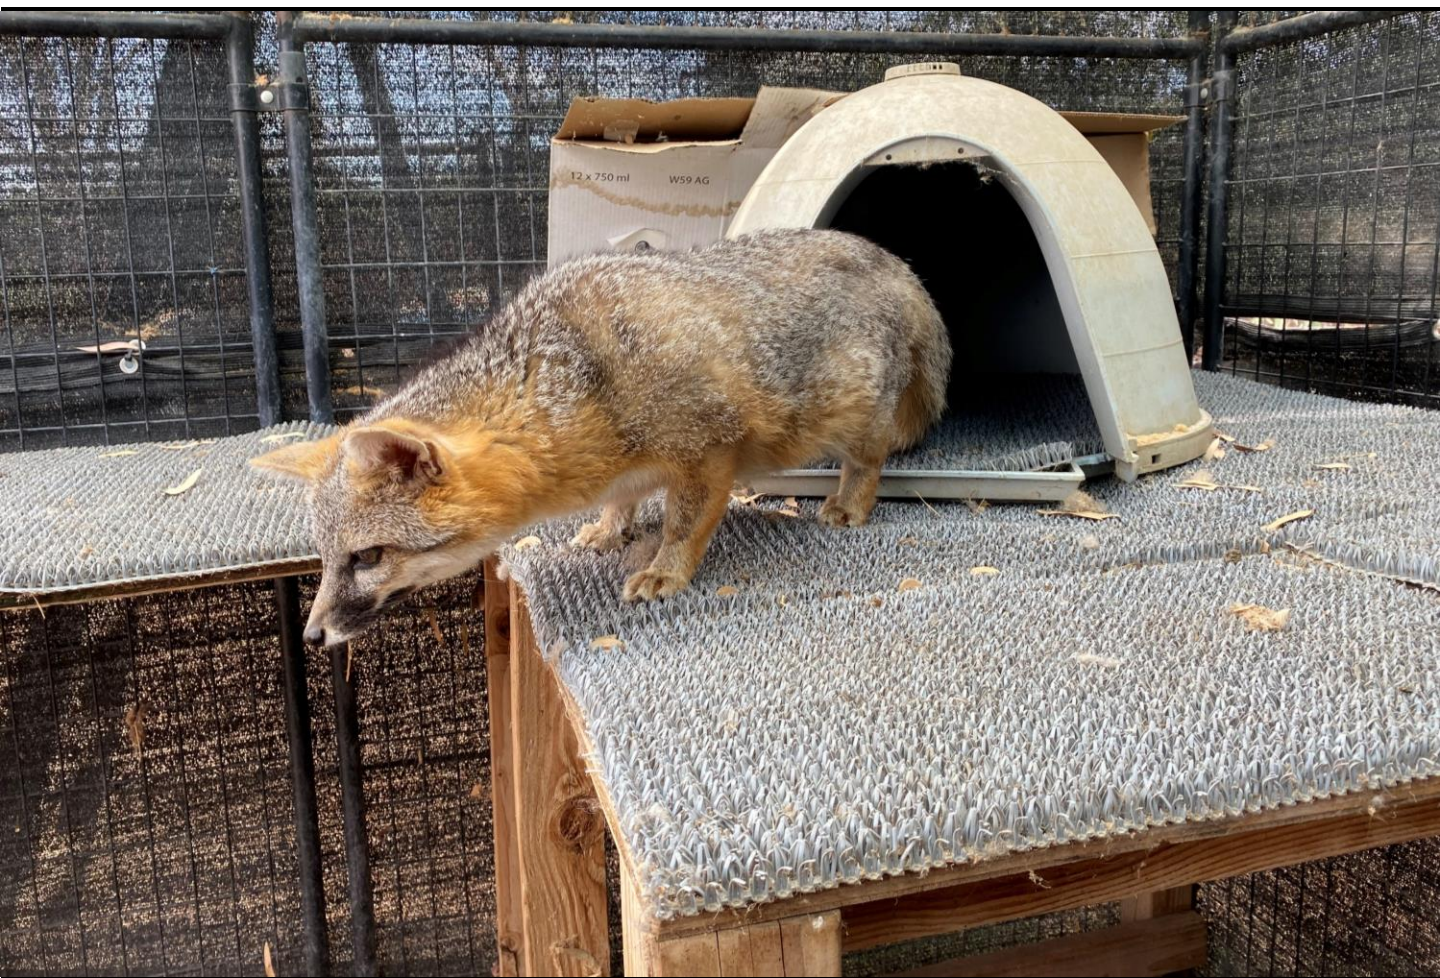
Figure 10. Fox enclosure enrichment: elevated platform, artificial grass/mat, and hide/shelter at Fresno Wildlife Rescue and Rehabilitation.

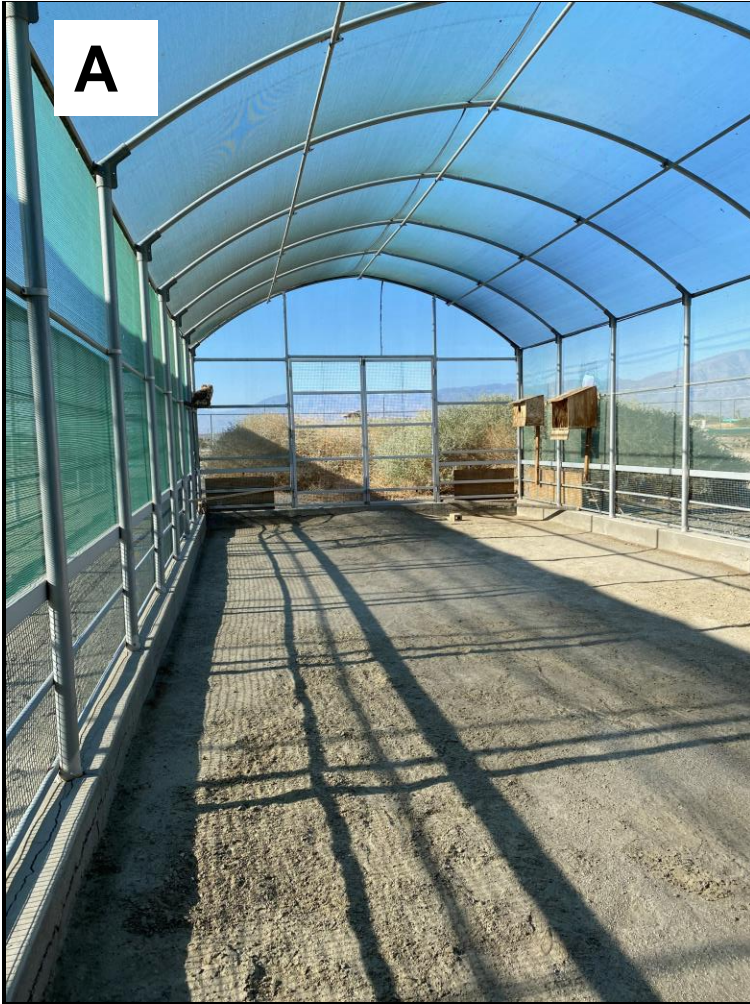
Figure 11. Outdoor flight aviaries allows for access to natural light patterns: raptors with arched roof and hide boxes (A: Coachella Valley Bird Center) and waterbirds with pool and proper substrates to protect sensitive feet (B: International Bird Rescue).

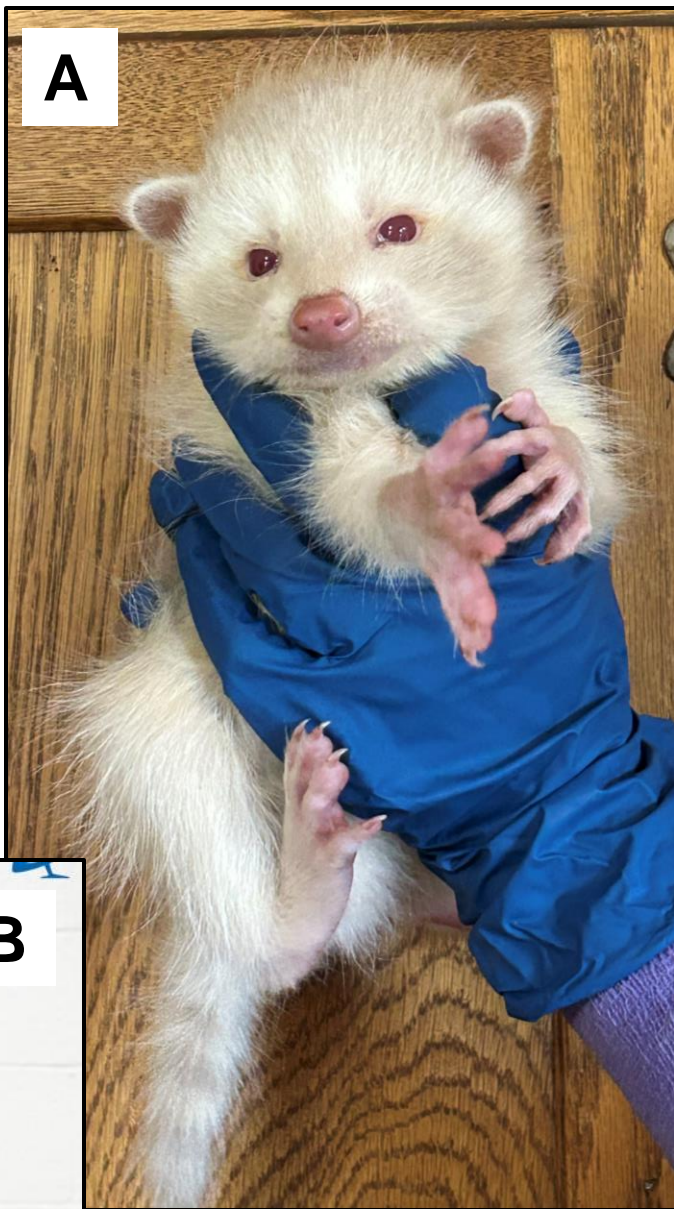
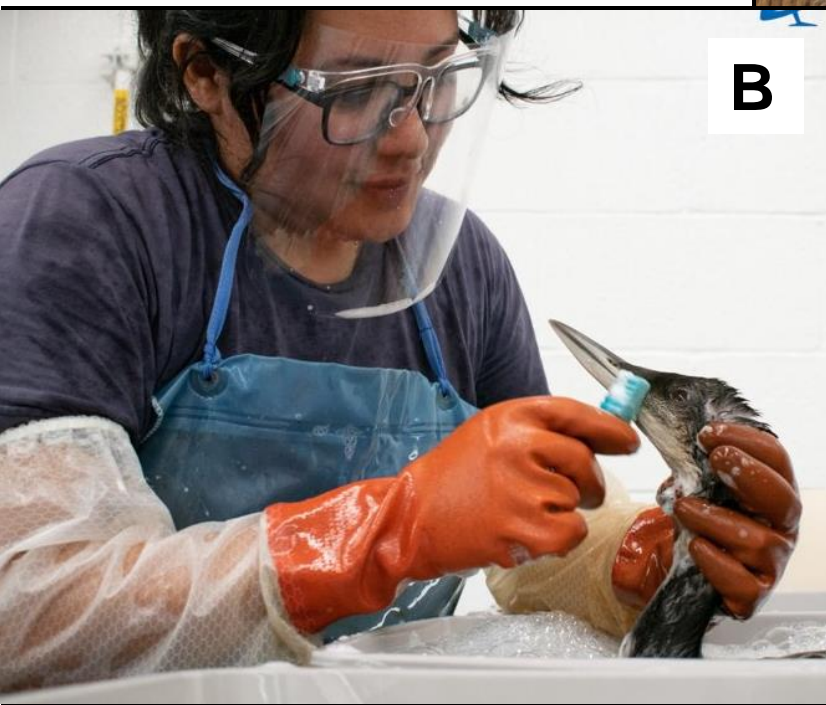
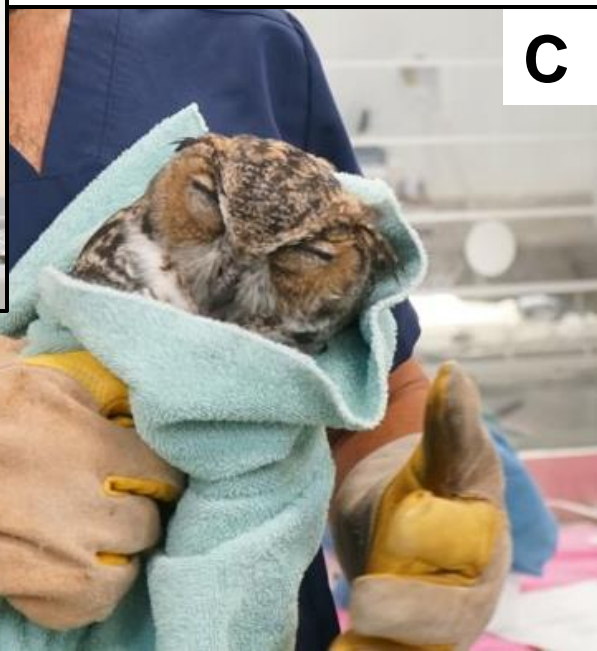
Figure 12. Proper PPE while handling wildlife: juvenile albinistic raccoon (A: Sierra Wildlife Rescue); oiled loon (B: International Bird Rescue); injured great horned owl (C: Project Wildlife San Diego).
