Basso/La Grange Reach Floodplain Restoration Project Phase 1 – Implementation

Organization: Tuolumne River Preservation Trust

Project Period: June 2024 – December 2025

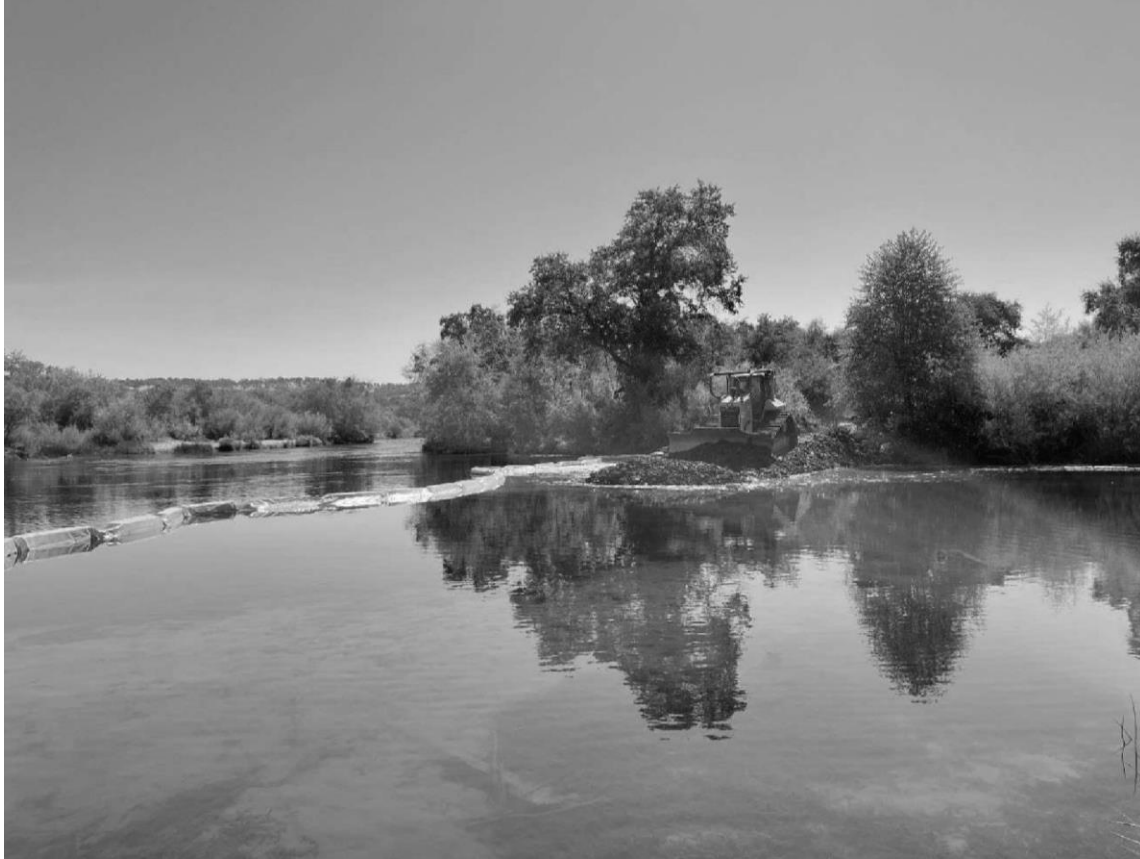
Filling in Floodplain 1 with pit run material. The yellow turbidity curtain is in place to keep as much sediment as possible inside the floodplain area as opposed to letting it flow down the main channel. Large pulses of sediment can be harmful to fish populations, so a multitude of mitigation measures were installed wherever machines and/or sediment were entering the river.
