Thomas R. Payne & Associates
Fisheries Consultants
P.O. Box 4678
Arcata, California 95518-4678
(707) 822-8478
trpa@northcoast.com

RE: Survey of Anadromous Fish Migration Barrier, Thomes Creek, California

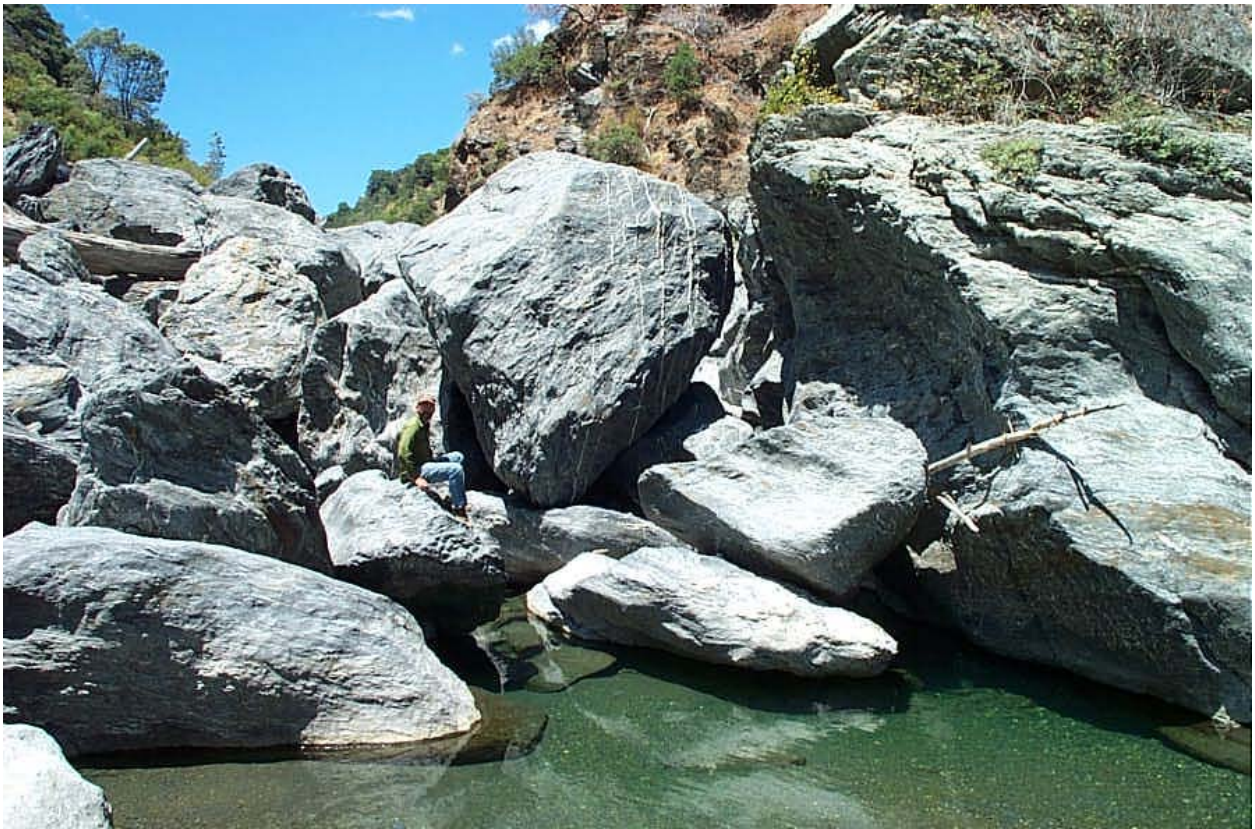
Figure 1. Thomes Creek barrier looking upstream – flow on right center.

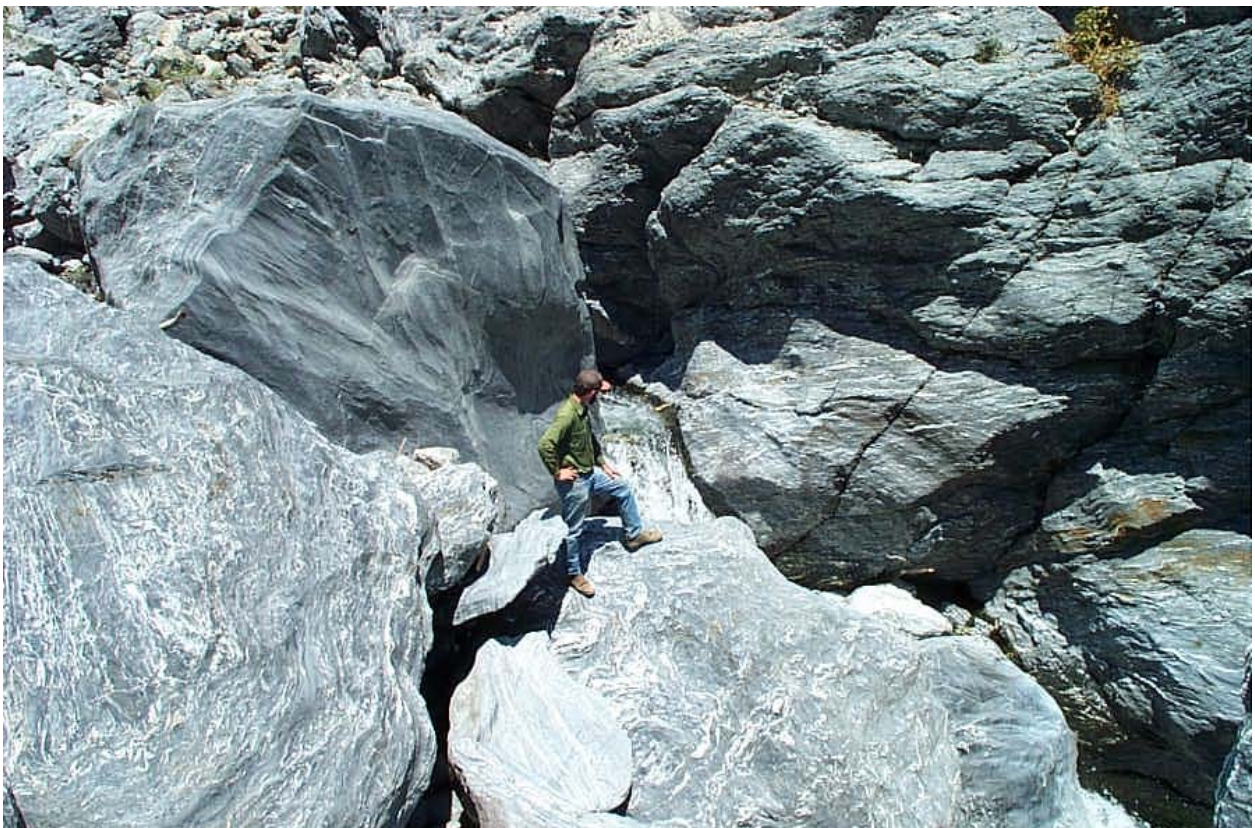
The barrier is not a single fall, but is comprised of three 5- to 6-foot drops and intermediate chutes (Figure 2). The drops angle through the barrier between narrow openings, and would require a leaping fish to make a very precise jump to reach a 2- to 3-foot landing area. Their swimming reaction upon landing must be instantaneous to avoid being swept back. A small, shallow pool between the second and third drop provides minimal staging depth for the final jump. At high flows, all three drops would contain high velocities and very poor leaping platforms.

Figure 2. Thomes Creek barrier looking down into narrow falls and chutes.

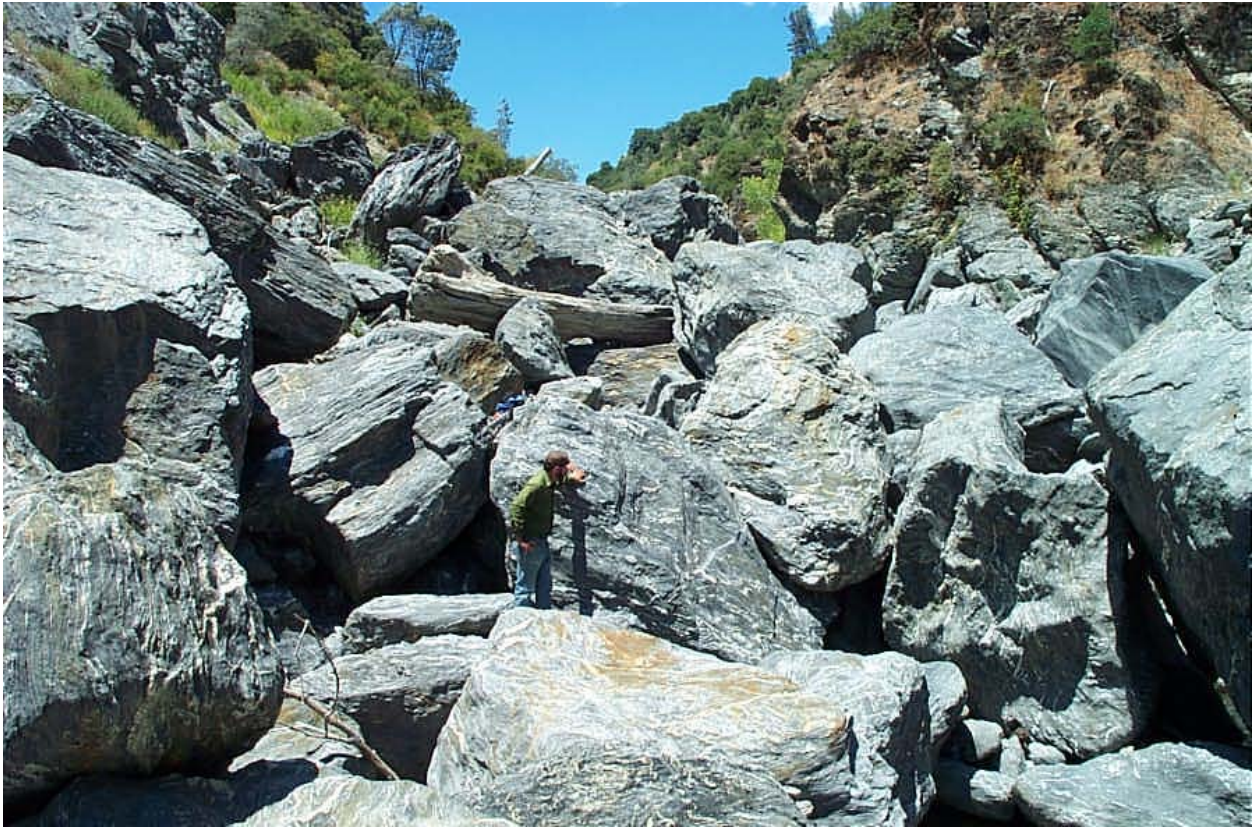
The portion of the barrier to the west of the drops is a jumble of large rocks that contained little water at the time of my observation (Figure 3). When water might be flowing there, I tried to visualize the physical conditions to be encountered by a migrating fish, particularly steelhead, the best jumpers among anadromous salmonids. There would unlikely be jumping pools or individual drops; more likely tumultuous white water throughout. Narrow openings through the boulder jumble and small pockets of quieter water among the rocks, however, could conceivably allow a strong, determined fish to navigate through, with considerable effort and luck at finding the right path at the right time.

Figure 3. Thomes Creek barrier looking upstream at western rock jumble.

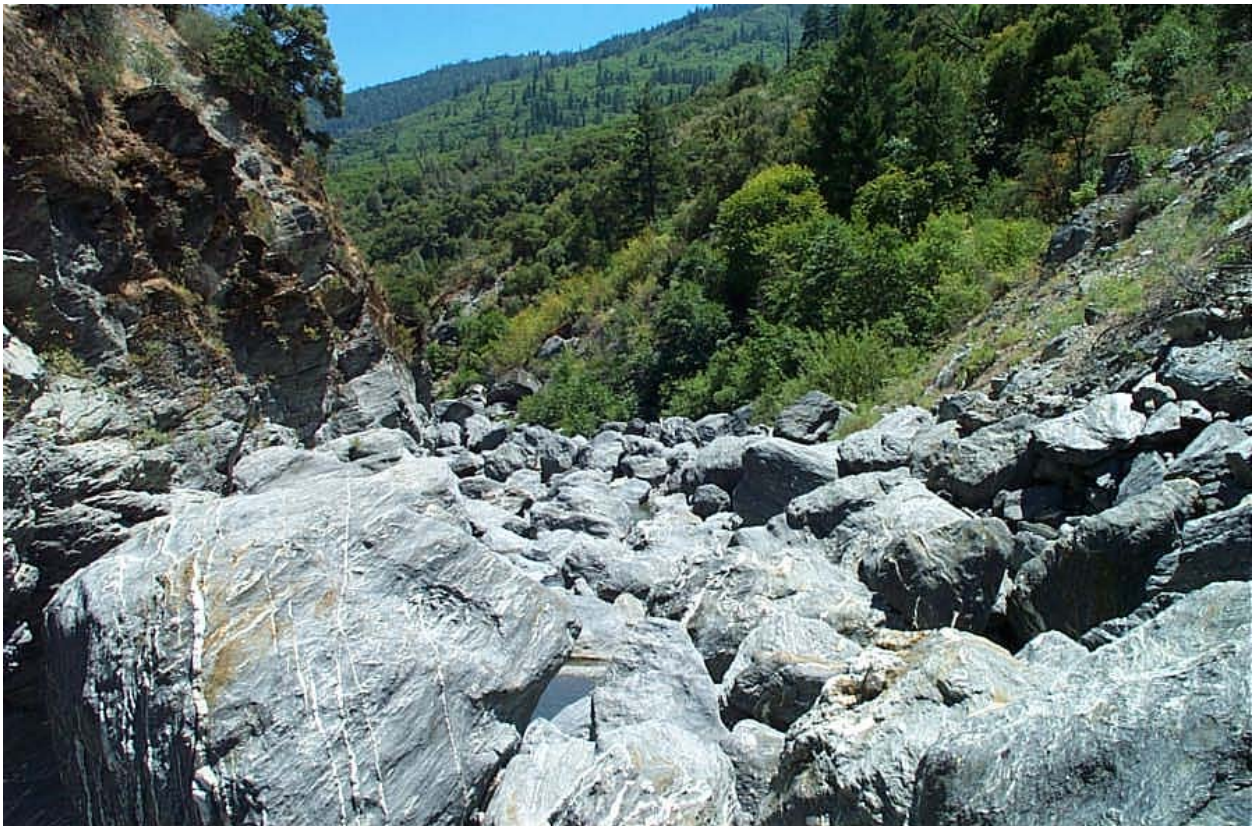
Figure 4. Thomes Creek looking downstream from top of barrier.
