**California Department of Fish and Wildlife**  
*Fisheries Restoration Grant Program*  
Restoration Project Case Study

**Q2010526 Bear Gulch Coho Stream Habitat Enhancement Project**

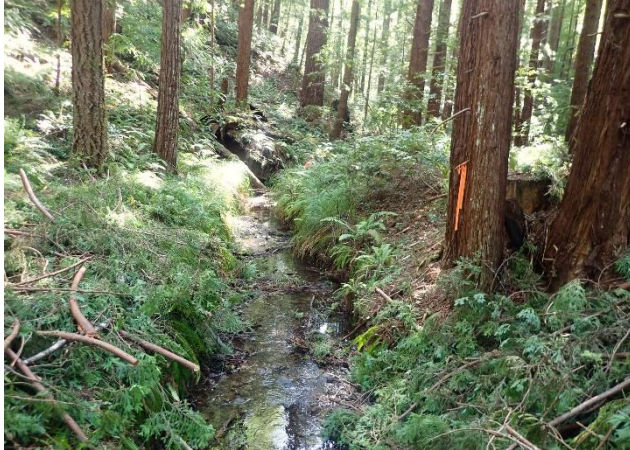
**Figure 1.** Bear Gulch prior to addition of LW showing low diversity habitat. Pre-treatment photo date: 3/31/2021

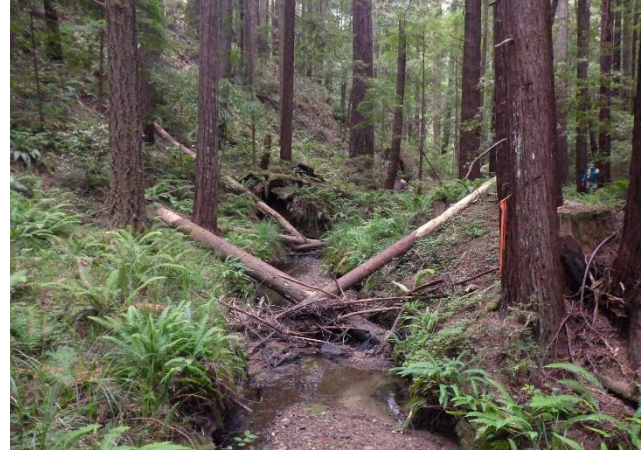
**Figure 2.** LW placed in the channel of Bear Gulch redirected flow to scour a pool, provide cover and improve salmonid habitat. Depth at this pool increased by 1.15 feet. Post-treatment photo date: 7/9/2025

Most features successfully scoured pools and added habitat complexity, but the channel remained straight, narrow and incised. Pool frequency within the treated reach increased from 14.3 pools/mi to 41.3 pools/mi. Of the 31 pools monitored, 25 (81%) increased in depth. The mean change in pool depth across all monitored pools was +0.70 feet (ft). Percent shelter cover within pool habitats increased at every feature by a mean of 29.4%.
