Fish Passage Improvement at Budiselich Flashboard Dam

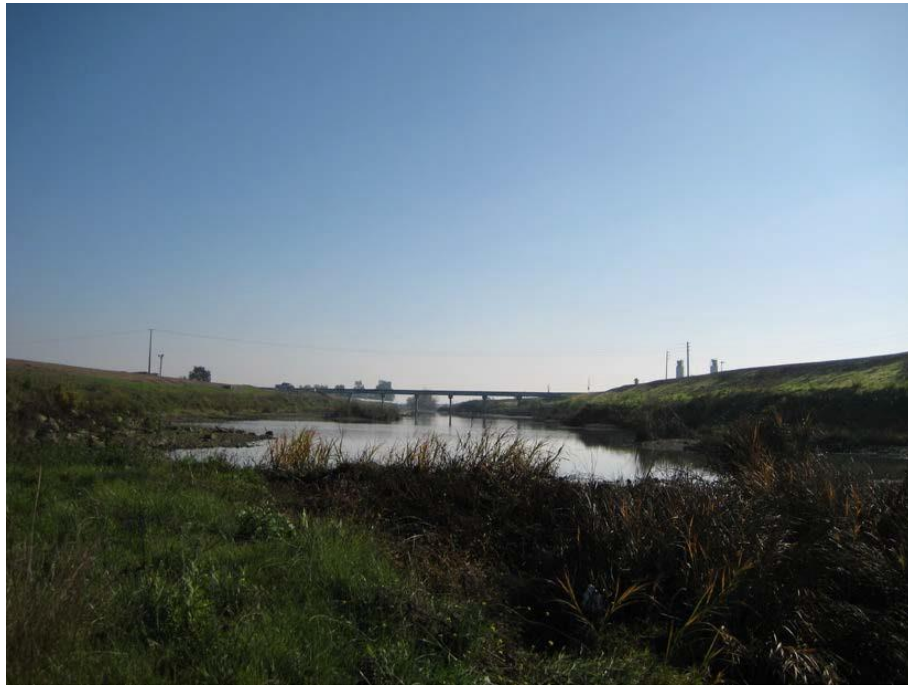
The Budiselich Flashboard Dam is located in the Mormon Slough/Stockton Diverting Canal channel, which serves as the main route for the lower Calaveras River. DWR prepared engineering plans to retrofit the dam. The removed structure was a concrete dam that spanned the length of the low flow portion of the Stockton Diverting Canal. The dam was perpendicular to flow, 100 feet wide, and had 8-foot high abutments on each side. There was a concrete apron, and the downstream face of the dam was protected by riprap that extended at least 50 feet downstream. The structure was a significant barrier to upstream fish migration because of shallow flow depths over the dam and the 6-10% slope of the channel (much of it over riprap) at the downstream end of the apron. The shallow flow depths and steep slope significantly impaired upstream migration for all species and life stages during flows less than 200 cfs. The proposed design for improving fish passage at the structure included a rock ramp fishway and series of boulder weirs. These passage improvements increase depth over the dam, overcome the steep channel slope, and achieve acceptable velocities.
