Site Name: FISH LADDER ACROSS ZINFANDEL BRIDGE

Stream Name: Napa River

Structure Owner: County of Napa

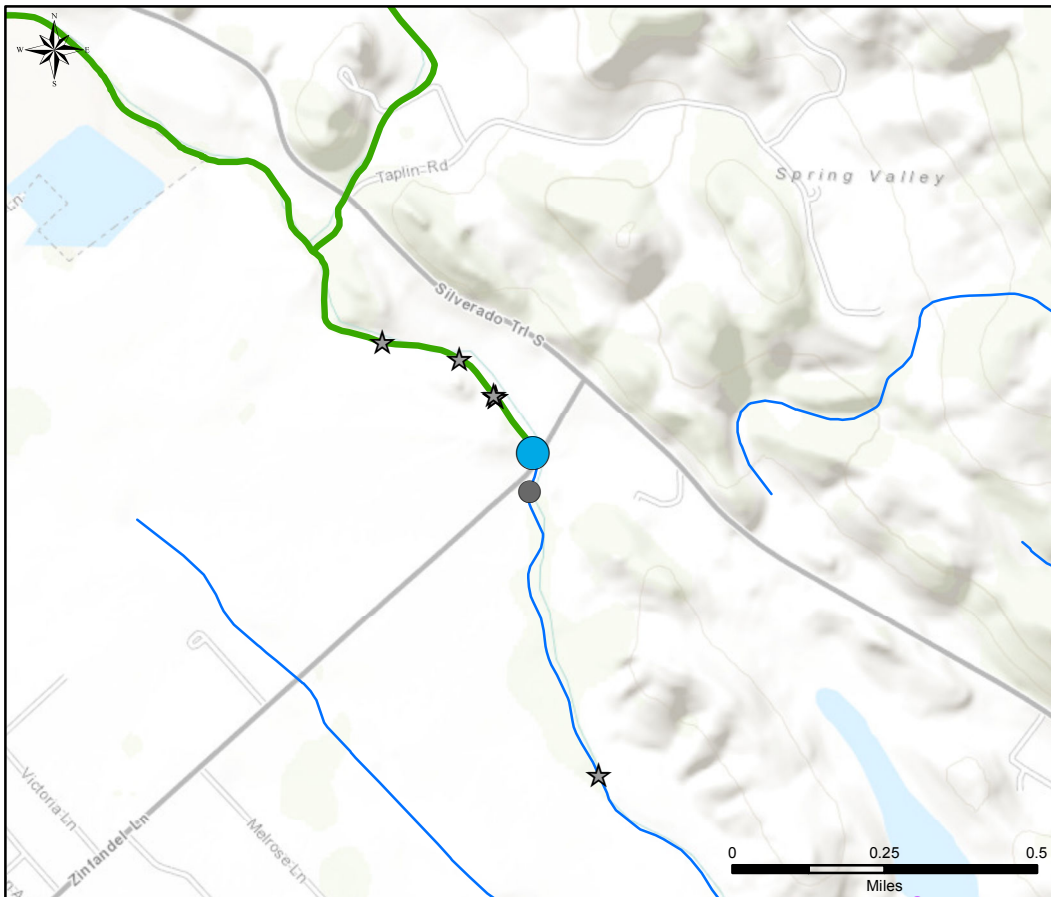
Barrier Description Prior to Removal: Concrete apron blocked Chinook and steelhead from swimming upstream and interfered with juveniles swimming downstream

Site Description After Removal: Concrete apron has been removed

Site Status After Removal: Remediated, fish response unconfirmed
