Brown Pelicans and Fish Waste Handling Conflicts
In Northern California Harbors
Summer 2012

Final Report to the Kure/Stuyvesant Trustee Council

By D. Jaques

Pacific Eco Logic

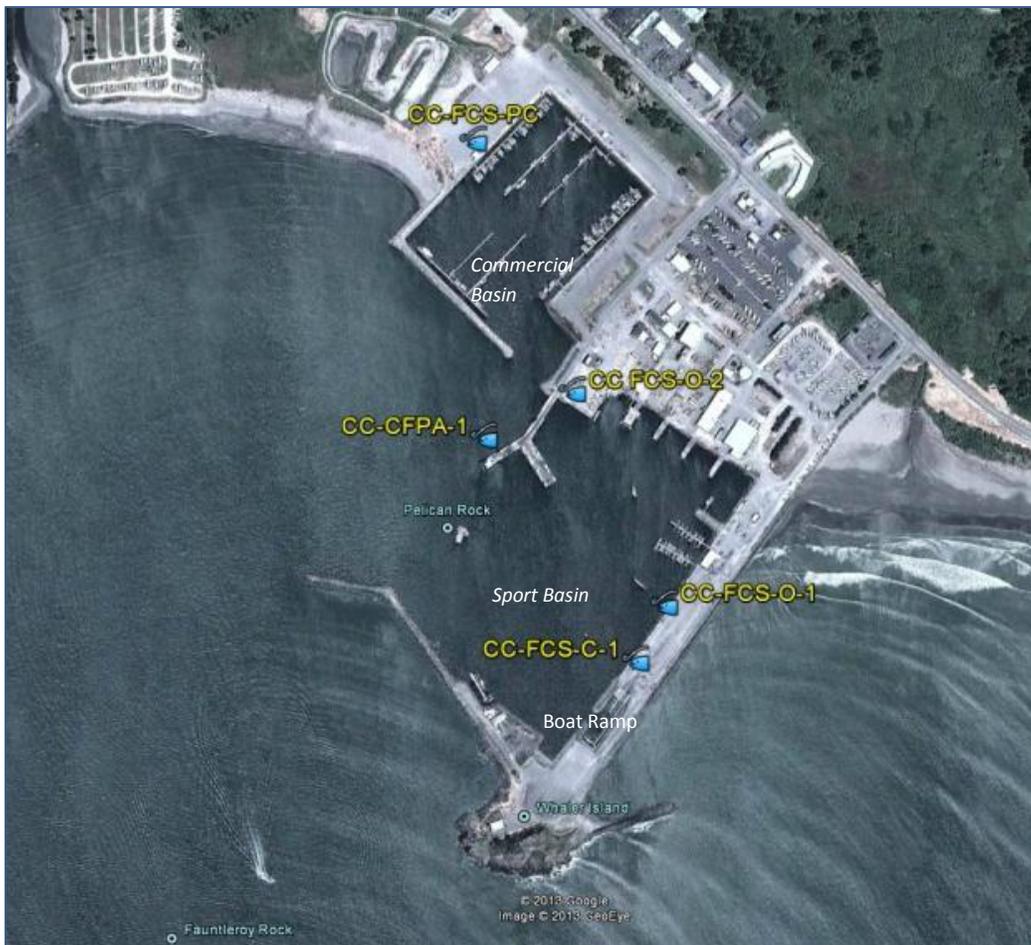
Figure 2. Crescent City Harbor, showing locations of fish cleaning stations, commercial fish processing areas, and sport boat ramp. Photo from Google Earth. See text for location codes.

Crescent City Fish Cleaning Station-Open-1 (CC-FCS-O-1). The most heavily used fish cleaning facility observed in summer 2012 was a recreational fishery open table station between a rip rapped shoreline and the primary parking lot of the sport basin (Fig 2) . The table was plumbed with water; oily waste water and flesh drained out to the harbor through a pipe perched about 10 feet above the rip rap shoreline (Fig. 3). Waste bins consisted of large plastic totes with hinged wooden lids, located on either side of the filet tables. The station was removed on July 20, 2012 due to wildlife conflicts.

Crescent City Fish Cleaning Station-Open-2 (CC-FCS-O-2). A secondary fish cleaning station was located in the northwest corner of the sport basin, in the 'Citizen's Dock' area (Fig 2). This facility had three smaller open tables with plumbing, flanked by fish waste totes with hinged wooden lids. Oily waste and fish scraps drained down open chutes and pipes to the harbor water from each table. The station was removed on July 20, 2012 due to wildlife conflicts

Crescent City Fish Cleaning Station-Closed-1 (CC-FCS-O-1). An enclosed fish cleaning station is located very near the boat ramp on Whaler Island and the open fish cleaning station in the sport basin parking lot (Fig 2). The station is solid construction with a chain link door and windows. Fish waste bins are located inside the structure and oily waste drains directly into the Crescent City sewage system (CCHD, pers. comm).

Crescent City Commercial Fish Processing Area-1 (CC-CFPA-1). The primary commercial fish transfer and loading area is on a two part pier at the end of Citizen's Dock Road (Fig 2). Other commercial fishing activities take place in the commercial basin and north side of the sport basin.

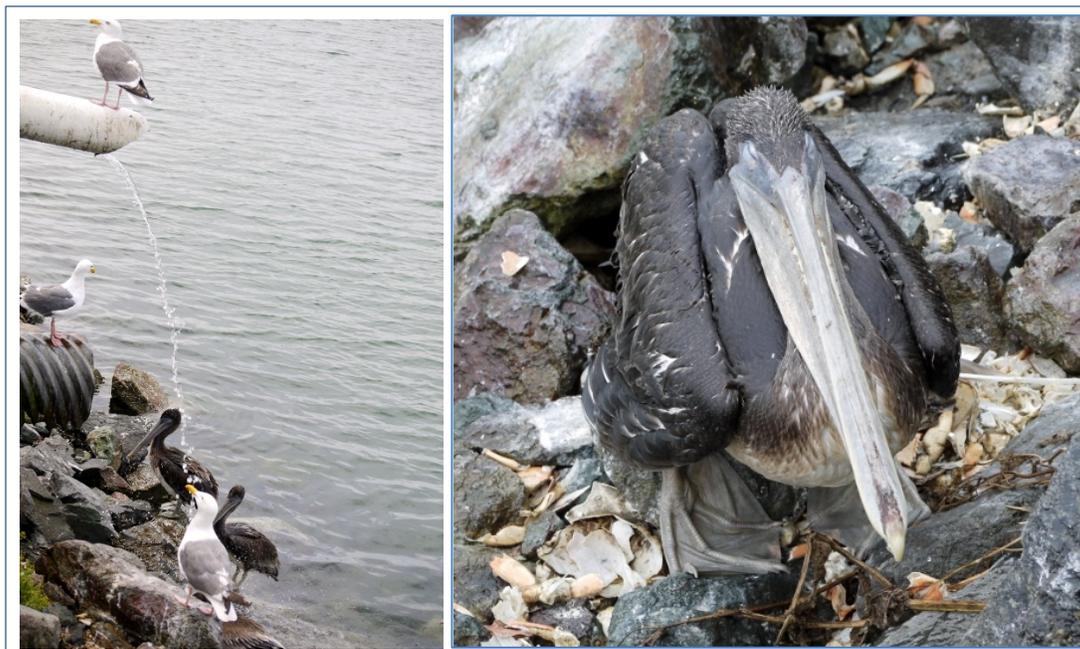
Figure 3. Drain pipe at CC-FCS-O-1 and oiled pelicans below it.

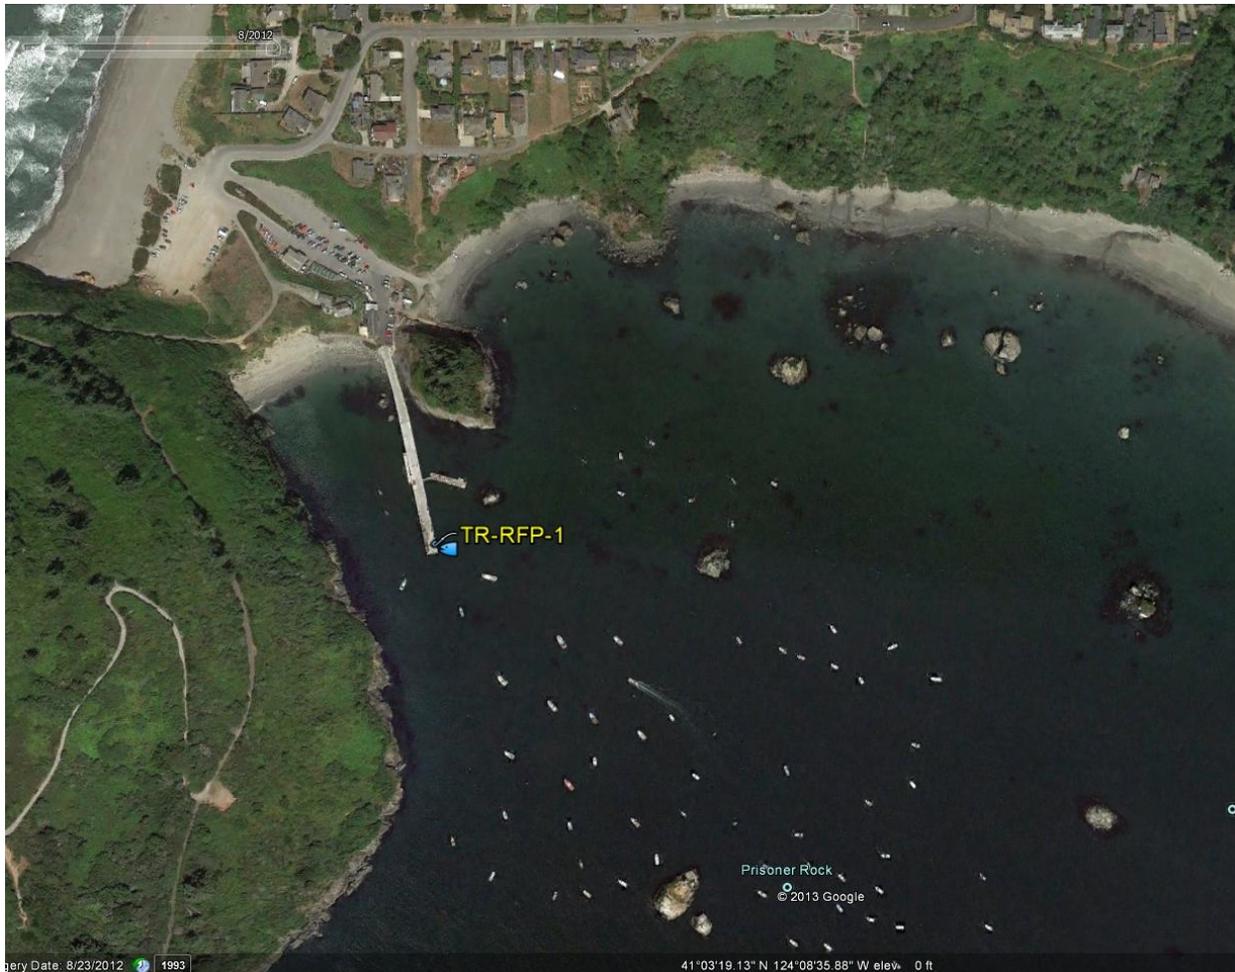
Figure 4. Trinidad Harbor showing the recreational fishing pier and boat moorage.

Trinidad Harbor is owned and managed by the Trinidad Rancheria. No fish cleaning or handling facilities were observed in this harbor during July and August 2012. The “Trinidad Pier Reconstruction” project was recently completed. This structure (**TR-RFP-1**) serves as a recreational fishing pier and temporary mooring; longer term mooring takes place in the associated sheltered waters (Fig. 4). All runoff from the new pier drains into inlets on the decking; this runoff is conveyed via PVC piping to a stormwater treatment vault. Runoff from the former pervious pier deck, which potentially contained trash, fish waste, and hydrocarbon pollutants, flowed directly into the Bay and was considered a problem (Baskin 2012). A fish cleaning station that was present on the old pier is no longer there. Fish cleaning is not allowed on the new pier, which was a coastal commission requirement to reduce potential pollutants from fish waste into the Trinidad Area of Special Biological Significance (ASBS).

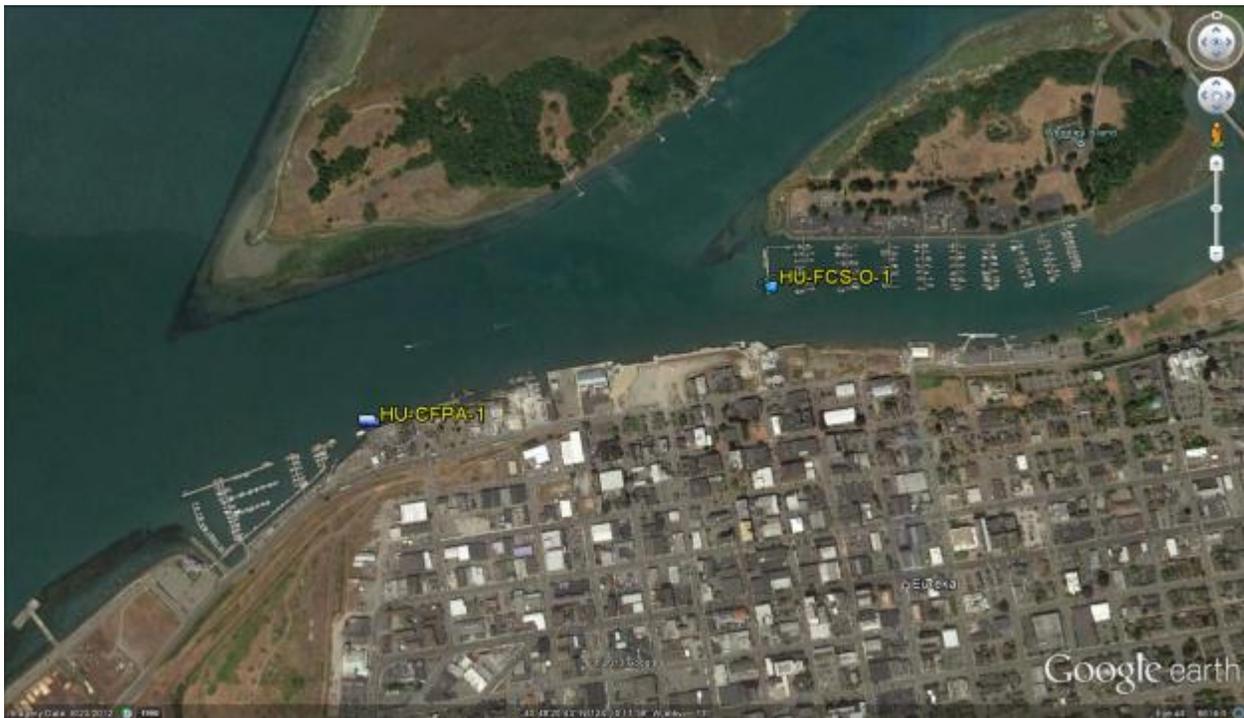
Figure 5. Northeastern Humboldt Bay, showing marinas and commercial fish processing areas near Eureka.

Humboldt Bay Fish Cleaning Station Open-1 (HB-FCS-O-1). One small open fish cleaning station was located at the south end of the Woodley Island Marina at the end of a pier (Fig 5). The table is plumbed and has a discharge pipe that goes directly into the bay into the water column (J. Crider, HBHRCD, pers. comm).

Humboldt Bay Commercial Fish Processing Area-1 (HB-CPFA-1). Fish processors are adjacent to the Eureka Public Marina (Fig. 5). Restricted access and limited shore based vantage points precluded views of waterfront activities in this area.

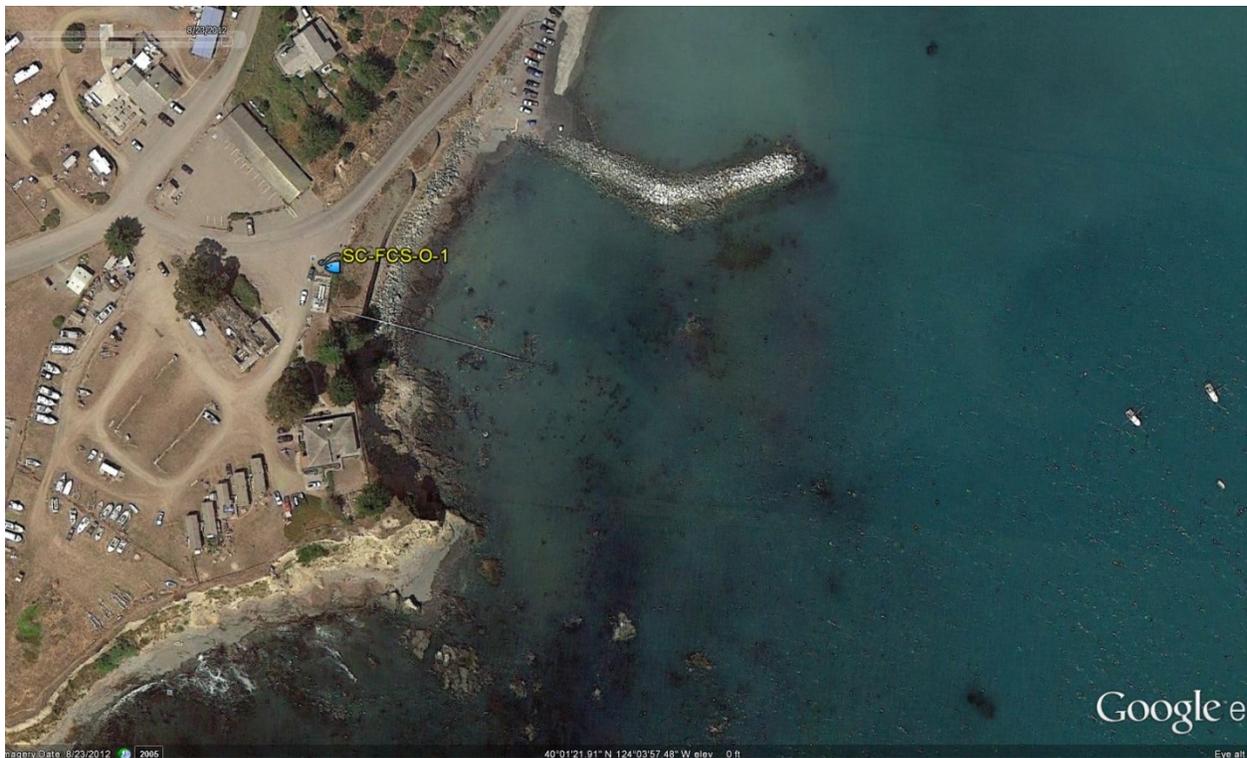
Figure 6. Shelter Cove harbor, showing the fish cleaning station (SC-FCS-O-1) and long fish slurry drain pipe.

Shelter Cove is a geographically remote location with an open-ocean boat launching facility. Public recreational boating and fish handling facilities are operated under the jurisdiction of the HBHRCD but are complicated by the fact that they are located on privately owned land, managed by the Shelter Cove Resort Improvement District (J. Crider, HBHRCD, pers. comm). There is a relatively large fish cleaning station within a chain link fenced area (**SC-FCS-O-1**; Fig. 6). The station formerly had an open top but in response to bird issues, a net top was recently installed. Fish waste from the cleaning table is temporarily stored in a container, then ground into a slurry and drained out to sea via a pipe. The pipe was perched many feet above the ocean's surface, until late July 2012, when it was extended to drain below the water level to eliminate showering scavenging seabirds with oil.

Like Trinidad, Shelter Cove is designated as an ASBS under the King Range unit. This designation specifically prohibits waste discharge into waters under the 2001 Ocean Plan. A compliance review in 2006 identified the discharge from the fish cleaning station at Shelter Cove as a problem (Gregorio et al. 2006). Division of Water Quality staff recommended that waste discharges from the fish cleaning stations at both Trinidad and Shelter Cove be eliminated. Staff recommended that all fish wastes be retained and hauled off-site for legal disposal or use, and all grey water be disposed to land under a waste discharge requirement (WDR) issued by the Regional Board. The State Board considered the Shelter Cove portion of the ASBS a high priority. The HBHRCD was notified to cease discharge from the fish cleaning station by August 2006, but discharge has continued to date. The pelican oiling issue in 2012 has finally set the process of eliminating the discharge in motion (described below).

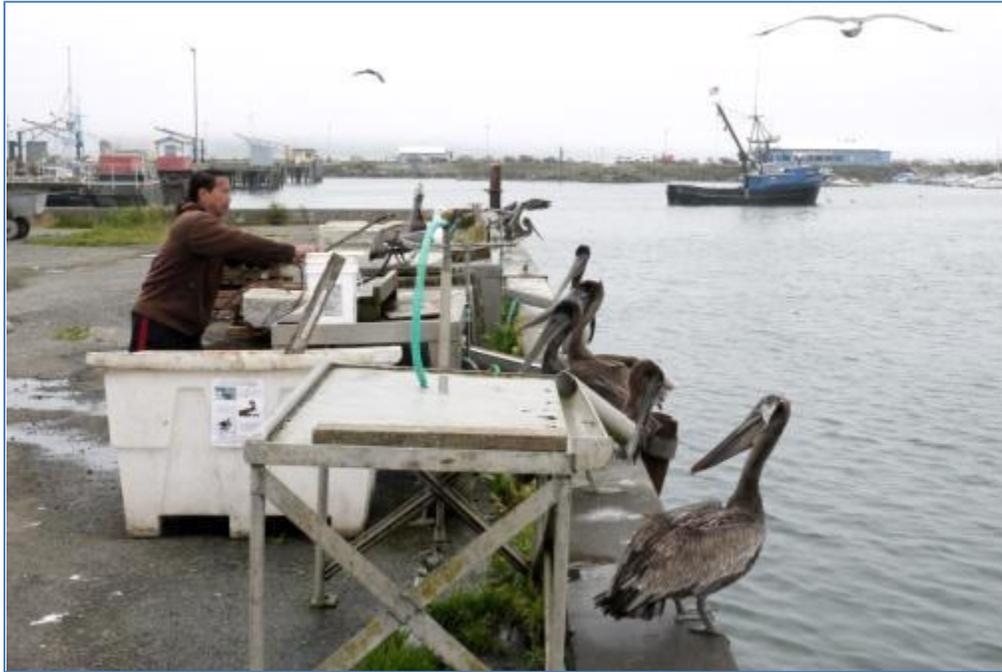
Photo 3. Crescent City Fish Cleaning Station-Open-2 (CC-FCS-O-2), showing open tables, drain system, fish waste bins, interpretive signs posted by the CCHD (on bins), scavenging human and pelicans. CCHD staff conveyed to this non-English speaker that pelicans should not be allowed access to bins and he complied. 7/19/2012.

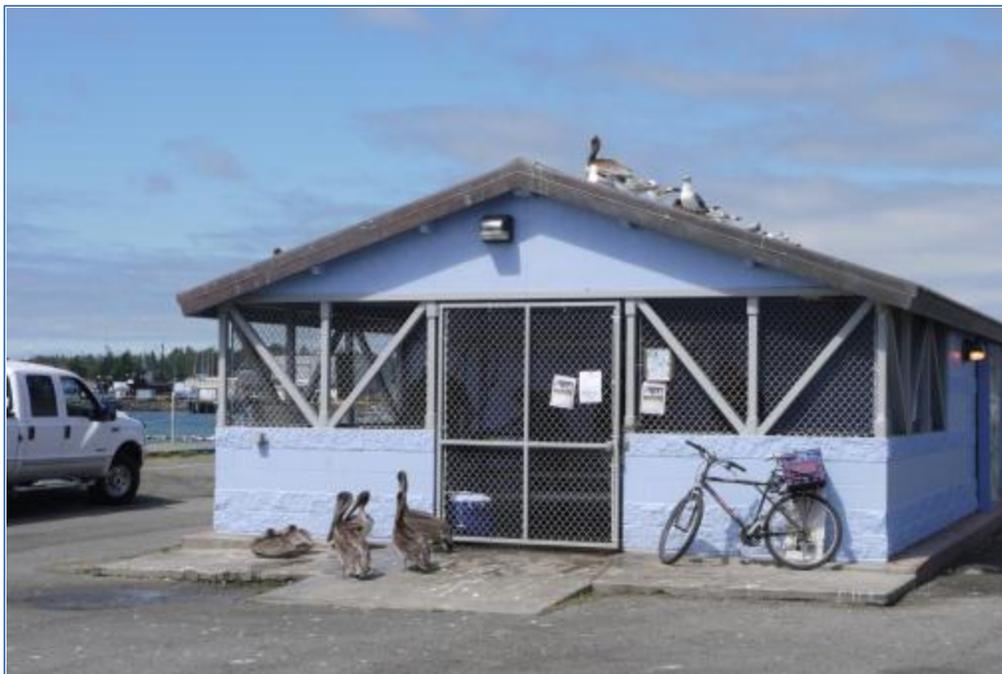
Photo 4. Crescent City Fish Cleaning Station-Closed-1 (CC-FCS-C-1) near Whaler Island boat ramp, showing restrictions to access by pelicans. 7/20/2012.

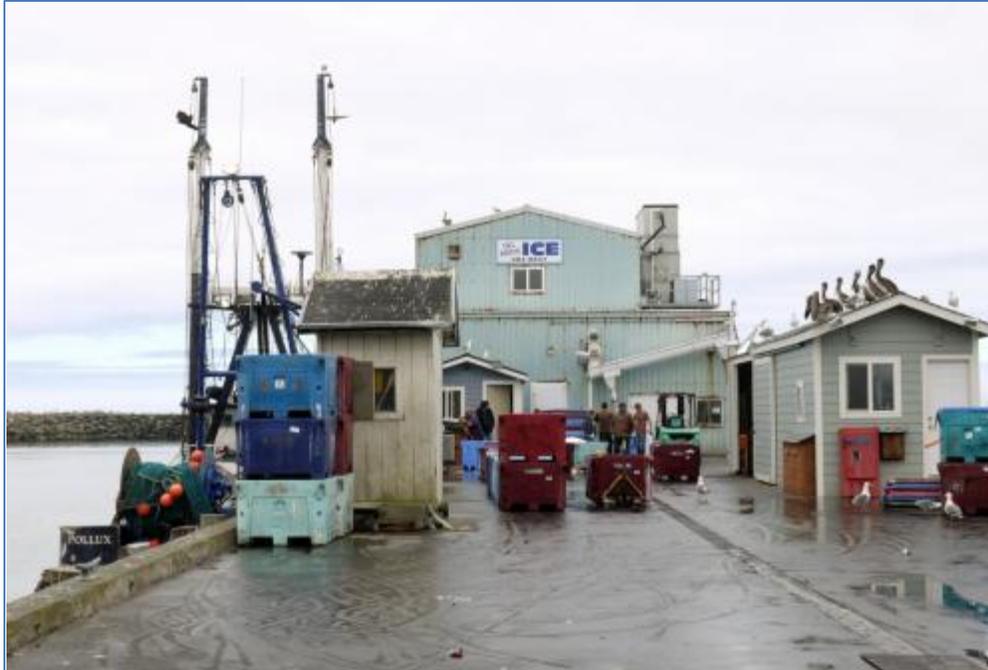
Photo 5. Crescent City Commercial Fish Processing Area (CC-CFP-1), at the end of Citizen's Dock Road the morning the open fish cleaning stations were removed. Catch from fishing vessels is off-loaded into totes at this location. Pelicans were not observed to receive any scraps during observations and ceased attending the site by afternoon. 7/20/2012.

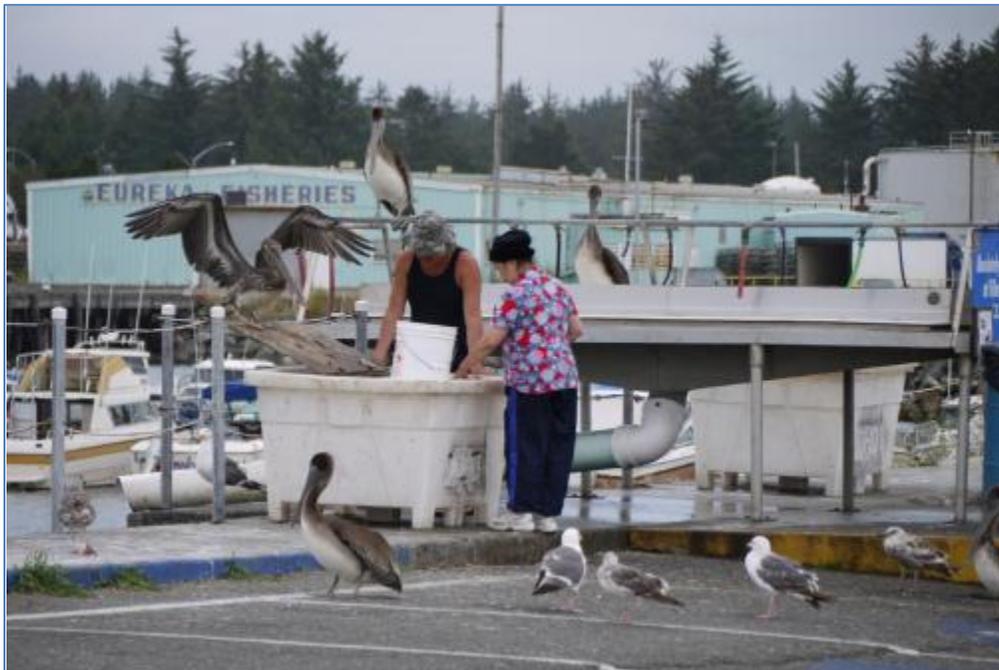
Photo 6. Crescent City Harbor fish cleaning station (CC-FCS-0-1), showing people scavenging for discarded fish, tote lid style, and boldly scavenging partially oiled pelicans. 7/16/2012.

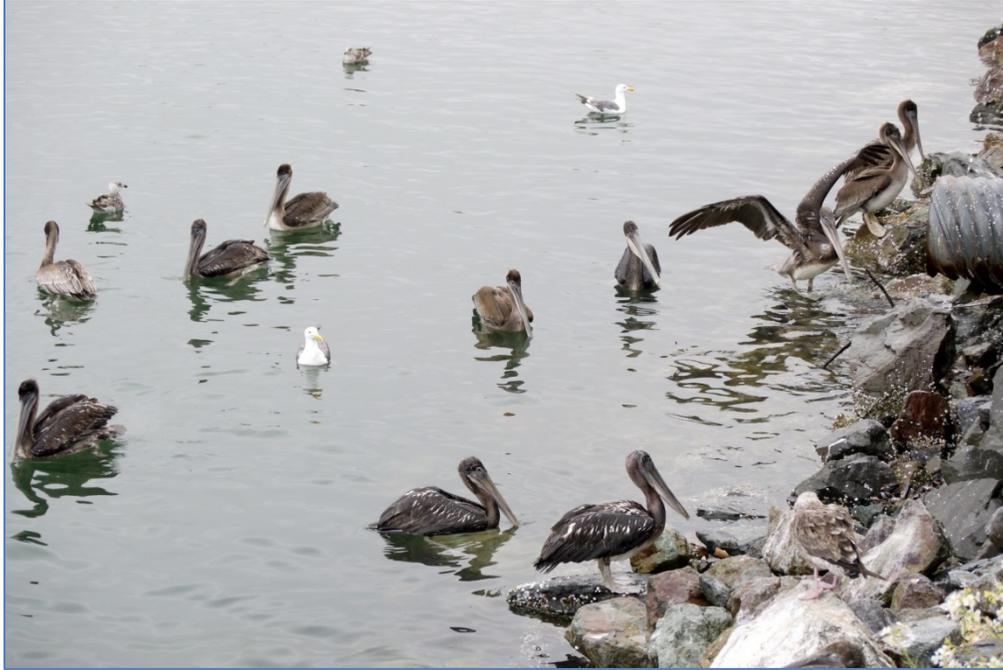
Photo 7. Pelicans scavenging below the perched outflow pipe at CC-FCS-O-1.

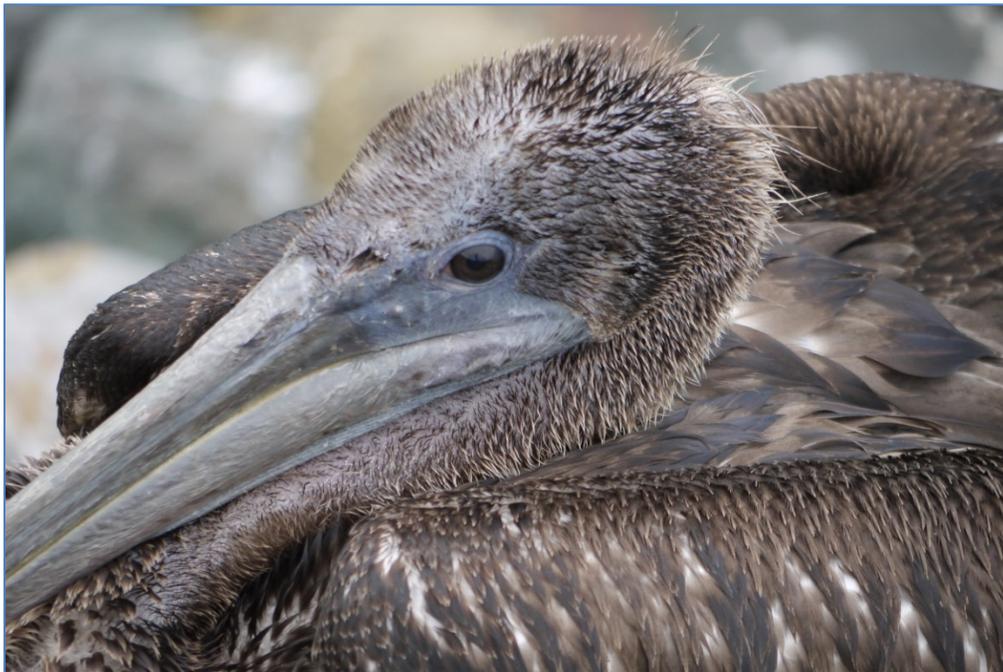
Photo 8. Pelican wet to the skin below the CC-FCS-O-1, presumably contaminated with fish oil.

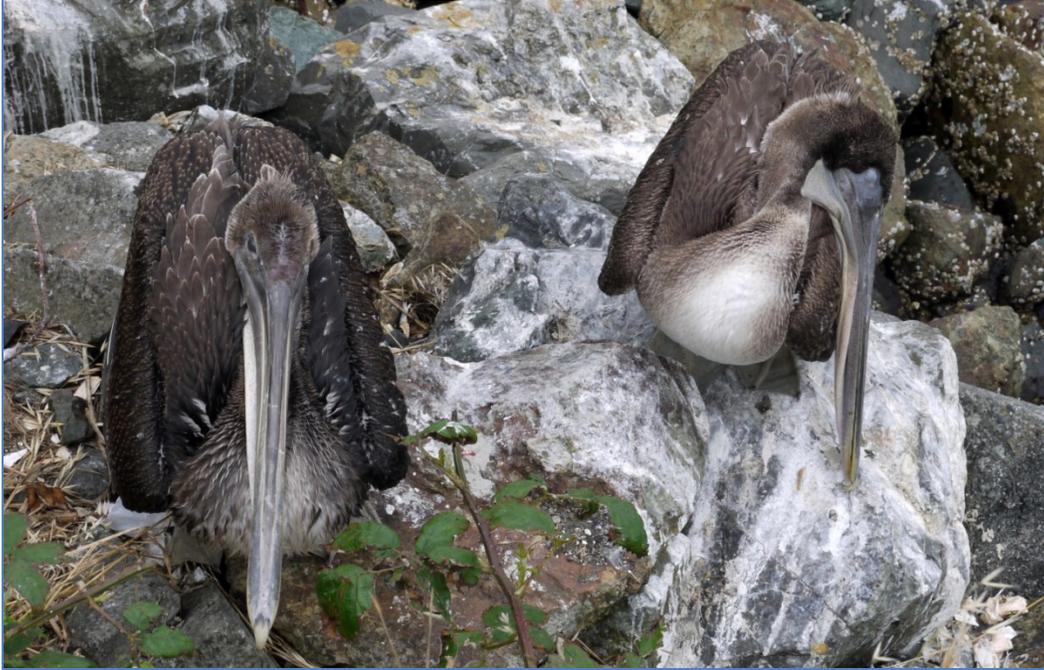
Photo 9. Juvenile pelicans dying on the rip rap in the sport fishing basin at Crescent City Harbor, bird on left is clearly contaminated, bird on right appears dry but may be contaminated. Bird on the right died in place overnight.

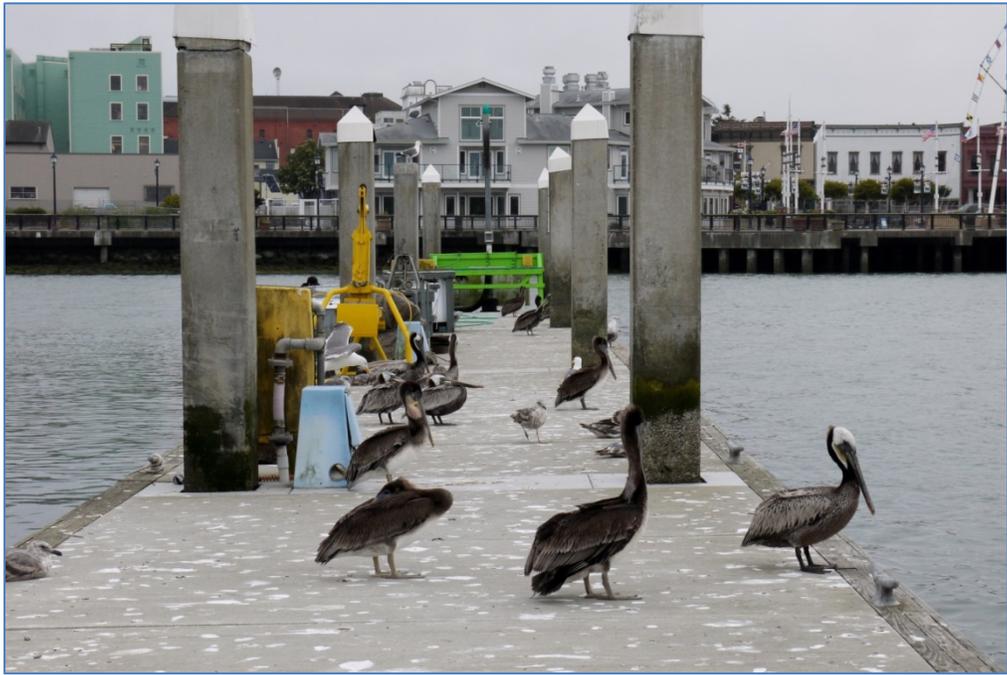
Photo 10. Pelicans attending Woodley Island Marina HB-FCS-O-1, showing a juvenile with a large fish part stuck in its pouch. Soon after the photo was taken, a fisherman arrived and provided birds with tuna carcasses thrown into the water, despite the presence of advisory signs. Many of the pelicans had plumage that was not waterproof, presumably contaminated with fish oil. 7/19/2012.

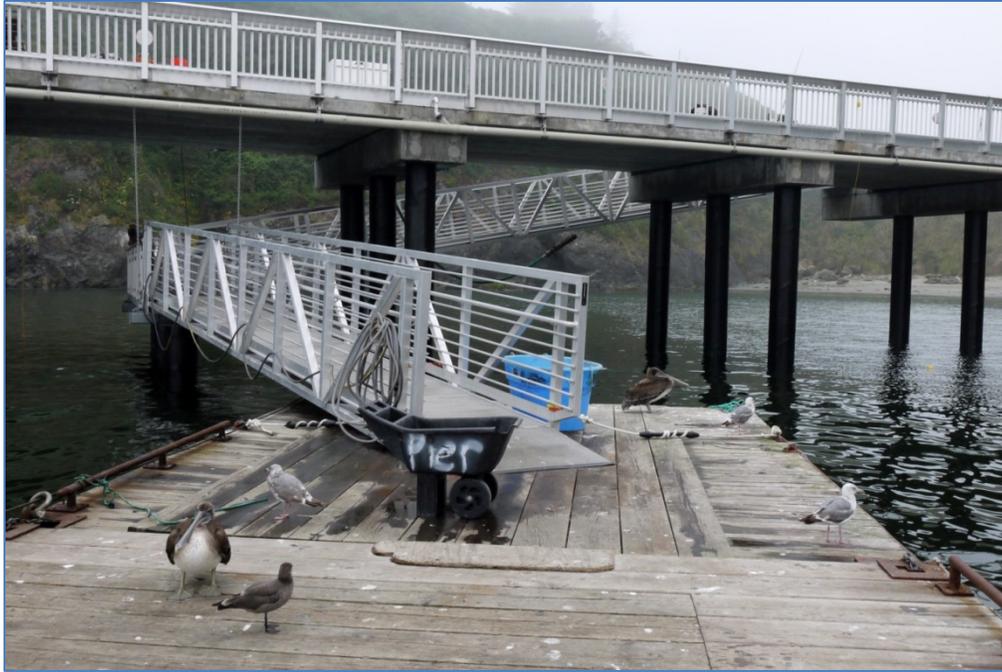
Photo 11. Trinidad recreational fishing pier (TR-RFP-1) and debilitated pelicans. 7/19/2012.

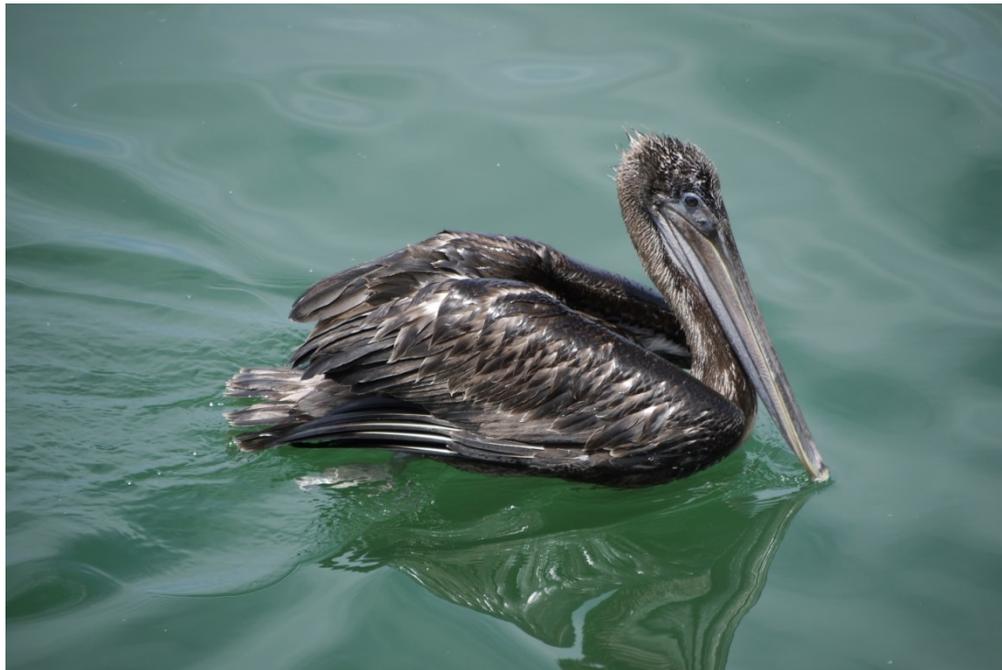
Photo 12. A thoroughly wet pelican floating in the Crescent City Harbor sport basin, below CC-FCS-O-1.

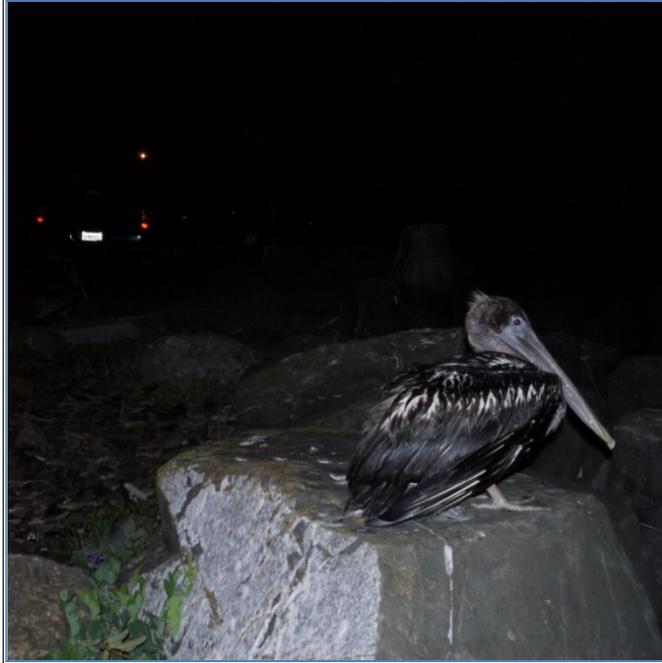
Photo 13. A contaminated pelican attending a shoreline crab fishing area near the Crescent City Boat ramp at night.

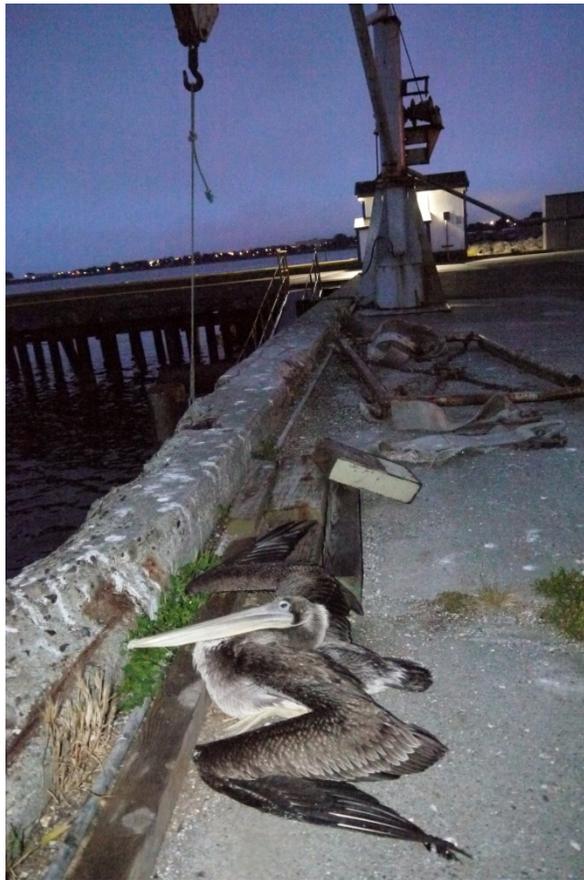
Photo 14. Dying pelican at CC-FCS-O-2 July 19, 2012. Died overnight.
