A Field Study of Small Vertebrate Use of Wildlife Underpasses in San Diego County, 2014

By Jeff A Tracey, Cheryl S. Brehme, Carlton Rochester, Denise Clark, and Robert N. Fisher¹

DRAFT Data Summary

California Department of Fish and Wildlife
Prepared for Local Assistance Grant P1182111

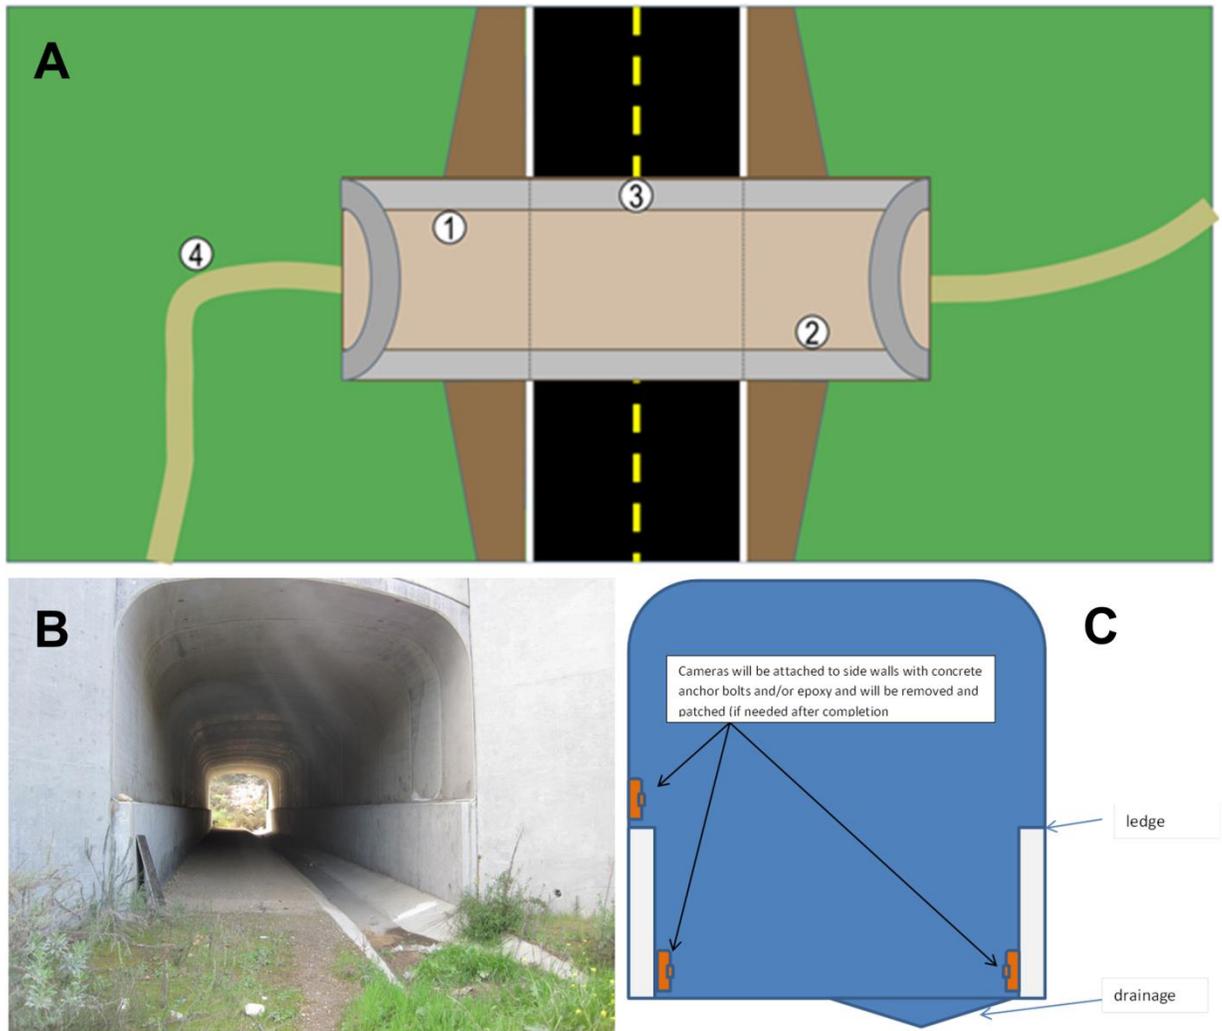
Figure 2: Placement of cameras at study sites. A general layout of cameras in the underpasses is shown in A. Camera positions are shown as circles with numbers, but not all underpasses had concrete ledges. Valley Center Middle, shown in B, is an example of an underpass with concrete ledges. A cross-section of camera placement in the underpasses is shown in C.

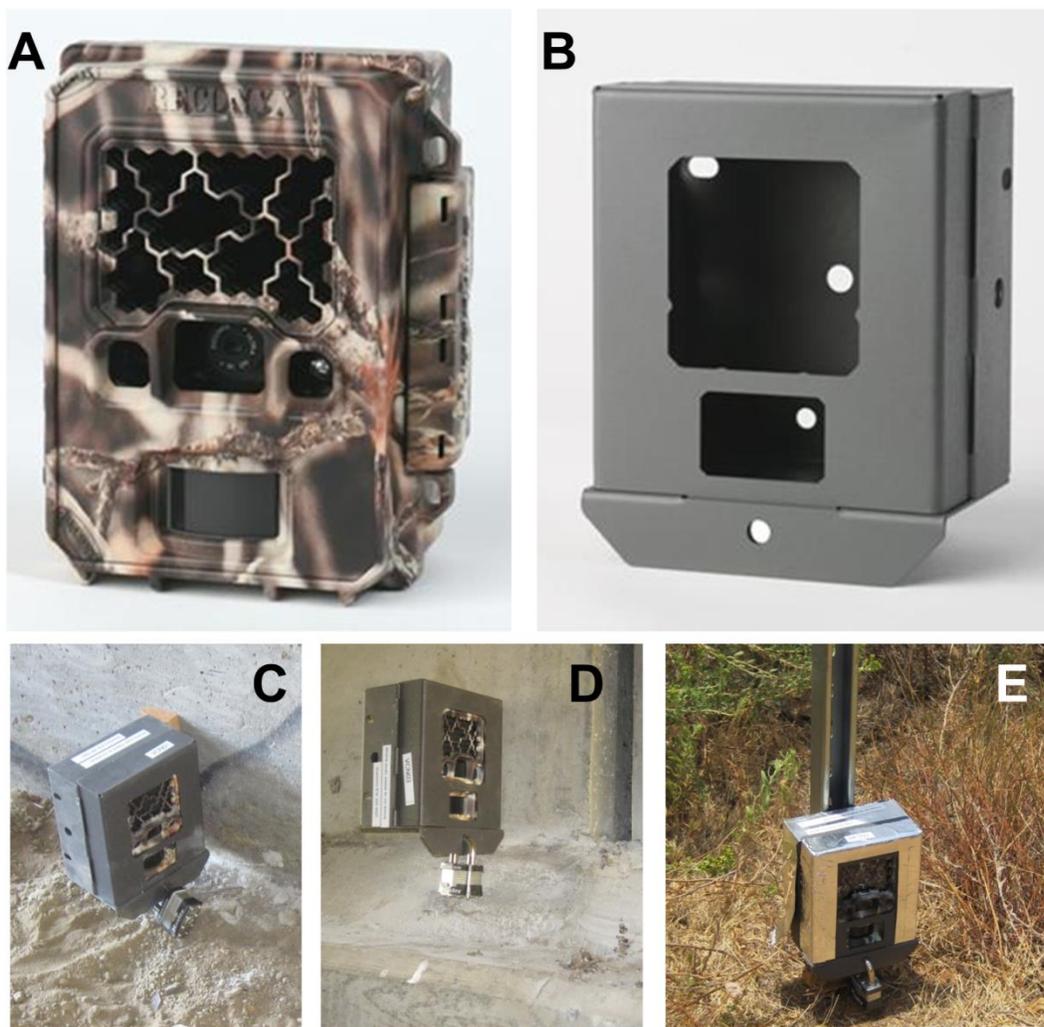
Figure 3: Cameras and installation. The camera model we used, the Reconnyx HyperFire PC800, is shown in A, The camera security box is shown in B. We placed cameras in the underpass interior at ground level (C), on concrete ledges inside the underpass (D), and at exterior locations at ground level (E).

For security, a numerical code can be set that must be entered whenever the camera is turned on or when the user changes settings. In addition, Reconyx makes custom fit security enclosures for HyperFire Series cameras (Figure 3B). The 17.8h × 14.0w × 8.9d cm enclosures are made of 16-gauge steel with weather resistant powder coat finish. The security enclosure provided a way to mount the cameras, remove them when not in use, and replace them in the same position and orientation at a later time.

In addition to security boxes, padlocks, and mounting hardware, each camera requires batteries and memory cards on which to store images. The cameras are powered by 12 AA batteries. To minimize cost and waste, we used rechargeable NiMH batteries (AccuPower NiMH-AKKU) for the interior cameras. The rechargeable batteries drained quickly in the exterior cameras (presumably due to the higher temperatures), so we used high-quality lithium batteries (Energizer Ultimate Lithium) in the external cameras. The cameras store images on SDHC cards, so we used two SanDisk 8GB or 16GB SDHC cards per camera.

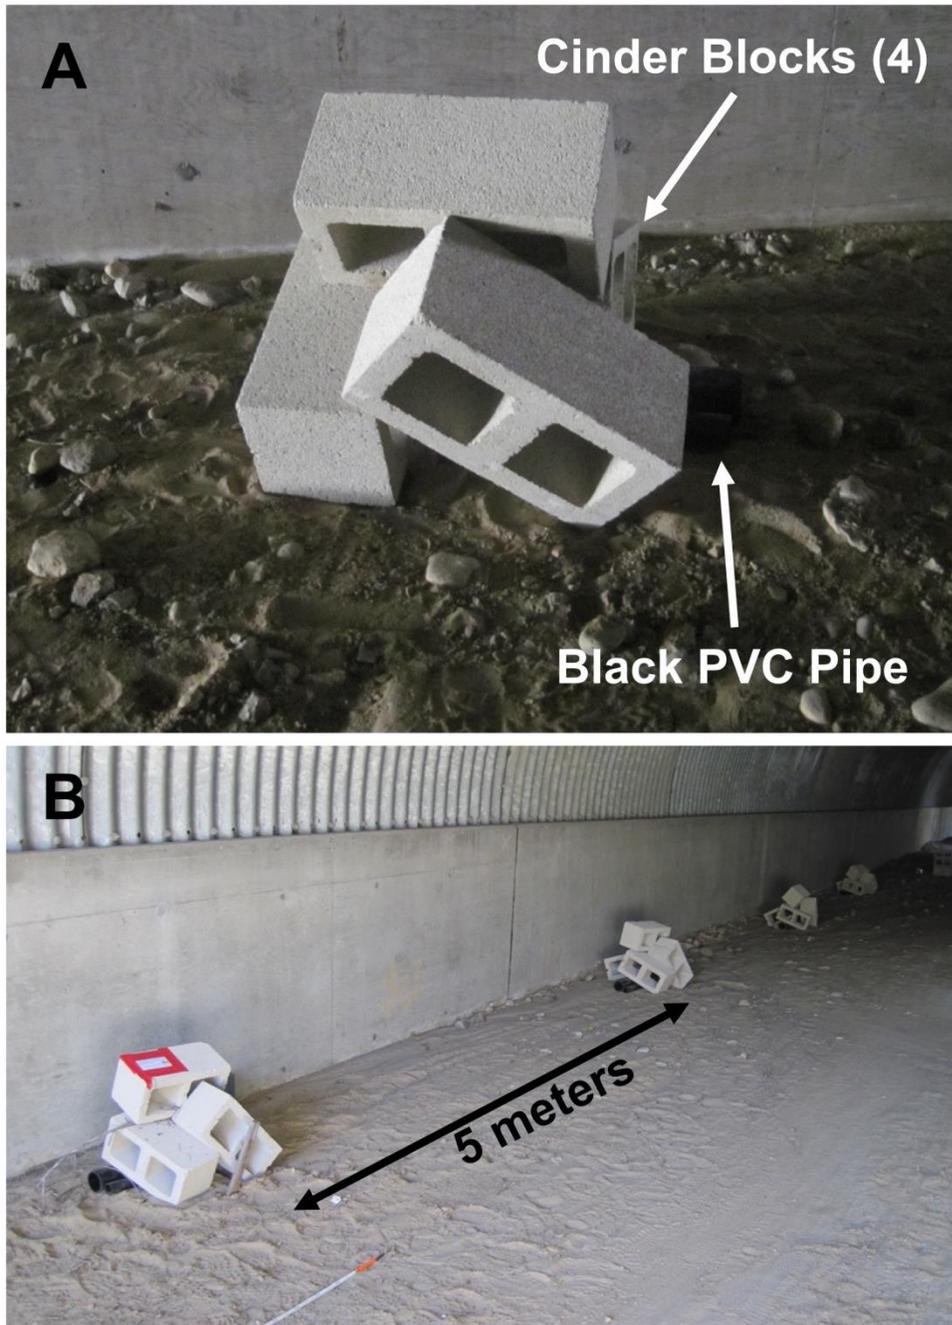
Figure 4: Treatment applied to randomly selected underpasses. Each structure consisted of four cinder blocks, one 0.5-meter length of 1-inch black PVC pipe, and one 0.5-meter length of 1-inch black PVC pipe (A). Structures were placed at 5 meters intervals along one wall of the treatment underpasses for the entire length of the underpass (B). Thus, the number of structures placed in the control underpasses varies based on the length of the underpass (**Table 1**).

We randomly assigned four underpasses to the treatment group and four underpasses to the control group (Table 1). In January of 2013, we added small structures to the treatment underpasses. Each structure consisted of concrete blocks stacked on top of two half-meter sections of black PVC pipe (Figure 4A). The structures were placed at five-meter intervals along the entire length of one side (the “cover side”) of the treatment underpasses (Figure 4B), and were intended to allow small vertebrates to move from one structure to the next, thereby facilitating movement through the underpass. We did not place structures on the wall opposite the cover side of the treatment underpasses (the “open side”). The purpose of this design was to facilitate movement of species with both open and closed microhabitat preferences. Furthermore, the structures were very small compared to the lengths and widths of the underpasses, so they would not impede the movement of humans or any other animals. Since there were two interior cameras at ground level on each wall of each underpass, one of the ground-level interior cameras was on the cover side and the other was on the open side of the treatment underpasses. We allowed over two months for animals to habituate to the treatment before subsequent post-treatment monitoring (late March to late September 2013).

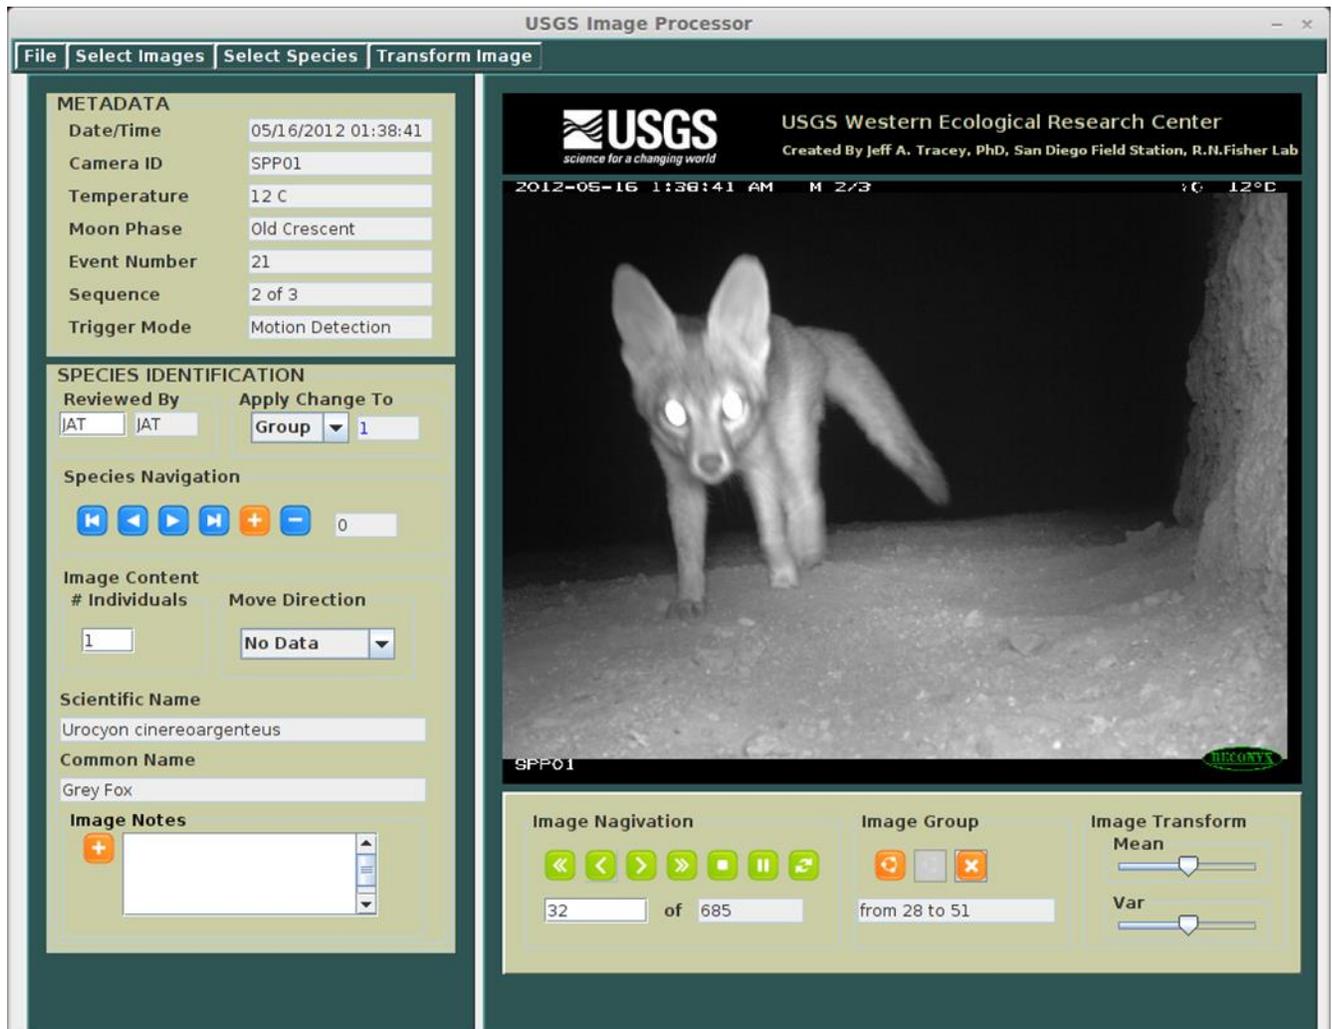
Figure 5: User interface for an image-processing program developed at the USGS San Diego Field Station.

A cross-platform Java program, written by Jeff A. Tracey (USGS, San Diego Field Station), allowed personnel to rapidly review images and assign data to them (**Figure 5**). USGS staff used the first version of the program in 2012 to process images. The program was further tested and improved in late 2013. Because the cameras create image files with the same sequence of file names (IMG_0001, IMG_0002, ...), there is a risk of over-writing image files and losing the data they contain. Thus, the program we created automatically copies images to a new file with a unique name. During this process, the program also automatically extracts and stores Exif metadata (date, time, camera name, temperature, moon phase, trigger mode, and image sequence) by making a system call to the ExifTool utility (<http://www.sno.phy.queensu.ca/~phil/exiftool/>). A reviewer can then view the images by stepping through them one image at a time, or animating them, in either a forward or backward direction. A reviewer can also group similar images together and assign species data from a pull-down menu, indicate the number of individuals in the image, and the direction that the animals were traveling. This interface allowed the data assigned to an image to be checked, and because qualitative data was added from menu selections, these attributes were recorded in a consistent manner. Image processing projects can be saved to XML files and re-opened, and the data generated by a reviewer using the program can be exported to CSV (comma-separated values) files (Figure 6). Additional details about the image processing methodology can be found in the user guide for the image processing program (Appendix B).

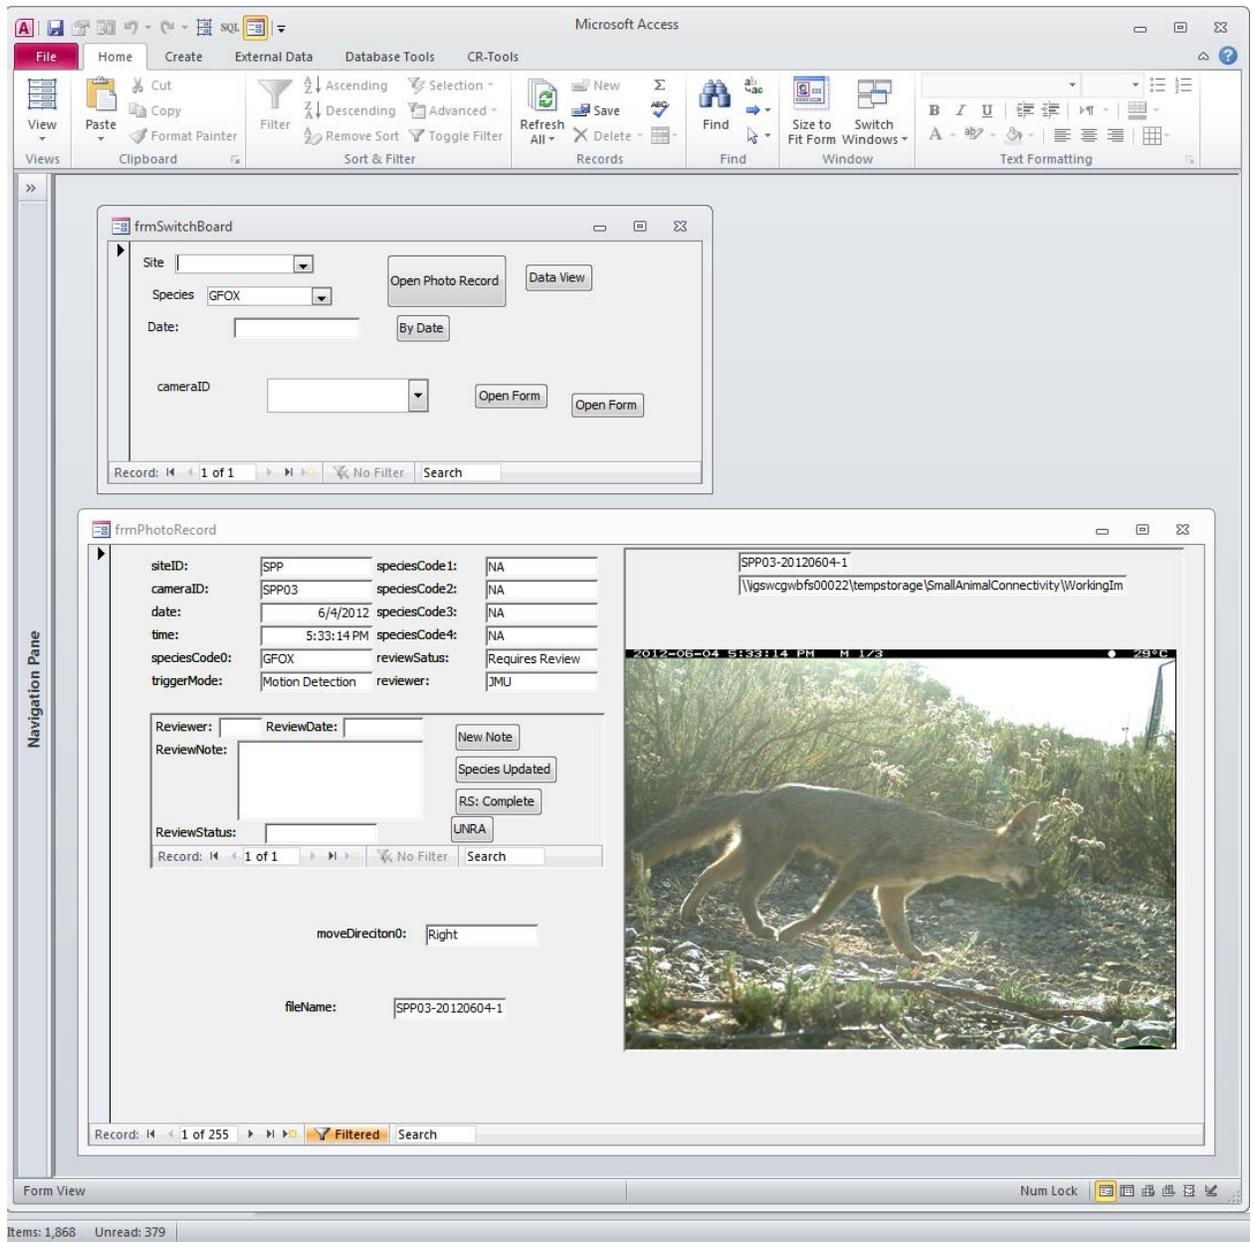
Figure 7: Screenshot of a Microsoft Access tool to QAQC data associated with images.

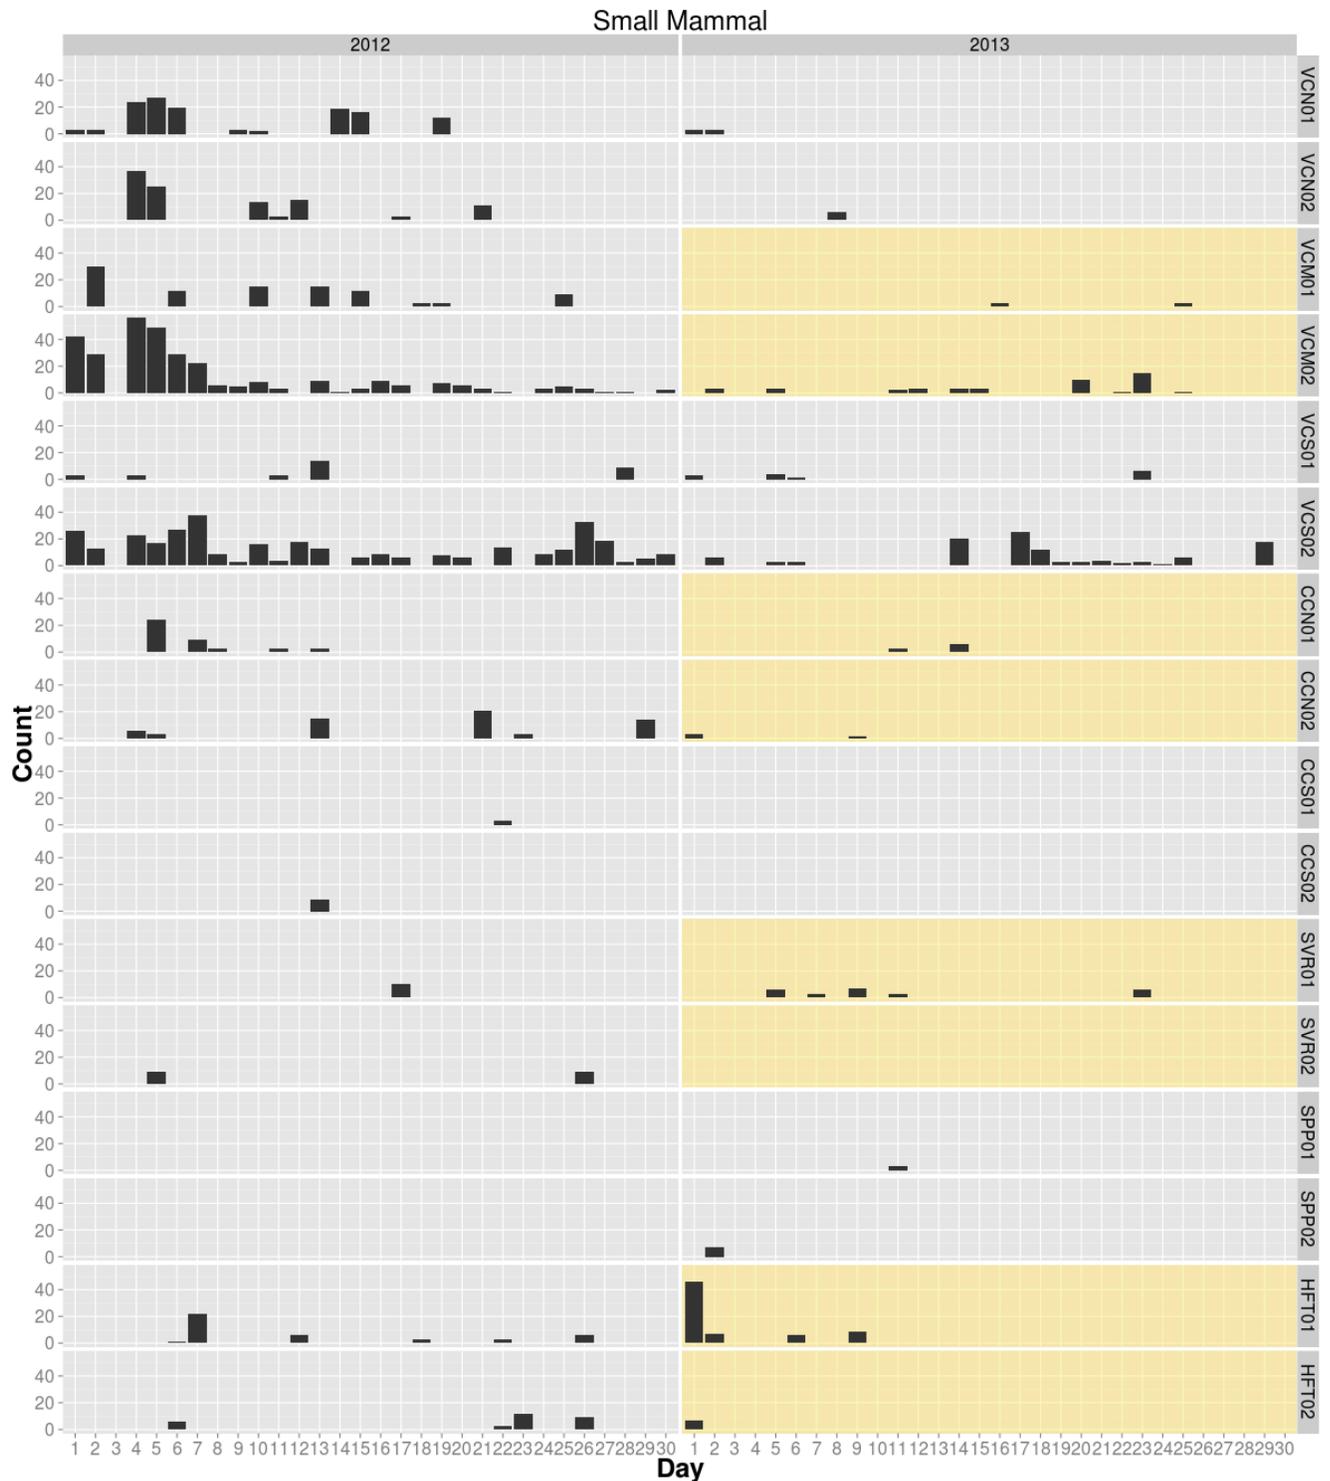
Figure 8: Numbers of images with small mammals per sample day. Separate bar plots are shown for each camera and year. Plots shaded in yellow indicate underpasses where the treatment was applied. The sample day is given on the x-axis and the number of images per day that captured species in this group is given on the y-axis.

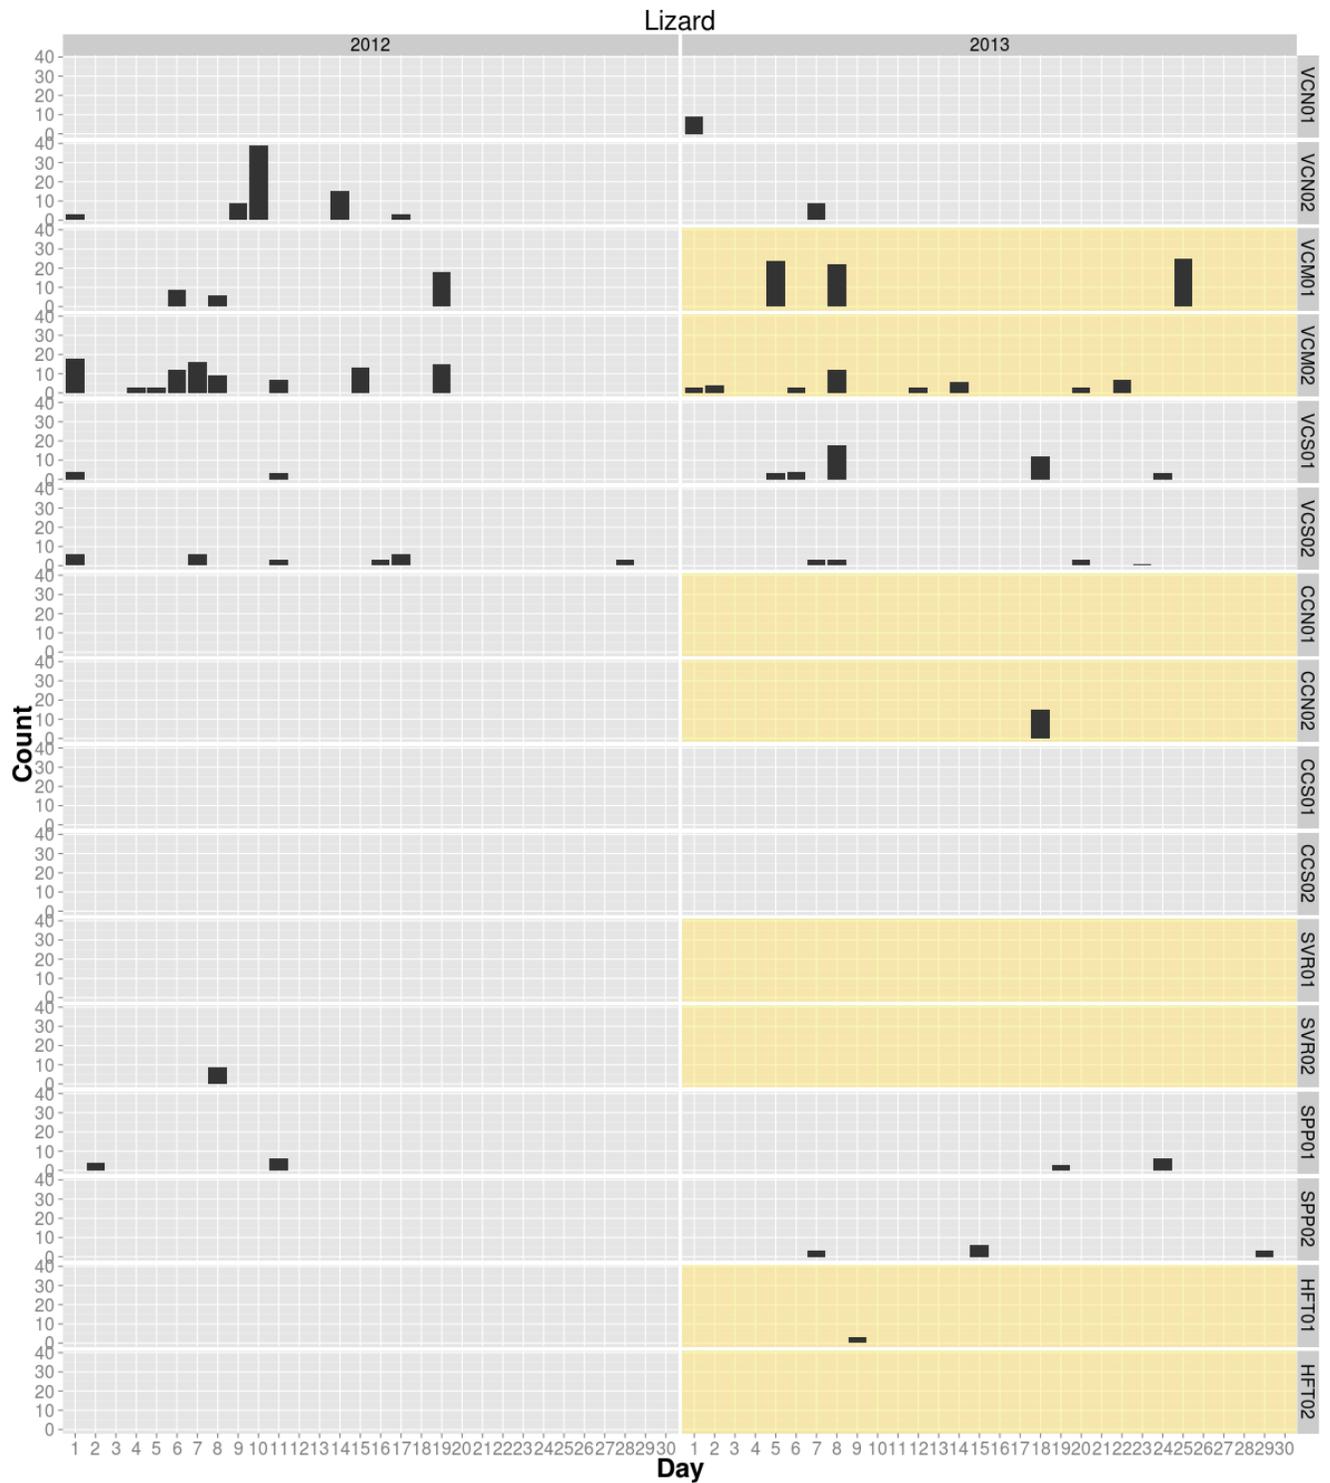
Figure 9: Numbers of images with lizard species per sample day. Separate bar plots are shown for each camera and year. Plots shaded in yellow indicate underpasses where the treatment was applied. The sample day is given on the x-axis and the number of images per day that captured species in this group is given on the y-axis.

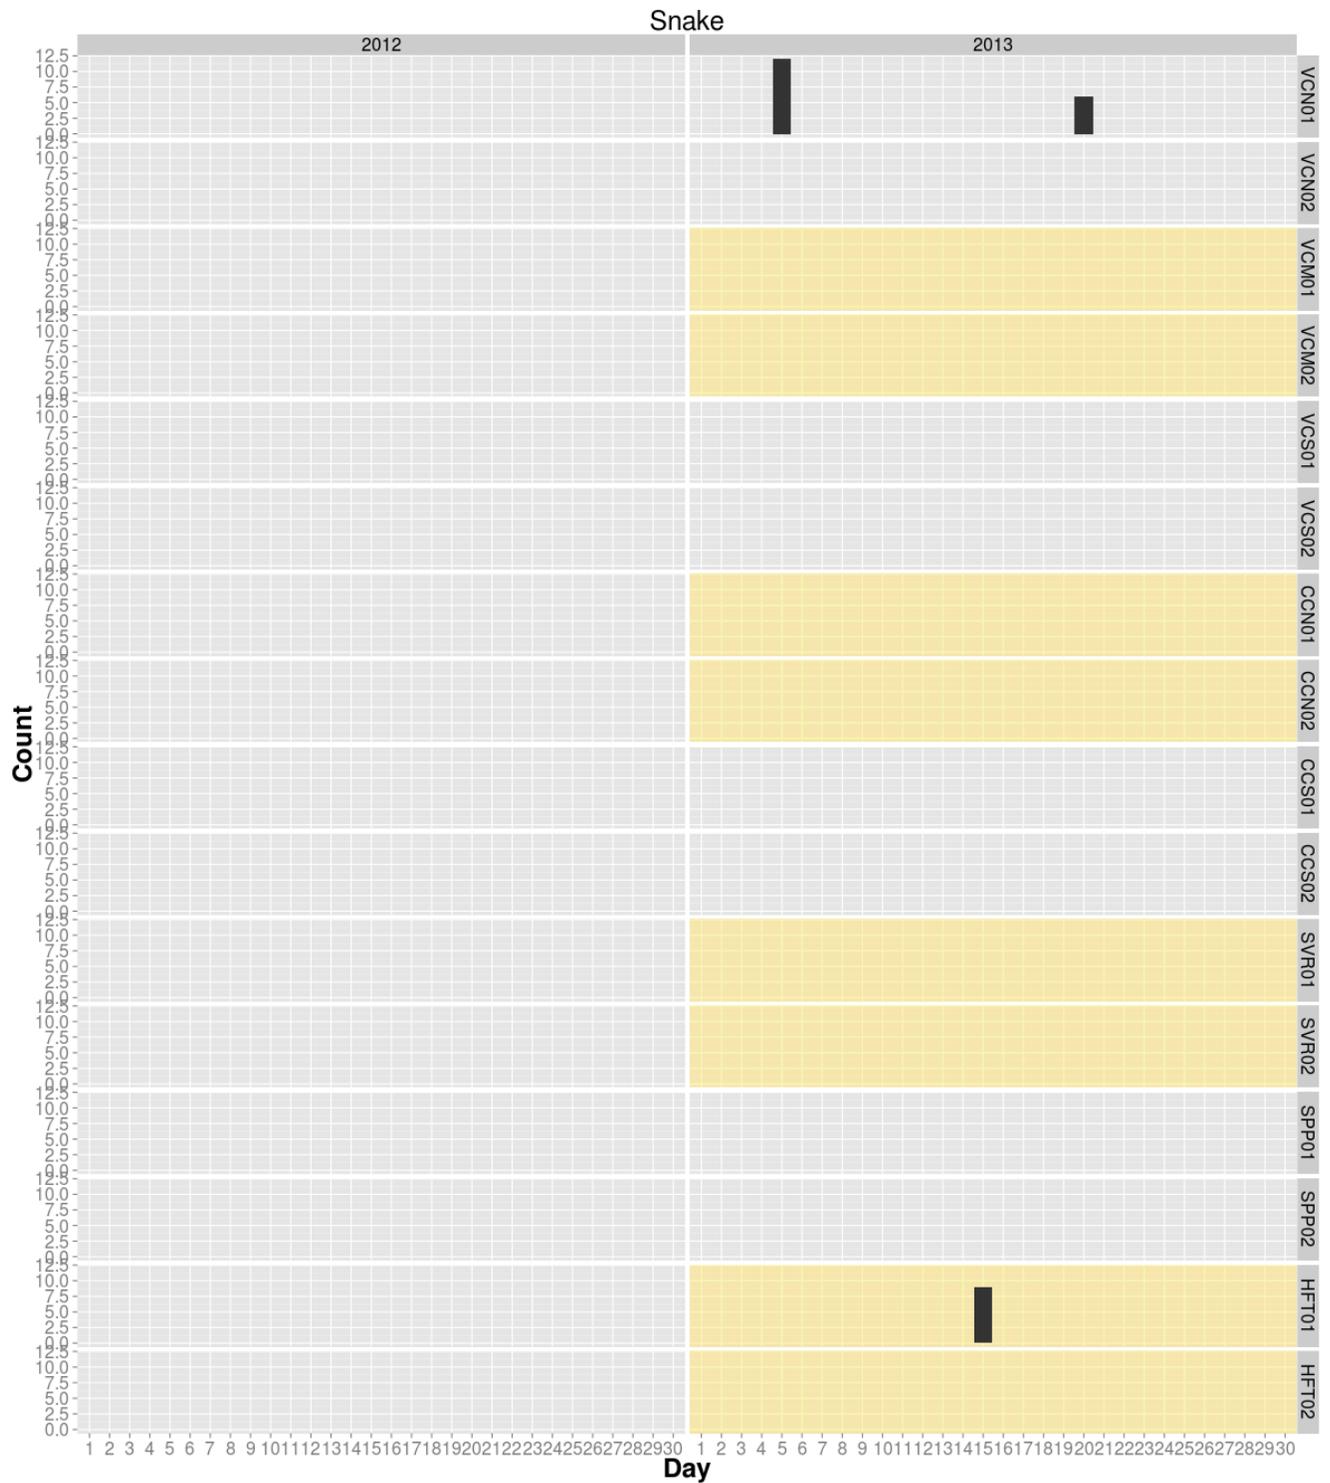
Figure 10: Numbers of images with snake species per sample day. Separate bar plots are shown for each camera and year. Plots shaded in yellow indicate underpasses where the treatment was applied. The sample day is given on the x-axis and the number of images per day that captured species in this group is given on the y-axis.

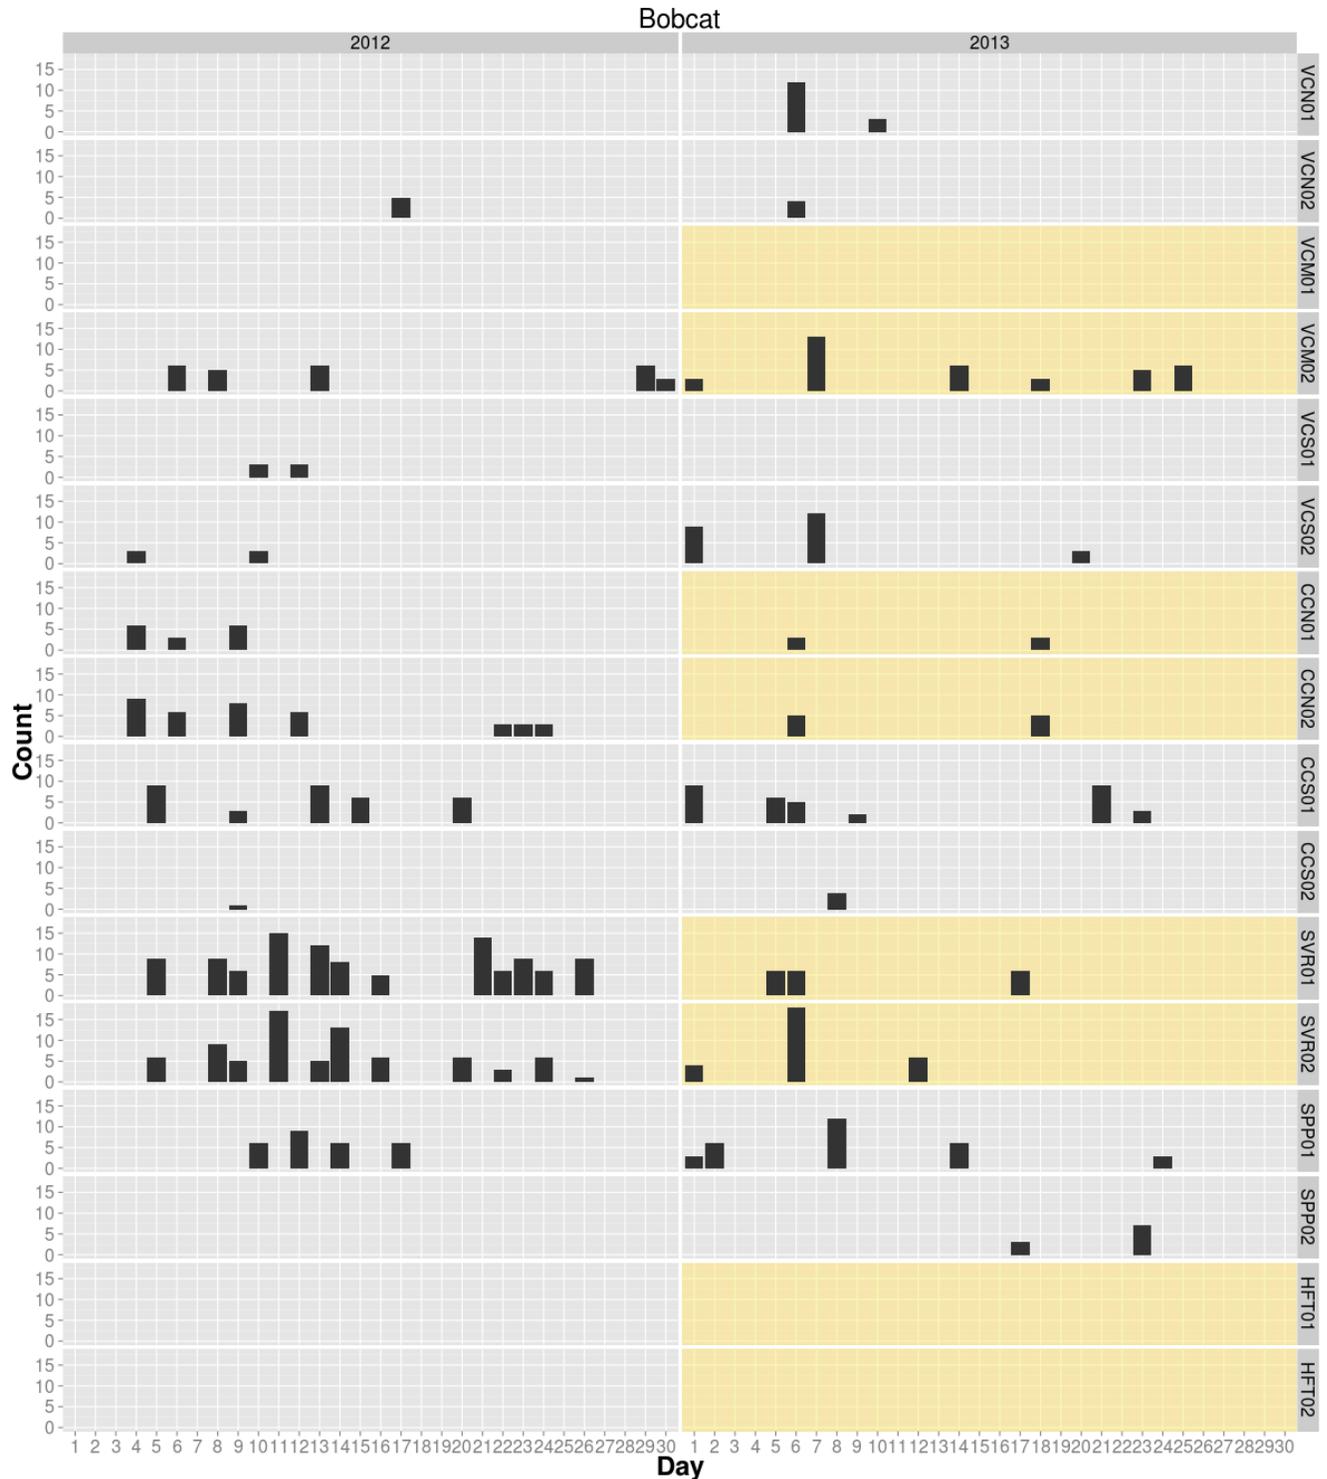
Figure 11: Numbers of images with bobcats per sample day. Separate bar plots are shown for each camera and year. Plots shaded in yellow indicate underpasses where the treatment was applied. The sample day is given on the x-axis and the number of images per day that captured species in this group is given on the y-axis.

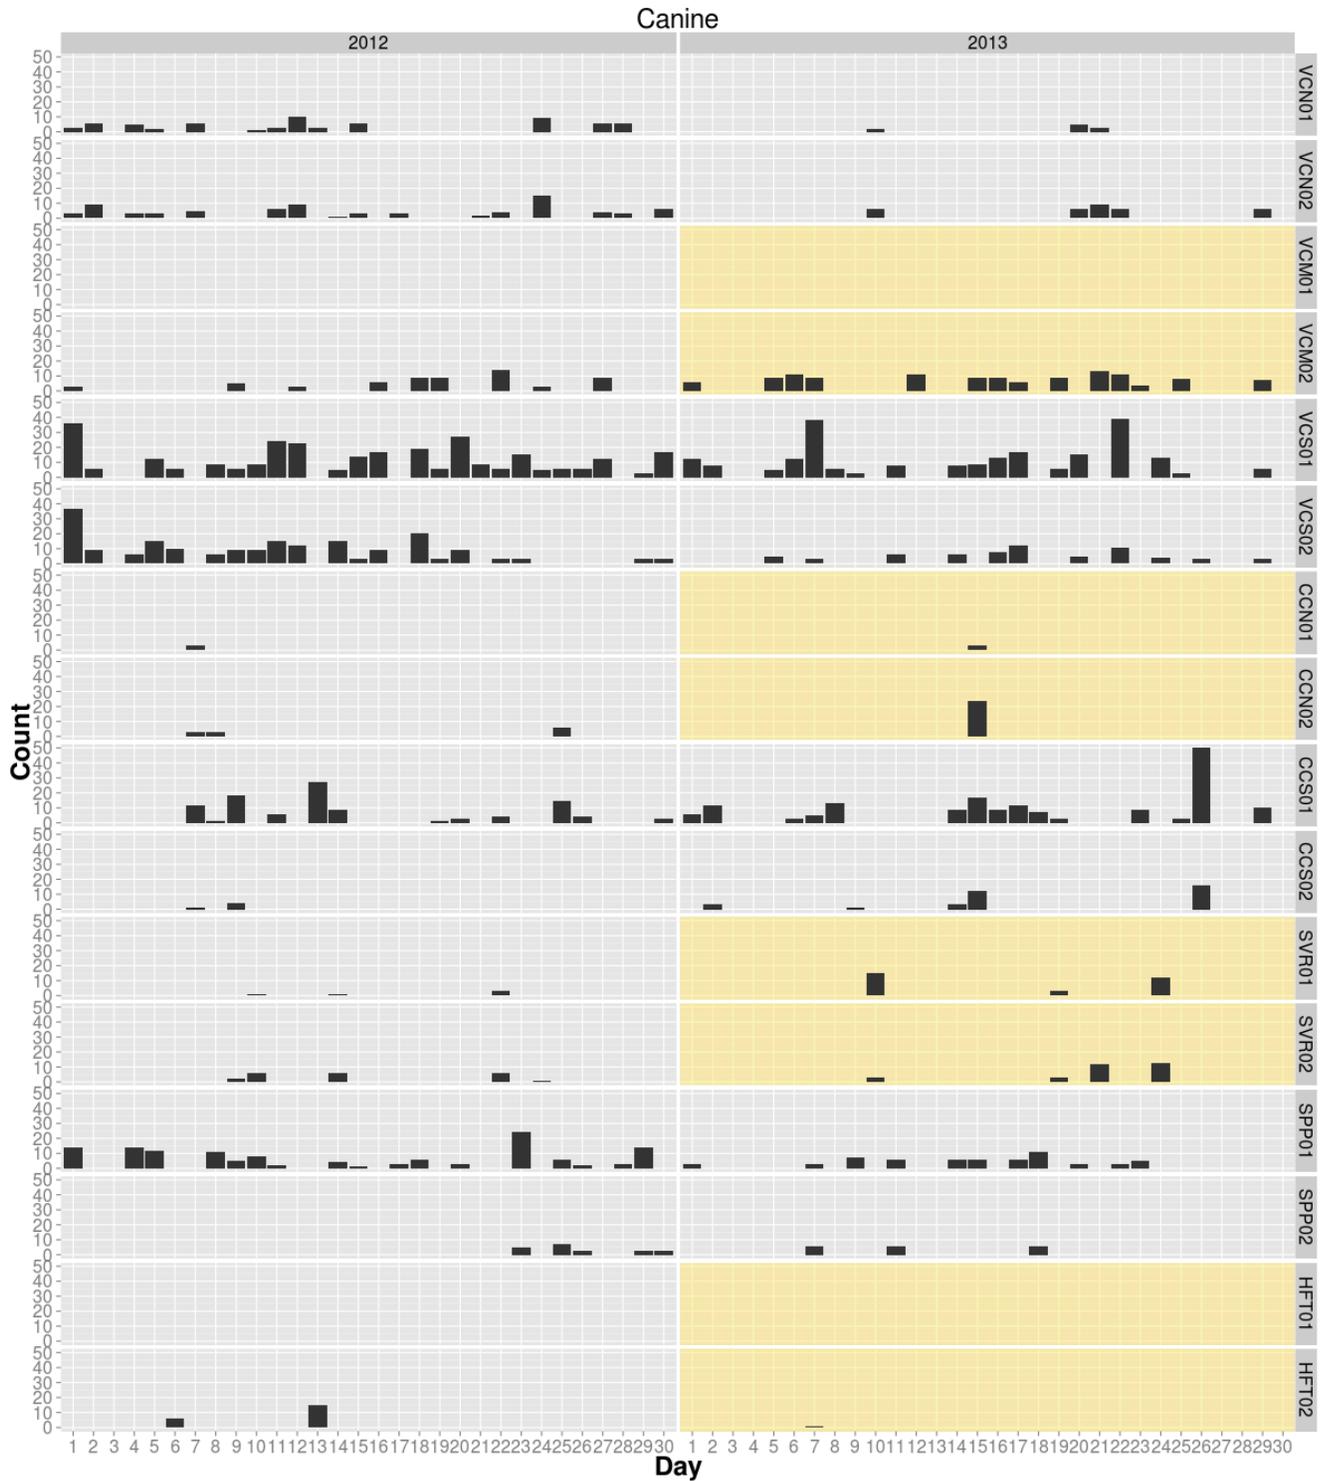
Figure 12: Numbers of images with coyotes or foxes per sample day. Separate bar plots are shown for each camera and year. Plots shaded in yellow indicate underpasses where the treatment was applied. The sample day is given on the x-axis and the number of images per day that captured species in this group is given on the y-axis.

study sites, with the exception of HFT (Figure 12). They were detected by camera HFT02 in 2012, but not in 2013. Like bobcats, they were not detected either year by camera VCM01, but were detected on the side of the underpass with the drainage ditch and camera VCM02. Deer were also common, but were not detected by cameras CCN01 and VCM01 (Figure 13). Again, like bobcats and canine species, they were detected more often on the side of the underpass with the drainage ditch. At HFT, they were only detected on the cover side of the underpass by camera HFT01 during the pre-treatment year, but the number of detections were small and they were detected more often on the open side of the underpass by camera HFT02 during both years. Roadrunners were uncommonly detected at HFT02 (both years), VCN01 (both years), and VCN02 (2012 only; Figure 14). However, they were most often detected by camera VCS01 and less frequently by CVS02 during both years. Medium-sized mammal usage was detected at all sites, but most often at the Valley Center Road and Scripps Poway Parkway sites (Figure 11). At HFT, they were only detected in 2013 on one side of the underpass by camera HFT02. Rabbit species usage was detected most often at the VCN and HFT sites, less commonly at VCM, VCS, CCN, and SVR sites, and not at all at the CCS site (which is the site most heavily used by humans; Figure 16). At SVR, they were only detected post-treatment on the cover side of the underpass. Squirrel (ground squirrels) usage was detected very often at VCS and less commonly at the other sites, except for HFT where they were not detected (Figure 17).

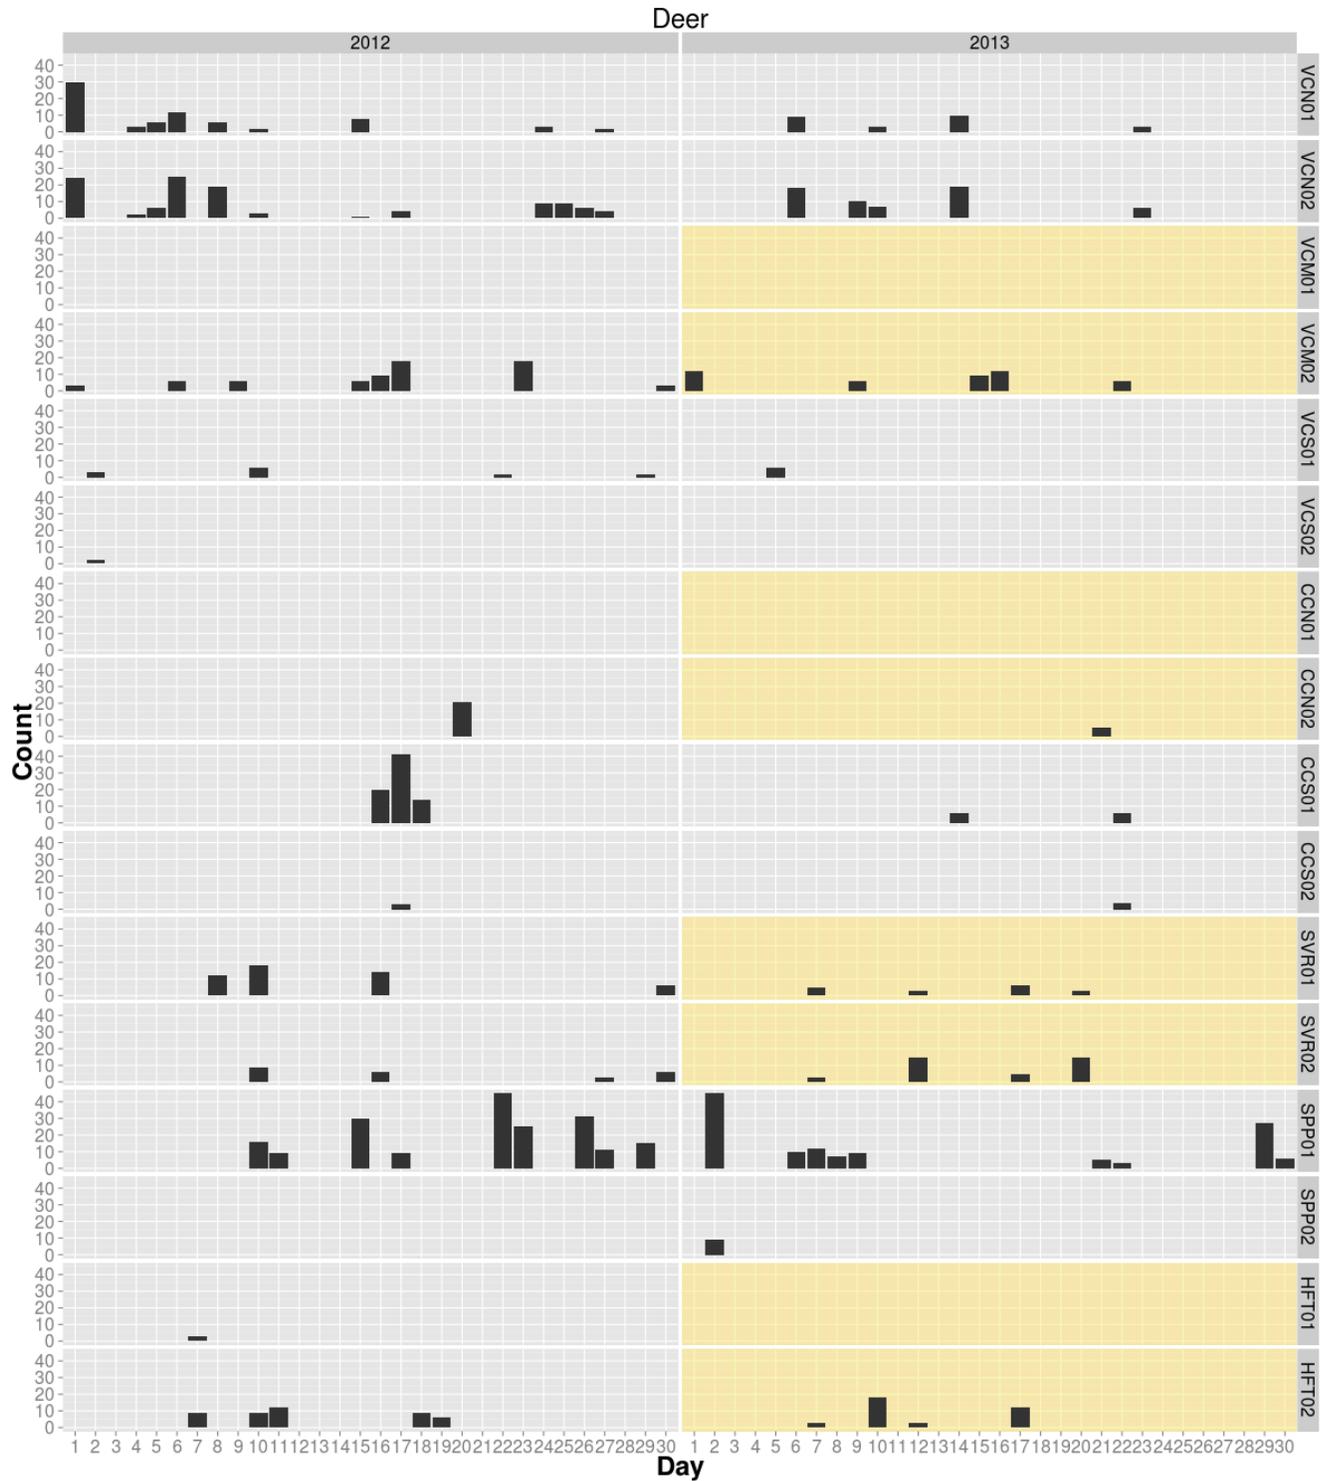
Figure 13: Numbers of images with deer per sample day. Separate bar plots are shown for each camera and year. Plots shaded in yellow indicate underpasses where the treatment was applied. The sample day is given on the x-axis and the number of images per day that captured species in this group is given on the y-axis.

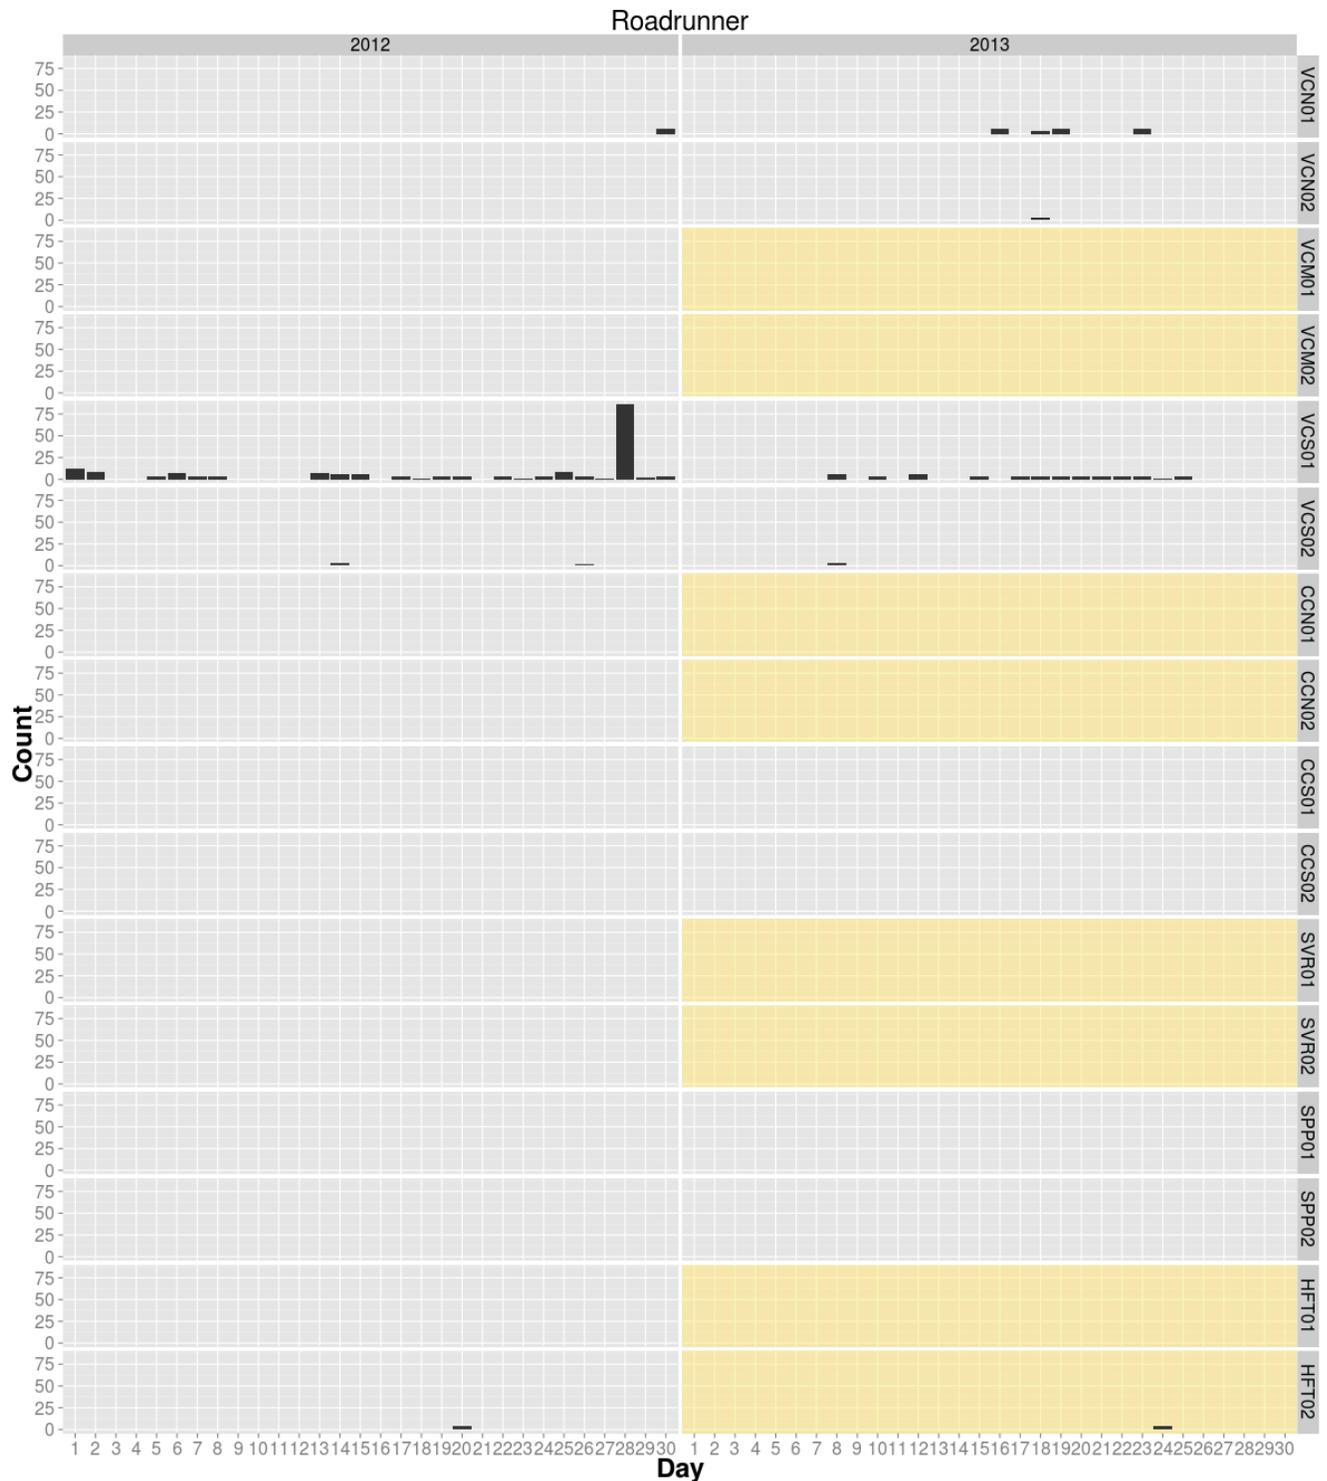
Figure 14: Numbers of images with roadrunners per sample day. Separate bar plots are shown for each camera and year. Plots shaded in yellow indicate underpasses where the treatment was applied. The sample day is given on the x-axis and the number of images per day that captured species in this group is given on the y-axis.
