A Field Study of Small Vertebrate Use of Wildlife Underpasses in San Diego County, 2014

By Jeff A Tracey, Cheryl S. Brehme, Carlton Rochester, Denise Clark, and Robert N. Fisher¹

DRAFT Data Summary

California Department of Fish and Wildlife
Prepared for Local Assistance Grant P1182111

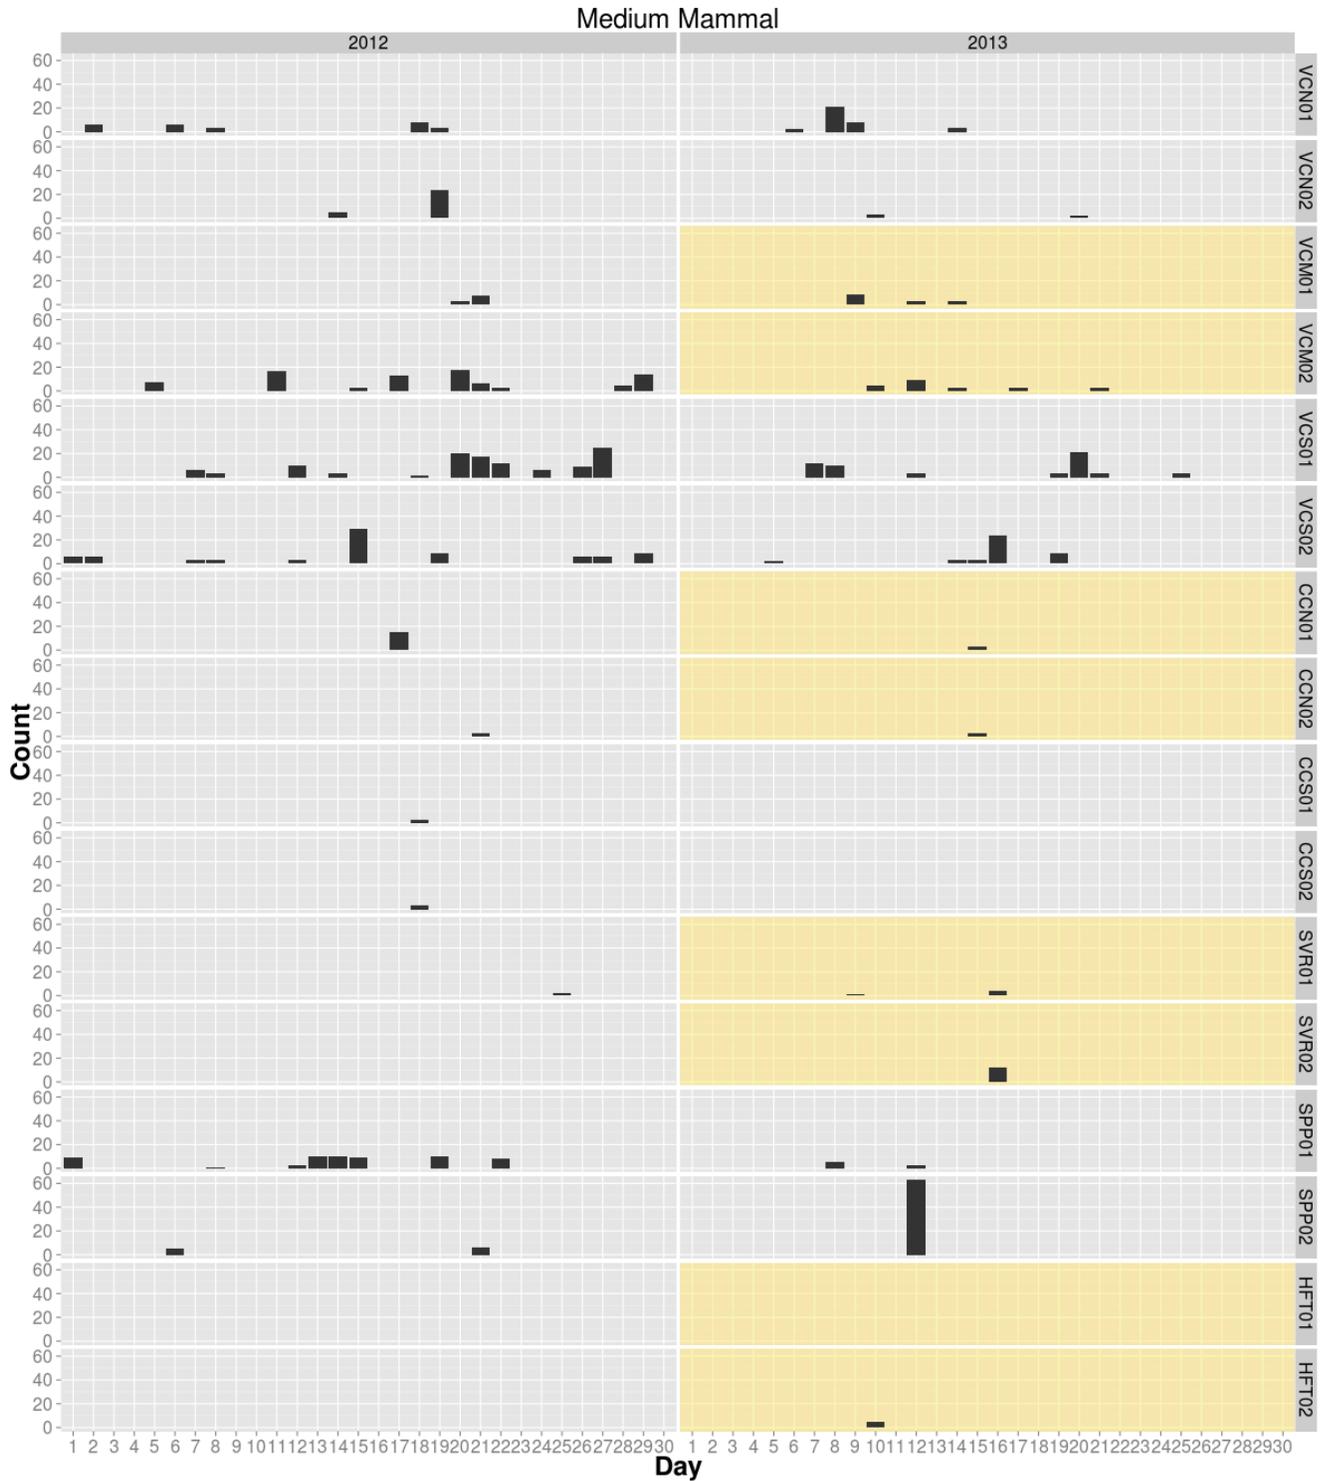
Figure 15: Numbers of images with medium-sized mammals per sample day. Stripped and spotted skunks, opossums, and raccoons. Separate bar plots are shown for each camera and year. Plots shaded in yellow indicate underpasses where the treatment was applied. The sample day is given on the x-axis and the number of images per day that captured species in this group is given on the y-axis.

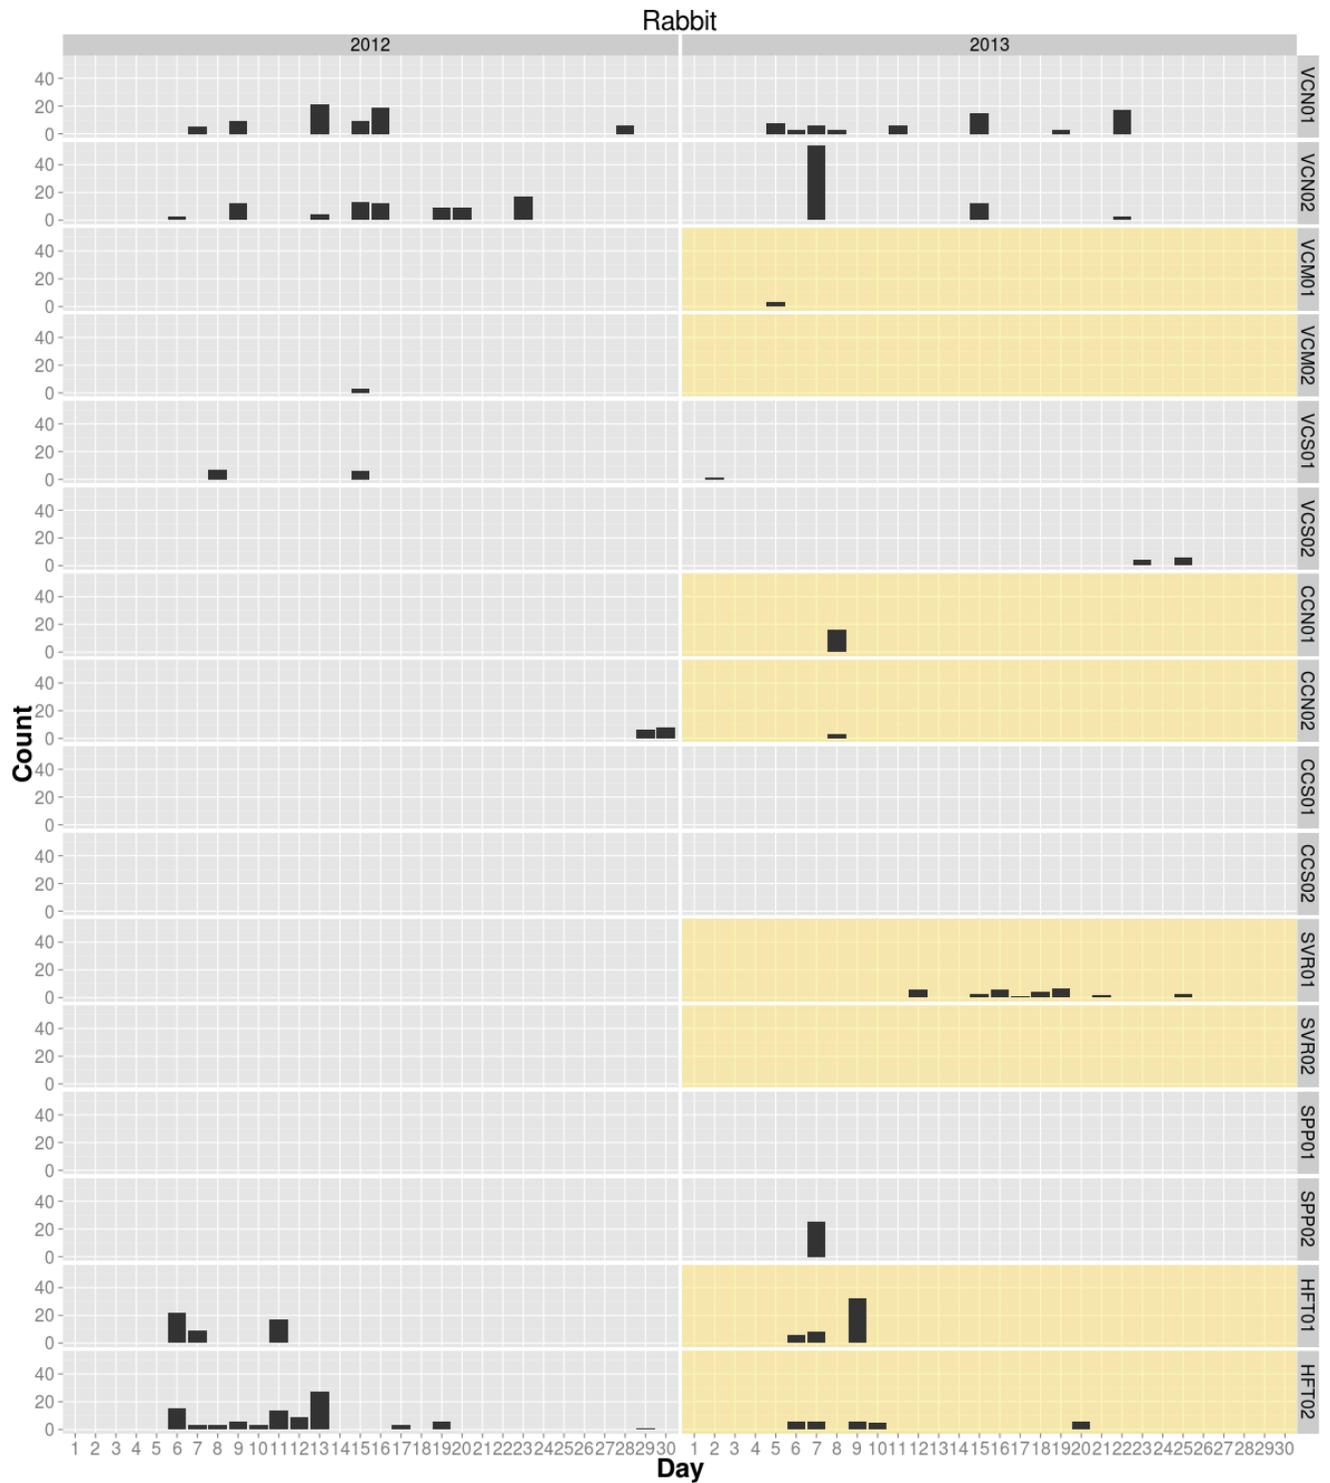
Figure 16: Numbers of images with rabbit species per sample day. Separate bar plots are shown for each camera and year. Plots shaded in yellow indicate underpasses where the treatment was applied. The sample day is given on the x-axis and the number of images per day that captured species in this group is given on the y-axis.

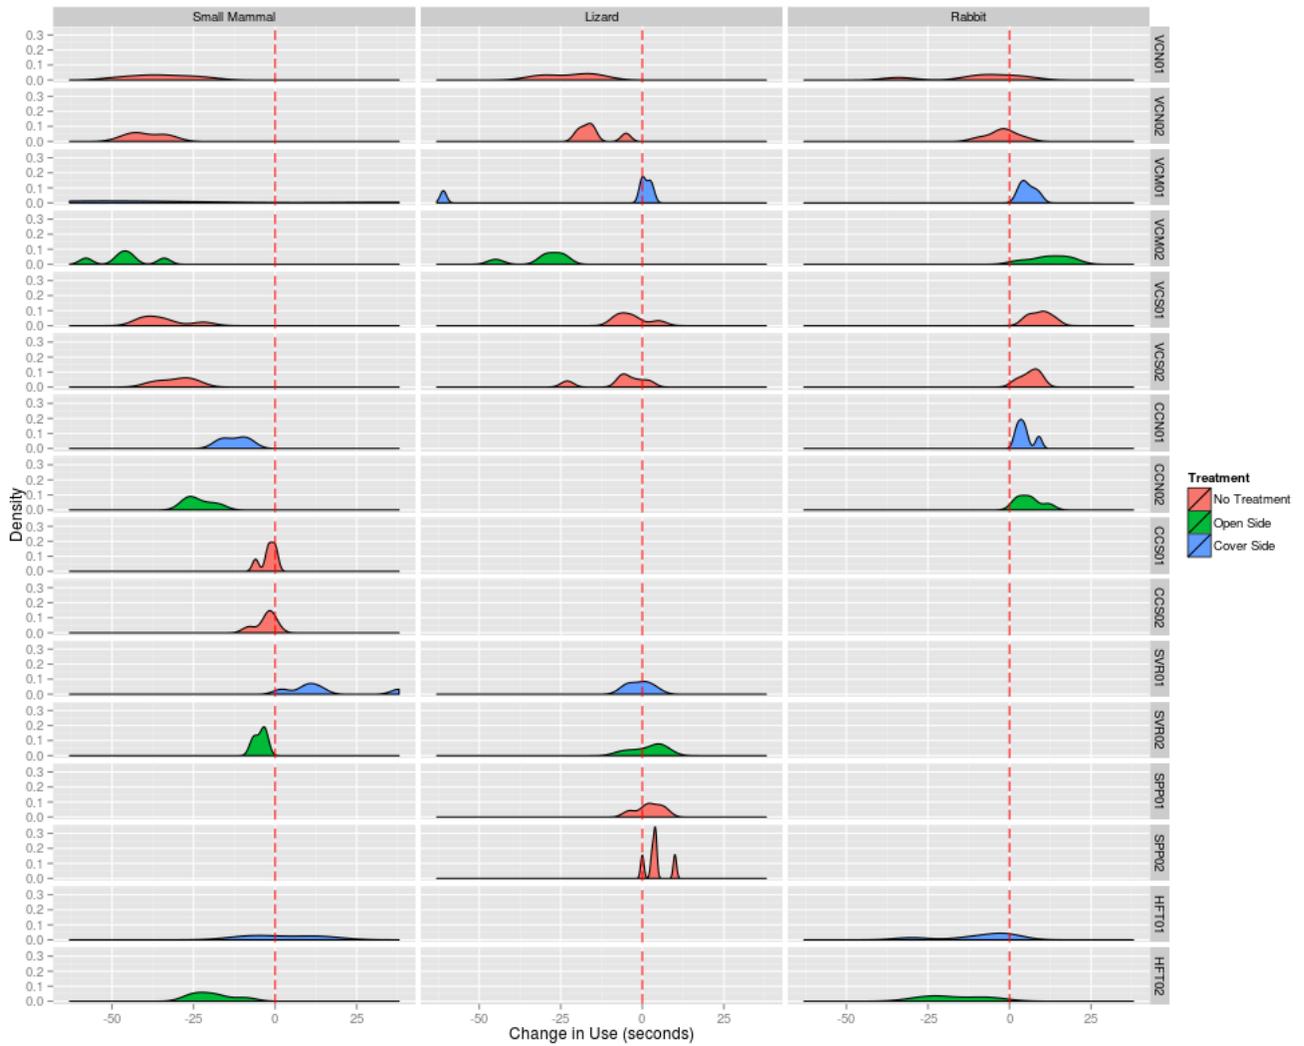
Figure 18: Results from a parametric bootstrap of change in usage based on the models with the lowest AIC for small mammal, lizard, and rabbit species at each camera. The change in usage from 2012 to 2013 is shown on the x-axis and the density of the simulated values is shown on the y-axis. The red, vertical, dashed line at 0 indicates no change in usage. Subplots with no density correspond to sites where the initial usage in 2012 had a high standard error due to little or no detected usage at the site.

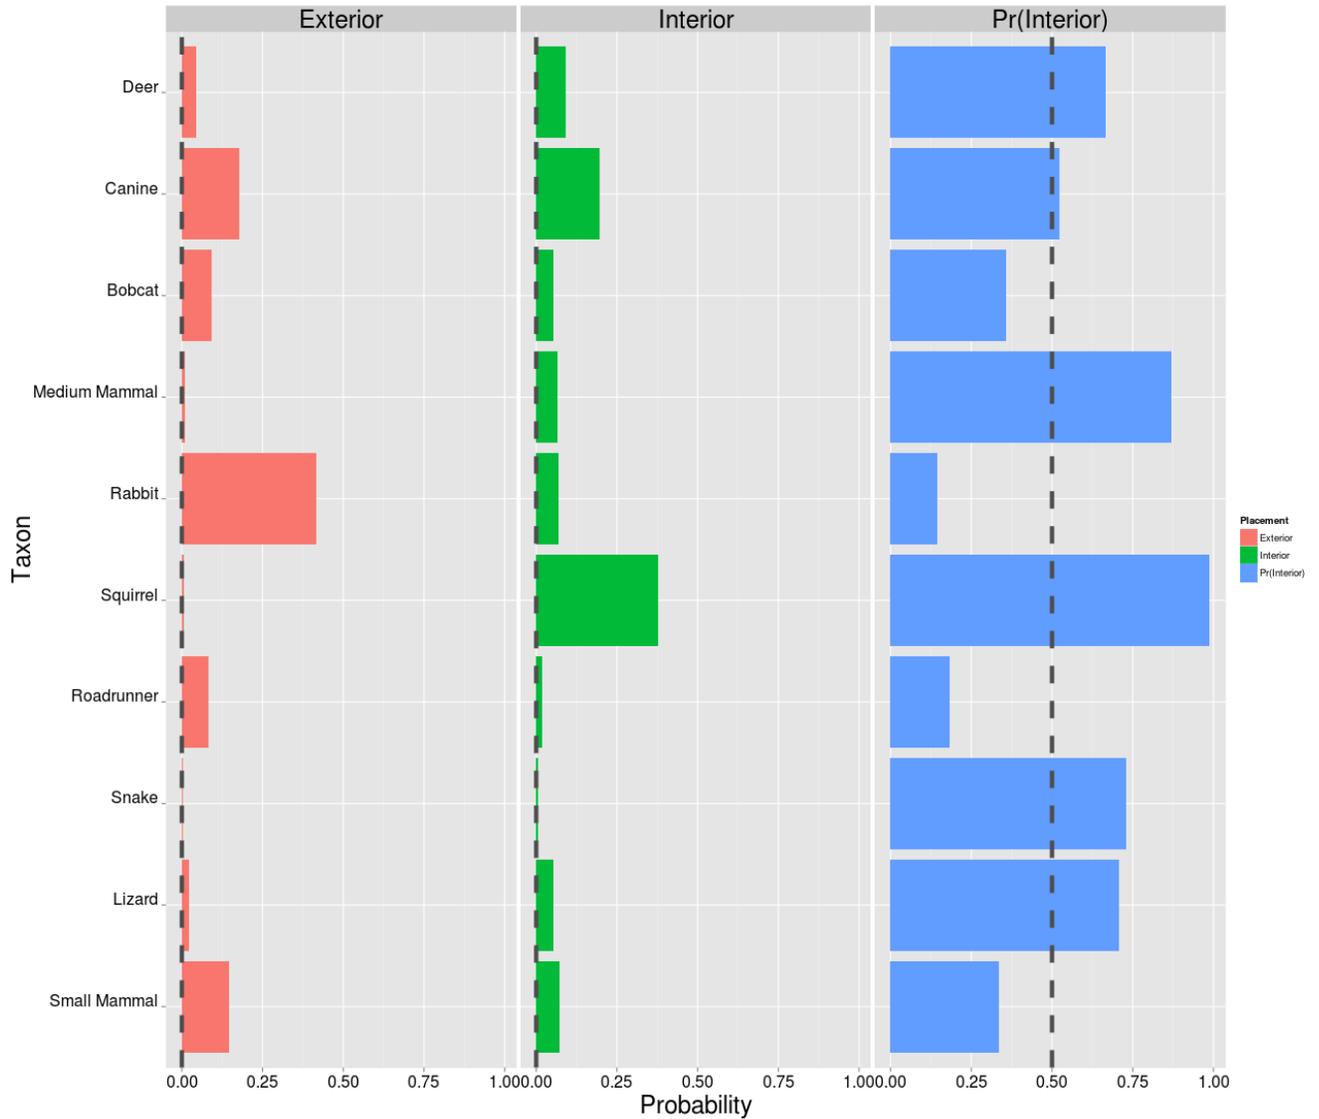
Figure 19: Relative Use of Underpasses by species or group. The first two columns represent the probability an animal species or group was observed within the underpass and outside of the underpass. The last column represents the relative probability an animal or group is within the underpass. Values less than 0.5 indicate avoidance of underpass while probabilities greater than 0.5 indicate preferential use of underpass (but see discussion).

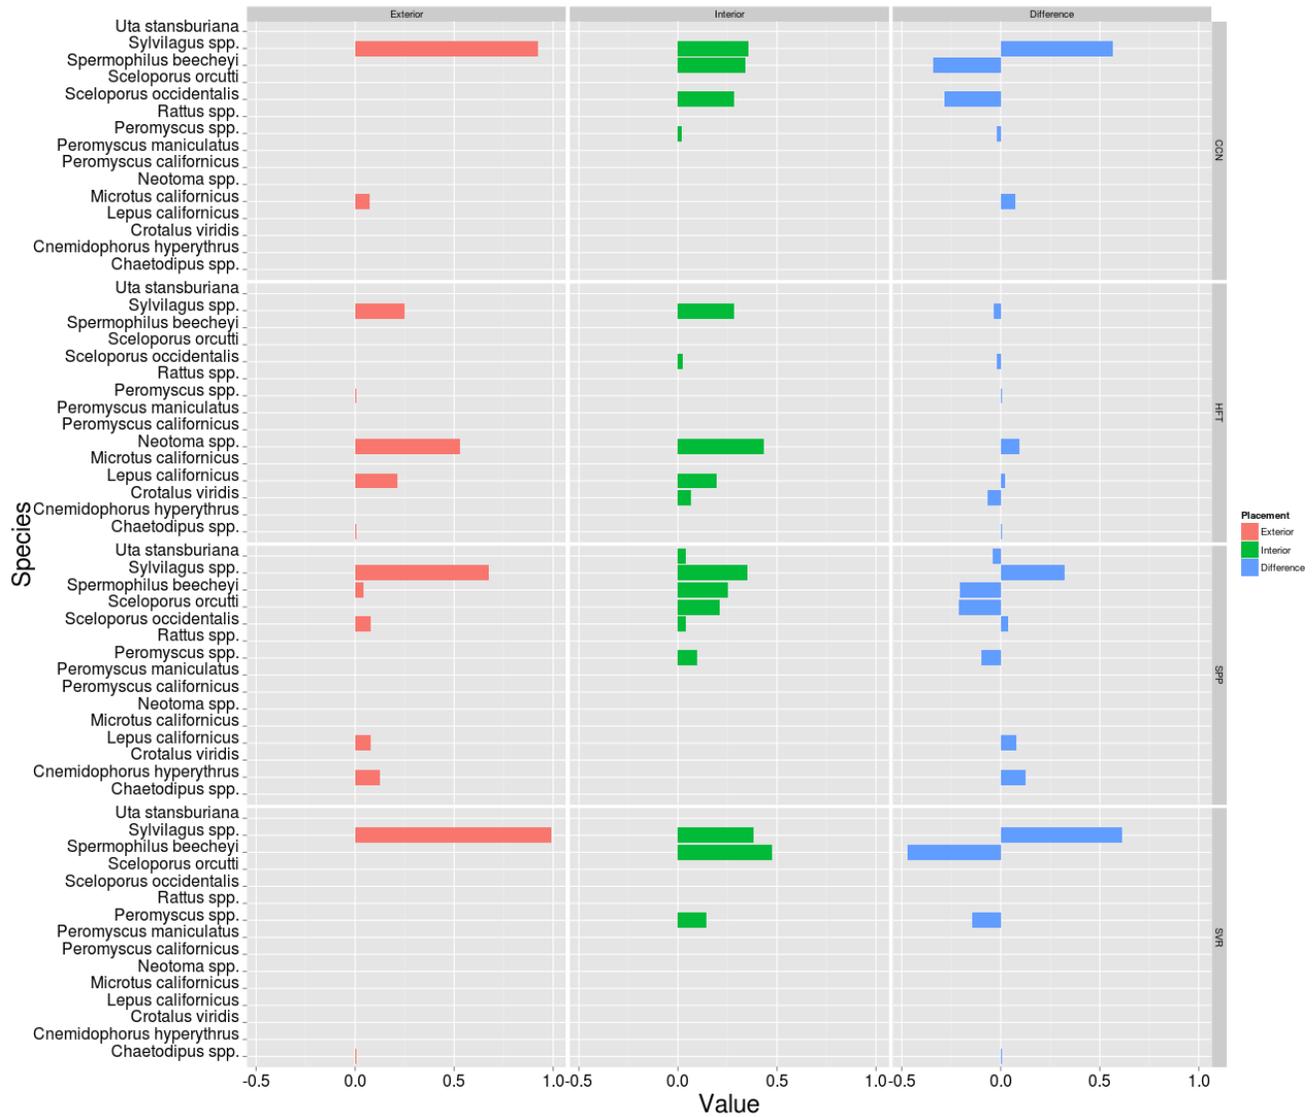
Figure 20: Comparison of normalized proportion of images by species. Here we focus on lizard, snake, small mammal, rabbit, and squirrel species at sites where motion detection images were available for both internal and external cameras.

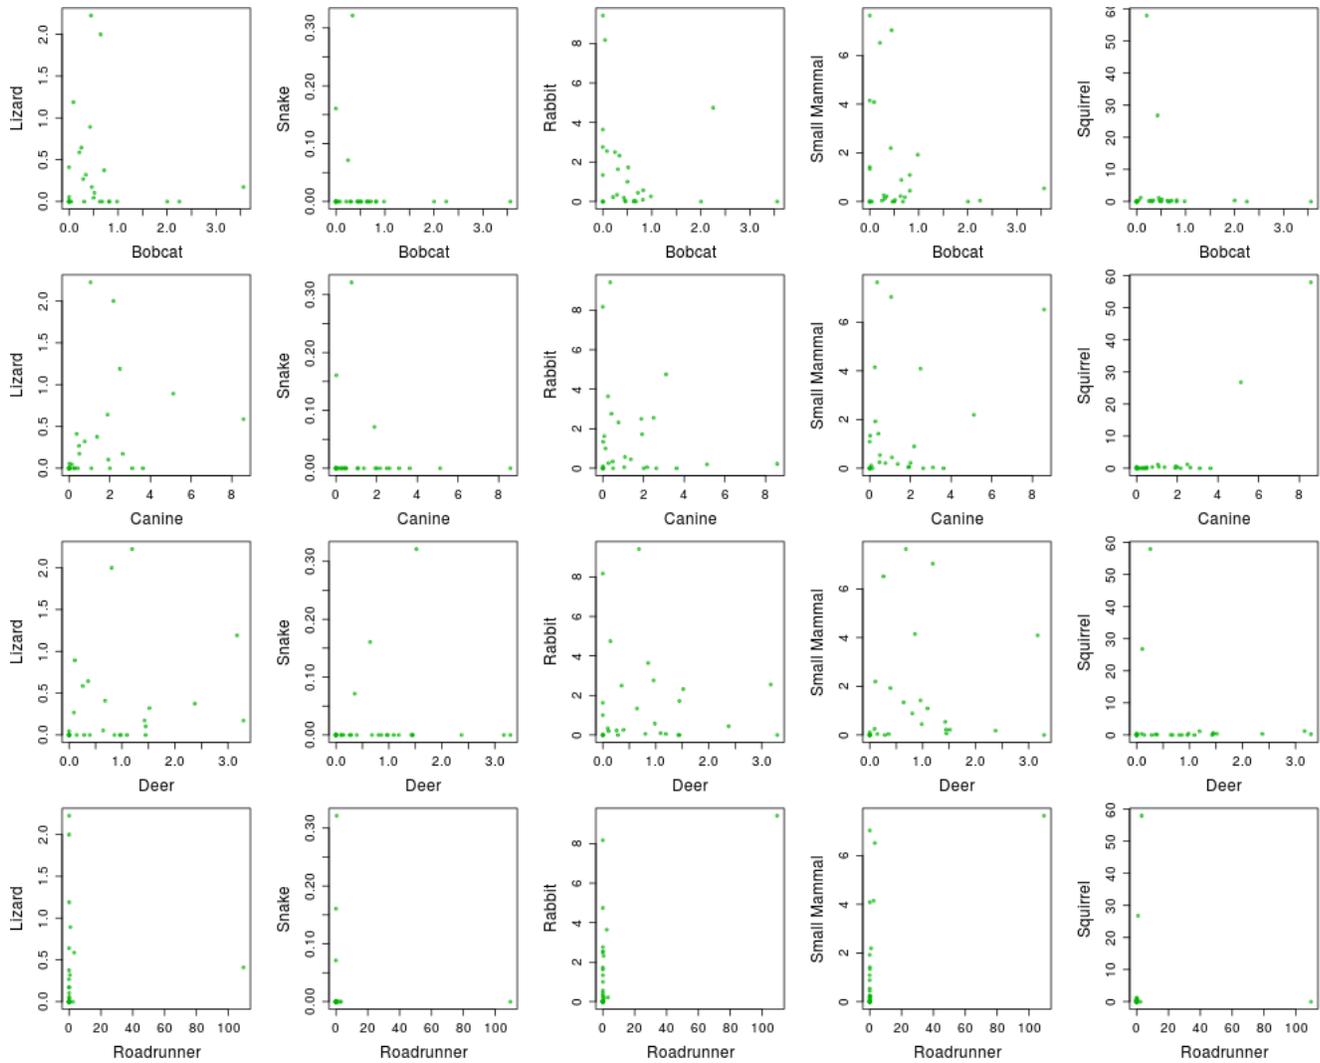
Figure 21: Scatterplots showing mean pictures per day for species often used as indicators of connectivity versus small vertebrates.

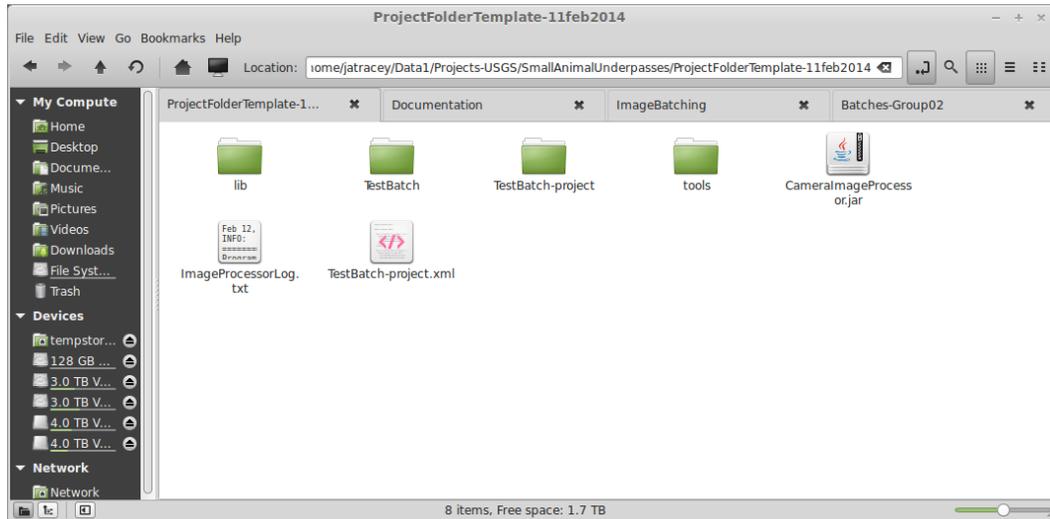
Figure 22: Layout of a project directory

- Supporting tools and files (tools directory)
- Project files (an XML file and a directory containing other files; if a project has been created)
- Working image directories
- Program log file (called “ImageProcessorLog.txt,” created by the program)

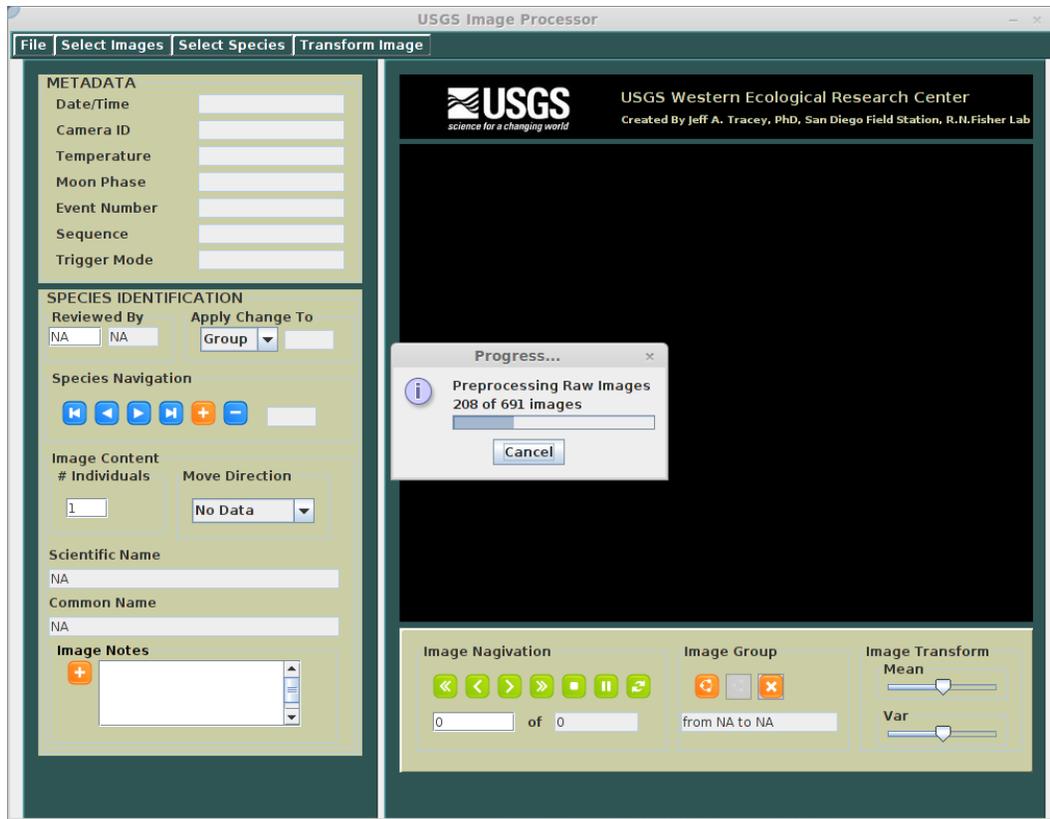
Figure 24: Preprocessing the images in the working image directory. Notice that there should be a progress bar showing how many images have been loaded. It may take a few minutes for the progress bar to appear, depending on the number of images in the working image directory.

- In the File menu, select "Preprocess Files." After a few minutes (it may take a little while) a progress bar (*Figure 24*) should appear indicating the progress of the image import process. If you do not see this progress bar after a while (I would start worrying after 5 or 10 minutes, depending on how many images are in the batch), something probably has gone wrong. A common problem is that there is one or more spaces in the folder names on the path to the directory containing your image project.
- If the process completes, you should see an image in the viewer. At this point, select "Save Project" in the File menu. You do not have to preprocess the images again if they have already been successfully imported and you have saved the project.

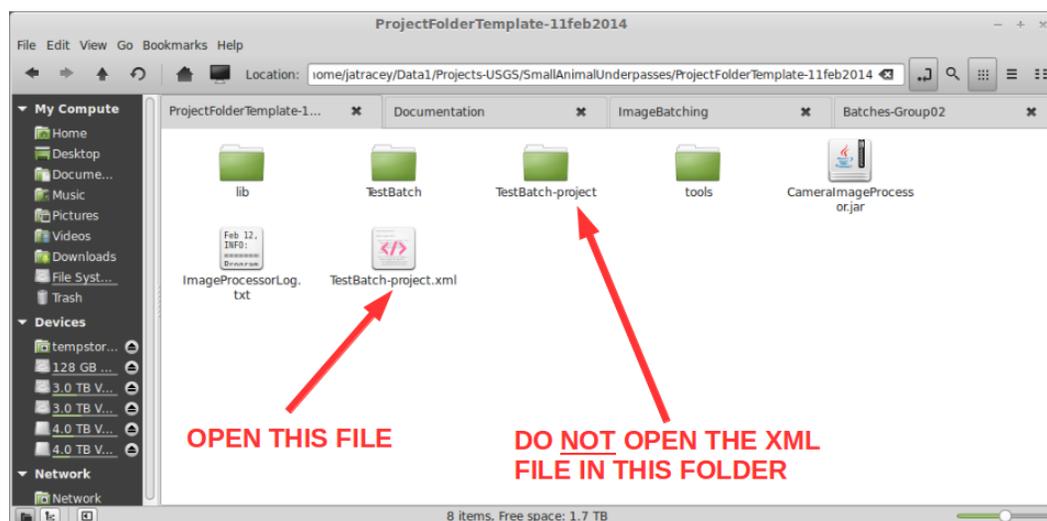
Figure 25: Opening an existing project. Notice that there is a folder called “TestBatch.” In this example, this is our working image directory. After the project has been saved for the first time, there will be a new folder with the same name but with “-project” appended to it. This folder contains the project data. The file that you open is the XML file with the same name as the working image directory but with “-project.xml” appended to it.
