STREAM INVENTORY REPORT

“Walters Gulch”

WATERSHED OVERVIEW

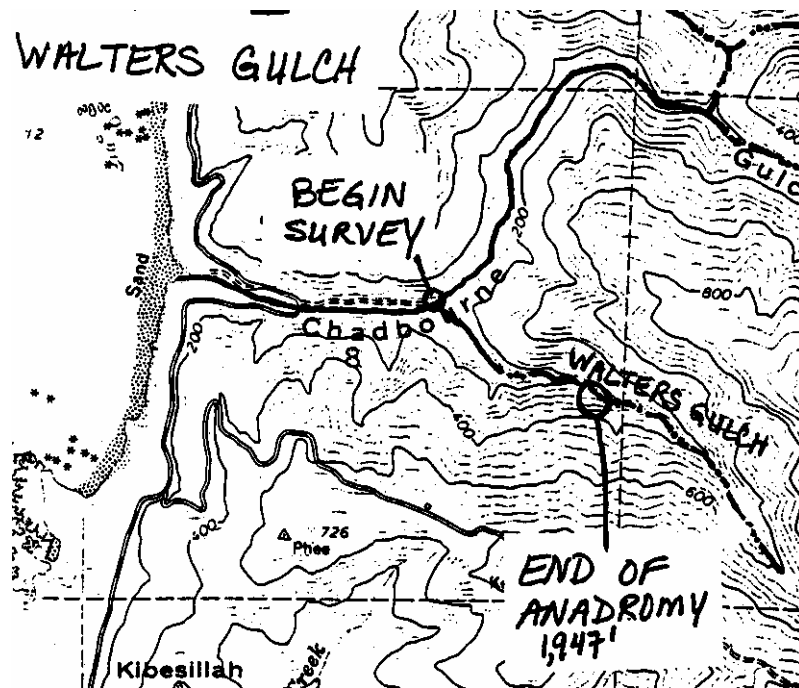
The unnamed tributary to Chadbourne Gulch, commonly known as, and herein after referred to as, Walters Gulch is a tributary to Chadbourne Gulch (Figure 1). Elevations range from 80 feet at the mouth of the creek to 600 feet in the headwater areas. Walters Gulch's legal description at the confluence with Chadbourne Gulch is T20N R17W Sec8. Its location is 39°36'45"N. latitude and 123°46'18"W. longitude according to the USGS Inglenook 7.5 minute quadrangle.
