# STREAM INVENTORY REPORT

## DeHaven Creek

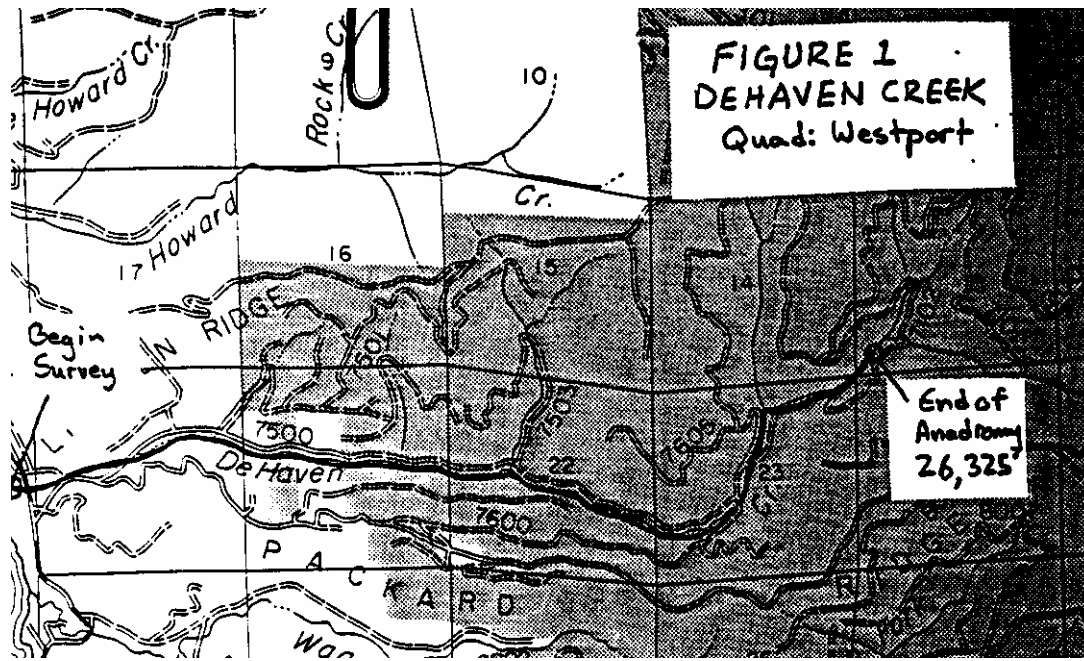
DeHaven Creek is a tributary to the Pacific Ocean (Figure 1). Elevations range from 0 feet at the mouth of the creek to 1,800 feet in the headwater areas. DeHaven Creek's legal description at the confluence with the Pacific Ocean is 21N 17W S19. Its location is 39°39'4"N. latitude and 123°47'0"W. longitude according to the USGS Westport 7.5 minute quadrangle. DeHaven Creek drains a watershed of approximately 5,207 acres.
