STREAM INVENTORY REPORT

Hayshed Gulch

WATERSHED OVERVIEW

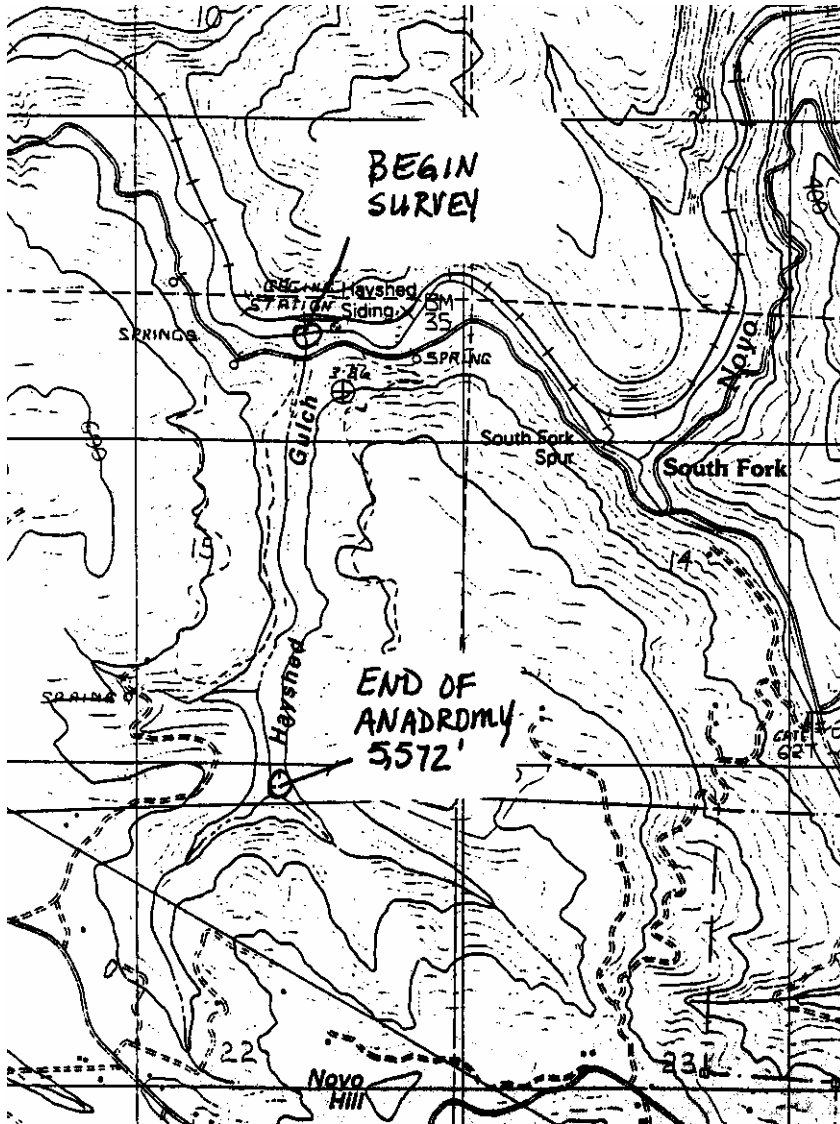
Hayshed Gulch is a tributary to the Noyo River (Figure 1). Elevations range from 0 feet at the mouth of the creek to 600 feet in the headwater areas. Hayshed Gulch's legal description at the confluence with the Noyo River is T18N R17W S15. Its location is 39°25'42"N. latitude and 123°43'43"W. longitude according to the USGS Noyo Hill 7.5 minute quadrangle.
