# **STREAM INVENTORY REPORT**

## **Little North Fork Noyo River**

The habitat inventory of August 19, 1996 through August 23, 1996, was conducted by Diana Hines. The total length of surveyed stream in Little North Fork Noyo River was 22,458 feet (4.3 miles, 6.8 KM) (Table 1). There were no side channels in this stream.

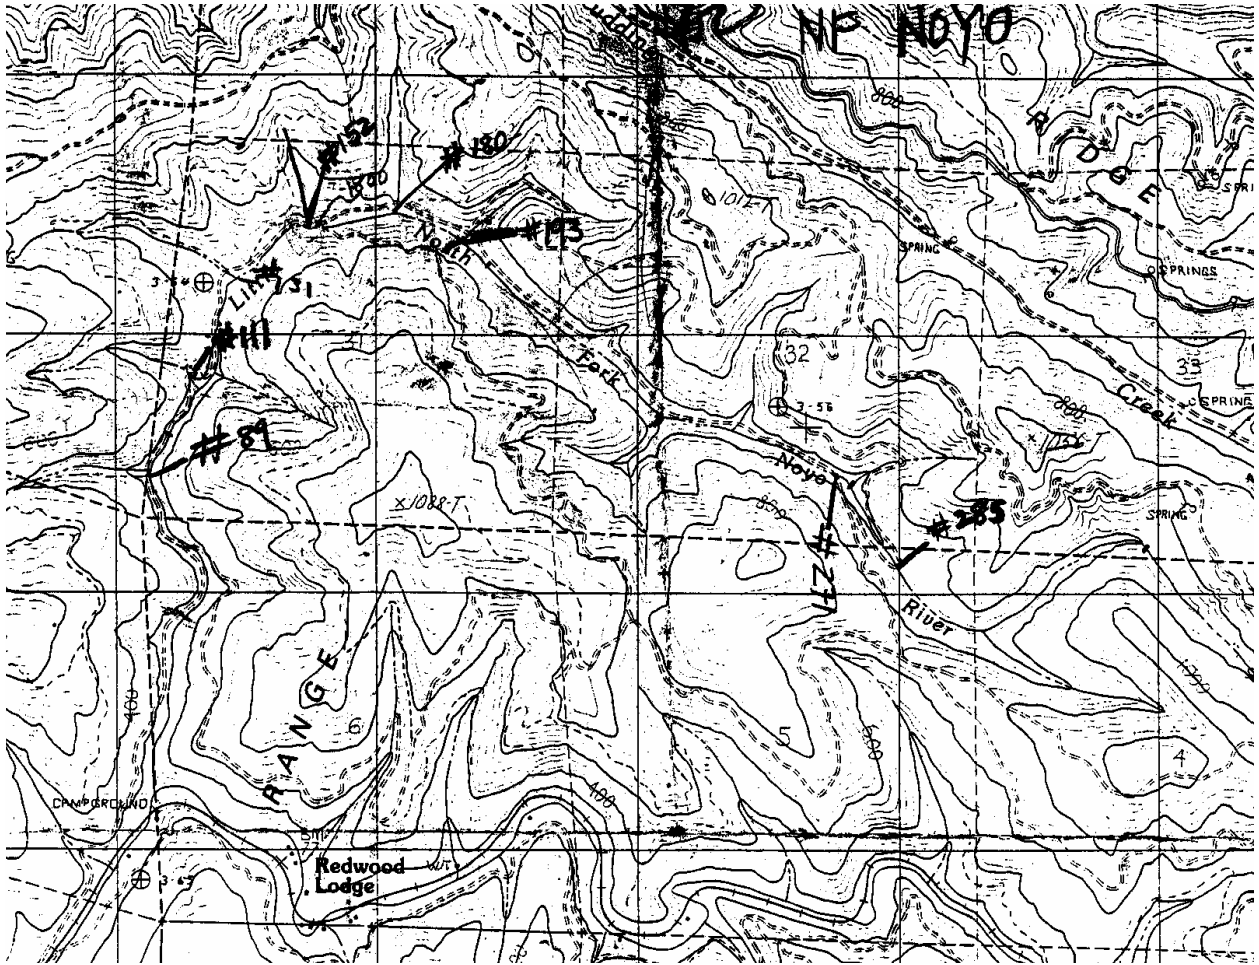
# Little North Fork Noyo River

Little North Fork Noyo River is a tributary to the Noyo River (Figure 1). Elevations range from 100 feet at the mouth of the creek to 1000 feet in the headwater areas. Little North Fork Noyo River's legal description at the confluence with the Noyo River is T19N R16W S06. Its location is 39°26'42"N. latitude and 123°42'50"W. longitude according to the USGS Noyo Hill 7.5 minute quadrangle.
