Site Name: Red Hill Rd.

Stream Name: Conner Creek

Structure Owner: Trinity County

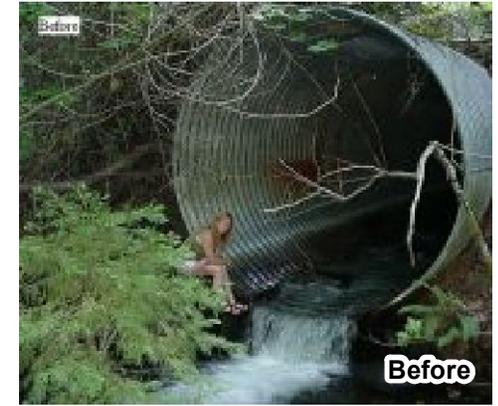
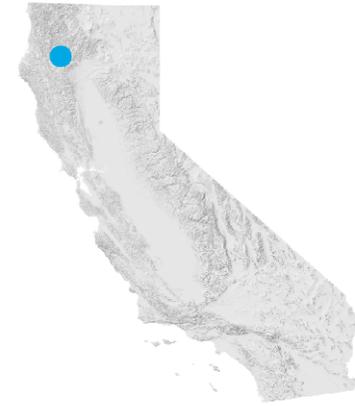
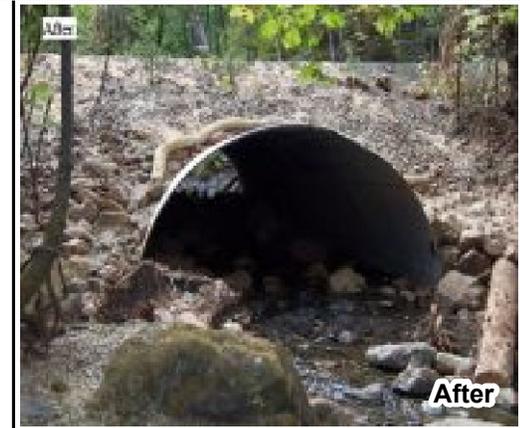
Barrier Description Prior to Remediation: Partial

Notes: FPIP description: http://www.5counties.org/docs/projects/conner2_final.pdf. Before: Barrier was listed as a partial barrier, a partial barrier to adults, and a total barrier to juveniles (unspec) upstream per FishXing Software. This was assessed by Ross Taylor and Associates. Barrier Status: GREY: the Green-Gray-Red filter determined this crossing fails to meet passage criteria for all species of adult salmonids and all age classes of juveniles.

Year Remediated: 2012

Site Status After Remediation: Remediated, fish response unconfirmed
