City of Berkeley Piling Replacement and Dock Repair Project: Final Programmatic Report (AMENDED)

Recipient Organization/Agency: City of Berkeley

Project Number: #8006.12.032926

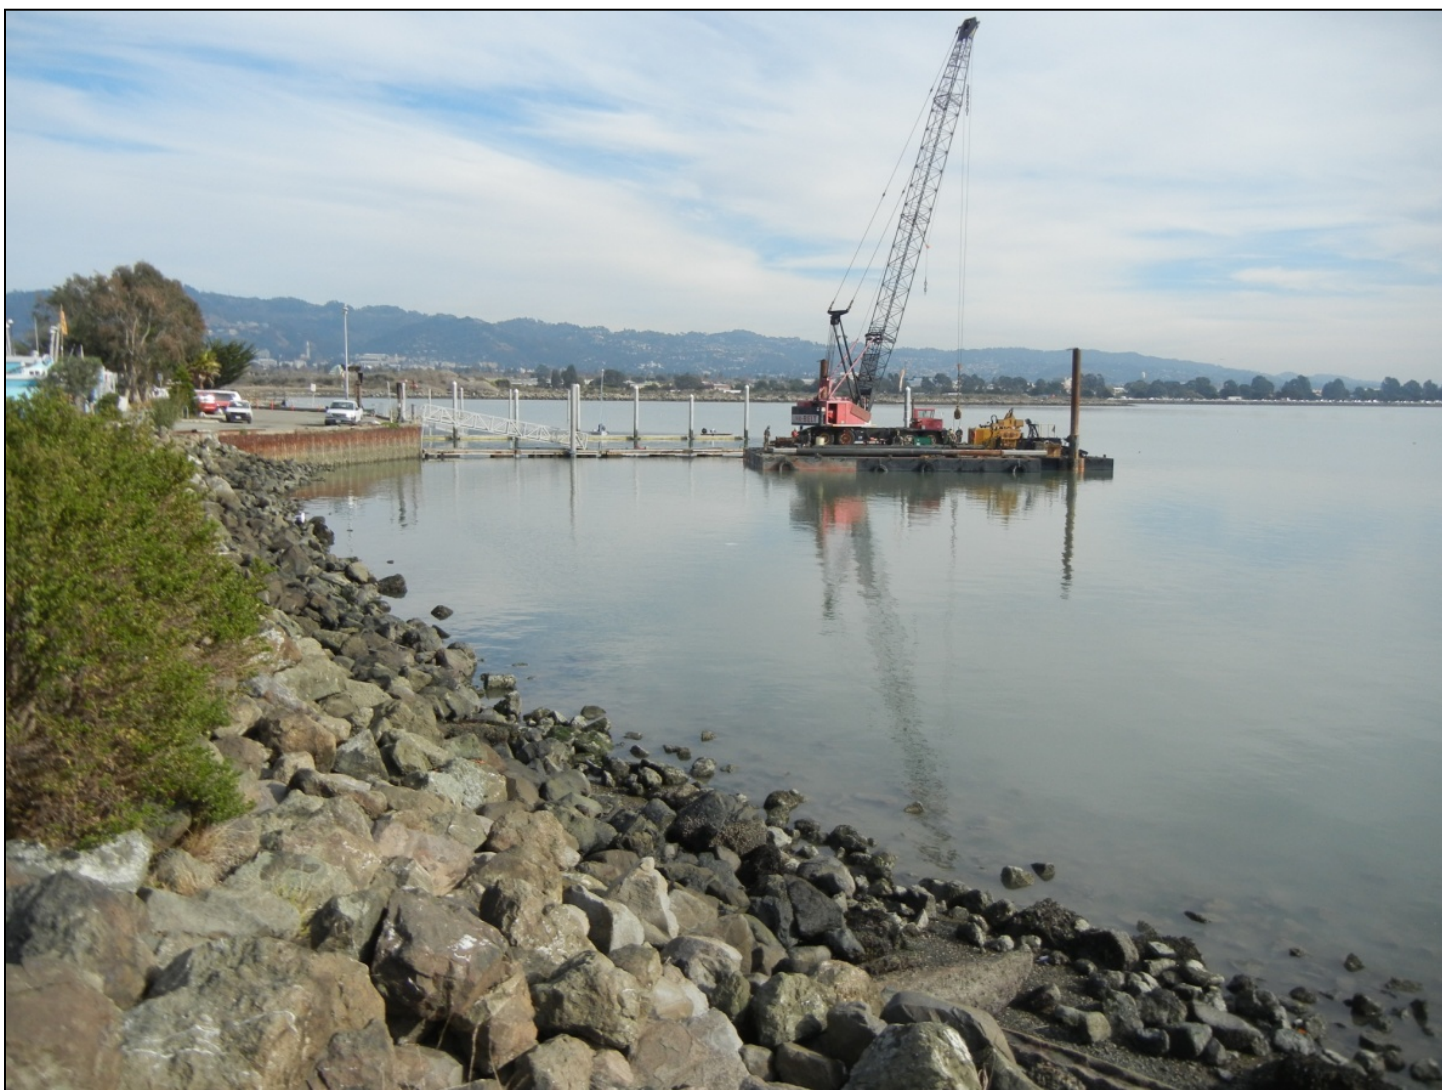
Photograph 1: South Sailing Cove – Pile Driving Rig at West Dock during the pile driving phase. The rig removed the old pilings and drove in the new pilings (Photo: R. Miller, City Staff).

- The existing damaged pilings were pulled from the Bay mud and new pilings were driven using a floating pile driving rig. In addition, the damaged gangway beam at O Dock was replaced.

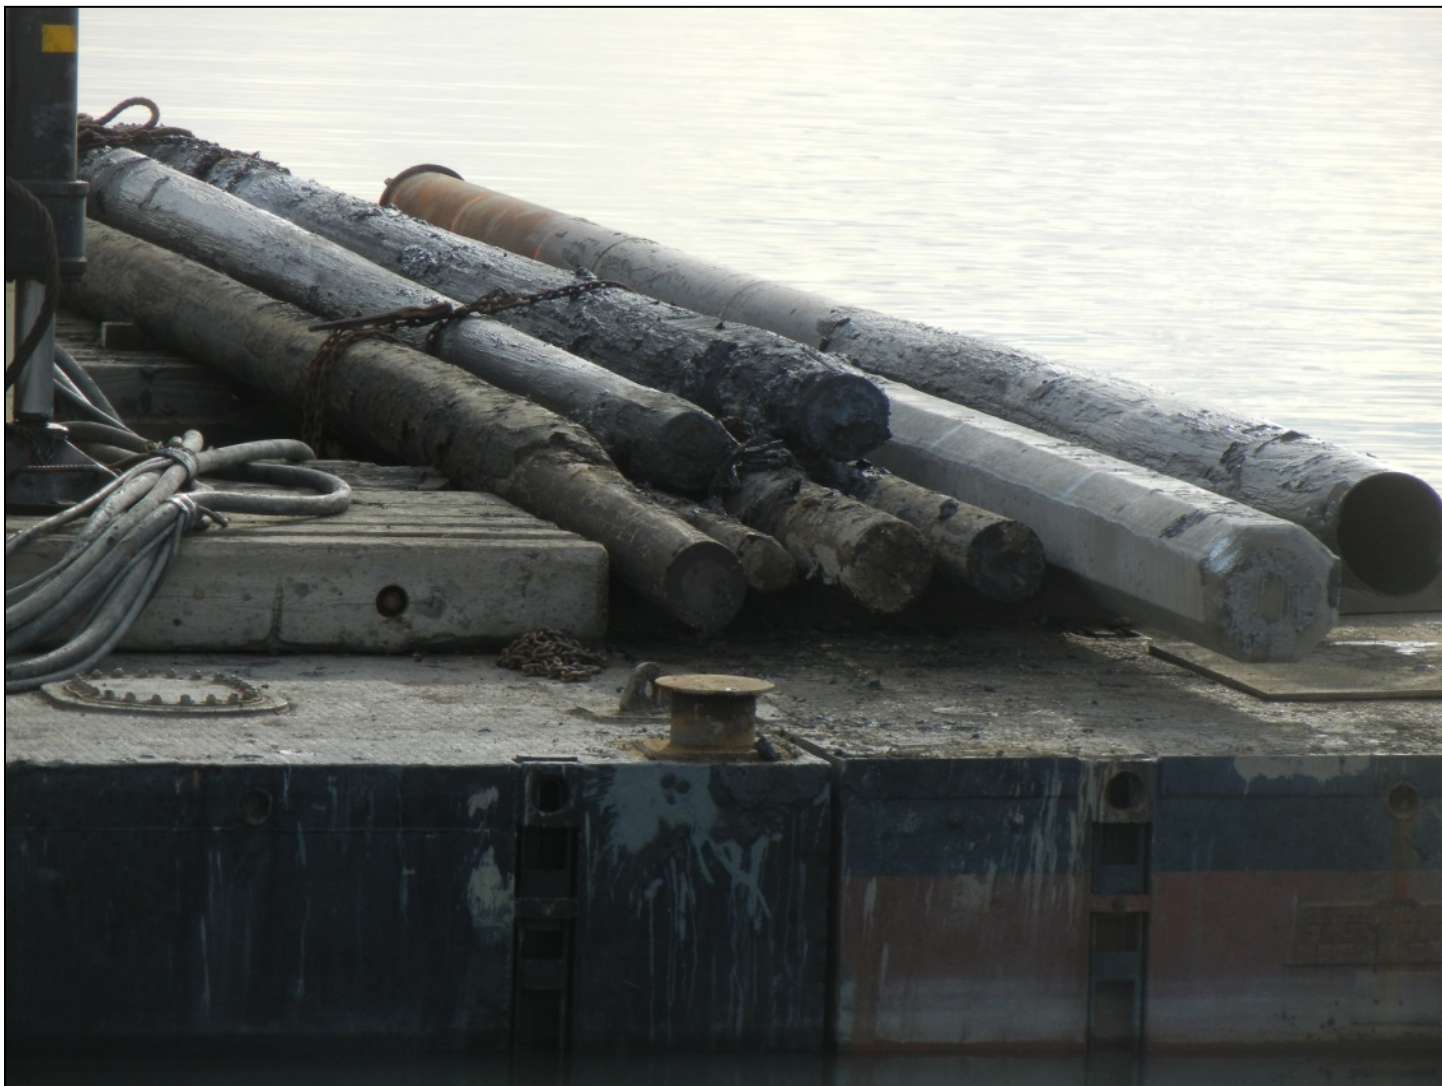
Photograph 2: South Sailing Cove – Old pilings removed from the Bay mud. (Photo: R. Miller, City Staff)

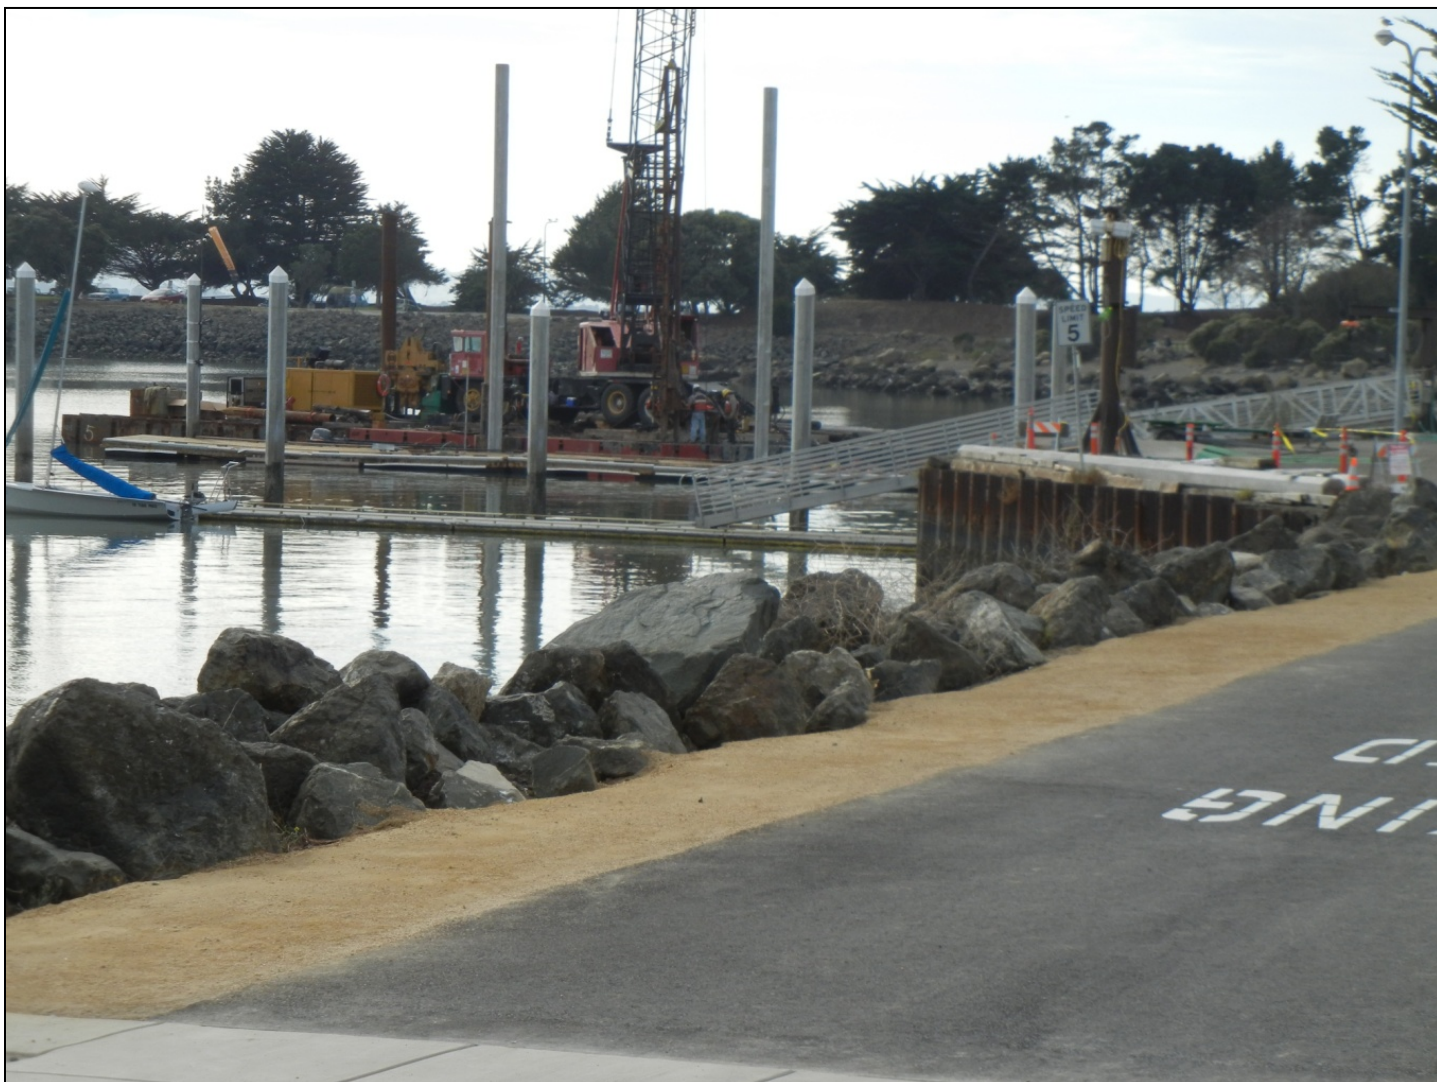
Photograph 3: South Sailing Cove – New pilings installed at West Dock with Driving Rig in background. Photo was taken from the newly-installed Bay Trail Extension Trail at the Berkeley Marina. (Photo: R. Miller, City Staff)

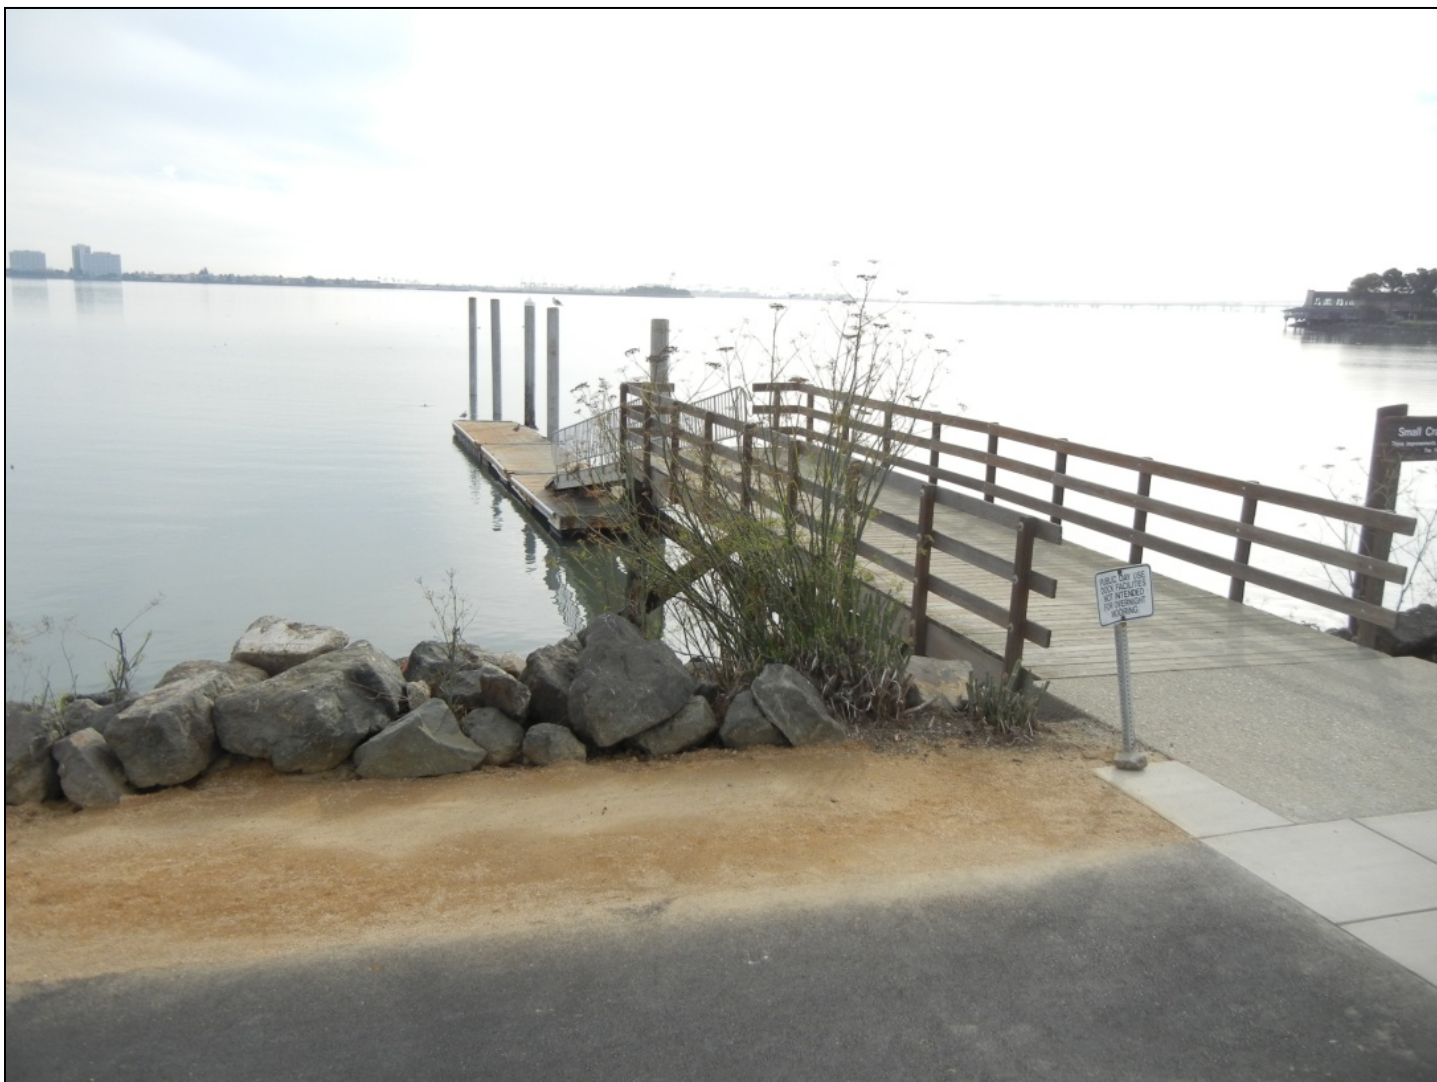
Photograph 4: South Sailing Cove – New pilings installed at East Dock at the new Bay Trail Extension Trail. (Photo: R. Miller, City Staff)

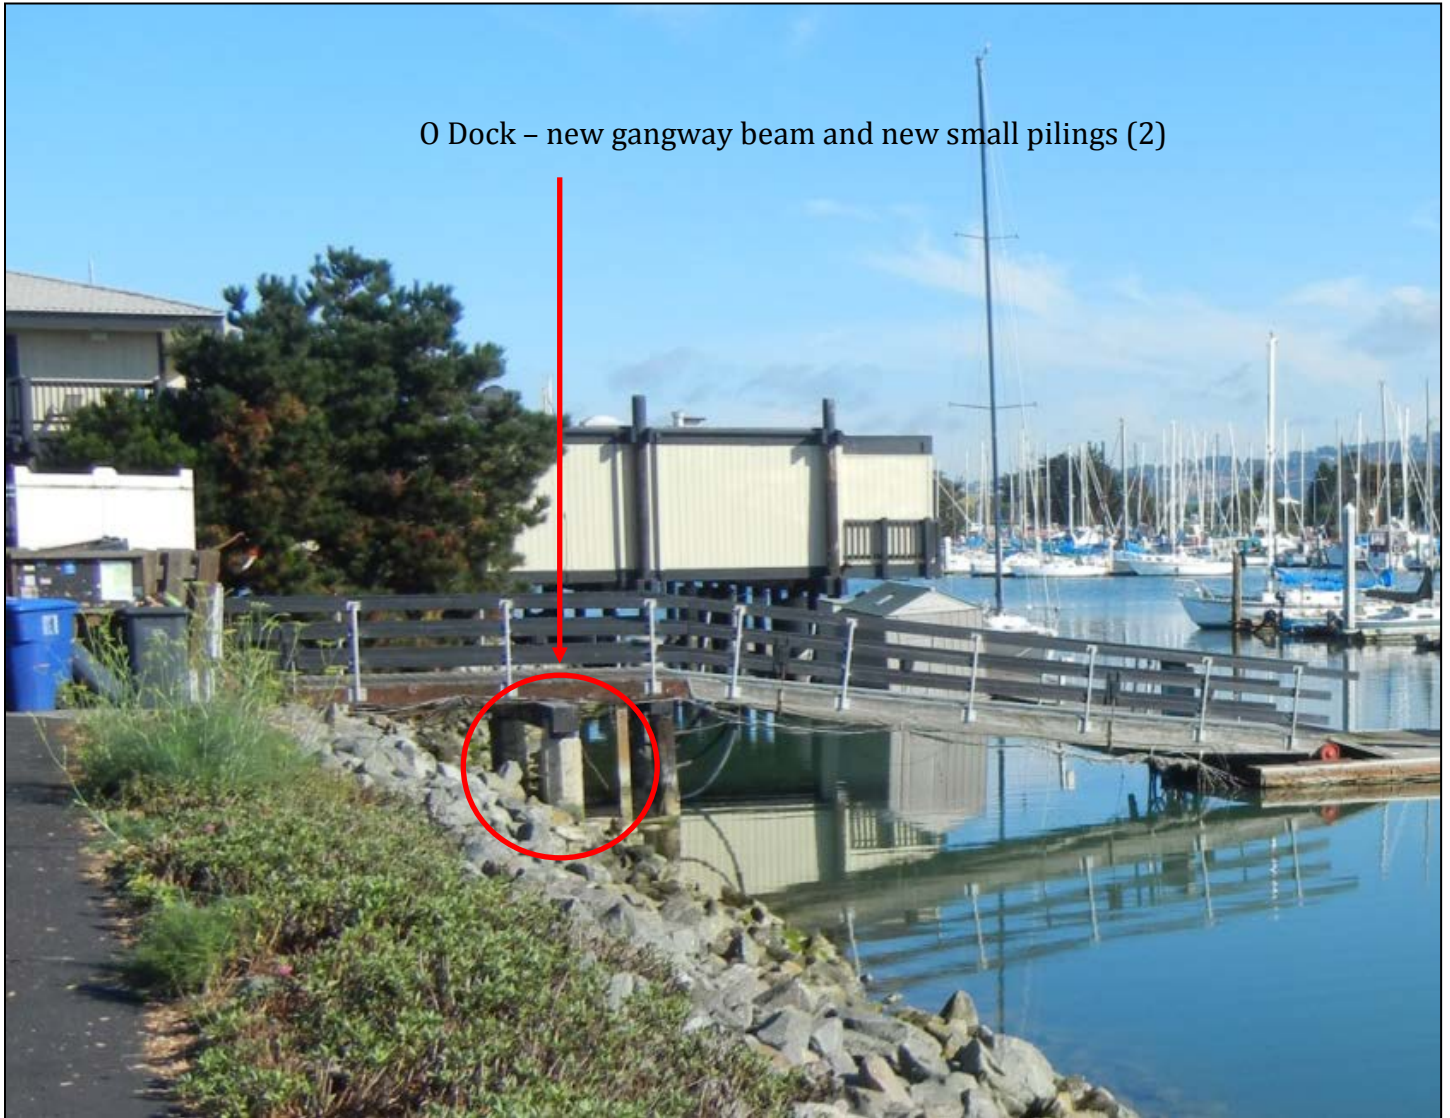
Photograph 5: O Dock – New gangway beam and new small pilings (2). (Photo: R. Miller, City Staff)

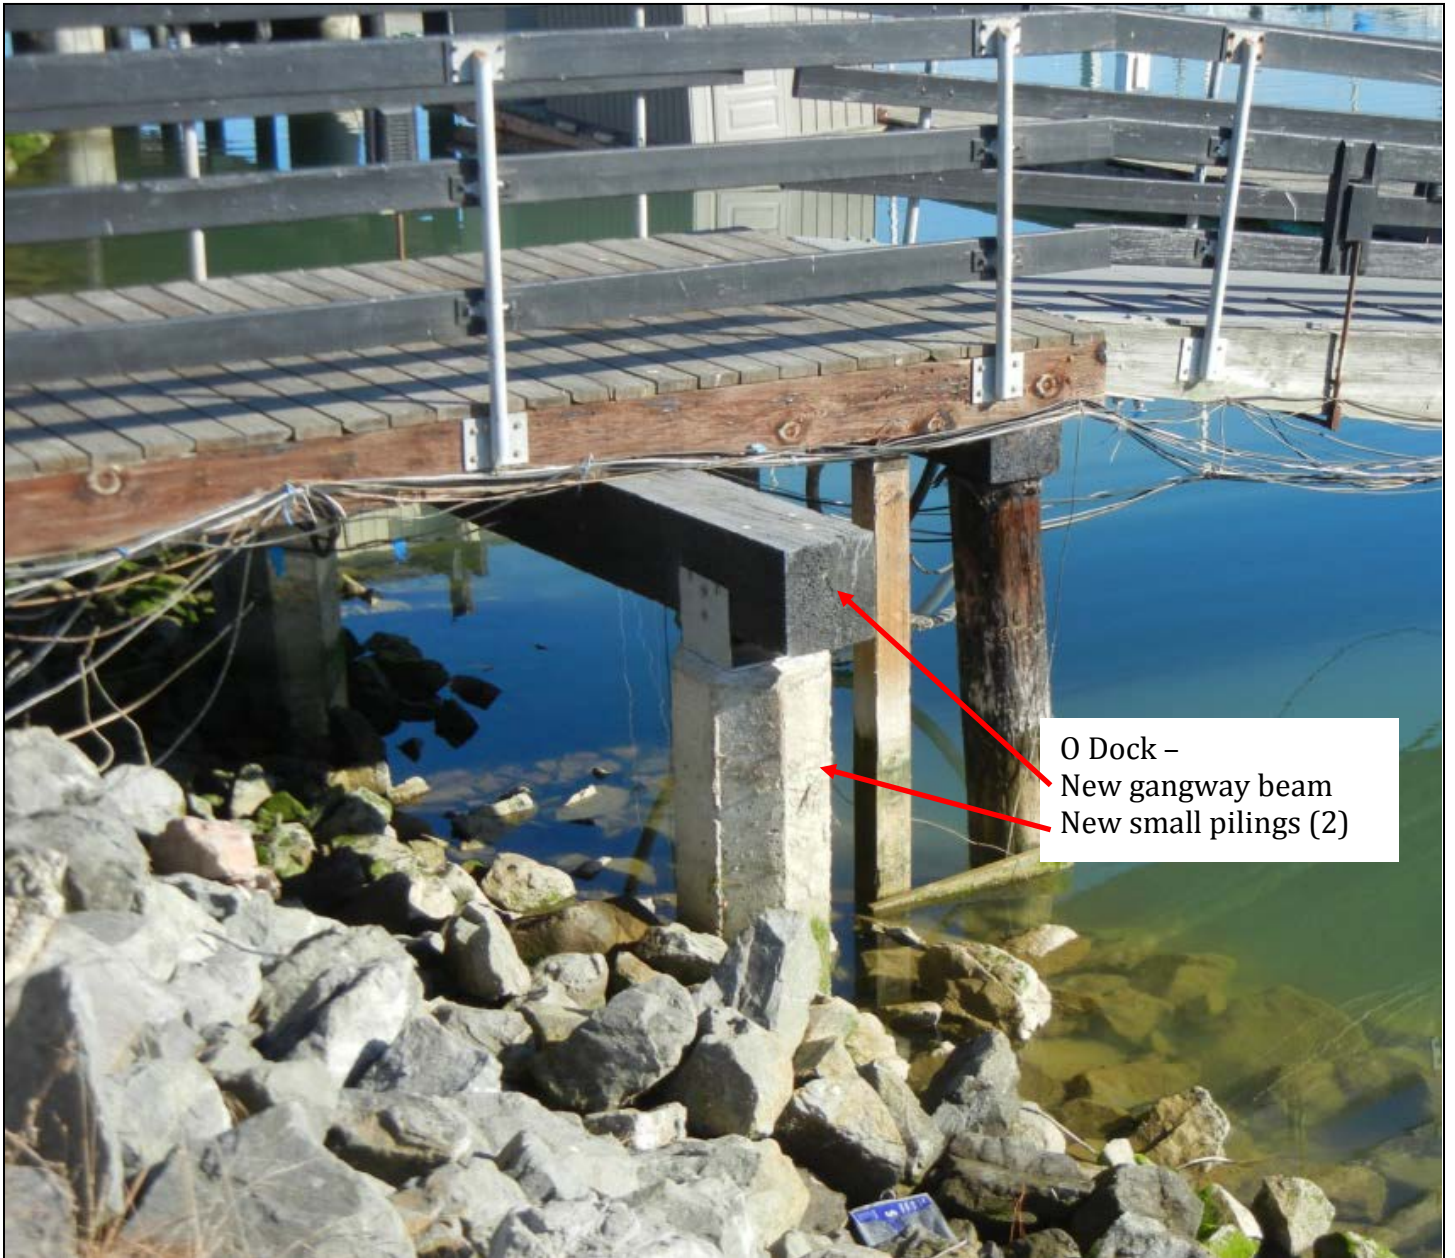
Photograph 6: O Dock – Close-up of new gangway beam. (Photo: R. Miller, City Staff)

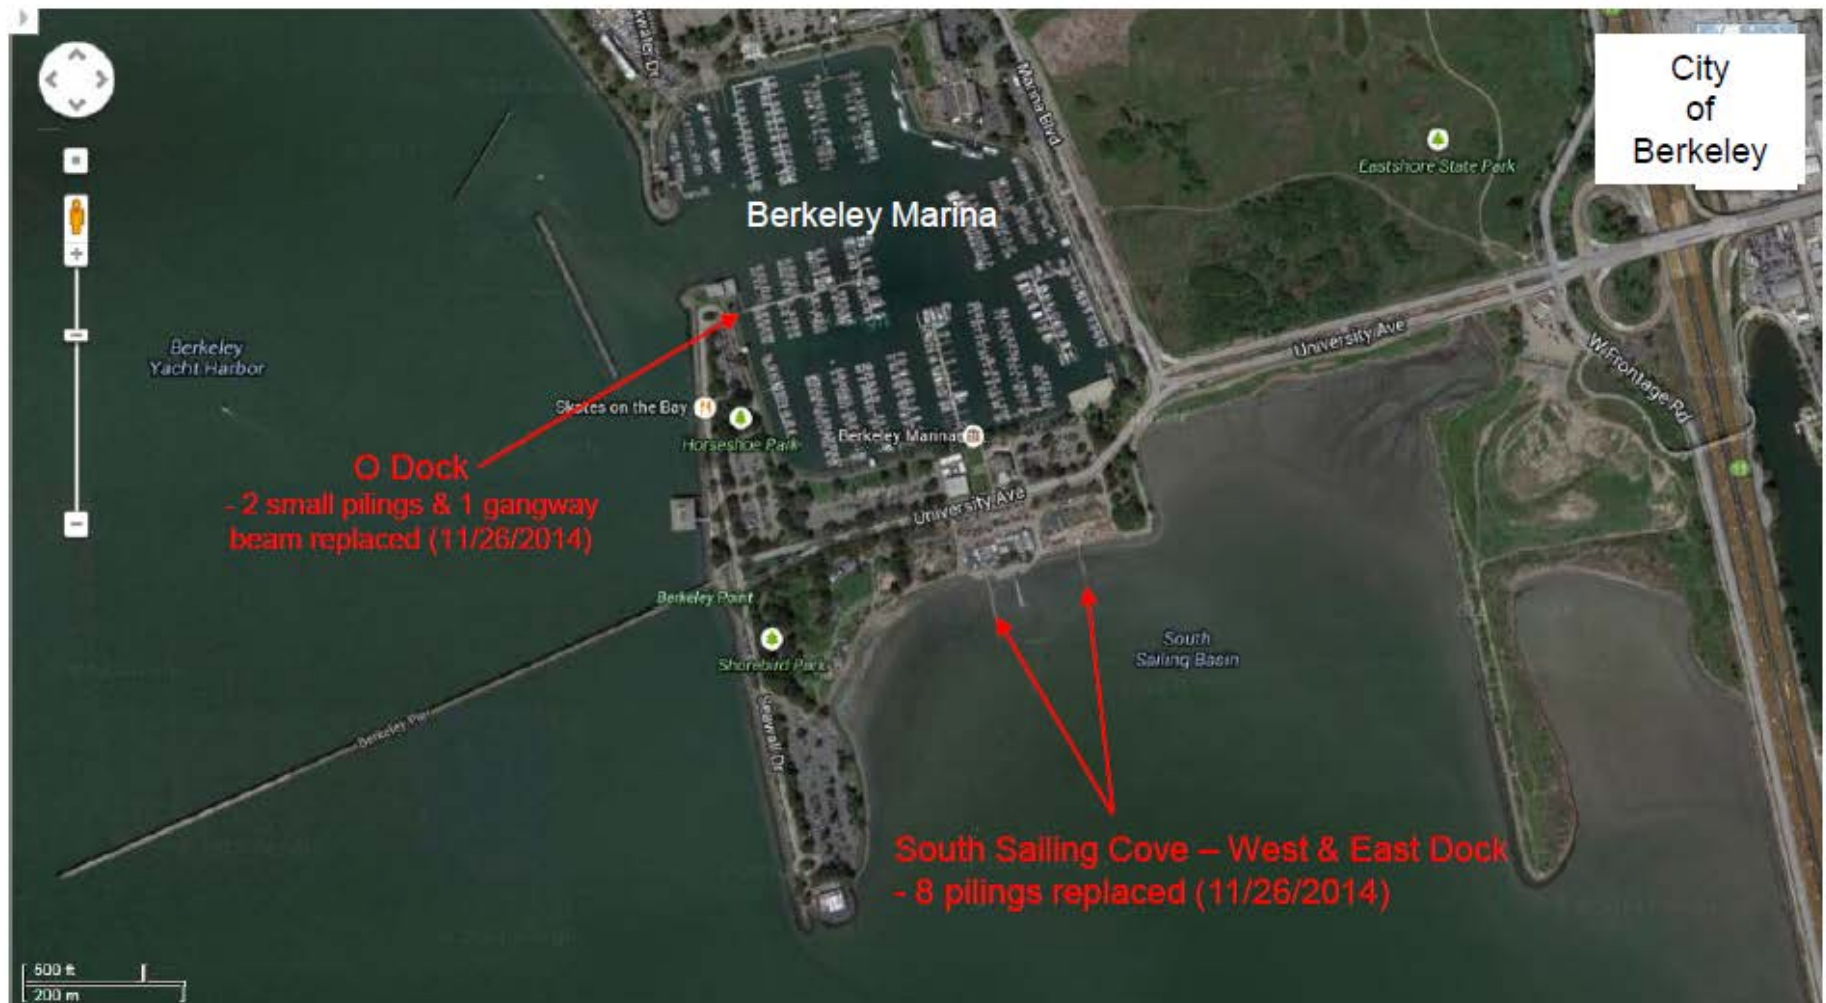
7. Pilings Project, South Sailing Cove & O Dock, Berkeley Marina, aerial photo - Cosco Busan grant, December 2013

- 8 pilings replaced at East & West Docks at S. Sailing Cove (as of Nov 26, 2013)
- 2 small pilings and 1 gangway beam replaced at O Dock (as of Nov 26, 2013)

WEST DOCK - pre-existing
Cosco Busan Grant Work Completed:
 Pilings 1, 2, 3, 4 replaced on 11/26/2013

EAST DOCK - pre-existing
Cosco Busan Grant Work Completed:
 Pilings 6, 7, 9, 10 replaced on 11/26/2013
