Date Aug. 14, 1950

El Dorado Co.

Horseshoe L.

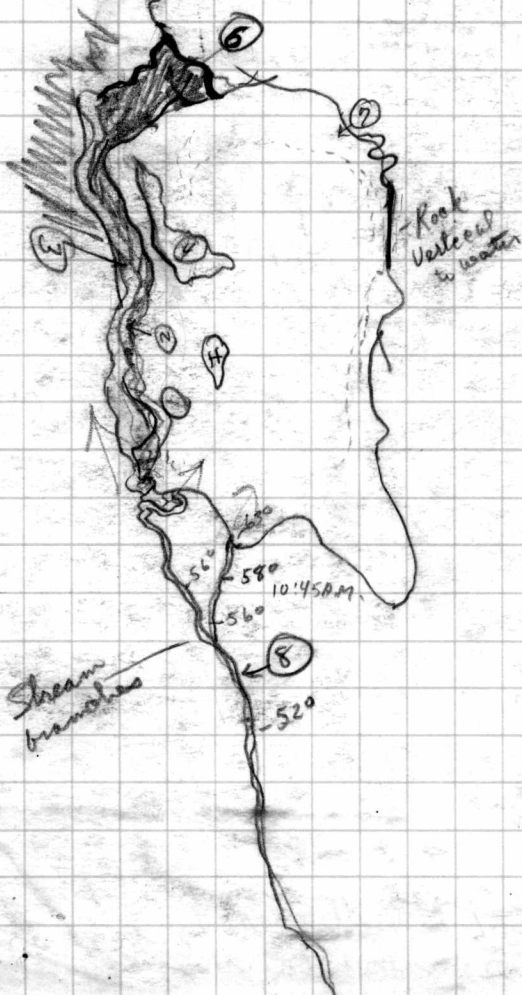
- ① Extensive rush beds
Rushes dominate riparian
border of the entire l.
- ② High ground w/ rushes
& willows separating
main l. from Canal
- ③ Canal which in its
lower (eastern end) is
lower than lake level
- ④ Island w/ 6 lodgepole
(small to medium size) 5 small
white pines + one Hemlock
Island is composed of
large boulders.
- ⑤ Entire bottom of lake is
mud + silt w/ small bunch
grass.
- ⑥ Outlet Flow $\frac{1}{2}$ c.f.s Temp.
at overflow = 62.5° @ 9:45 A.M.
Flow for about 100 yds in pools
then drops of precipitous into confluence
below over steep bedrock

(7) Shore temp 69° @ 10:15 AM

(8) From here on into the lake the inlet is slow moving deep meadow type stream - gravel bottom - flow $\frac{1}{2}$ c.f.s. very good spawning beds (excellent) & accessible for about $\frac{1}{4}$ mile to lake fish. Natural reproduction would keep this lake adequately supplied with fish.

(9) Absolutely no sign of any fish - lake, outlet or inlet. Lake appears to be barren.

(11) Lake appears to be very productive and except for its shallowness should support a fair population of fish.

(12) Entire shore bordered by ledgepole & some white pine & hemlock. No steep slope. Booby

(10) Would suggest 500 to 1000 EB or CT (!?).
