**MARIA YGNACIO
STREAM INVENTORY REPORT
FEBRUARY, 2010**

MAY 2011

STREAM INVENTORY REPORT

MARIA YGNACIO CREEK

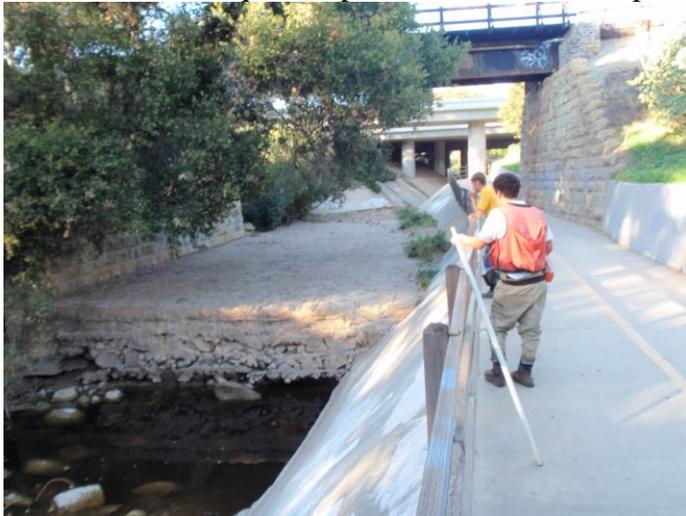
Stoecker ID: BR_AO_MY_4

MY Beneath the USRR Crossing, LB looking US

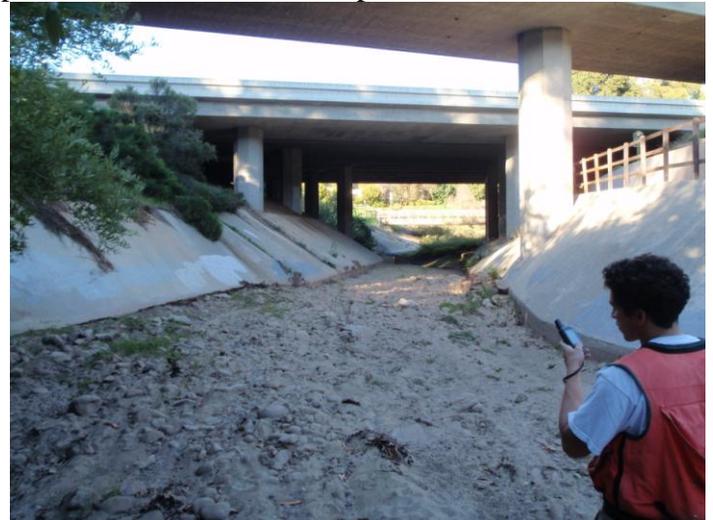
MY Beneath the 101 bridge, , looking US

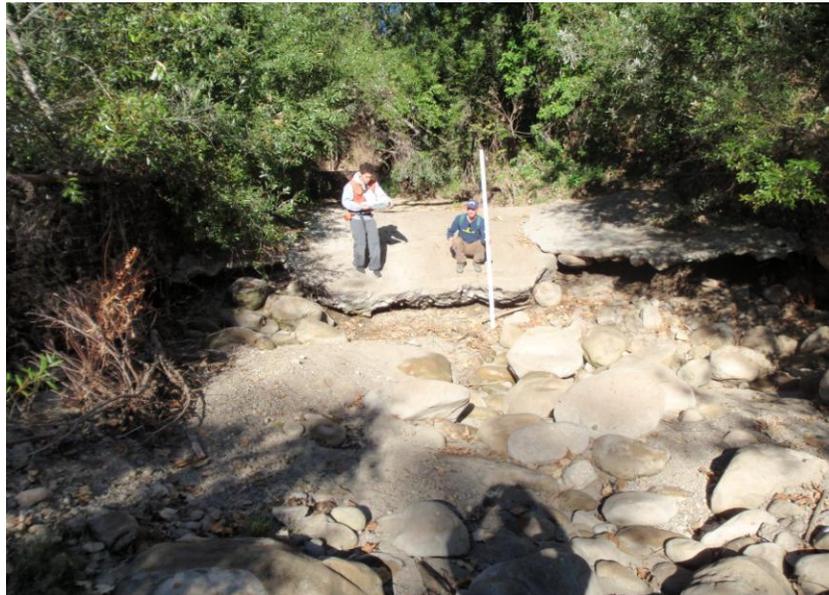
Stoecker ID: BR_AO_MY_6

MY Concrete Grade Control Structure 1

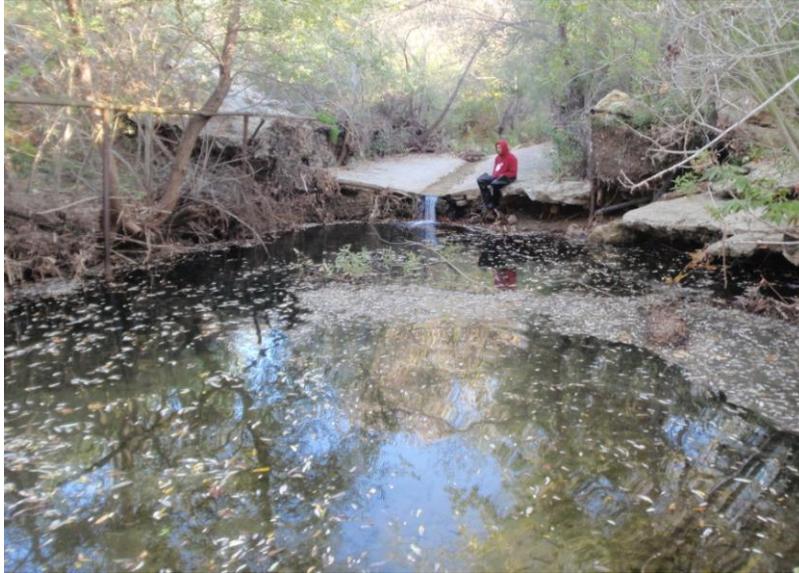
Stoecker ID: BR_AO_MY_12

MY Concrete Grade Control Structure 6

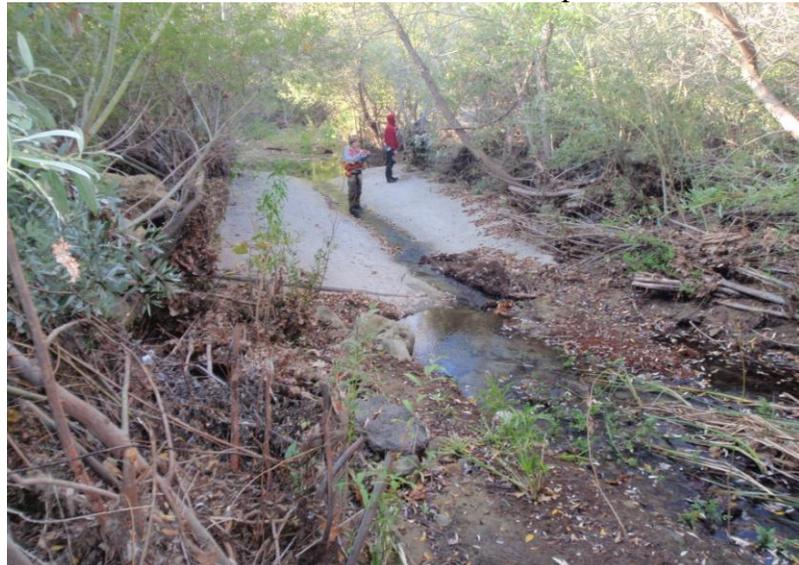
Stoecker ID: No Stoecker ID

MY Concrete Grade Control Structure 7

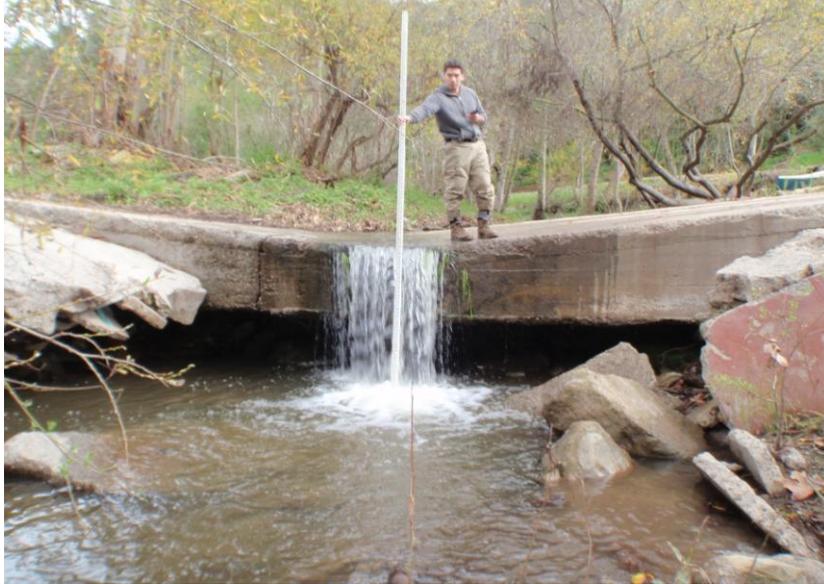
Stoecker ID: BR_AO_MY_15

MY Arizona Crossing 2, looking US

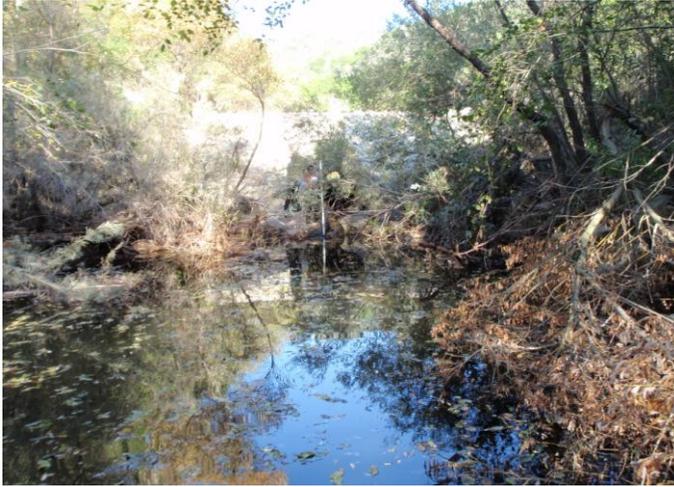
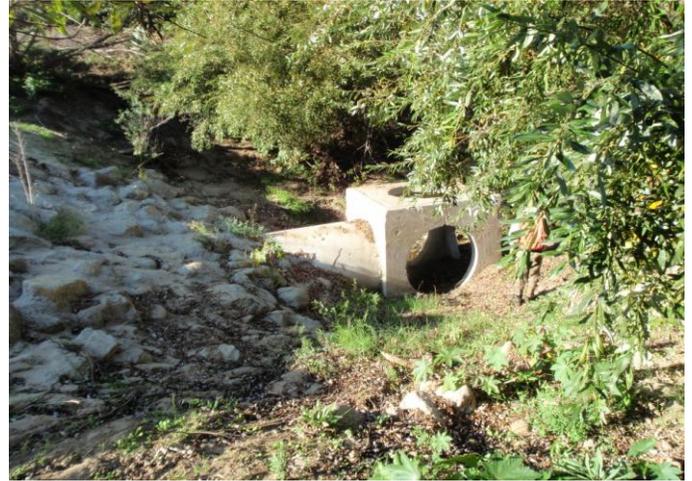
NAME: MY DEBRIS BASIN

Description: The Maria Ygnacio debris basin was built in 1990 after the Painted Caves Fire and was constructed using a massive concrete riprap dam with a 136 ft pipe (4.5 ft diameter) that runs beneath allowing for water passage. A plunge pool (max depth of 3.5 ft) was scoured beneath the downstream outlet with a 1.8 ft depth beneath the pipe and a 1.7 ft jump from the water to the lip of the pipe. With flow, entrance into the pipe would be possible but migrating through the 136 ft long pipe would be extremely difficult due to the force of the flow through such a smooth and narrow channel. Migration through the barrier might not be possible for steelhead.

MY Debris Basin, looking US

MY Debris Basin, LB, looking US

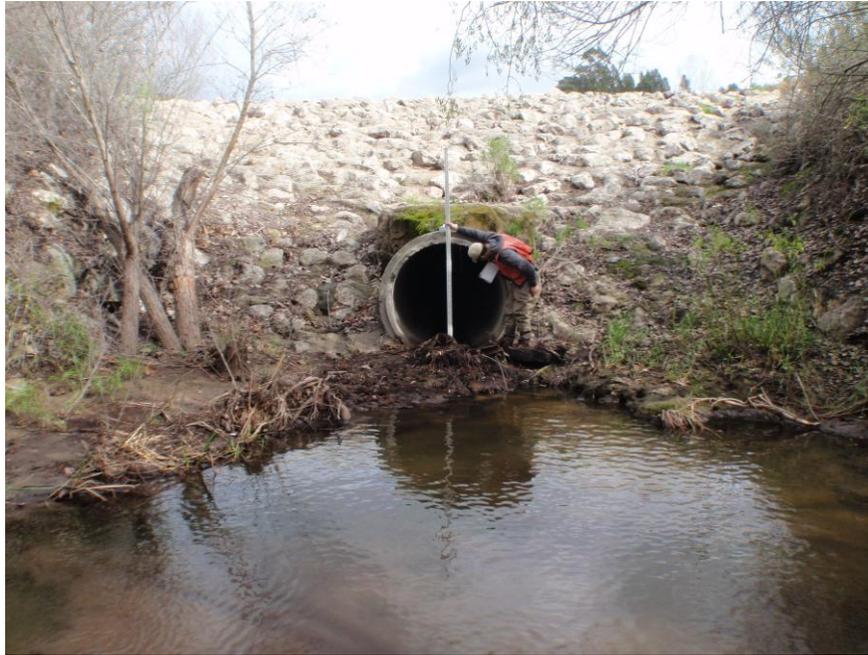
Stoecker ID: BR_AO_MY_EF_1

MYEF Debris Basin, looking US

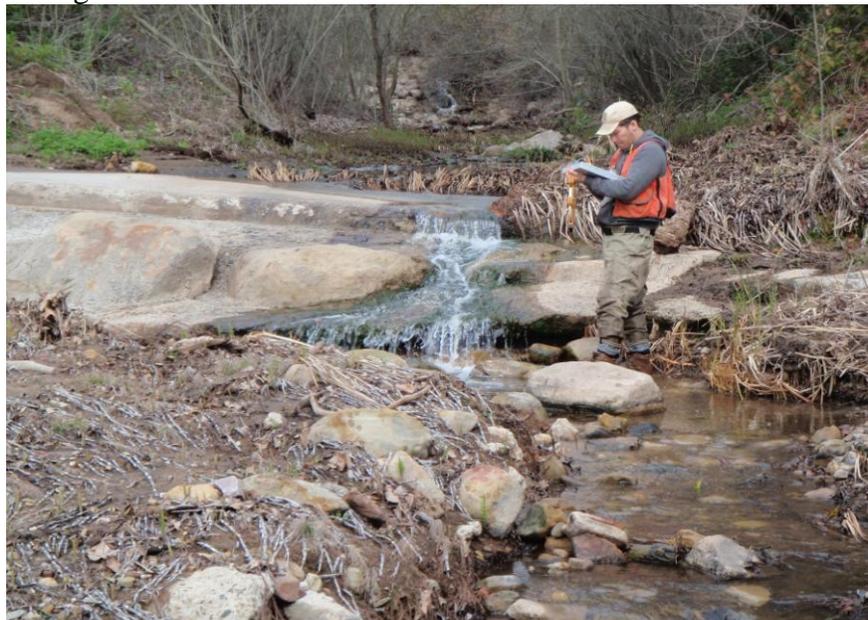
Stoecker ID: No Stoecker ID

MYEF Grade Control 2

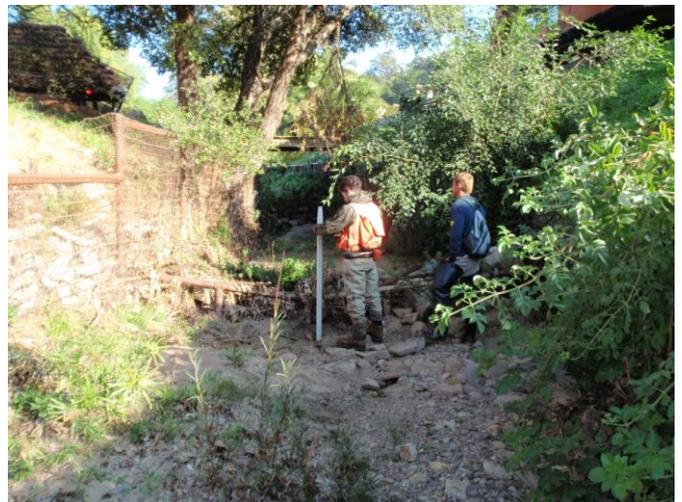
US Metal Pipe Check Structure

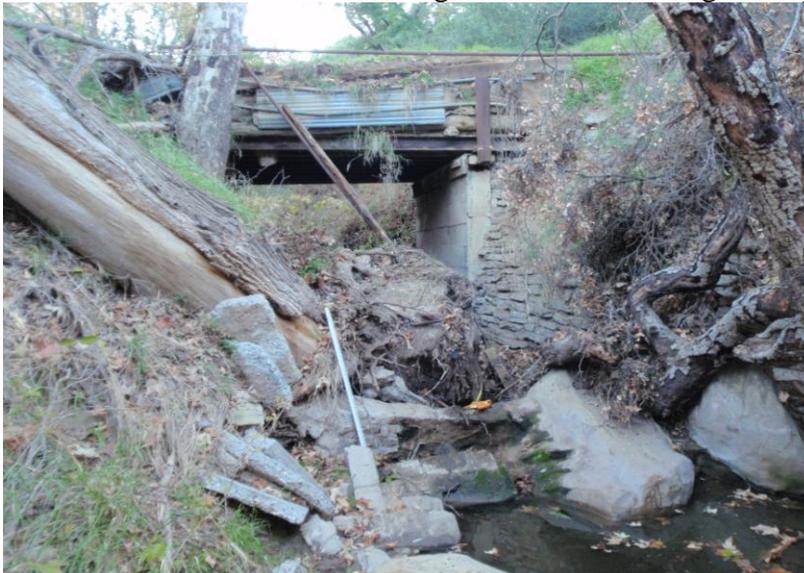
Stoecker ID: No Stoecker ID

La Riata Bridge, looking US

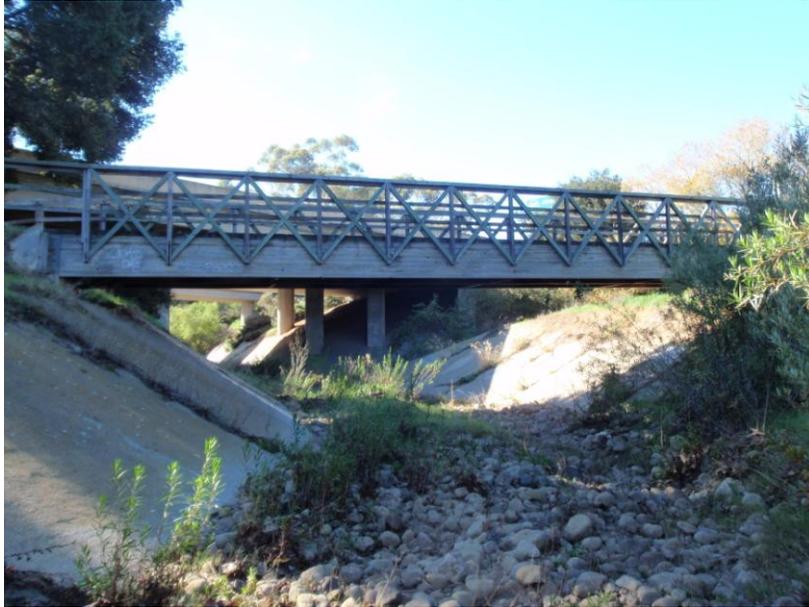
Stoecker ID: No Stoecker ID

San Antonio Footbridge, looking DS towards the Highway 101 and Calle Real bridges

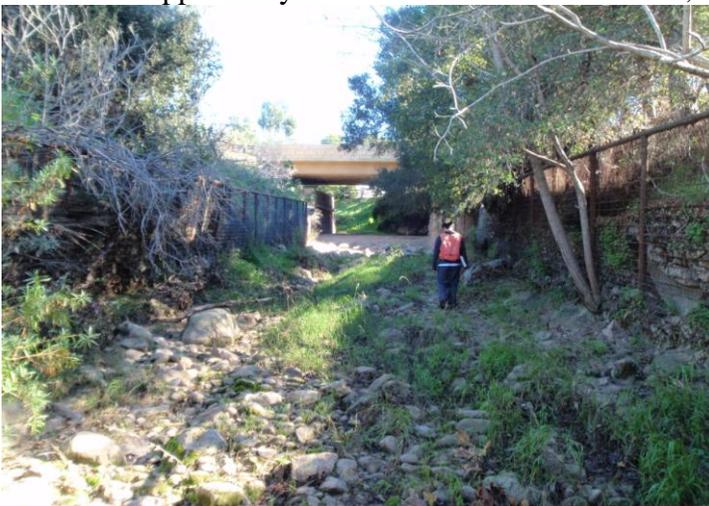
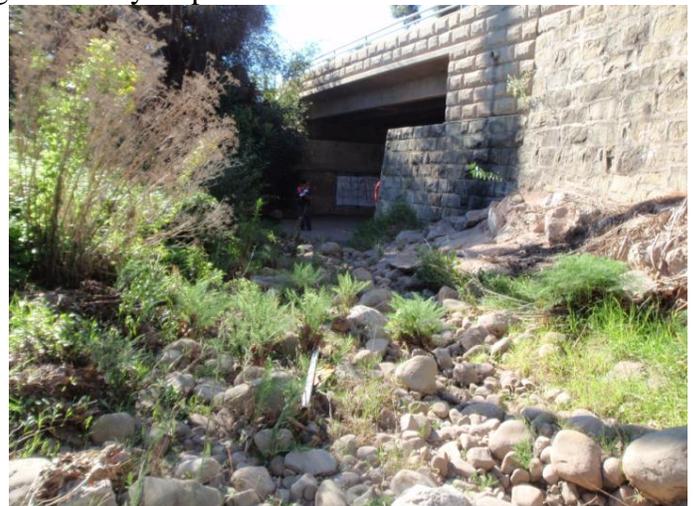
Stoecker ID: BR_AO_MY_SA_1

DS of San Marcos bridge, looking US

US of San Marcos bridge, looking DS

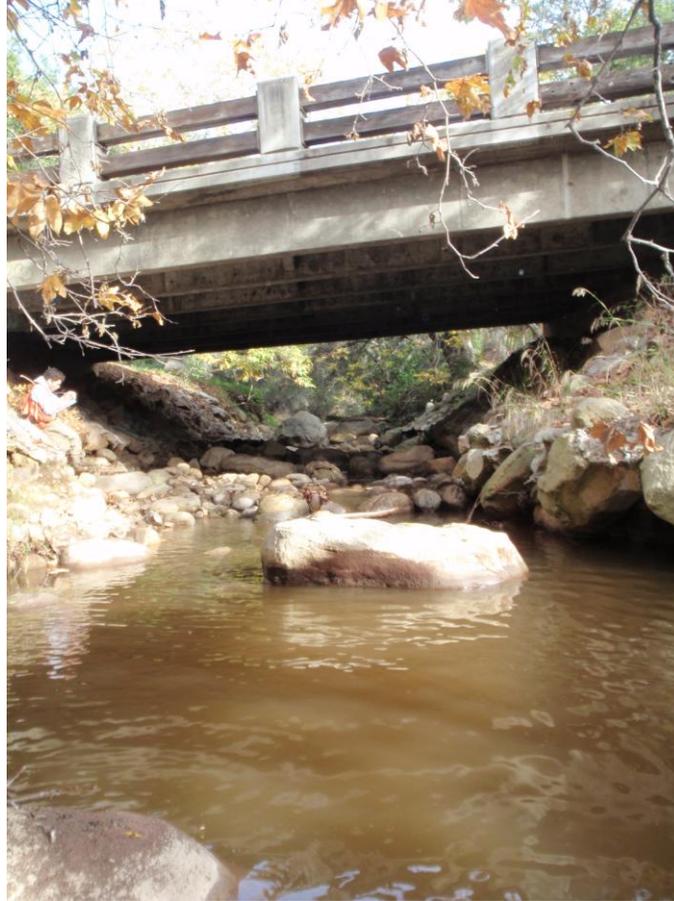
Stoecker ID: BR_AO_MY_SA_3

Turnpike bridge, looking US

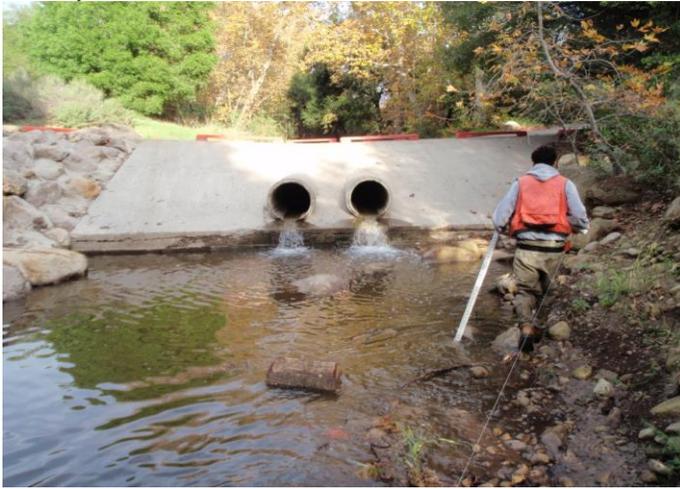
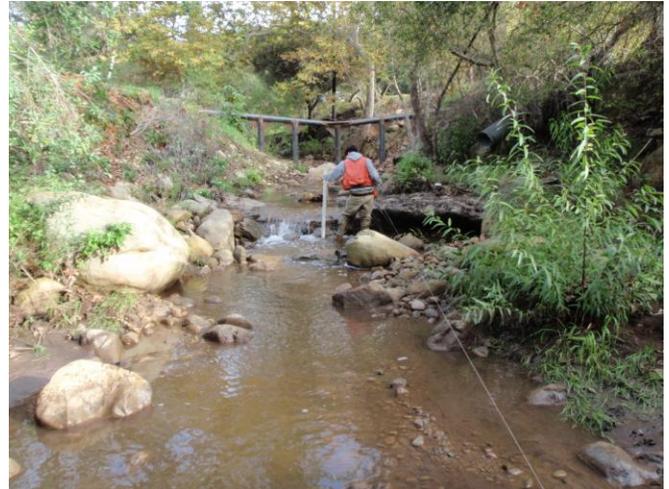
Stoecker ID: BR_AO_MY_SA_4

Tucker Grove Culvert, Looking US

Downstream Instream Debris Guard

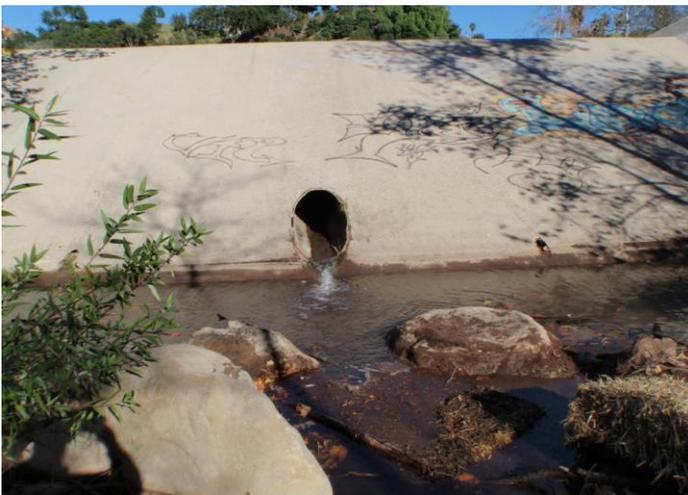
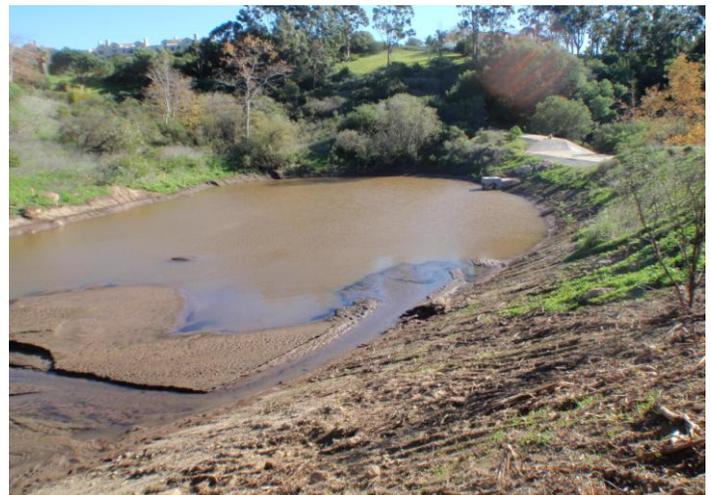
Stoecker ID: BR_AO_MY_SA_5

San Antonio Debris Basin, looking US

Debris Basin Pool Created US of Debris Basin Dam

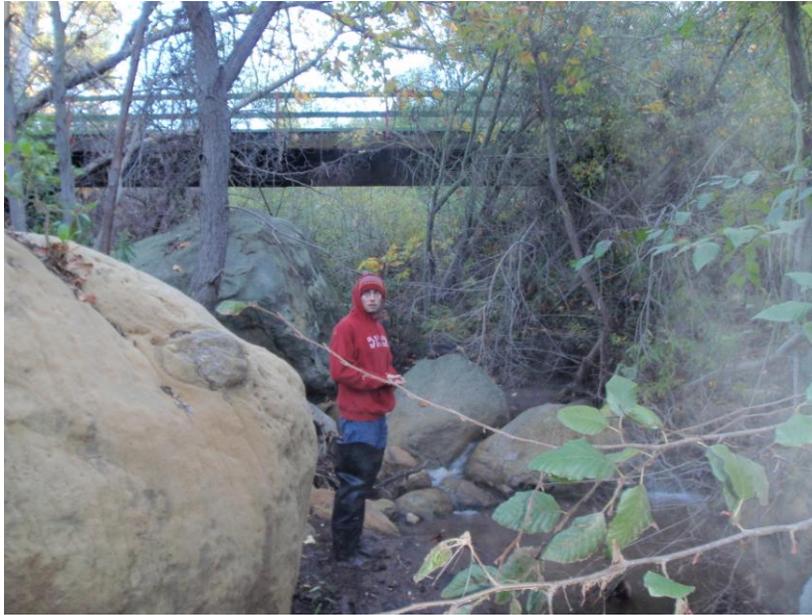
Stoecker ID: No Stoecker ID

Private bridge upstream San Marcos Pass, looking US

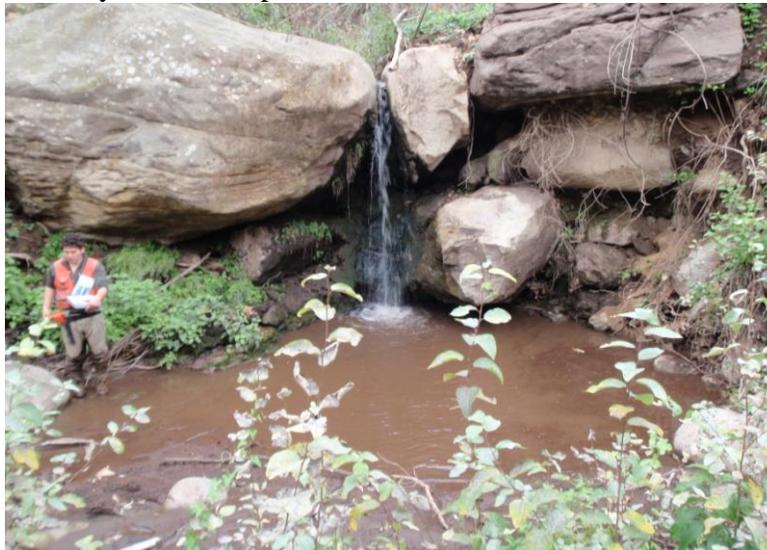
Stoecker ID: BR_AO_MY_SA_WF_1

San Antonio Anadromy Waterfall

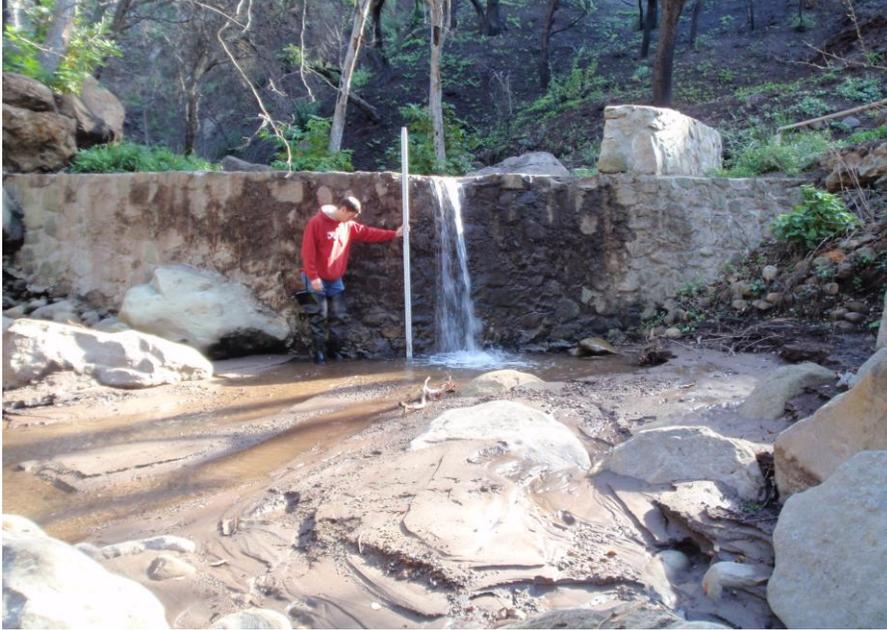
Stoecker ID: BR_AO_MY_SA_EF_1

SAEF Dam
