# City of Carlsbad Wildlife Movement Analysis Final Report

Local Assistance Grant Agreement No.  
P1282107

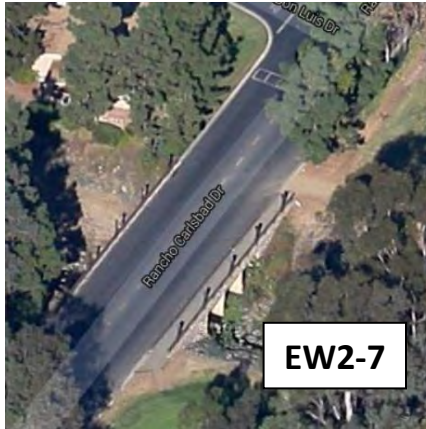
**EW2-6, EW2-7.** There are 2 undercrossings, EW2-6 at an western spur of Rancho Carlsbad Drive and EW2-7 at eastern spur of Ranch Carlsbad Dr. Needs further investigation to see if movement is possible. This is a gated area and may not allow access. There are a few small pedestrian bridges across the drainage east of Rancho Carlsbad Drive; these don't appear to obstruct movement.

The drainage narrows and is surrounded by development (appears to be equestrian facilities).

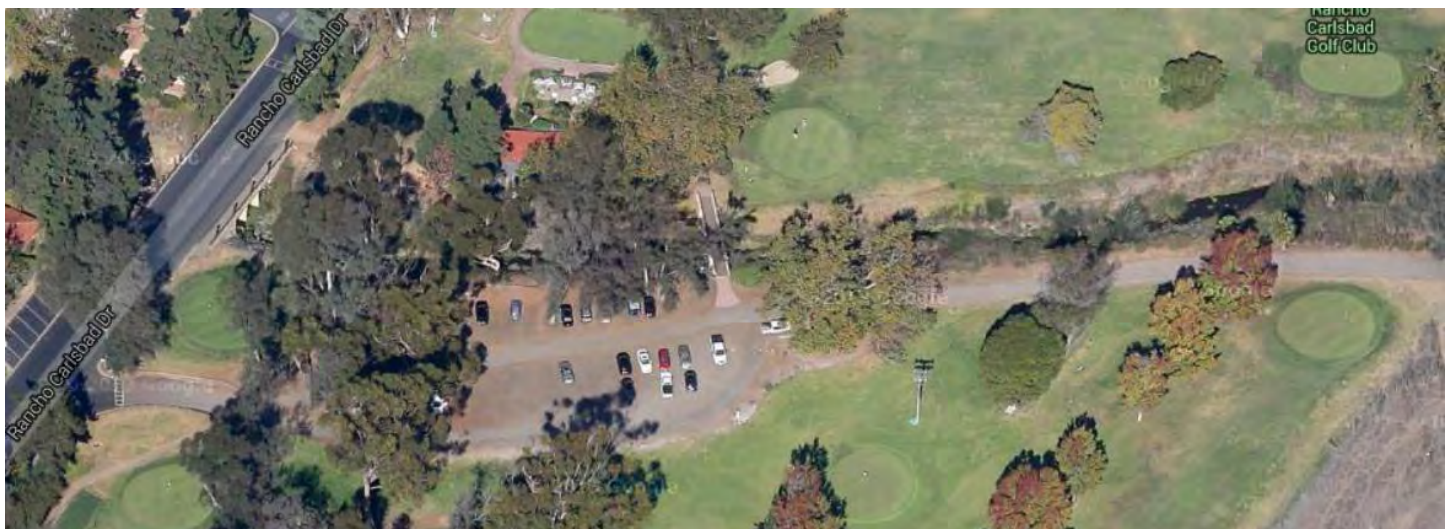
**EW2-8.** Rancho Carlsbad Golf Course and equestrian area to the east. The entire golf course needs to be walked along the riparian drainage to look for signs of obstructions to movement, such as fences. Like EW3-3, this area has a lot of small bridges across the drainage, which probably does not impede movement, but should be confirmed. There are also areas that are narrow with very dense vegetation surrounded by development. The area probably has access control during the night, so may not be a problem to wildlife unless there are wildlife proof fences. Note that the riparian area is protected (classified as open space but not part of HMP). Photos:

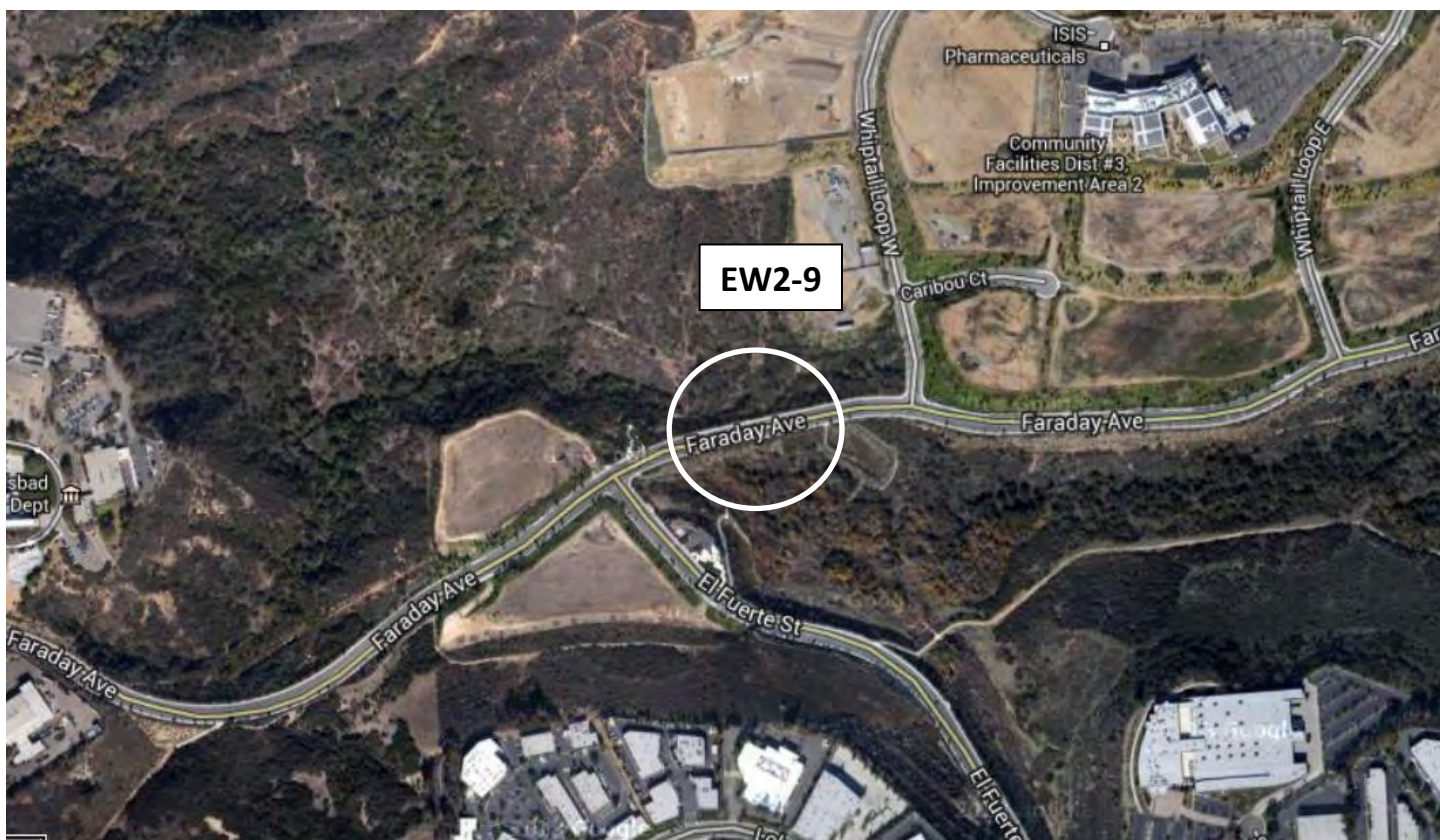
This linkage turns into Sunny Creek. Although hard to see, there are houses and dirt roads under the canopy. As such, there could be fences and other obstructions to movement.

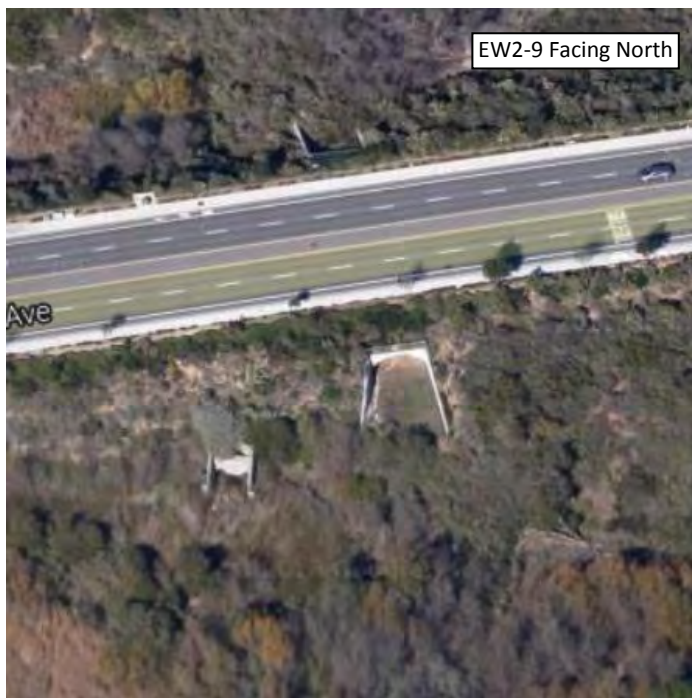
**EW2-9. High Priority.** Fencing around the tops of the box culverts, but otherwise the area is unfenced.

The installation of fencing can be useful if a viable alternative route, typically an undercrossing, is available. Fencing can also be used to restrict human access to an area with the possible benefit of protecting the pinchpoint and making the area more conducive to animal use. As discussed in Section 3.3, however, the installation of fencing does not always guide animals to the undercrossing; deer approaching EW3-6a go around the fencing along Rancho Santa Fe Road rather than using the tunnel, which is 3.7 meters high and 4.6 meters wide. Any recommendation for fencing to guide animals should be implemented only after a more detailed study of roadkill, tracking, and perhaps camera monitoring is completed. In the future, the area around EW3-1 and EW3-7 leading out from Batiquitos Lagoon may benefit from fencing to preclude human access, as well as both sides of the tunnel at EW2-9.

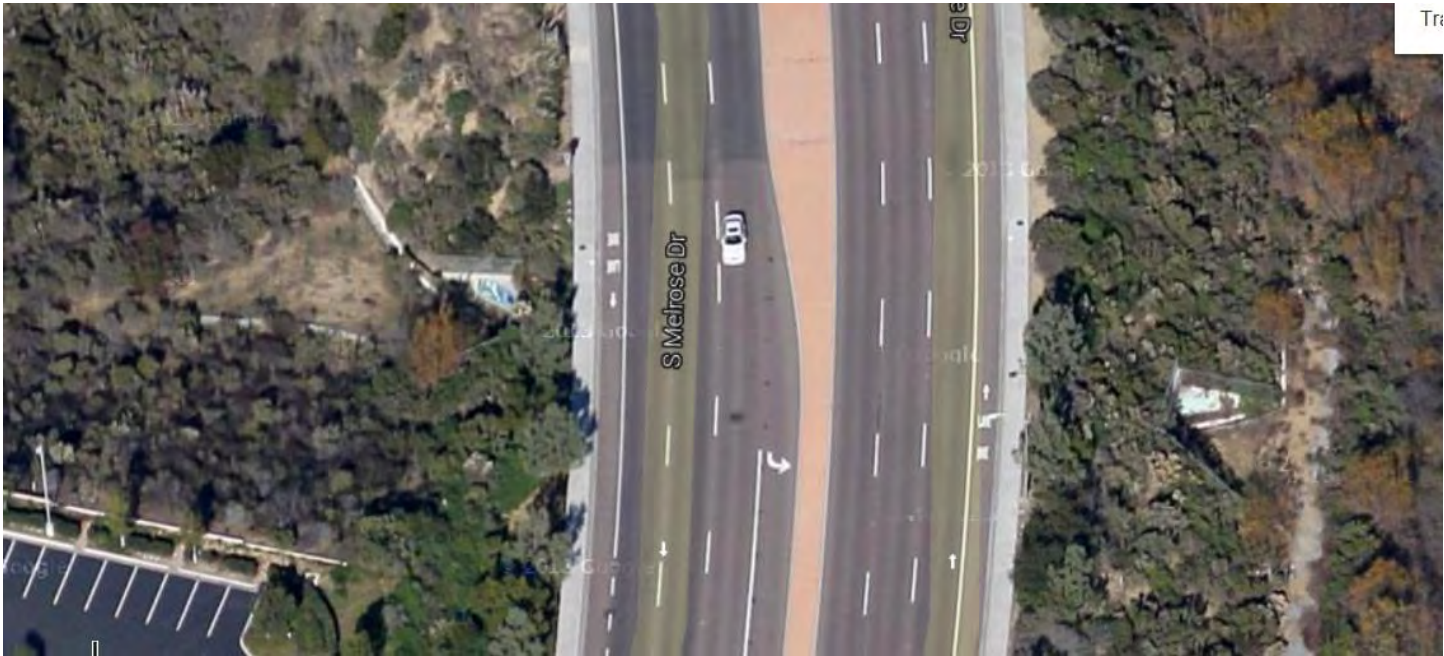
**EW2-10. High Priority.** Does not appear to be any fencing.

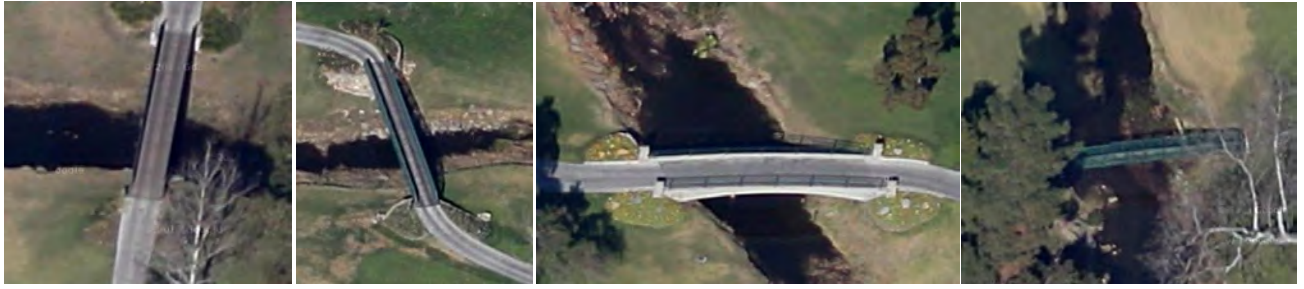
EW3-3f-i

**EW3-3a-3f-k.** Narrow bridges along San Marcos Creek for golf cart access.

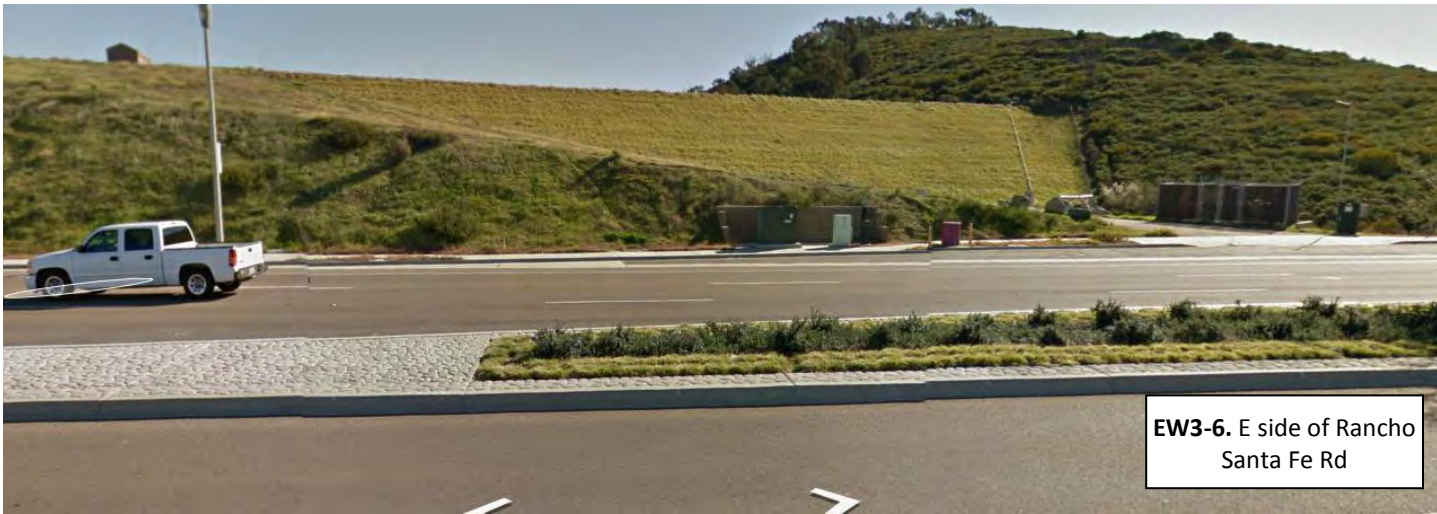
**EW3-6.** W side of Rancho  
Santa Fe Rd; Culvert

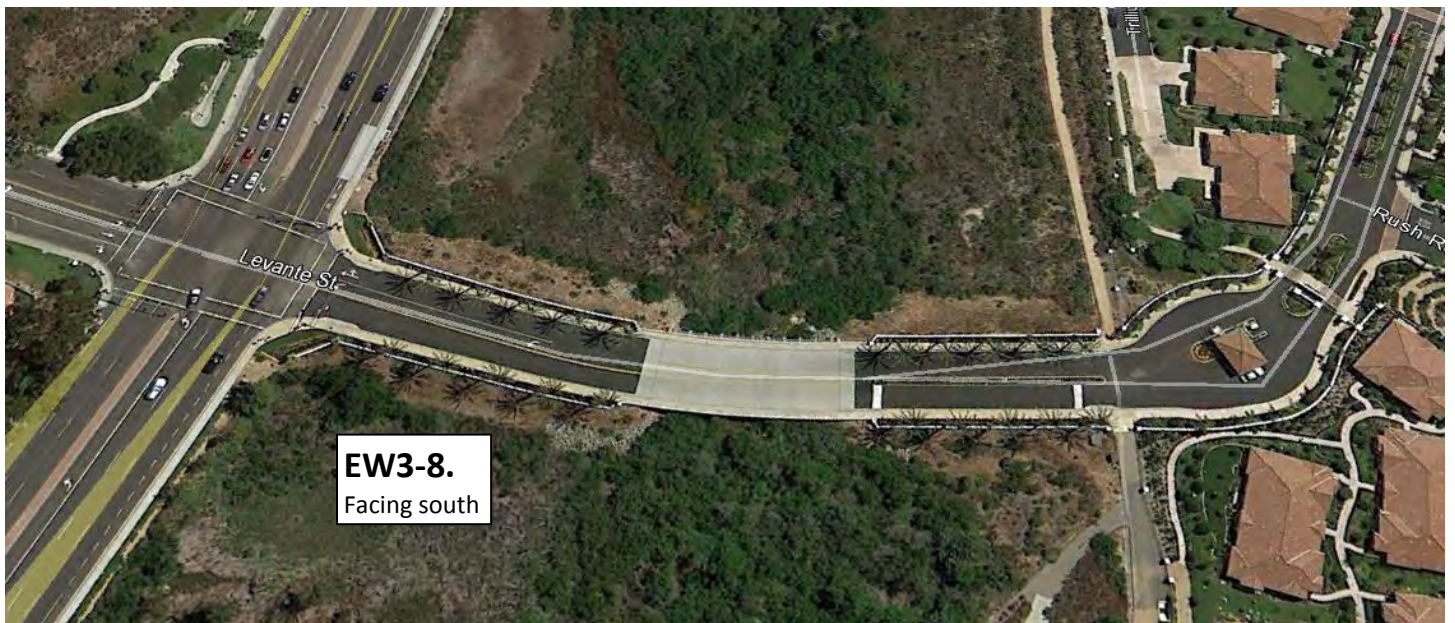
**EW3-8.** Encinitas Creek and Levante Street.

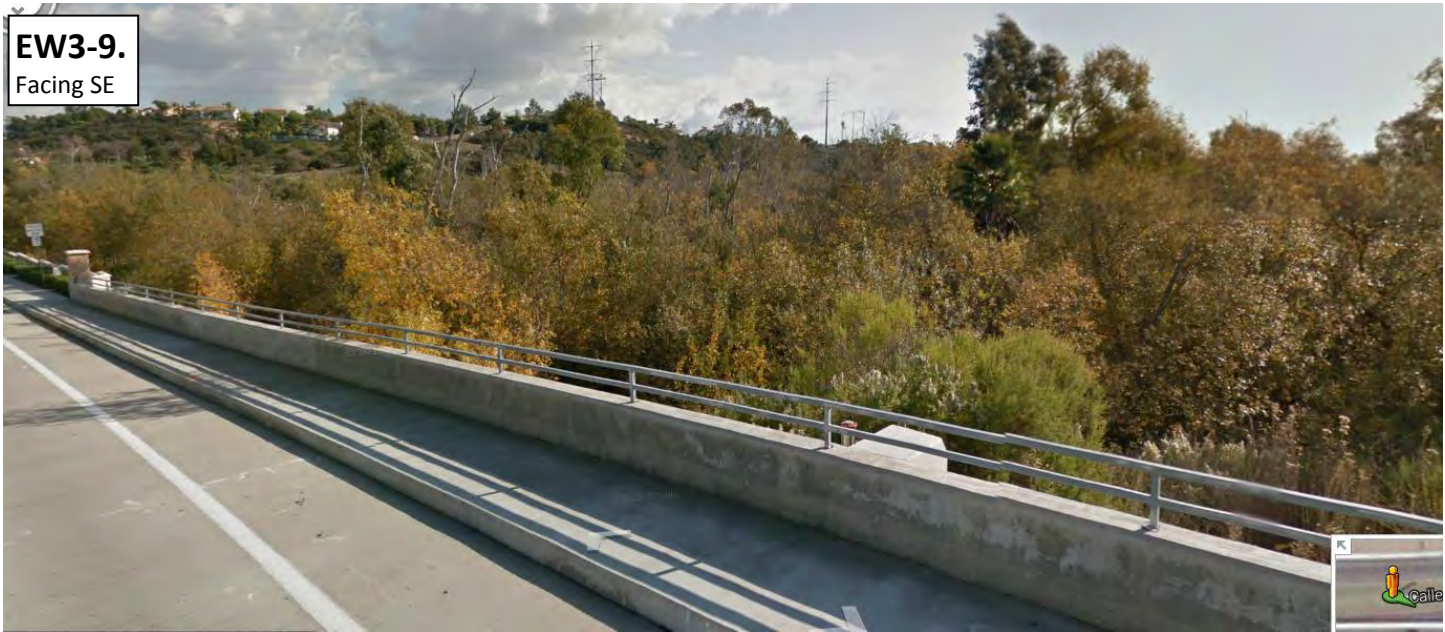
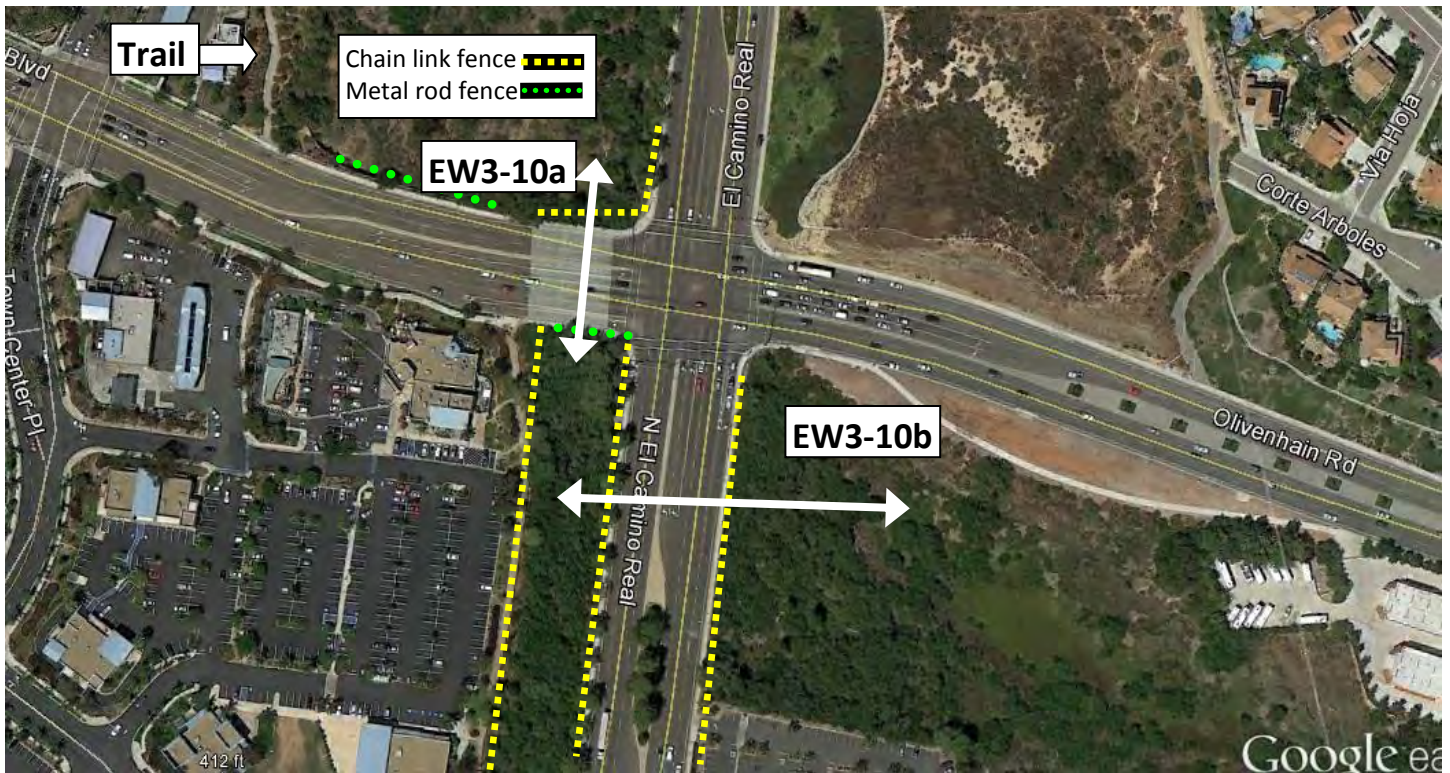
**EW3-9.** Encinitas Creek and Calle Barcelona.

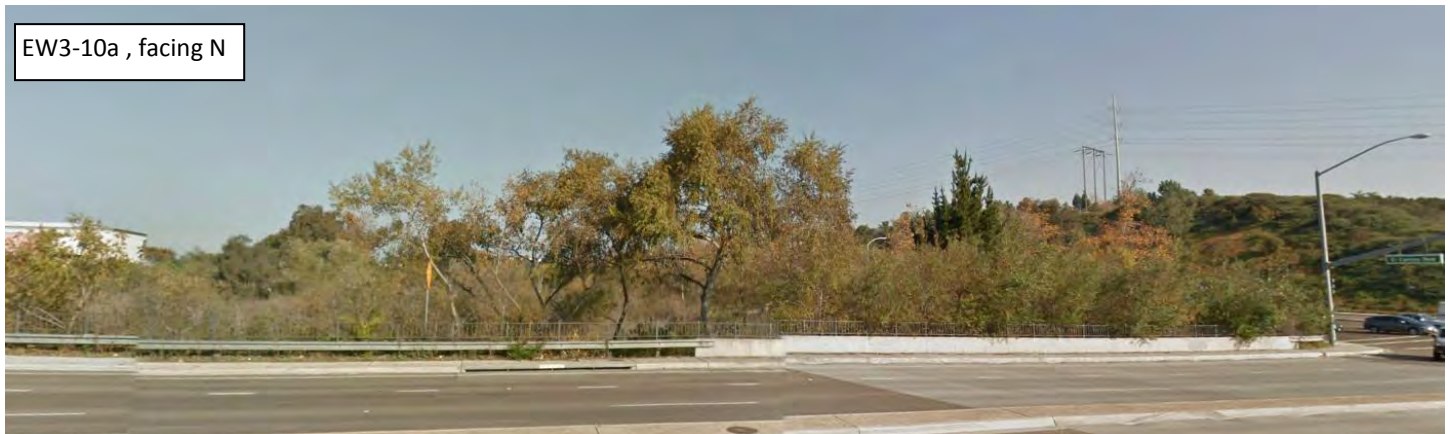
**EW3-10a and b.** Encinitas Creek and Leucadia Blvd (EW3-10a; N-S movement) and Encinitas Creek and El Camino Real (EW3-10b; E-W movement).

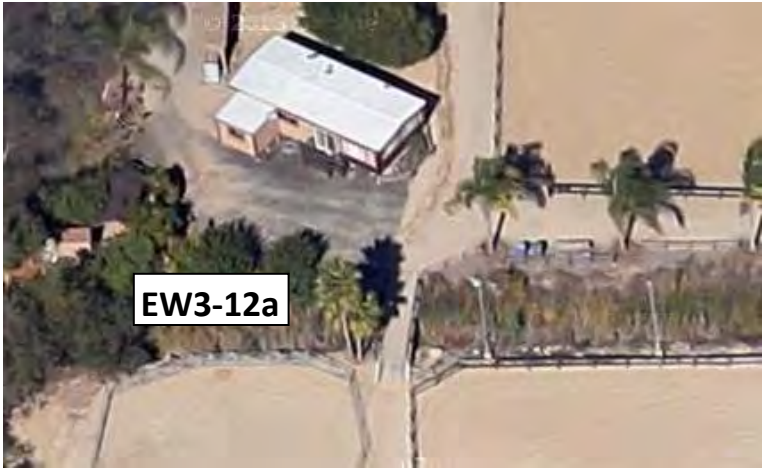
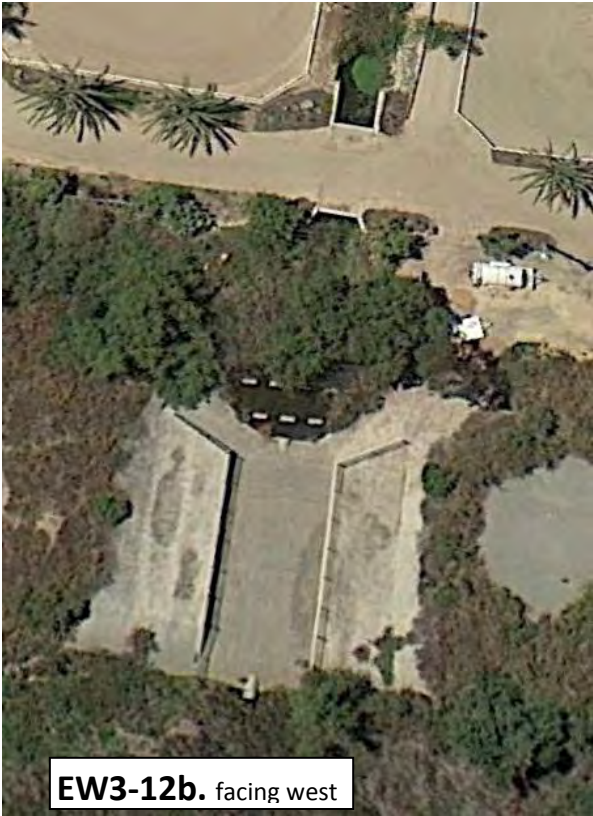
Overview of EW3-12a-c. Encinitas Creek and equestrian facilities (?), E of Amargosa, S of Olivenhain Rd. Not sure if wildlife movement through this area is possible. May not be access to this area.

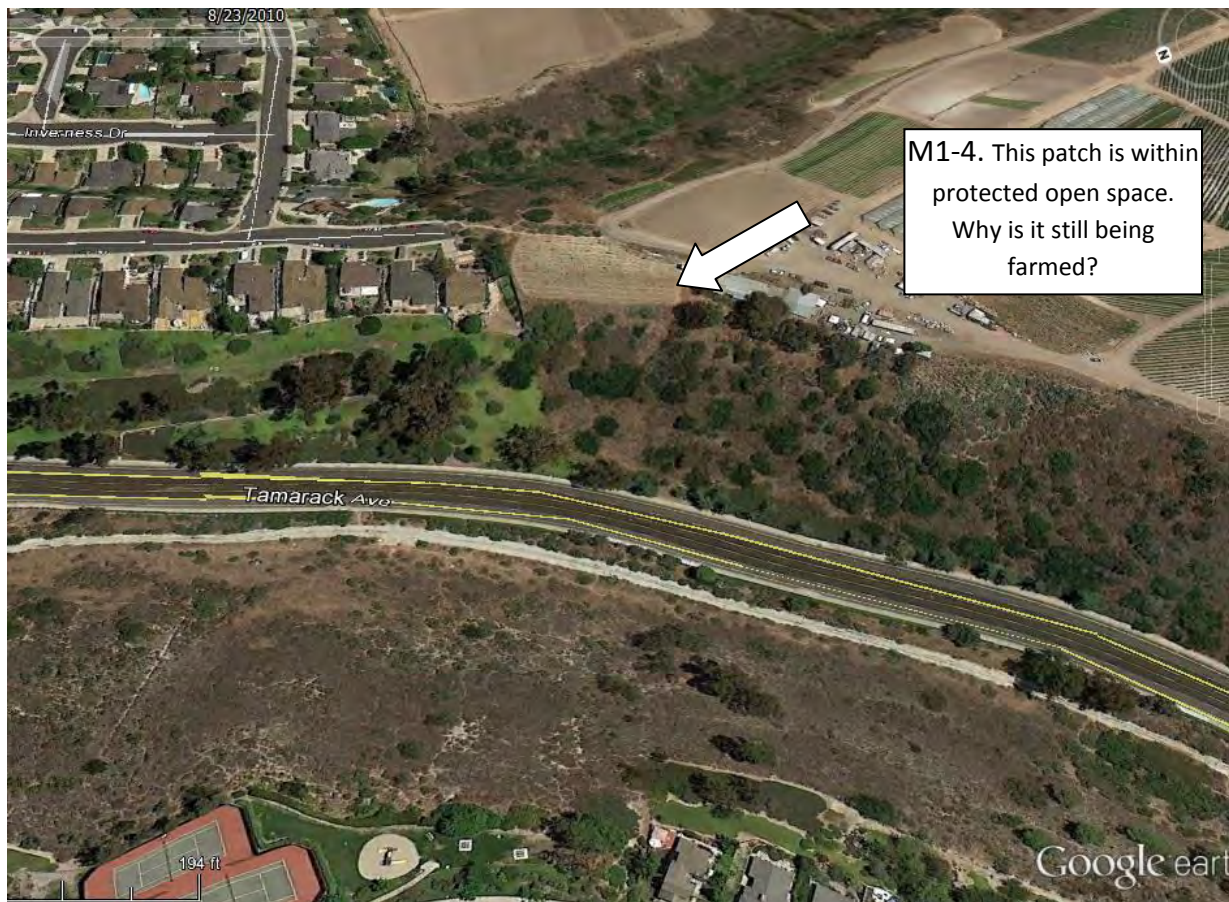
M1-4. Tamarack Ave near Gateshead R. Oblique view facing W. Appears to be no culverts or fencing along Tamarack Ave. Can animals travel across agricultural areas?

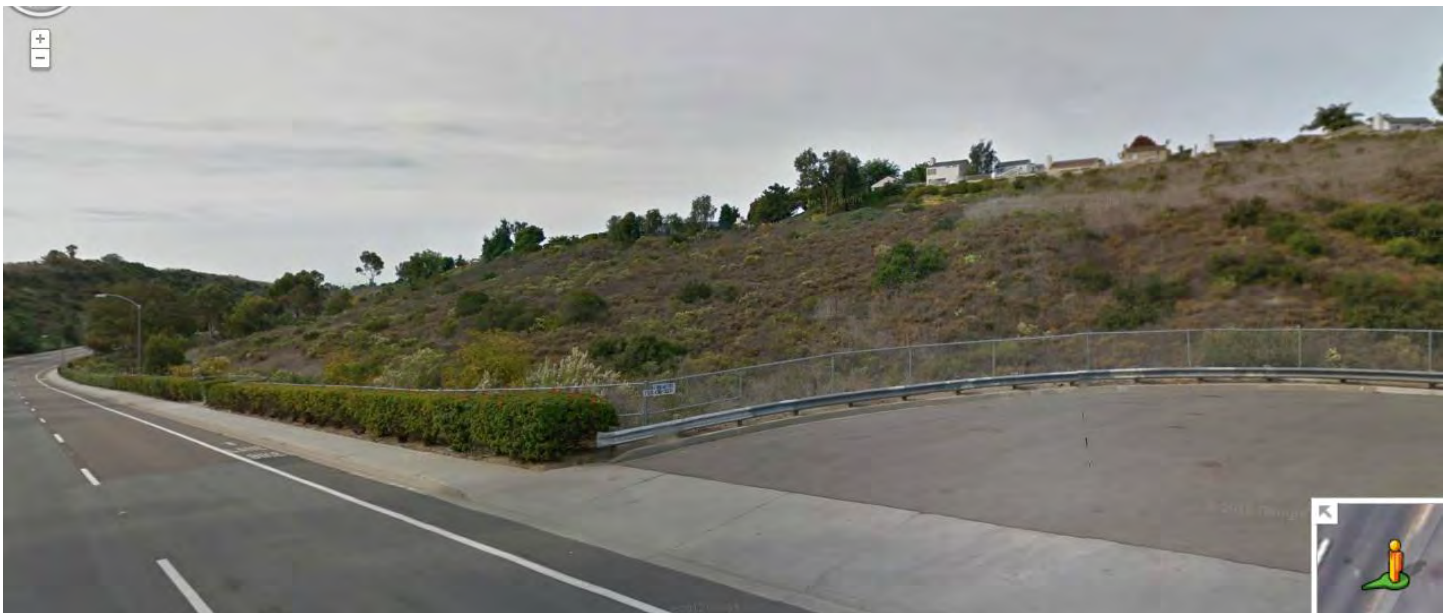
M1-4. End of Glasgow Rd. Will this be extended? If so, when and for how long?

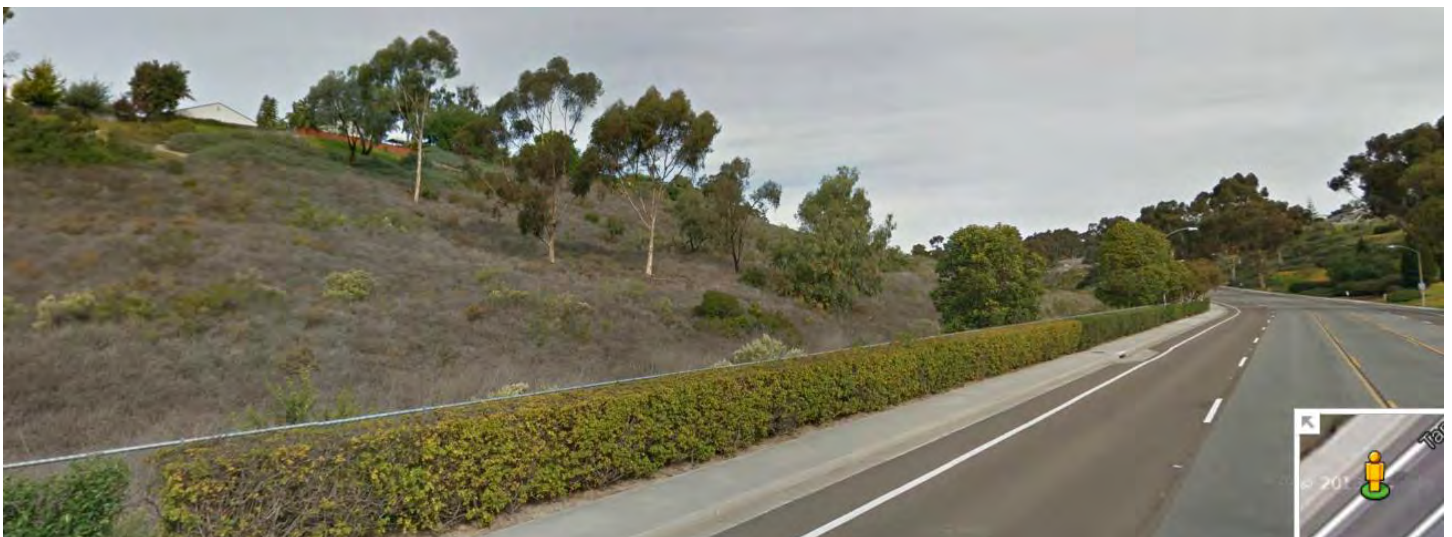
M1-4. Along Tamarack Ave showing low chain-link fence.

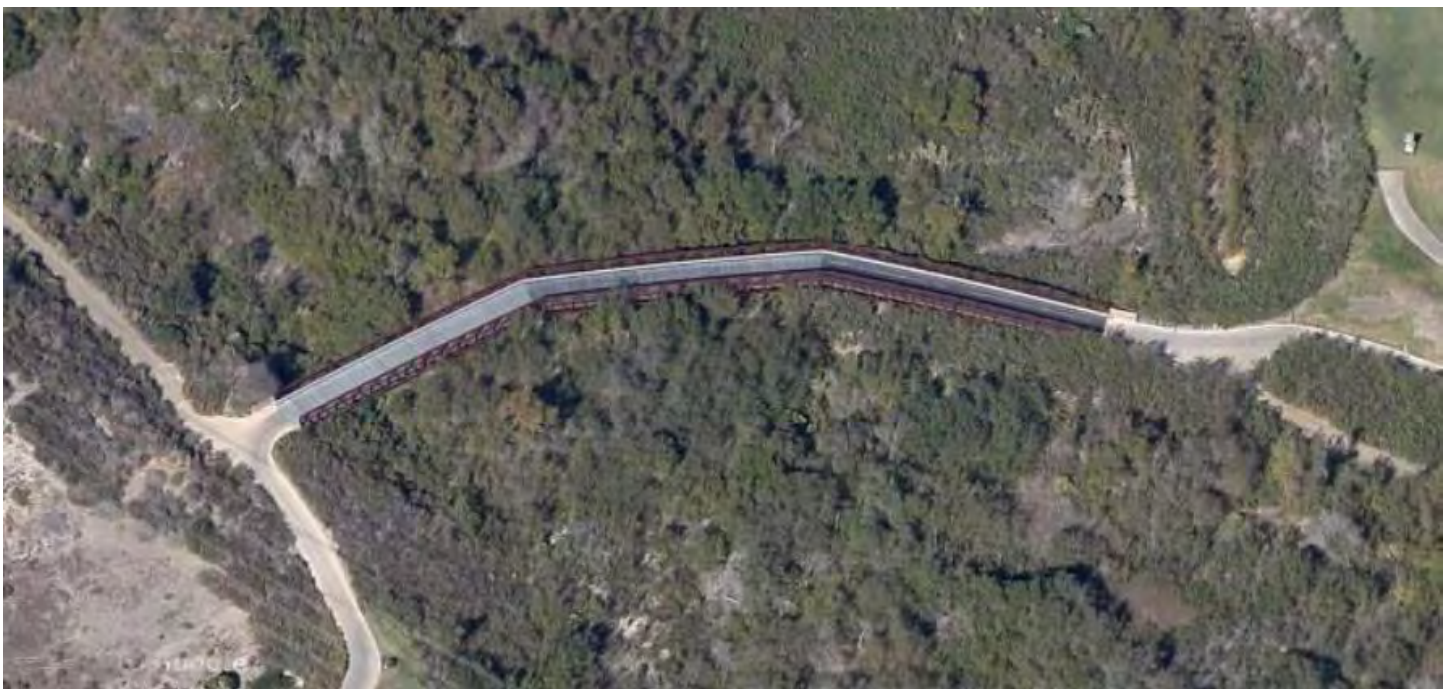
CC2-2- bridge for golf cart traffic. Not likely to be impediment to movement.

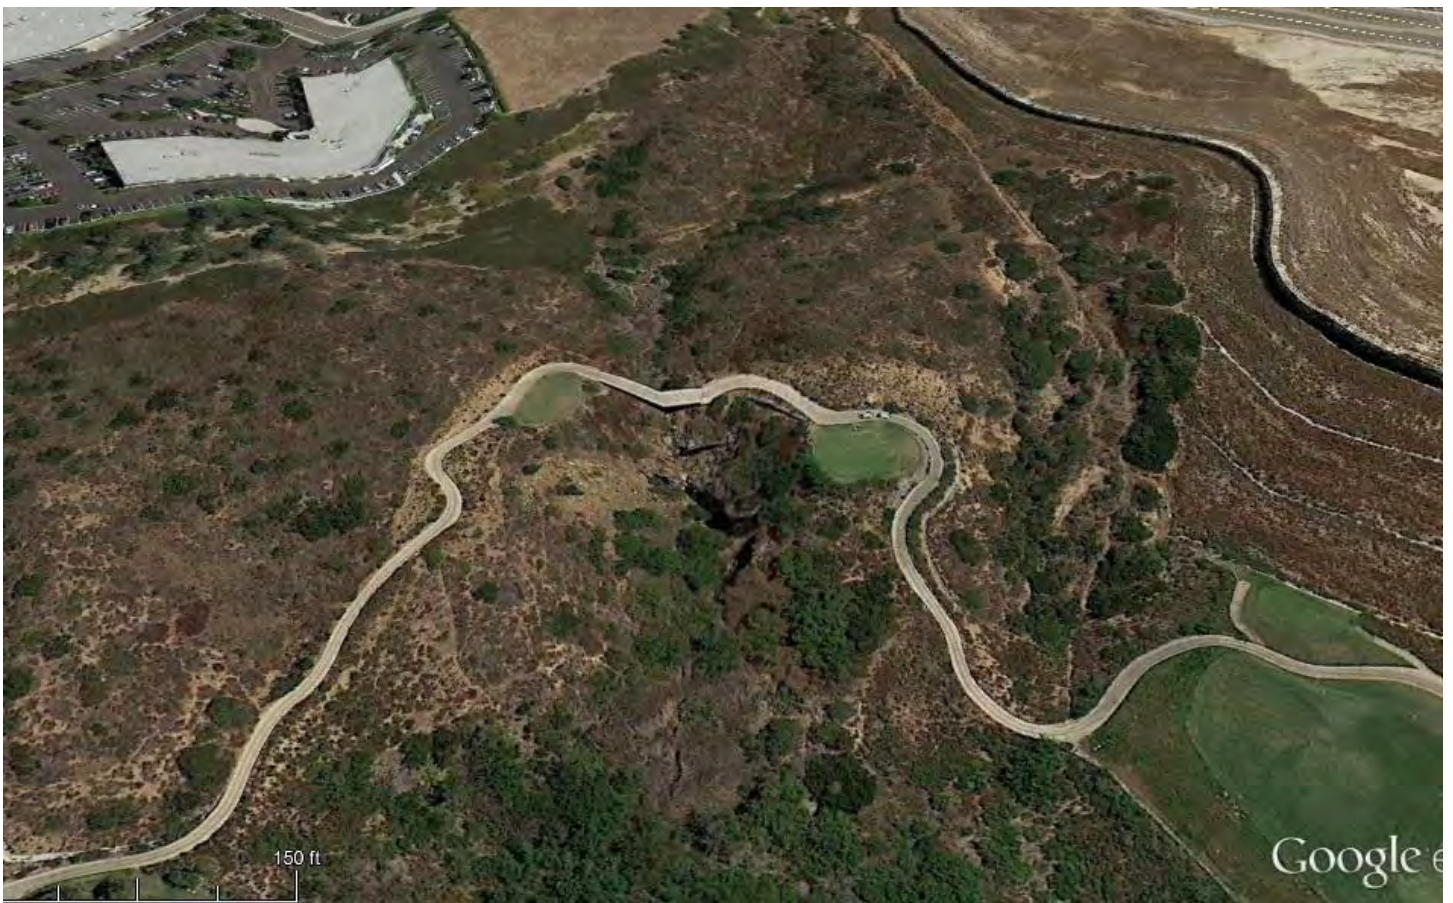
CC2-2. Far eastern end (facing E) of The Crossings Golf Course. Does not appear to be any obstructions to movement.

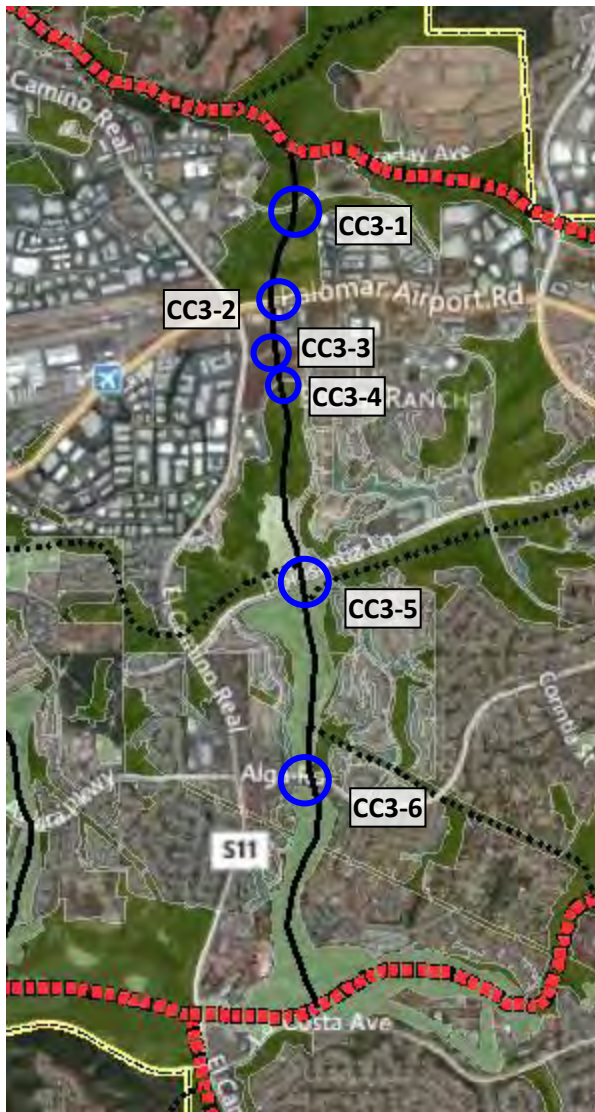
CC3-2. Palomar Airport Rd., near El Camino Real. No undercrossing? Movement highly constrained here.

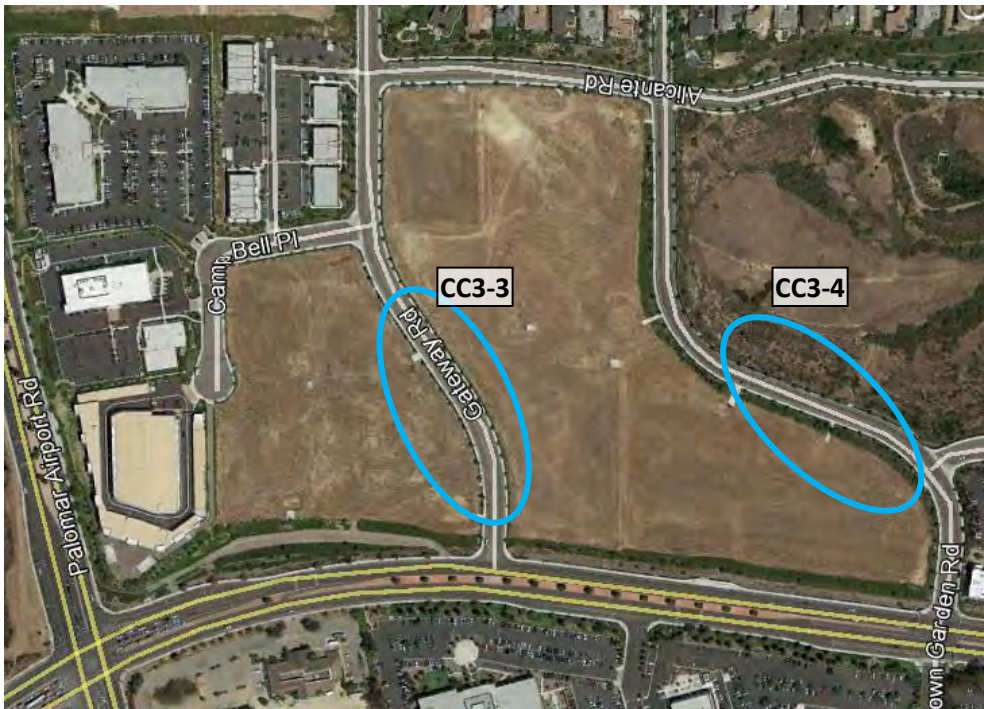
CC3-3. Gateway Rd. Not sure what this area is, but future development could restrict animal movement.

CC3-4. Town Garden Rd. Steep hill south of road. At-grade crossing.

Overview of CC3-3 and CC3-4.

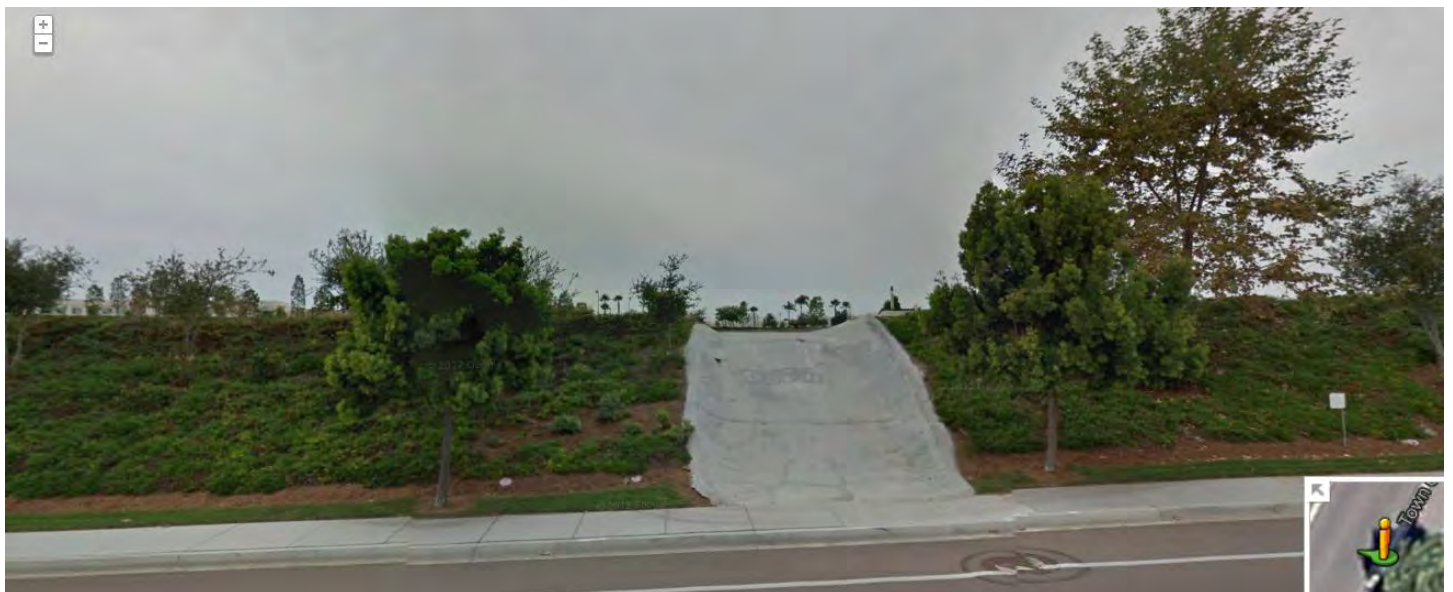
Photos below show CC3, facing W (on Cambell Place), and CC4, facing south, showing drainage structure.

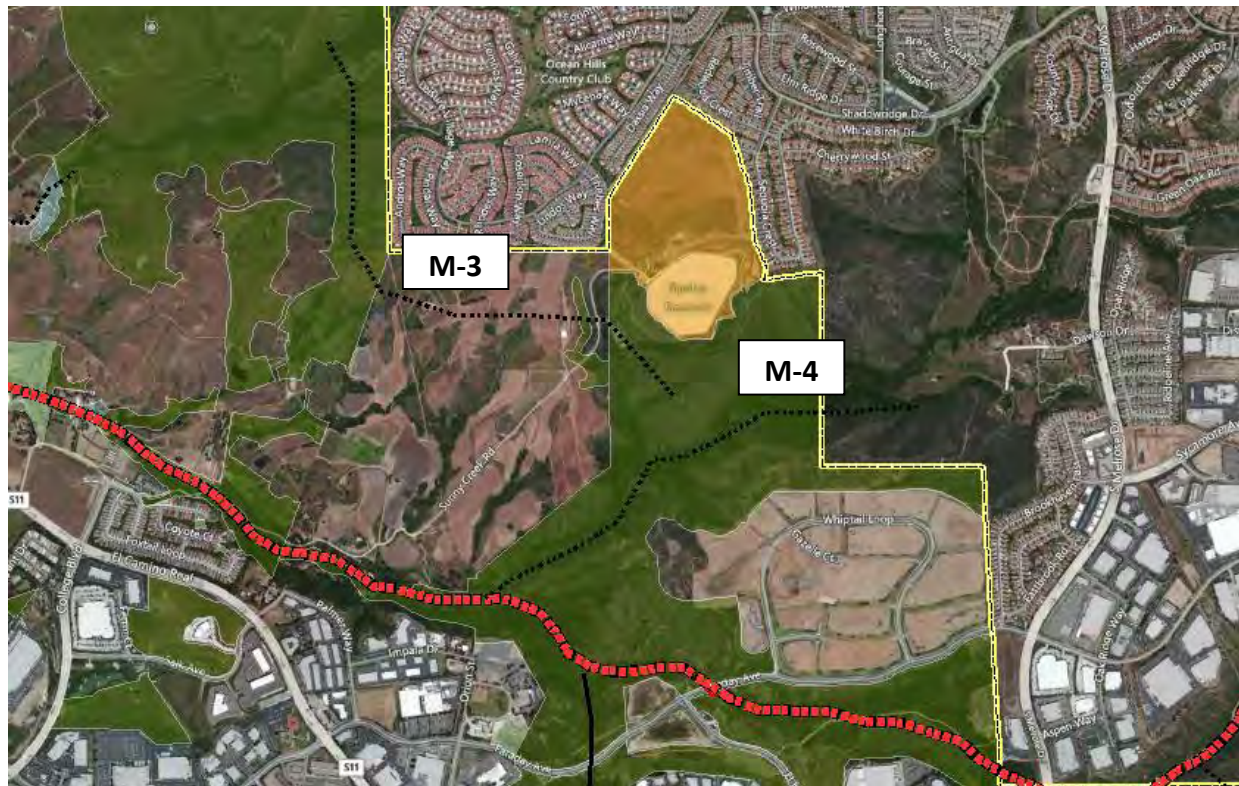
Overview of M3 and M4. Movement between HMP Core Area 3 and Core Area 5 (Link C). No obvious obstructions. Need to check on location of wildlife-proof fencing.

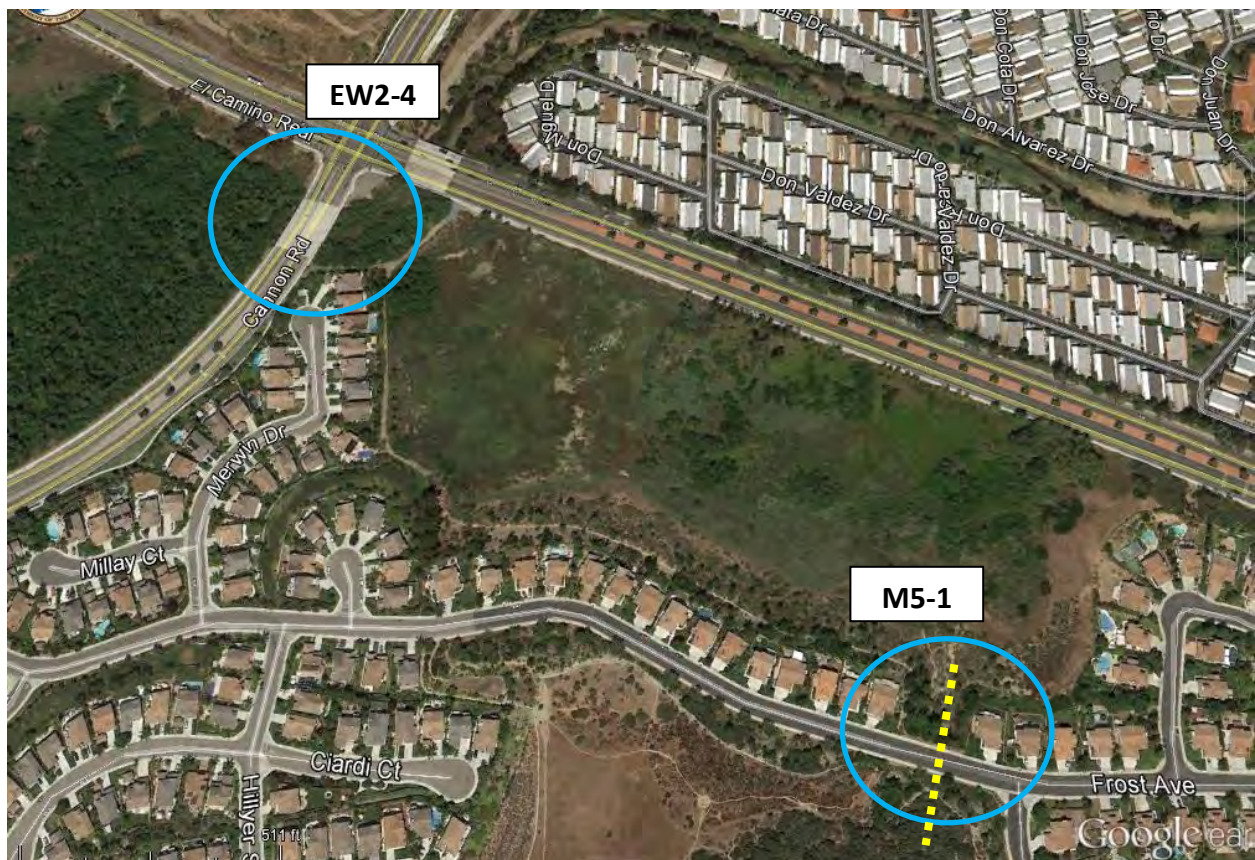
M5-1. Frost Avenue near Longfellow Rd. City GIS data shows culvert here.

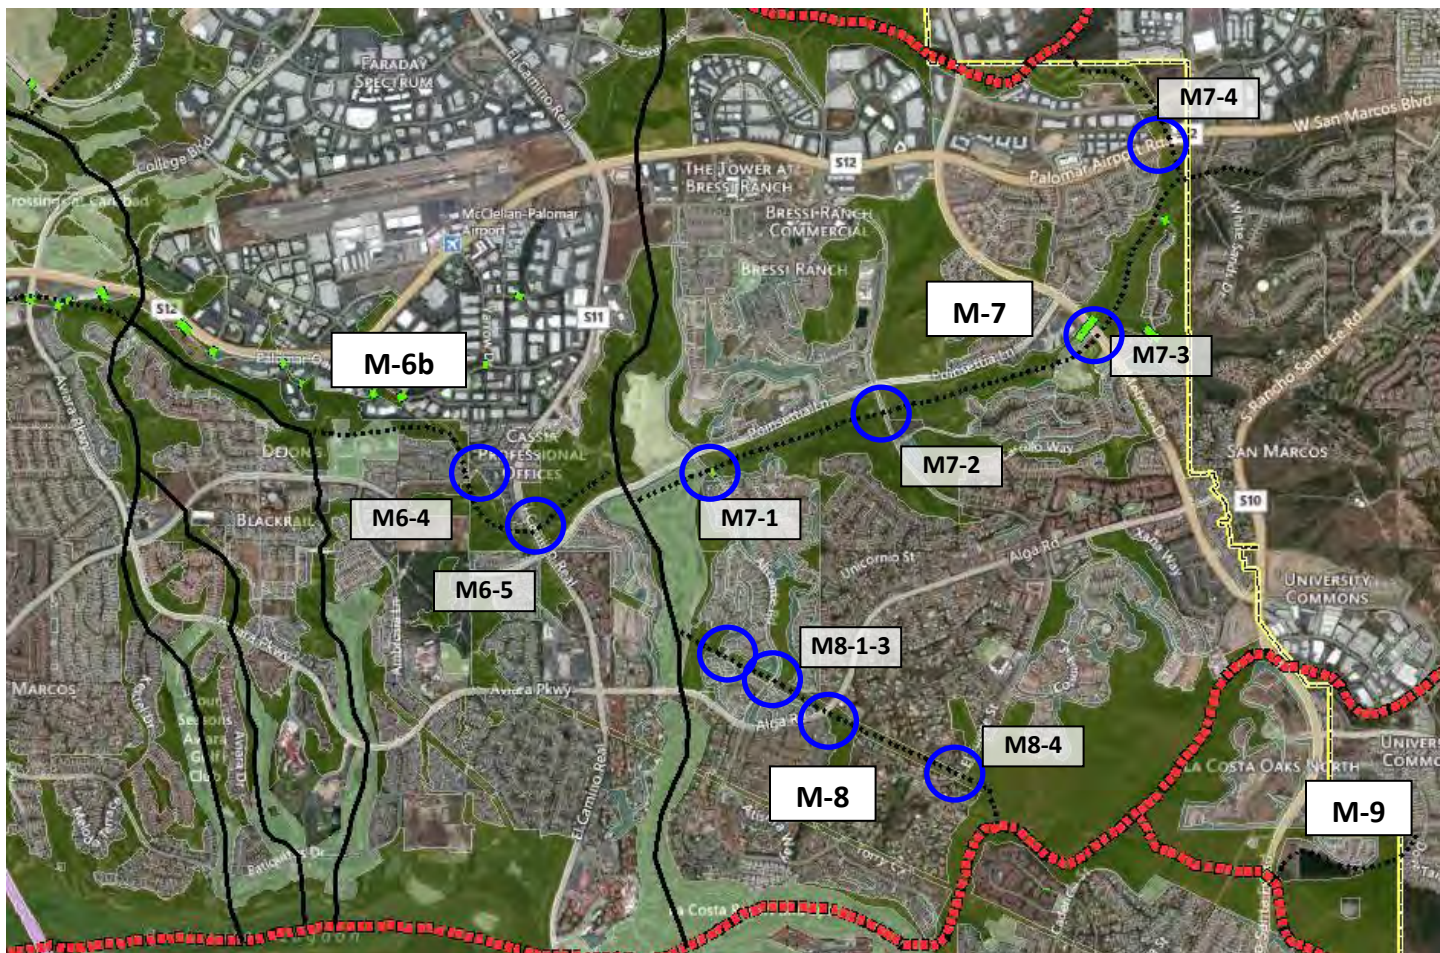
Overview of M7-9. M6-4 Cassia Rd.; M6-5 El Camino Real near Cassia R. M7-1. Alicante Rd; M7-2 El Fuerte St.; M7-3 Melrose Dr.; M7-4 Palomar Airport Rd. M8-1 Goldstone Rd.; M8-2 Alicante Rd.; M8-3 Alga Rd; M8-4 El Fuerte St. near Babilonia St. M9 – no obvious barriers.

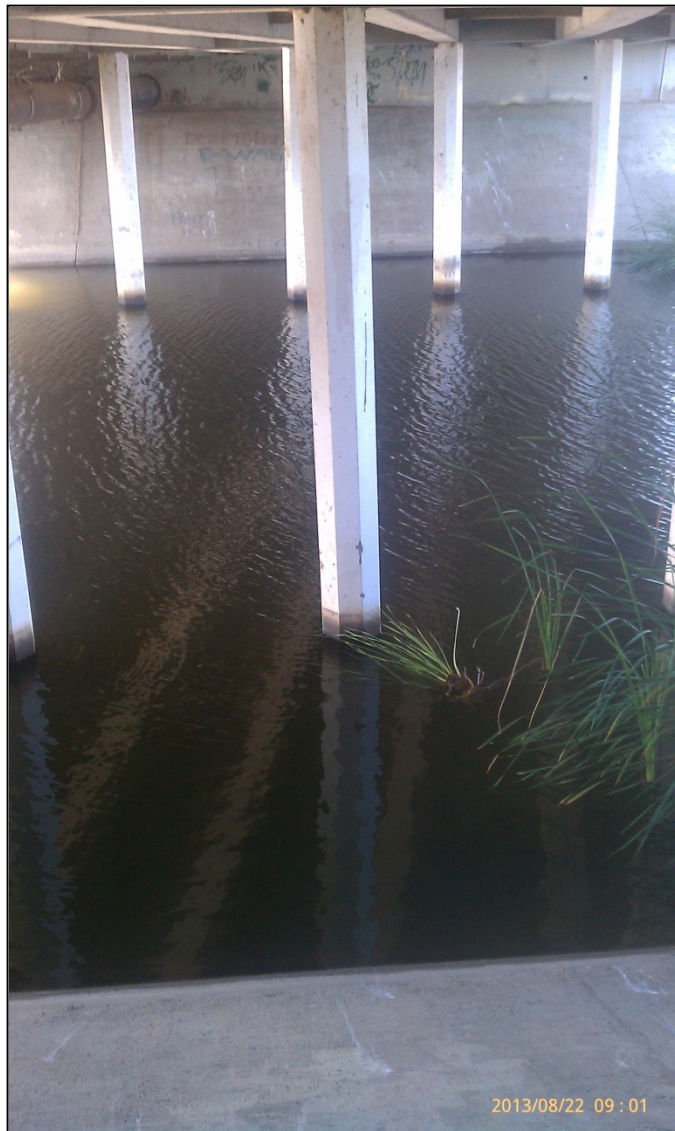
EW1-3, interior looking south from N side, August 2013.

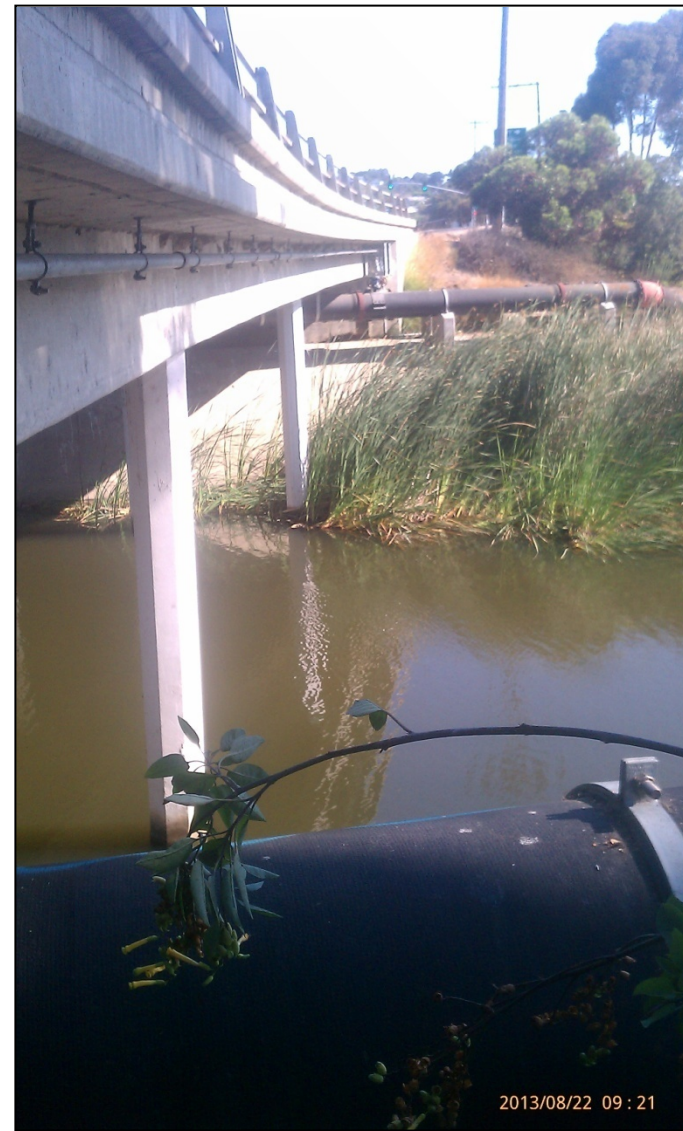
EW1-3, looking south along east entrance, August 2013
